DEPARTMENT OF TRANSPORTATION

Quality Assurance and Source Inspection

Contract #: 04-0120F4Cty: SF/ALA Rte: 80 PM: 13.2/13.9File #: 78.28**WELDING INSPECTION REPORT****Resident Engineer:** Casey, William**Address:** 333 Burma Road**City:** Oakland, CA 94607**Report No:** WIR-030088**Date Inspected:** 02-Oct-2013**Project Name:** SAS Superstructure**OSM Arrival Time:** 1430**Prime Contractor:** American Bridge/Fluor Enterprises, a JV**OSM Departure Time:** 2300**Contractor:** Steward Machine Co.**Location:** Birmingham, AL**CWI Name:** Fred Hudson**CWI Present:** Yes No**Inspected CWI report:** Yes No N/A**Rod Oven in Use:** Yes No N/A**Electrode to specification:** Yes No N/A**Weld Procedures Followed:** Yes No N/A**Qualified Welders:** Yes No N/A**Verified Joint Fit-up:** Yes No N/A**Approved Drawings:** Yes No N/A**Approved WPS:** Yes No N/A**Delayed / Cancelled:** Yes No N/A**Bridge No:** 34-0006**Component:** E2 Shear Key Anchorages**Summary of Items Observed:**

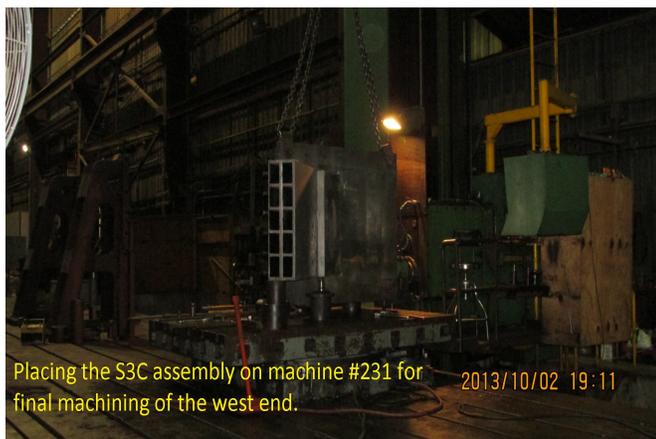
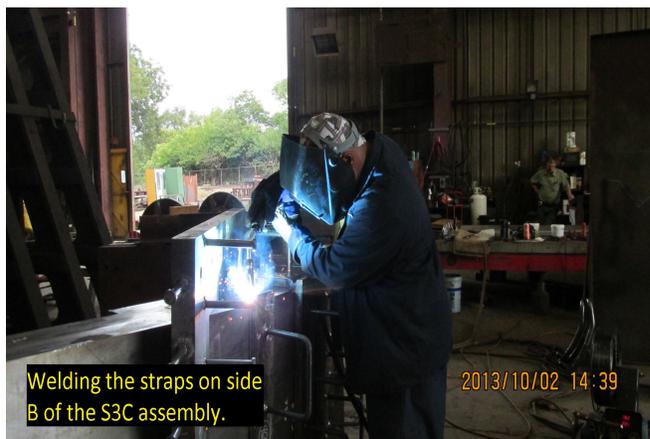
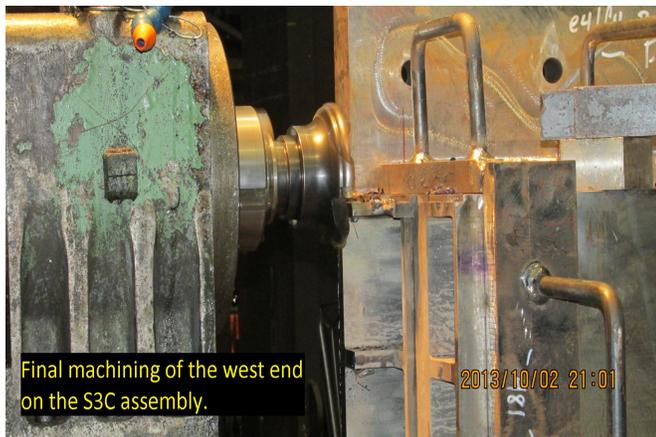
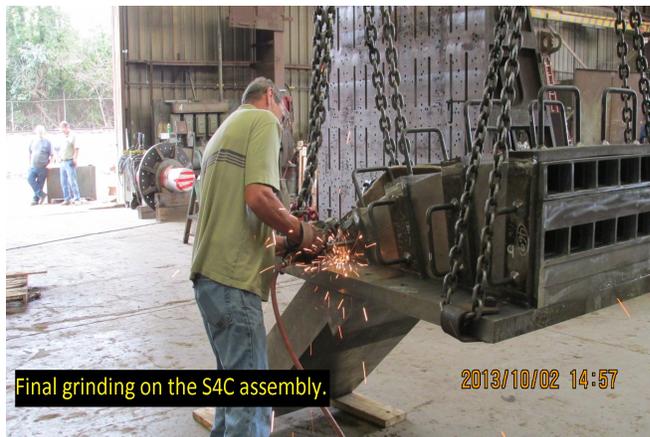
CNC Machine #231 milling assembly S3C. (Machining west end)

This QAI noted the above mentioned assembly having the final grinding being done in preparation for blast and paint. This QAI was informed that the final MPT as well as the blast and paint of this assembly will take place tomorrow.

This QAI noted the above mentioned assembly having the straps welded. The welding was being done on side B of the assembly. The welding was done by qualified welder Jeffery Hennington (476). The welding was done to

the approved welding procedure (WPS) P2-W126-B. All welding done was monitored by Certified Welding Inspector (CWI) Fred Hudson.

This QAI noted the above mentioned assembly was cut from the stand and moved to machine #231 for final machining on the west end of the assembly. This QAI was informed that the strap welds on side A would be completed after machining the west end.
