**DEPARTMENT OF TRANSPORTATION**

Contract #: 04-0120F4Cty: SF/ALA Rte: 80 PM: 13.2/13.9File #: 78.28**WELDING INSPECTION REPORT****Resident Engineer:** Casey, William**Address:** 333 Burma Road**City:** Oakland, CA 94607**Report No:** WIR-030090**Date Inspected:** 02-Oct-2013**Project Name:** SAS Superstructure**OSM Arrival Time:** 630**Prime Contractor:** American Bridge/Fluor Enterprises, a JV**OSM Departure Time:** 1500**Contractor:** Steward Machine Co.**Location:** Birmingham, AL**CWI Name:** Fred Hudson**CWI Present:** Yes No**Inspected CWI report:** Yes No N/A**Rod Oven in Use:** Yes No N/A**Electrode to specification:** Yes No N/A**Weld Procedures Followed:** Yes No N/A**Qualified Welders:** Yes No N/A**Verified Joint Fit-up:** Yes No N/A**Approved Drawings:** Yes No N/A**Approved WPS:** Yes No N/A**Delayed / Cancelled:** Yes No N/A**Bridge No:** 34-0006**Component:** E2 Shear Key Anchorages**Summary of Items Observed:**

# WELDING INSPECTION REPORT

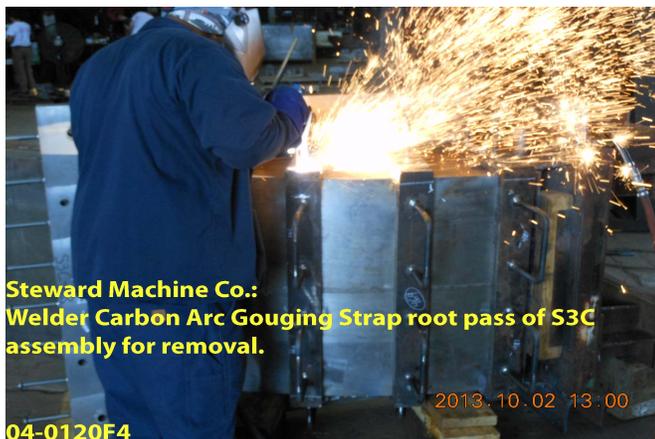
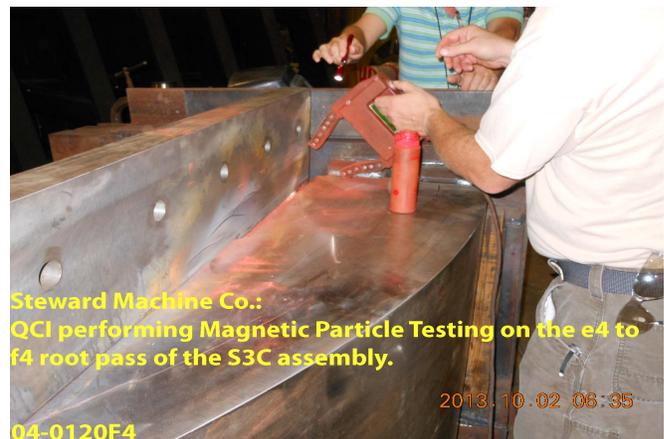
- Side A, Indication Excavations MT and Weld Repair Final MT. (MT acceptable)
- Side A, Final MT. (MT acceptable)
- Side A & B, e3 to f3 root pass. (MT acceptable)
- Side A & B, e3 to f3 final MT. (MT acceptable)
- Side A, Strap root pass x8. (MT acceptable)
- Side A, s3 fillet welds x6. (MT acceptable)
- West End, Final MT. (MT acceptable)

The QAI noted that the S4C assembly showed signs of mismatch in way of the bottom end of the assembly. Plates showing the mismatch were plates S4C-e4, S4C-f4 & S4C-g4. The plate mismatch ranged from 1.4mm to 5.2 mm. The QAI inquired of the QCI if he was aware of the issue and the QCI replied he was and that a Non-conformance Materials Report (NCRM) has been submitted. The issue was also brought to the attention of the SMR onsite who replied she will forward the information for clarification.
