Contract #: 04-0120F4Cty: SF/ALA Rte: 80 PM: 13.2/13.9File #: 99.28**WELDING INSPECTION REPORT**

Report No: WIR-030106
Date Inspected: 02-Oct-2013

Project Name: SAS Superstructure **OSM Arrival Time:** 700
Prime Contractor: American Bridge/Fluor Enterprises, a JV **OSM Departure Time:** 1730
Contractor: American Bridge/Fluor Enterprises, a JV **Location:** Job Site

CWI Name:	Tony Sherwood, Bernie Docena	CWI Present:	Yes	No
Inspected CWI report:	Yes No N/A	Rod Oven in Use:	Yes	No N/A
Electrode to specification:	Yes No N/A	Weld Procedures Followed:	Yes	No N/A
Qualified Welders:	Yes No N/A	Verified Joint Fit-up:	Yes	No N/A
Approved Drawings:	Yes No N/A	Approved WPS:	Yes	No N/A
		Delayed / Cancelled:	Yes	No N/A
Bridge No:	34-0006	Component:	SAS Tower

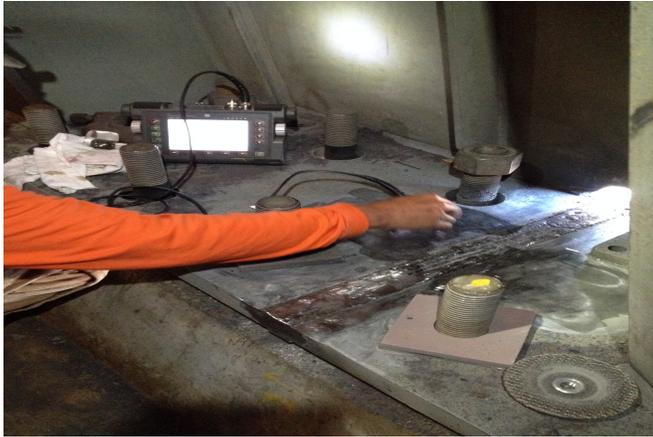
Weld crowns of CJP welds are in the as welded condition with 1/16" reinforcing on face side. QA Inspector observed QCI perform UT inspection on approximately 25% of CJP weld #002, QC deemed results acceptable, inspected at 1600 hours. Reference QA NDT reports for details.

QC UT completed weld #002 base plate splice.

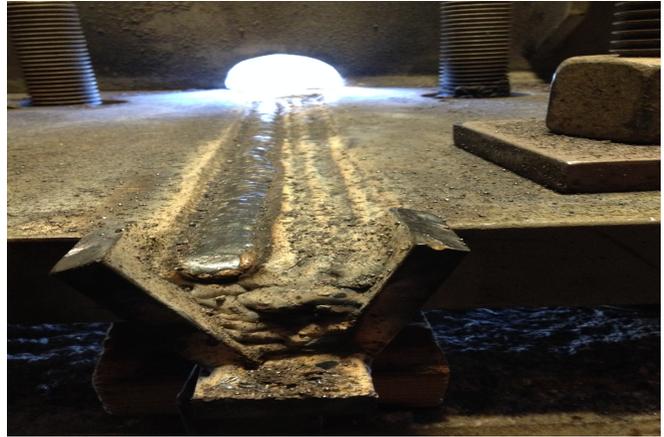
ABF personnel continued fit-up and welding of joints #001 CJP splice welds noted above. WPS #ABF-WPS-D15-2030-1 for flux core arc welding (FCAW) was utilized by QC Inspectors. Approved welder installed stringer passes and operated welding equipment within WPS electrical parameters. Be advised that the backing bar for joint #001 and #002 will remain in place, in accordance with RFI# ABF-RFI-003417R00.

- The weld joint fit-up and alignment was checked with a straight edge and bridge cam gauge.
- Pre-heat was performed with a rosebud torch and verified by QC with temperature stick (250°F).
- Welding was performed by approved welders (Kit Li).
- Electrical parameter check results for Kit Li (20.5 volts / 315 amps).
- The weld procedure and joint details utilized (FWT22) is CJP weld.
- Electrode utilized is FCAW NR-232, .072" diameter.
- Weld passes were de-slugged by grinder and wire wheel.

Weld #001 base Pl. splice prior to removing tabs.
