FHWA/CA/TL-80/03

Highway Operation And Plant Damage

April 1980

Department of Environmental Horticulture
University of California
Davis, CA 95616

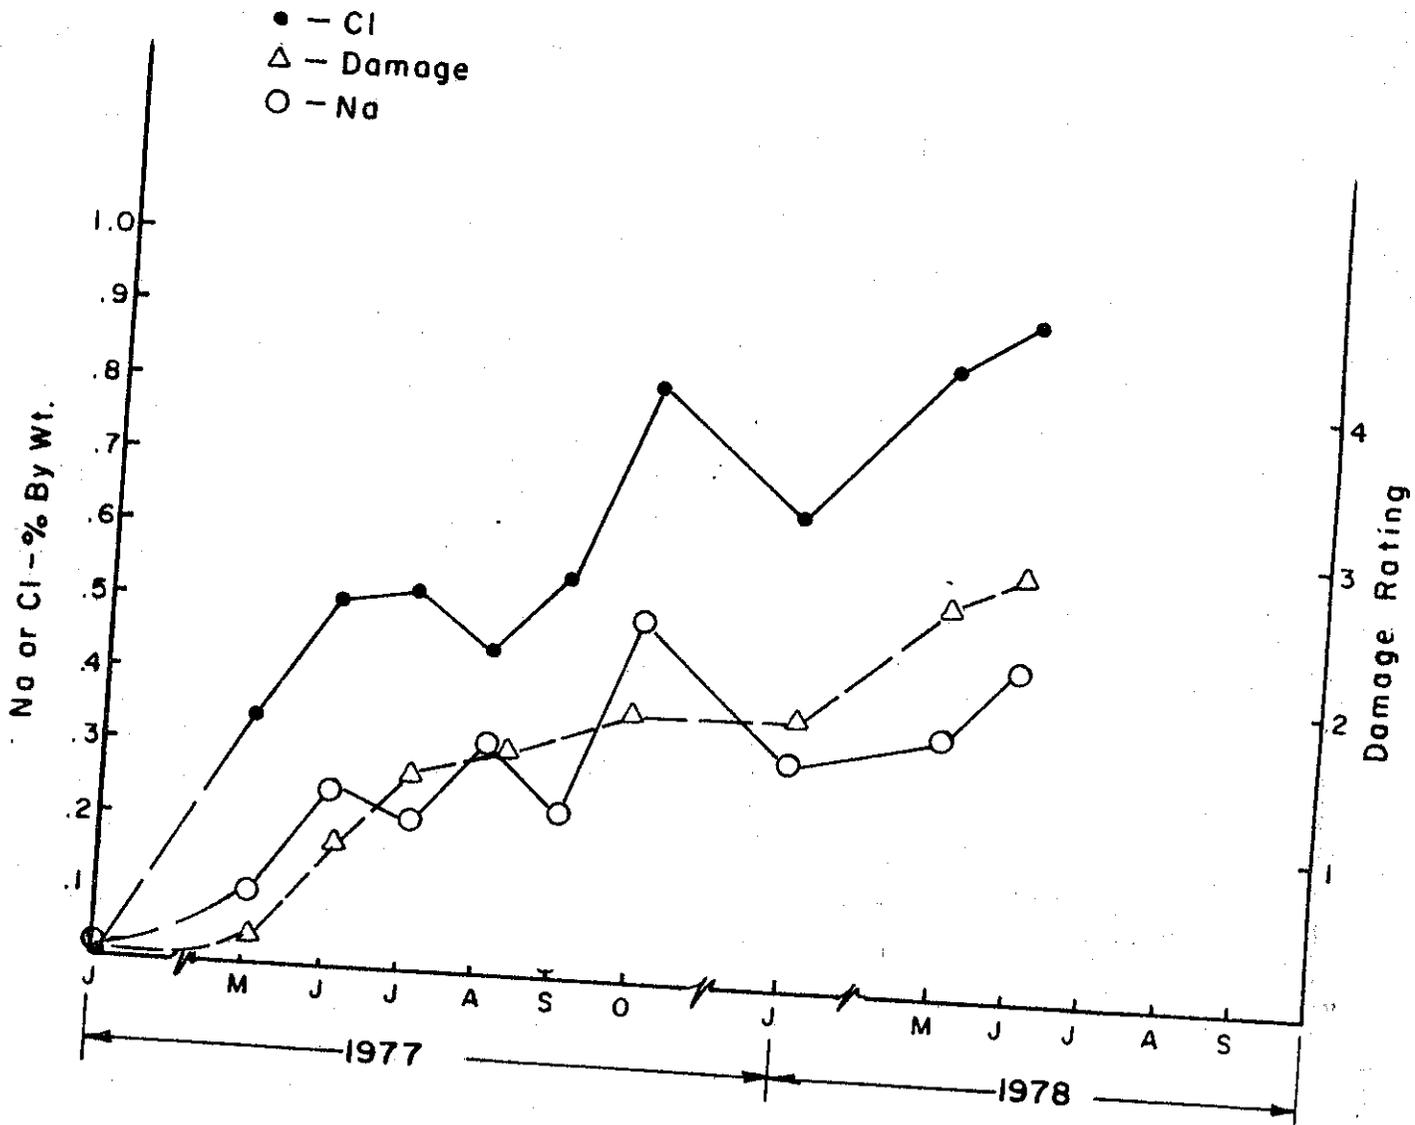
Figure 8. Soil Salt Application Study. Sodium and chloride concentrations and damage ratings for Jeffrey pine in October 1977 as a function of applied salt.

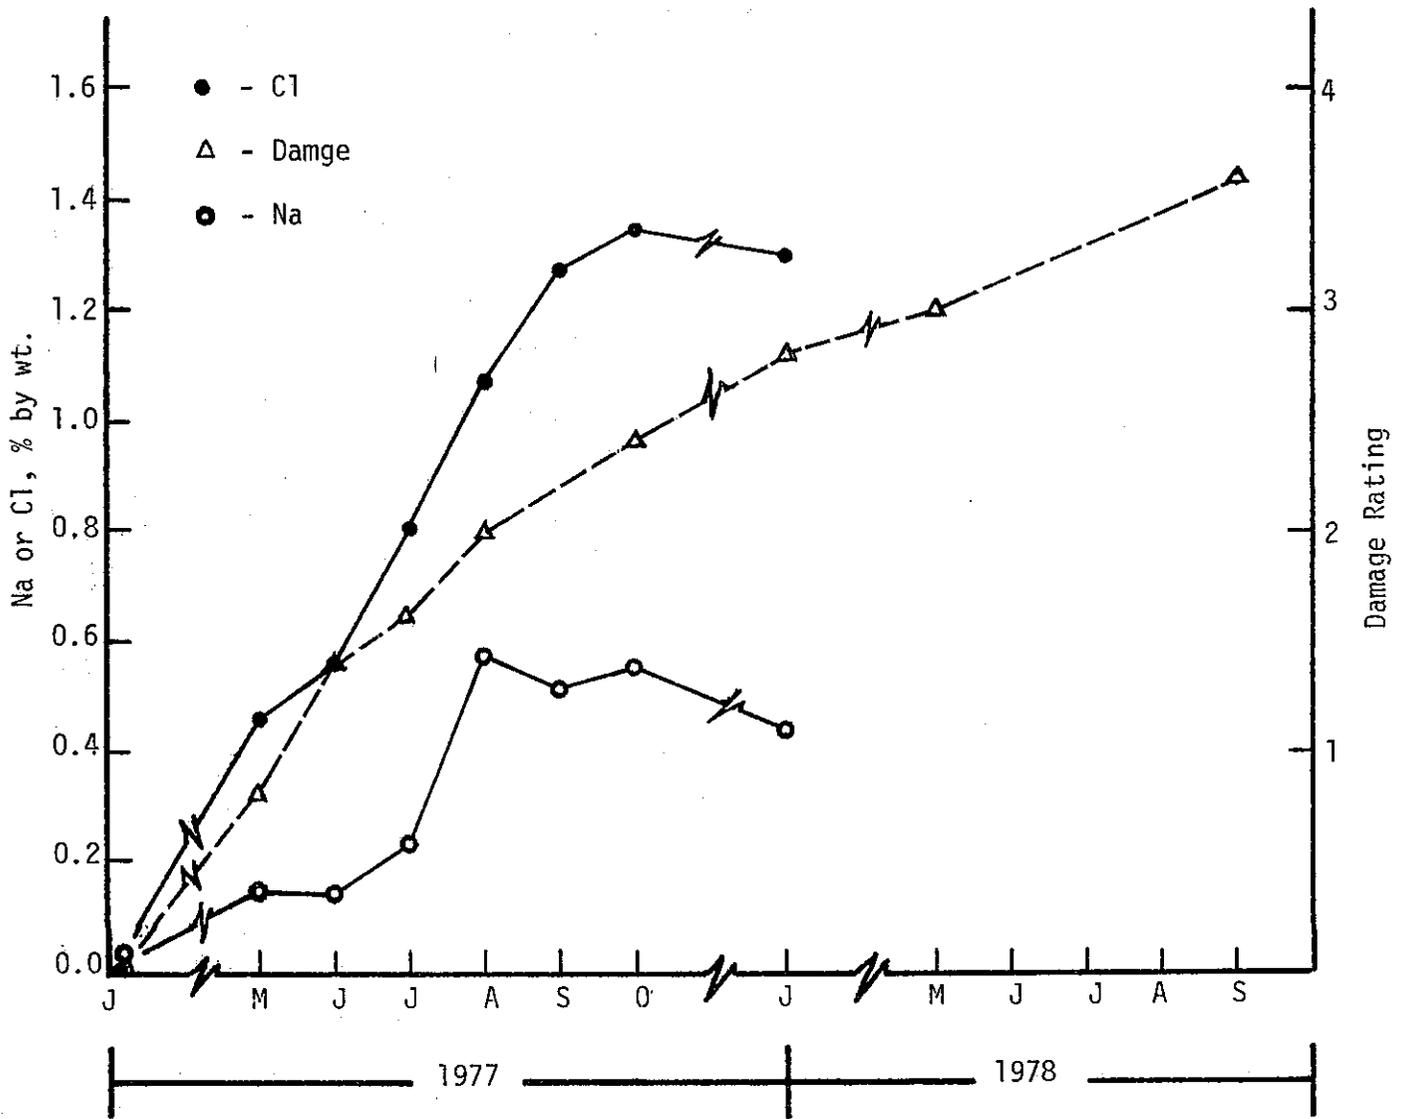
Figure 11. Soil Salt Application Study. Sodium and chloride concentrations and damage ratings for white fir on October 1977 as a function of applied salt.

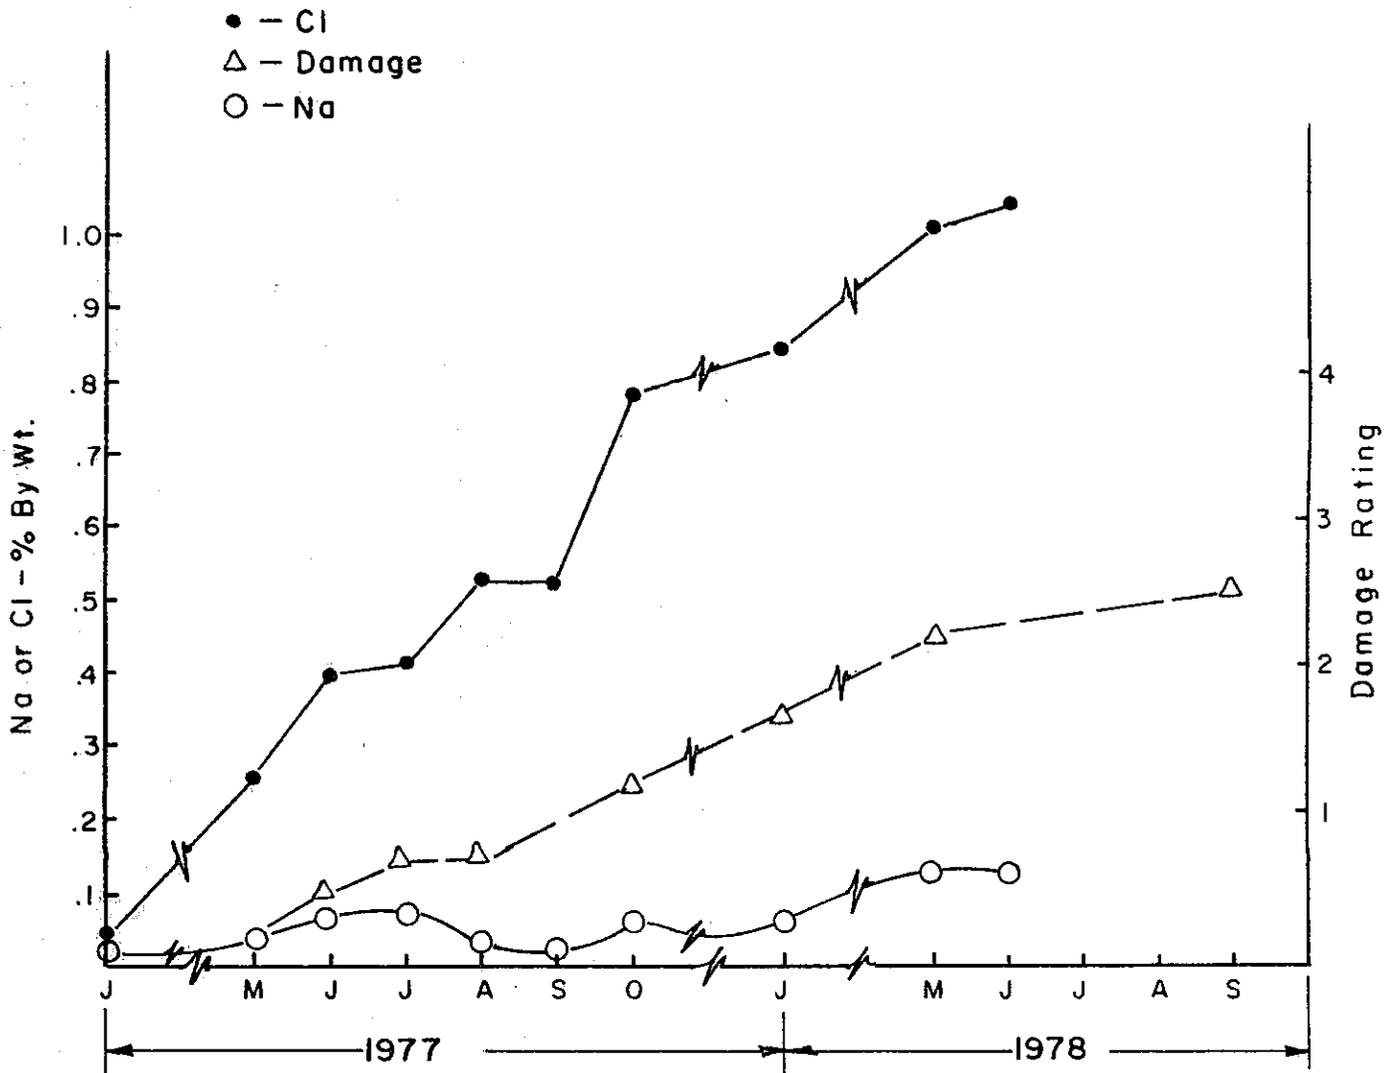
Figure 14. Soil Salt Application Study. Sodium and chloride concentrations and damage ratings for incense cedar in October 1977 as a function of applied salt.

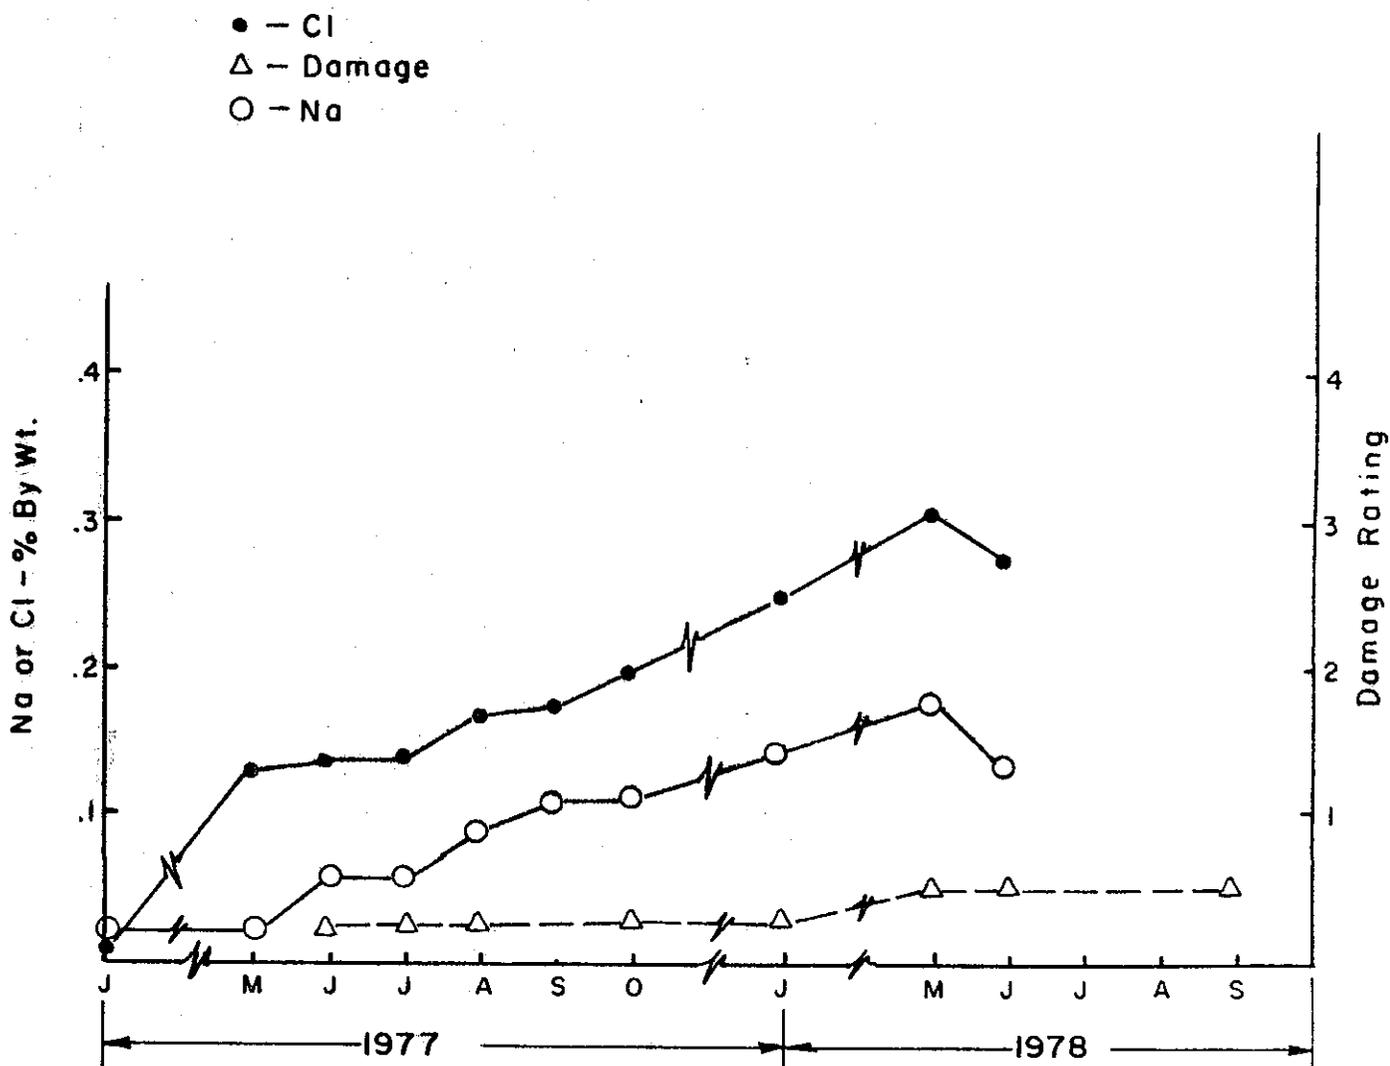
Figure 17. Soil Salt Application Study. Sodium and chloride concentrations and damage ratings for lodgepole pine in October 1977 as a function of applied salt.

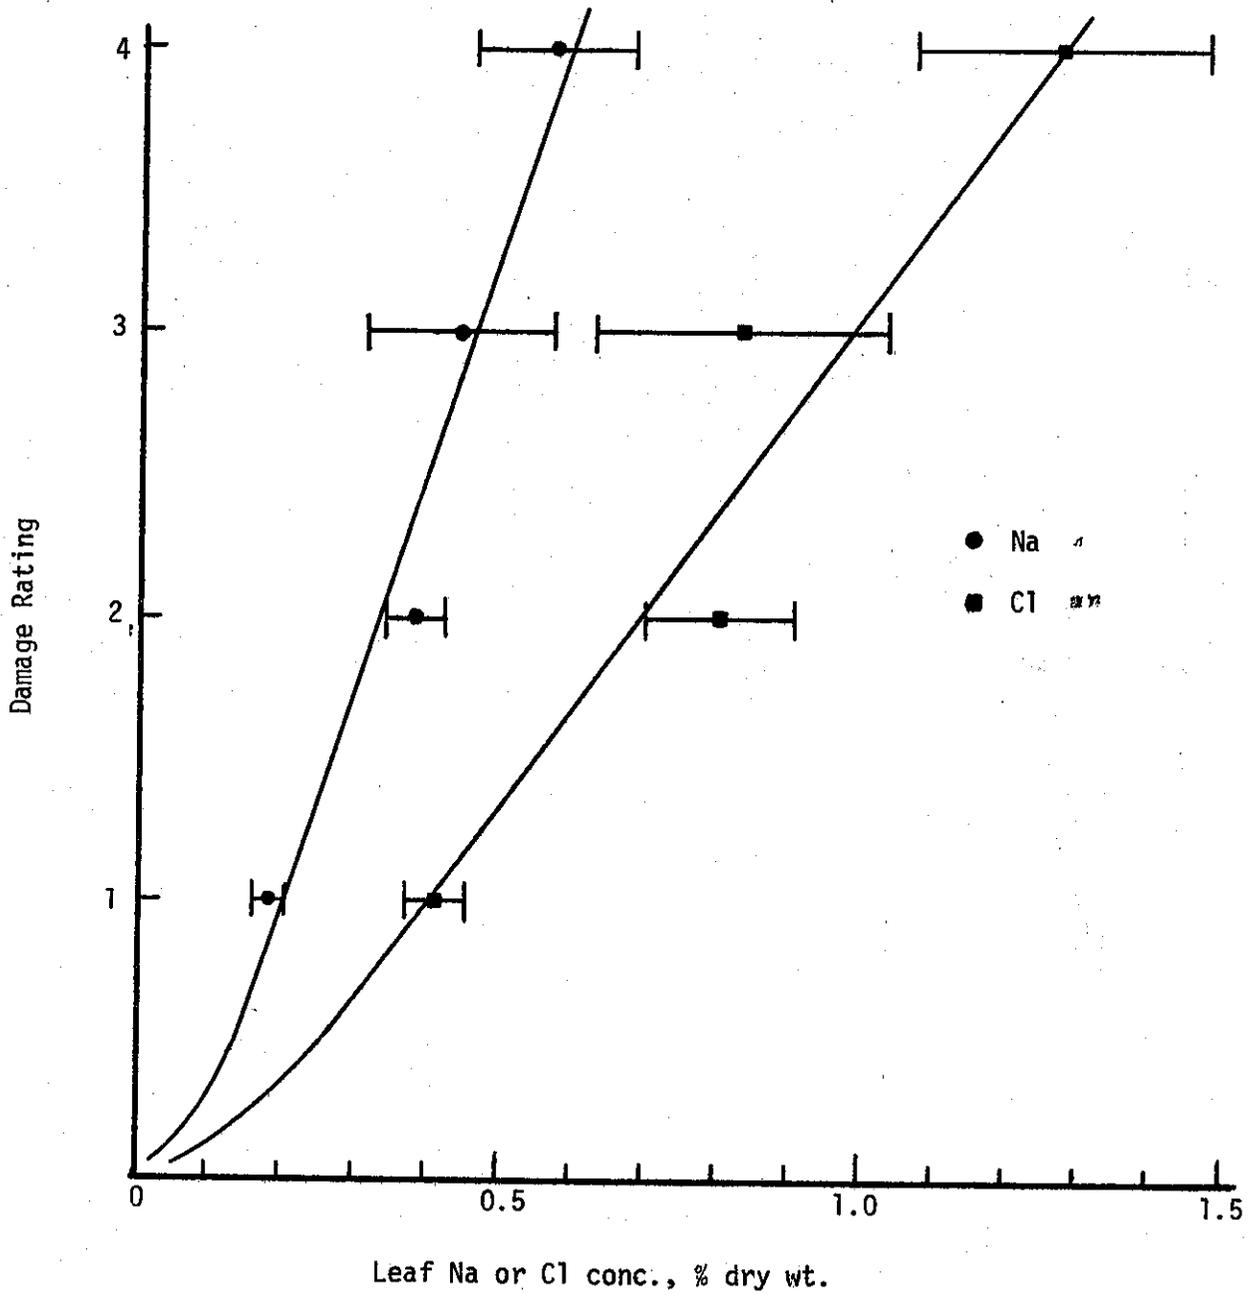
Figure 20. Soil Salt Application Study. Damage rating in white fir as a function of leaf sodium and chloride concentrations for individual tree data. Concentrations at 0.5-1 damage ratings are estimated threshold levels.

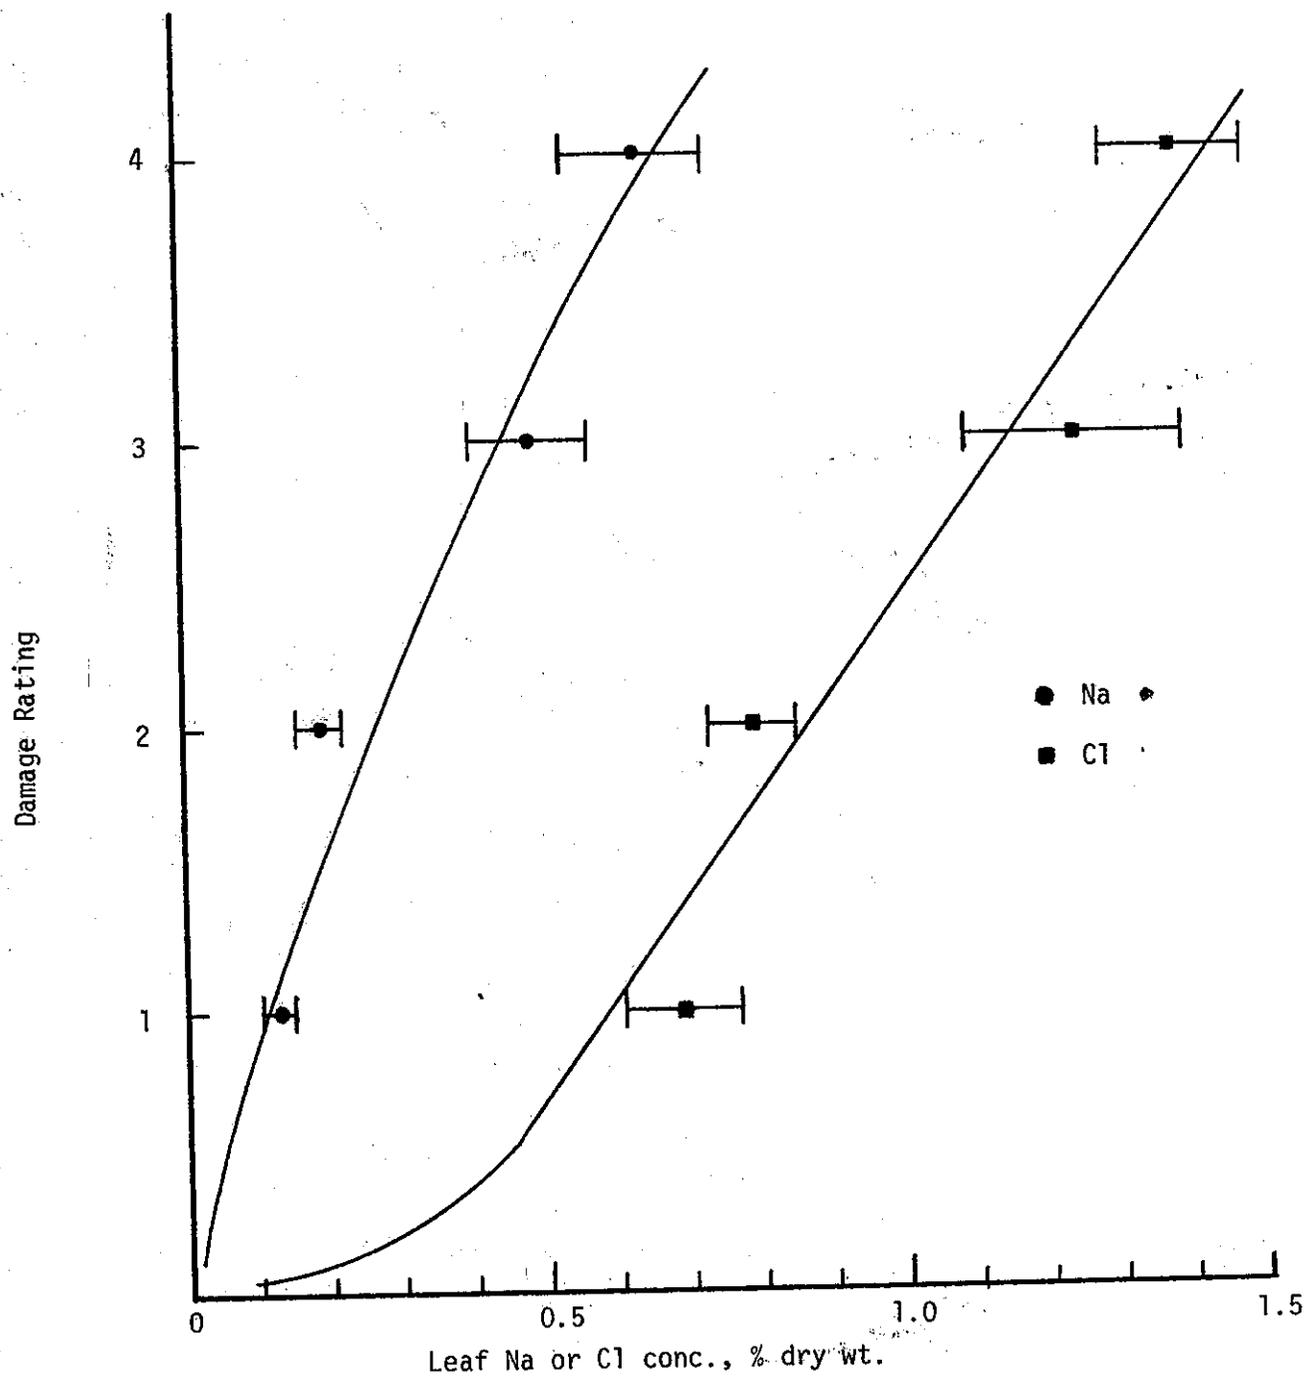
Figure 21. Soil Salt Application Study. Damage rating in incense cedar as a function of leaf sodium and chloride concentrations for individual tree data. Concentrations at 0.5-1 damage ratings are estimated threshold levels.

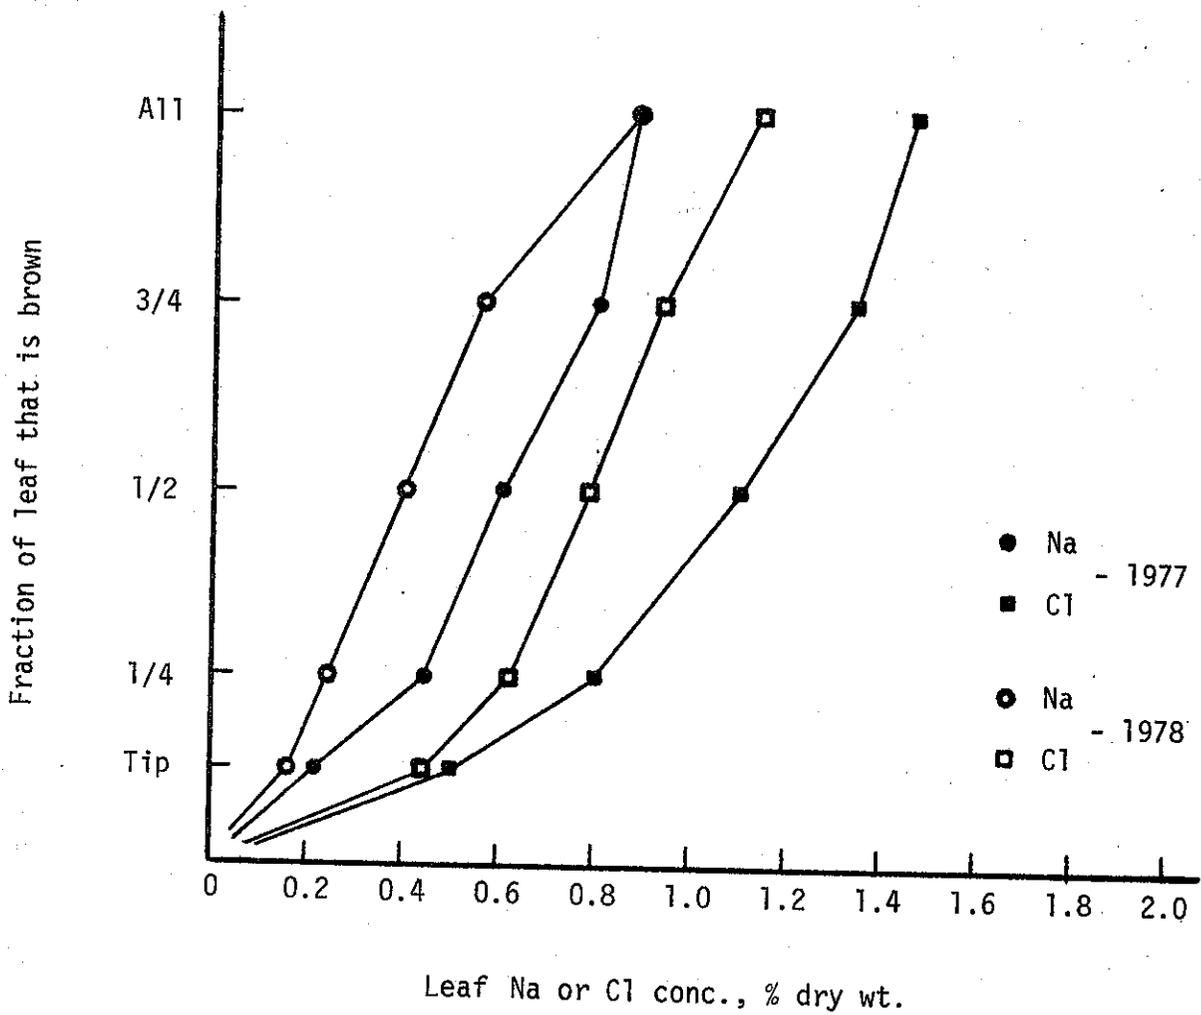
Figure 23. Soil Salt Application Study. Leaf sodium and chloride concentrations in white fir at different fractions of leaf browning.

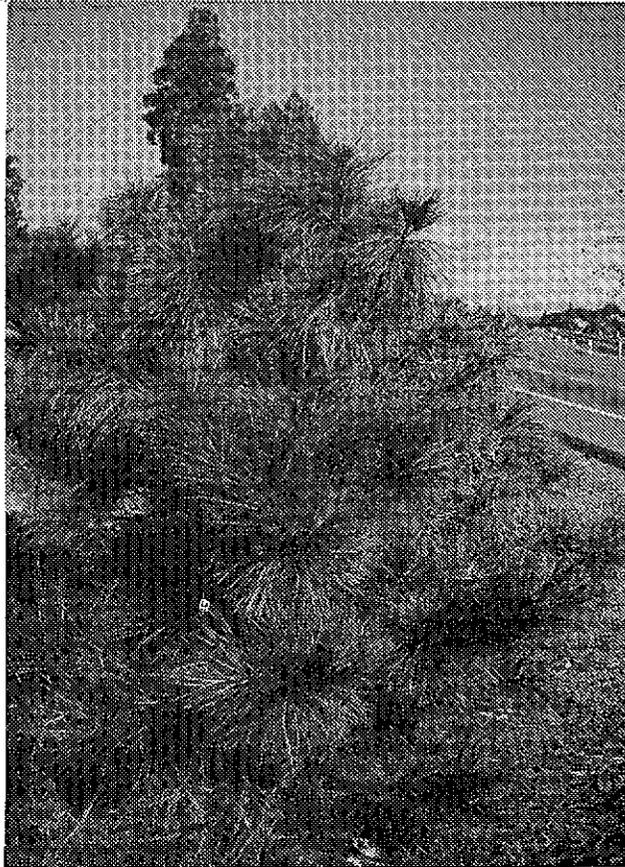
Photo 2. Beetle Damage. Symptoms in young Jeffrey pine, spreading basipetally (top to bottom) in tree. The tips and top branches are affected first.

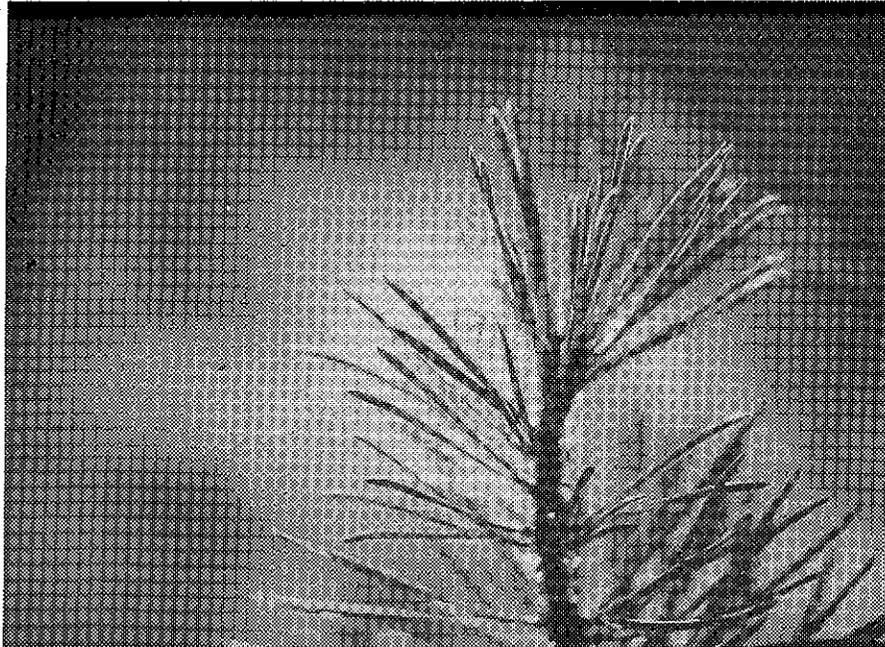
Photo 3. Beetle Damage. Symptoms in needles of Lodgepole pine develop acropetally (base to tip) in needles but basipetally in branches and tree.

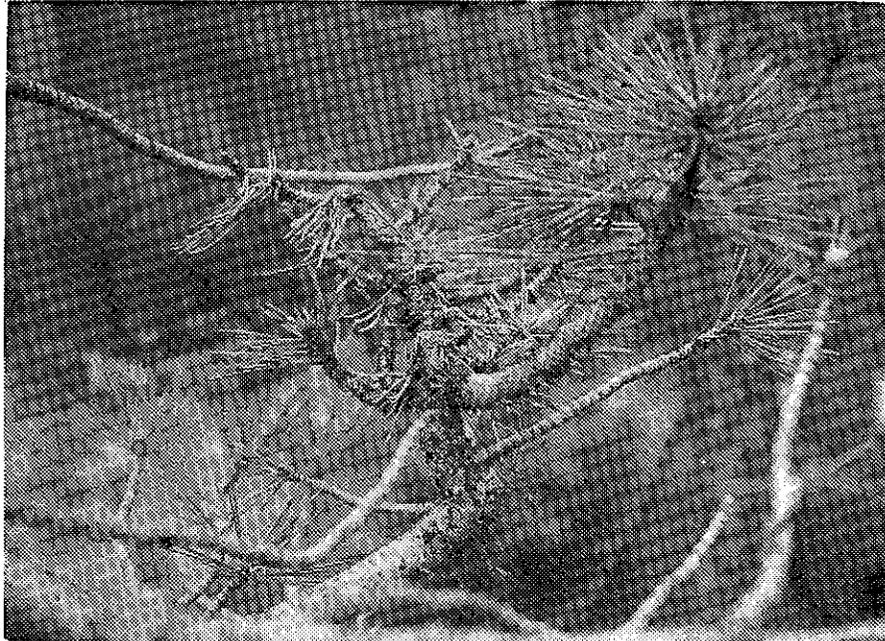
Photo 4. Mistletoe. Severe damage on Jeffrey pine caused by dwarf mistletoe; defoliation of older needles, dwarfing of younger needles, and swelling of branches.

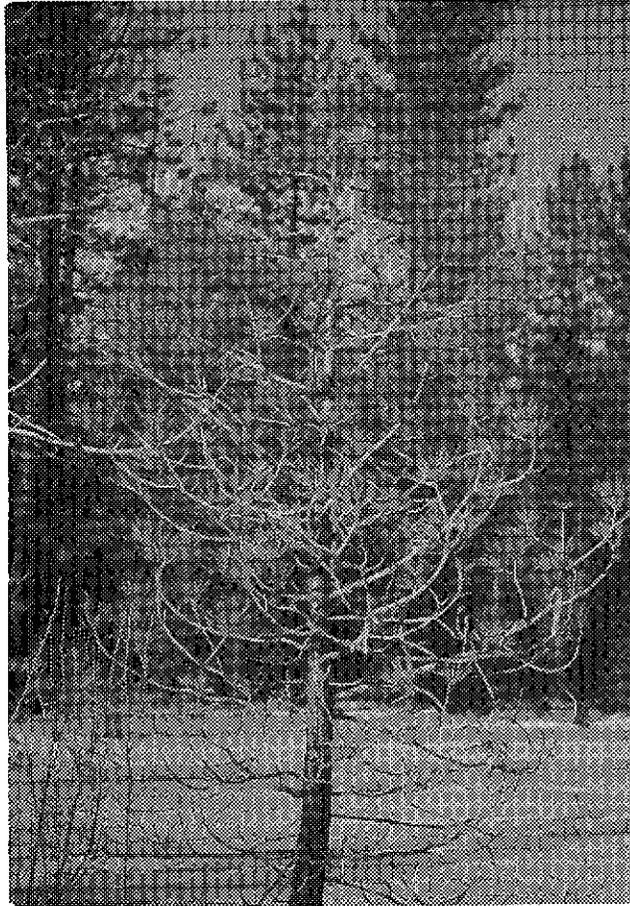
Photo 5. Salt Damage. Jeffrey pine treated with 5.33 T/A NaCl in 1977, photographed in January 1978. Damage is spreading acropetally (base to top) in the tree.

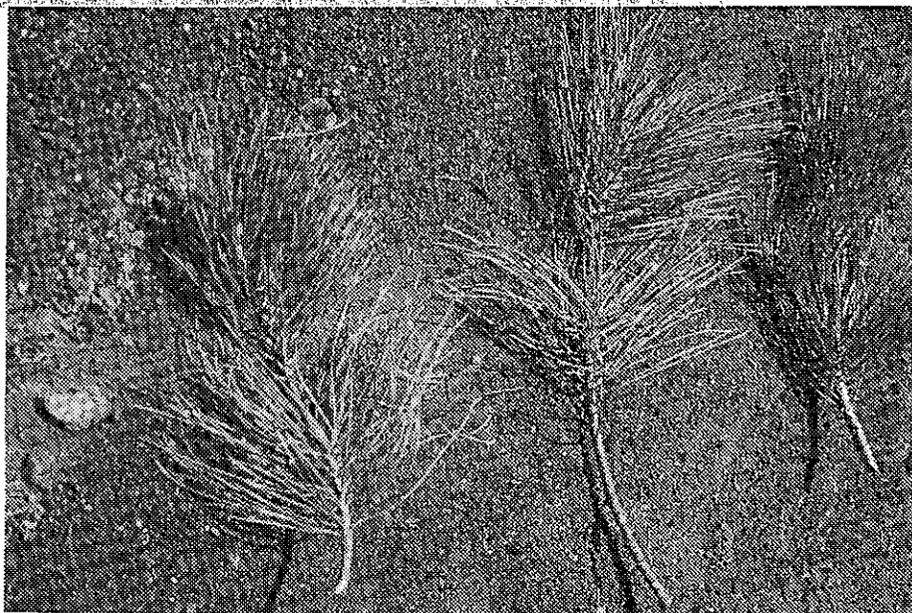
Photo 6. Salt Damage. Jeffrey pine needle damage spreads basipetally (tip to base) in needles. Left to right: 50, 25, and 0% damage (damage ratings of 2, 1, and 0).

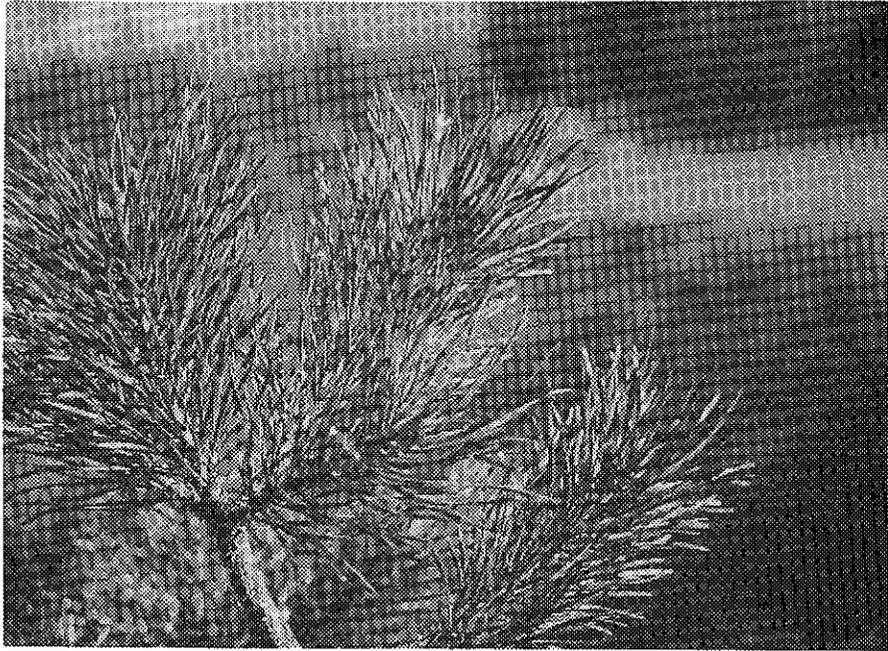
Photo 7. Salt Damage. Lodgepole pine treated with 2.67 T/A NaCl in 1977, photographed October 1977. Damage spreads basipetally (tip to base) in needles.

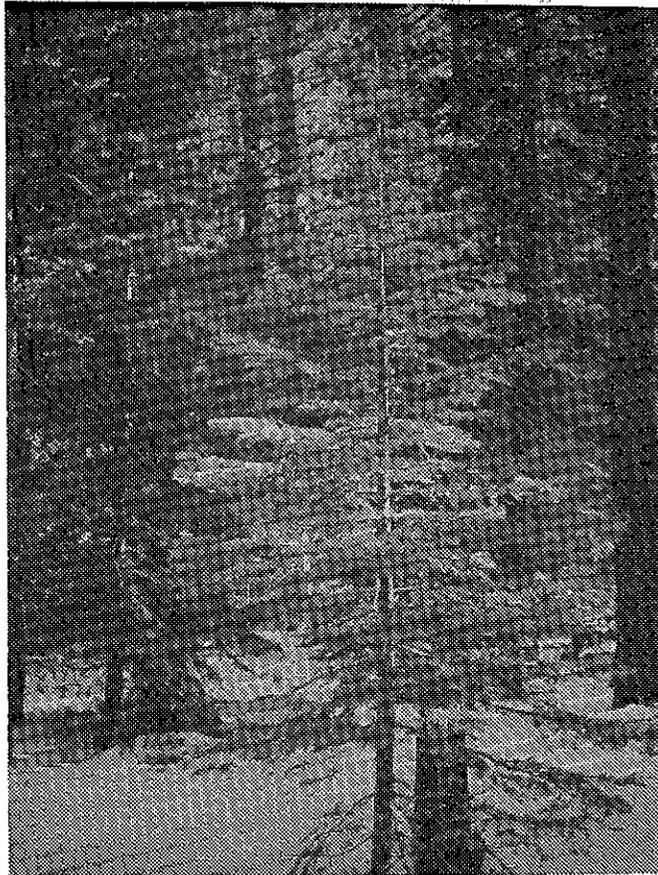
Photo 8. Salt Damage. White fir treated with 2.67 T/A NaCl in 1977, photographed January 1978. Damage spreads acropetally (base to top) in tree. The spiral pattern of damage sometimes seen, is developing in this tree.

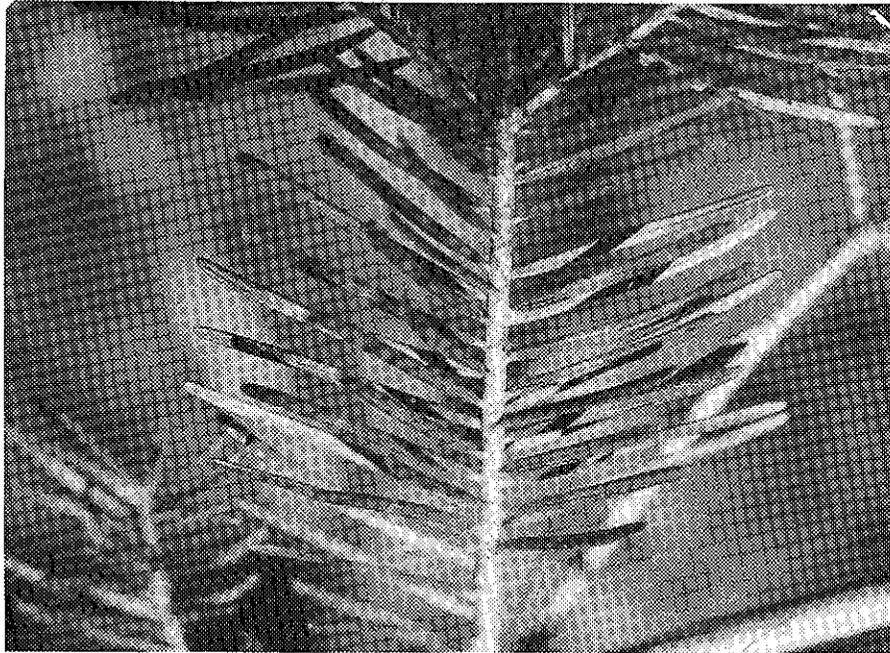
Photo 9. Salt Damage. White fir treated with 5.33 T/A NaCl in 1977, photographed in May 1977. Individual needle damage spreads basipetally (tip to base). These needles are about 75% brown.

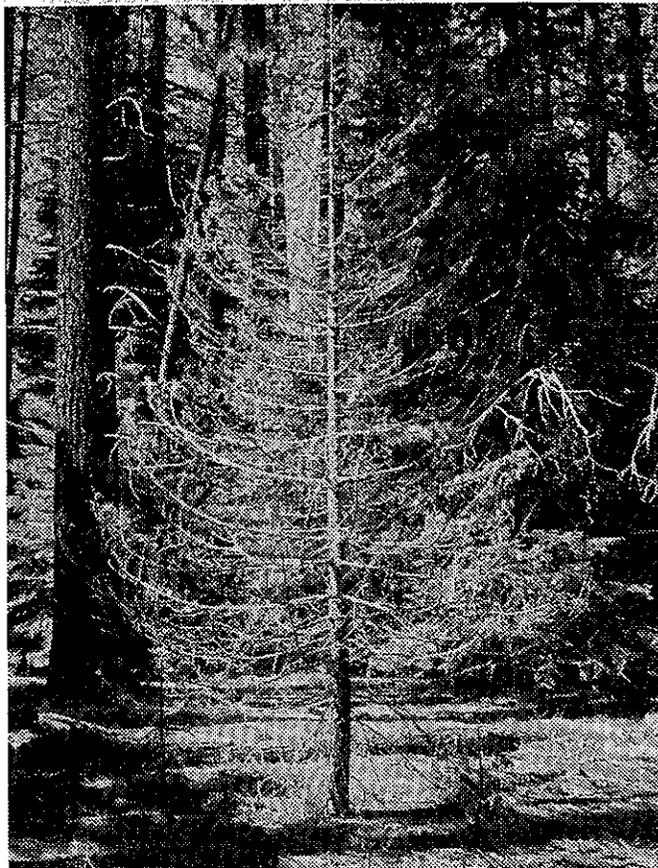
Photo 10. Salt Damage. White fir treated with 5.33 T/A NaCl in 1977, photographed in September 1977. This tree is virtually dead. The last remaining needles are those formed in the summer of 1977.

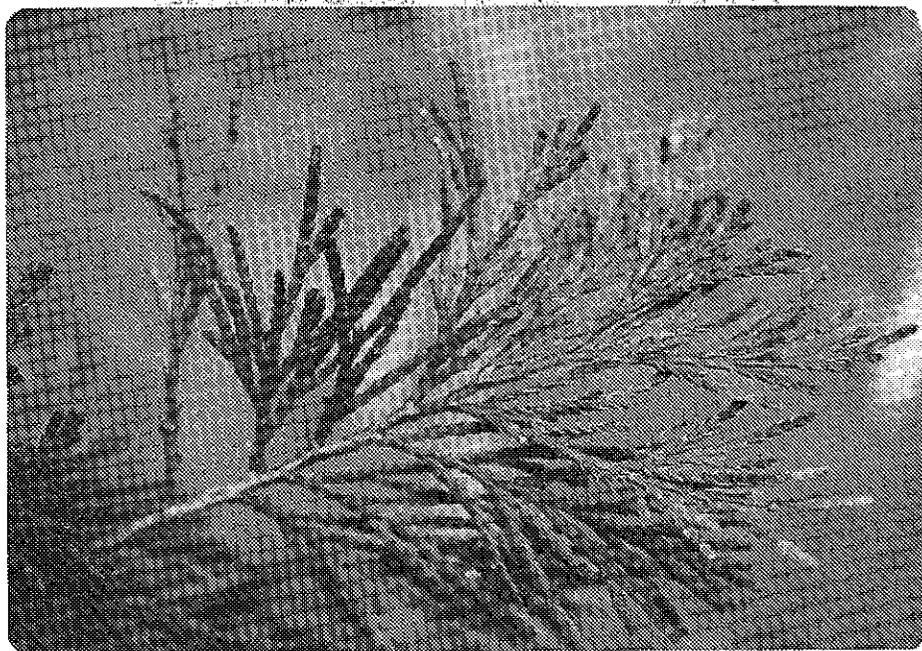
Photo 12. Salt Damage. Incense cedar treated with 1.33 T/A NaCl in 1977 and 2 T/A NaCl in 1978, photographed July 1978. Damage symptoms develop basipetally (tip to base) in the branchlets.
