Non-Destructive Estimate of the Rate of Change of Structural Degradation of the Lavic Road Overcrossing

October 1999

Texas Engineering Experimental Station
College Station, Texas 77843

California Department of Transportation,
Engineering Service Center

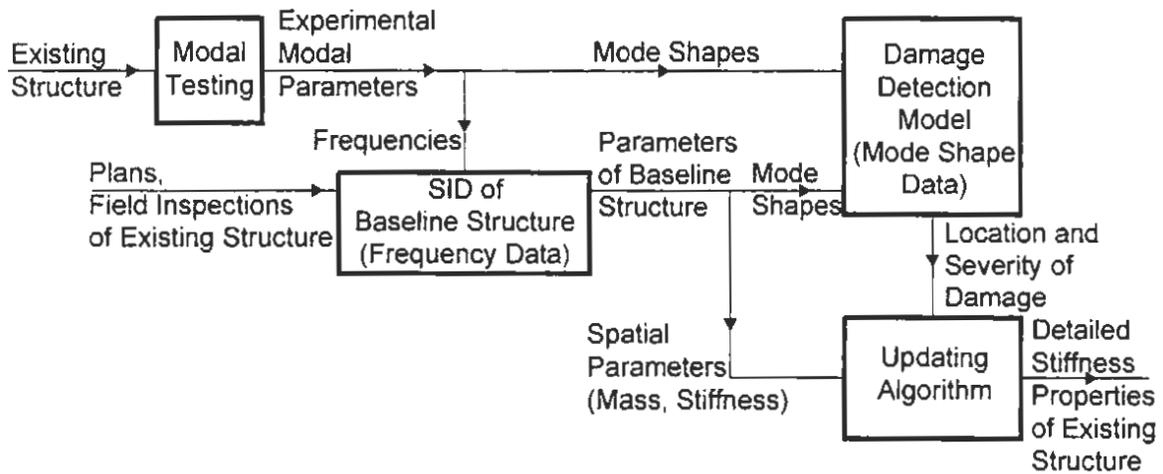
Figure 3.1 Schematic of Approach Used to Identify Stiffness Properties of Baseline and Existing Structures

A schematic of the approach used here to develop the stiffness properties of the existing structure is shown in Figure 3.1. The modal parameters of the existing structure are combined with information provided on as-built plans of the structure and a sensitivity-based systems identification (SID) procedure to generate a set of modal parameters for an idealized pristine (baseline/as-built) structure. The measured modal parameters of the existing structure and the theoretically-generated modal parameters of the pristine structure are used in combination with a proven damage detection method to generate possible locations and severity of damage in the existing structure relative to the pristine structure. Finally, by combining the location and severity of the damage in the existing structure with the pristine structure using a simple updating algorithm, the stiffness properties of the existing structure are identified. These properties can now be used to analyze the response of the existing structure. Note that the systems identification technique and the damage detection scheme mentioned above have been described in great detail elsewhere [Stubbs and Kim (1996),

The objective of this section is to generate an estimate of the appropriate stiffness properties of the Lavic Road Overcrossing using the field data measured in September 1998. The same schematic (Figure 3.1) in the previous section is utilized for systems identification, generation of possible locations and severity of damage in the existing structure, and estimation of the stiffness properties of the existing structure.

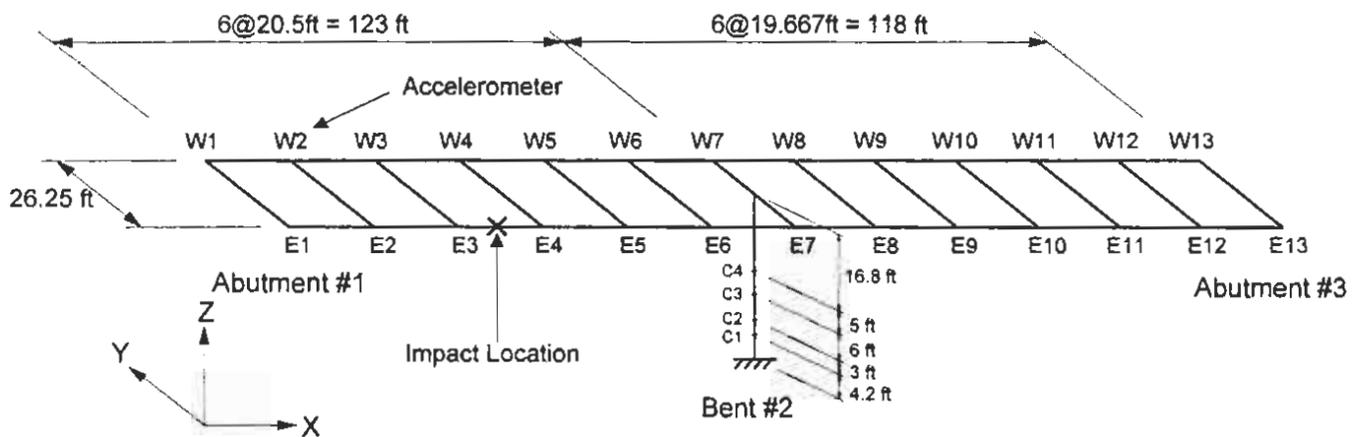
Figure 3.2 Locations of Accelerometers on the Bridge

1. Estimate a detailed modal amplitude representation for the deck by interpolating the thirteen sensor readings obtained in the field (i.e., W1-W13 and E1-E13) shown in Figure 3.2 using cubic-spline functions;
2. Estimate a detailed modal amplitude representation for the column by interpolating the four sensor readings obtained in the field (i.e., C1-C4) shown in Figure 3.2 using cubic-spline functions;
3. Generate the curvatures for the deck and the column using mode shapes from the baseline model and the field measurements;
4. Calculate the damage index DI_j for each element j ;
5. Calculate the normalized damage indicator z_j and
6. Determine if the structure is damaged or not damaged at Element j according to the pre-assigned decision rules with 84% of confidence level: (a) the element is damaged if $z_j \geq 1$; or (b) the element is not damaged if $z_j < 1$.

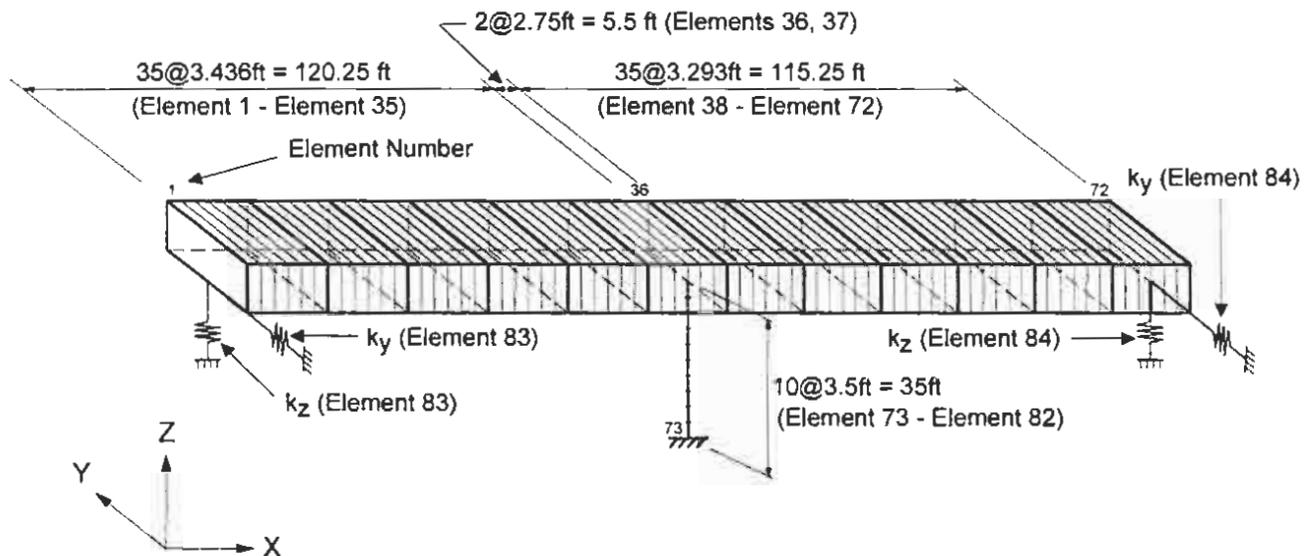
Figure 3.10 Damage Detection Model

The damage detection model used in this study for the location of damage and the estimation of the severity of damage is shown in Figure 3.10. The damage detection model has 84 elements, i.e., Elements 1 to 72 for the deck, Elements 73 to 82 for the column, and Elements 83 and 84 for the Abutment #1 and Abutment #3, respectively. The sectional properties for each member are listed in Table 3.17. The polar moment of inertia J is calculated by sum of the second moment of area

about the Y-axis (I_{yy}) and the second moment of area about the Z-axis (I_{zz}). Note that Elements 36 and 37 represent the bentcap. For the two bending modes in the Z-direction and a torsional mode, the deck (i.e., Elements 1 to 72) and the column (i.e., Elements 73-82) are considered as Euler-Bernoulli beam elements and only springs in the Z-direction (i.e., k_z in Figure 3.10) are included in the damage detection model for Elements 83 and 84. For the two bending modes in the Y-direction, the deck (i.e., Elements 1 to 72) and the column (i.e., Elements 73-82) are also considered as Euler-Bernoulli beam elements and only springs in the Y-direction (i.e., k_y in Figure 3.10) are included in the damage detection model for Elements 83 and 84.

The damage detection model for the location of damage and the estimation of the severity of damage is shown in Figure 3.10 and the sectional properties for the members are listed in Table 3.17. For the two bending modes in the Z-direction and a torsional mode, the deck (i.e., Elements 1 to 72) and the column (i.e., Elements 73-82) are considered as Euler-Bernoulli beam elements and only springs in the Z-direction (i.e., k_z in Figure 3.10) are included in the damage detection model for Elements 83 and 84. For the bending mode in the Y-direction, the deck (i.e., Elements 1 to 72) and the column (i.e., Elements 73-82) are also considered as Euler-Bernoulli beam elements and only springs in the Y-direction (i.e., k_y in Figure 3.10) are included in the damage detection model for Elements 83 and 84.

In this comparison, the properties of interest are referenced to the damage detection model shown in Figure 3.10. Recall that in the damage detection model Elements 1-72 represent approximately 3.4 ft. linear sections of the deck, Elements 73-82 represent 3.5 ft. linear sections of the column, and Elements 83 and 84, respectively, represent the south and north abutment systems. The bending, torsional, or axial stiffnesses associated with each element are summarized in Table 3.19 and Table 4.15 for the 1997 and 1998 structures, respectively.

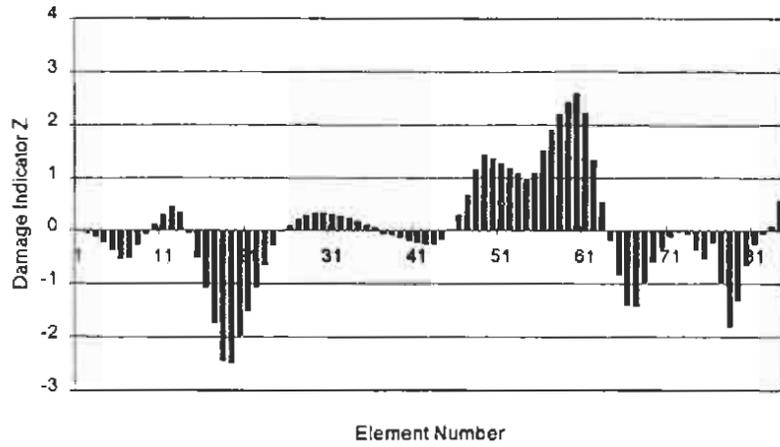
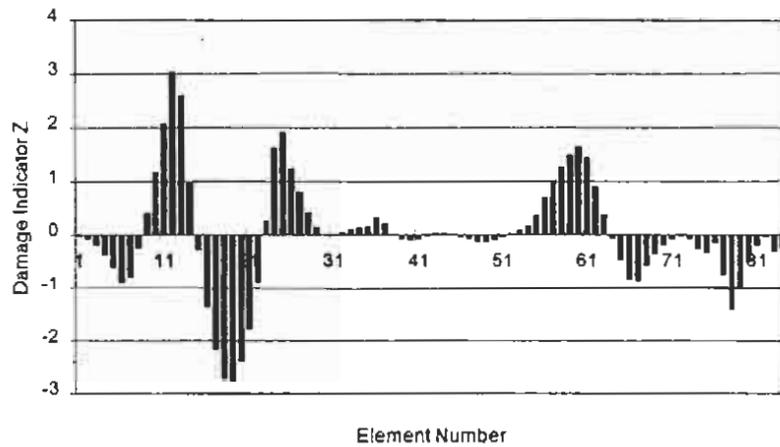
Figure 3.11 Damage Localization Results Using the First Bending Mode in the Z-dir. (December 1997): (a) Result using the measurements along the west girder (W1-W13);(b) Result using the measurements along the east girder (E1-E13).

The results for the predicted damage locations are summarized in Figures 3.11 to 3.15 in which the individual mode is used to locate the possible damage area. Note that for the two bending modes in the Z-direction, the measurement

The damage severity estimation is performed as follows. First, the baseline and post-damage sensitivities are obtained as described in the latter section. Second, the predicted damage locations are obtained from Figures 3.11 to 3.15. Finally, for each predicted damage location, the damage severity are estimated using the severity estimator (see Appendix A for detail). The estimated damage severities are listed in Table 3.18. Note that the magnitude of damage about the X-axis were estimated using the first torsional mode, the magnitude of damage about the Y-axis were estimated using the first two bending modes in the Z-direction, and the magnitude of damage about the Z-axis were estimated using the first two bending modes in the Y-direction. These magnitudes are fractional stiffness changes of those elements.

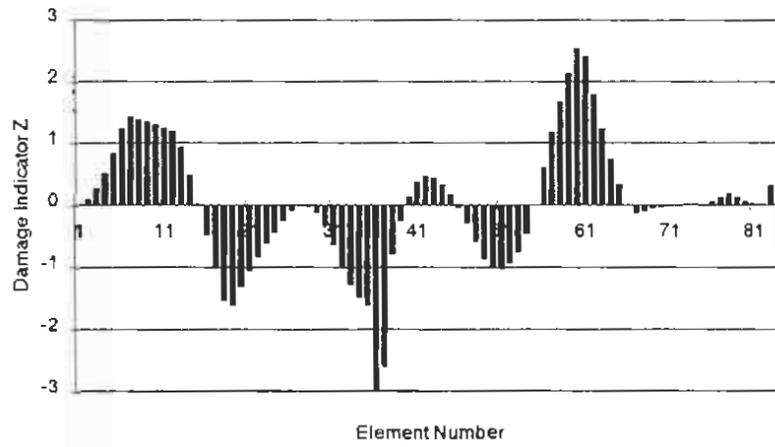
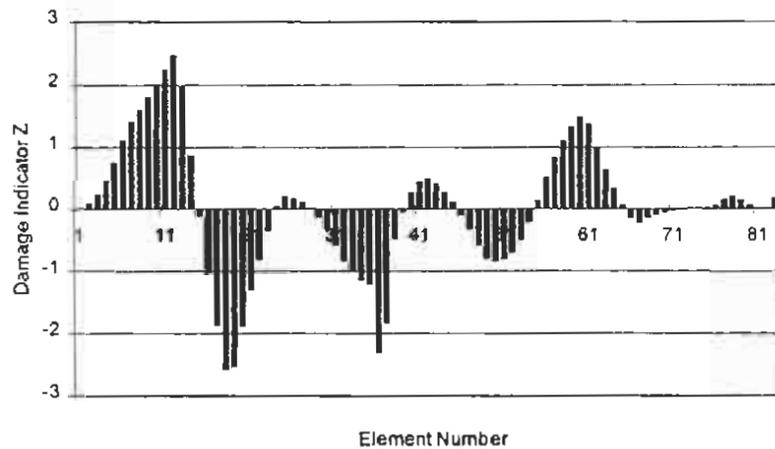
Figure 3.12 Damage Localization Results Using the Second Bending Mode in the Z-dir. (December 1997): (a) Result using the measurements along the west girder (W1-W13); (b) Result using the measurements along the east girder (E1-E13).

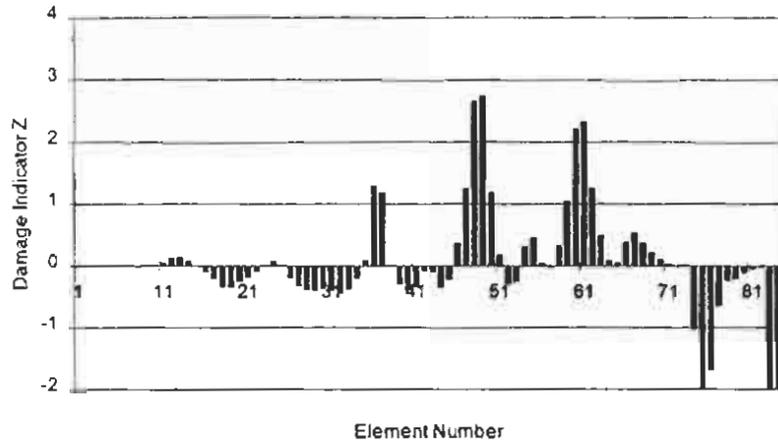
Figure 3.13 Damage Localization Results Using the First Bending Mode in the Y-dir. (December 1997)

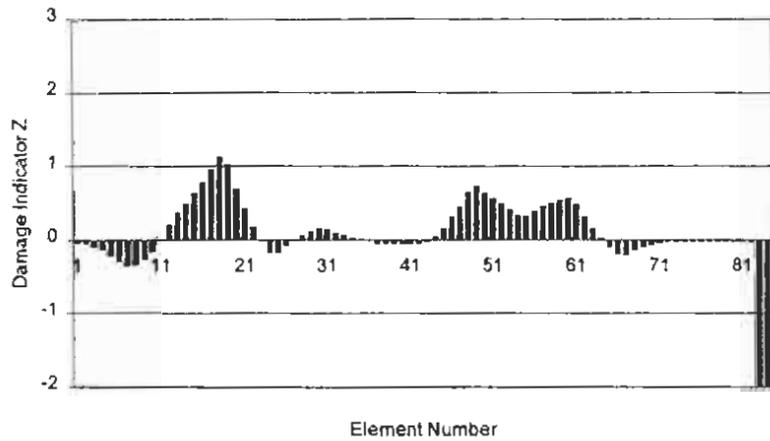
Figure 3.14 Damage Localization Results Using the Second Bending Mode in the Y-dir. (December 1997)

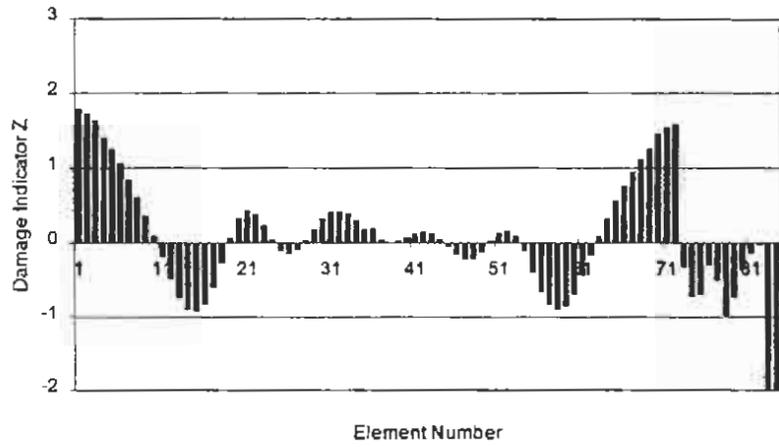
**Figure 3.15 Damage Localization Results Using the First Torsional Mode
(December 1997)**

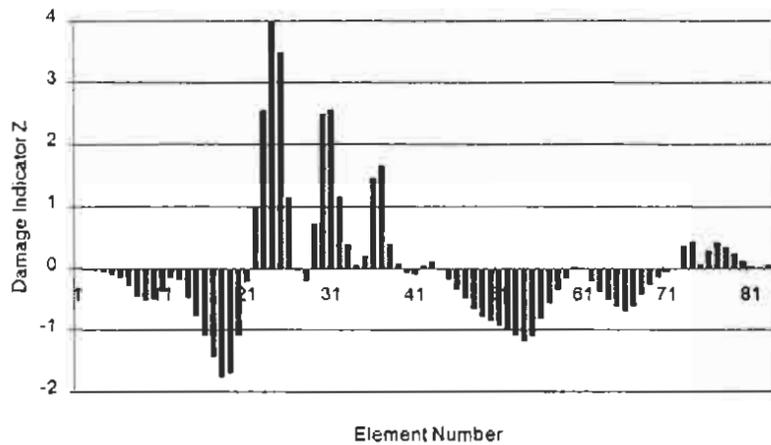
Figure 4.5 Damage Localization Results Using the First Bending Mode in the Z-dir. (September 1998): (a) Result using the measurements along the west girder (W1-W13);(b) Result using the measurements along the east girder (E1-E13).

The location of potential damage is implemented using the same steps provided in the Section 3.4. The results for the predicted damage locations are summarized in Figures 4.5 to 4.8. Note that for the bending modes, the measurements along the west girder (i.e., W1-W13) and the measurements along the east girder (i.e., E1-E13) are used separately.

The damage severity estimation is performed as follows. First, the baseline and post-damage sensitivities are obtained as described in the latter section. Second, the predicted damage locations are obtained from Figures 4.5 to 4.8. Finally, for each predicted damage location, the damage severity are estimated using the severity estimator. The estimated damage severities are listed in Table 4.14. Note that the magnitudes of damage about the X-axis were estimated using

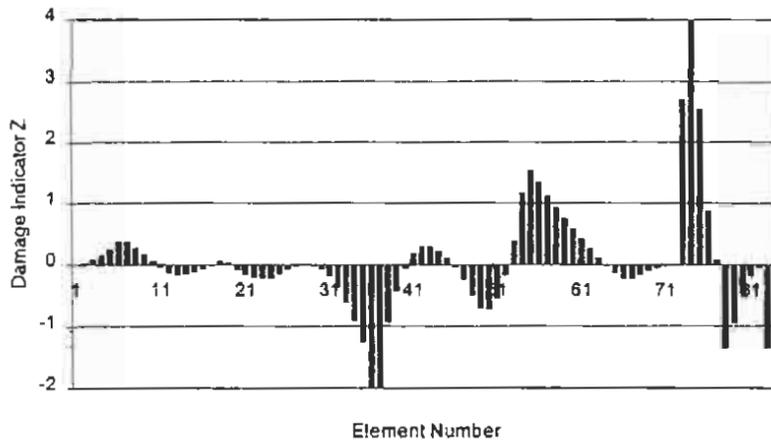
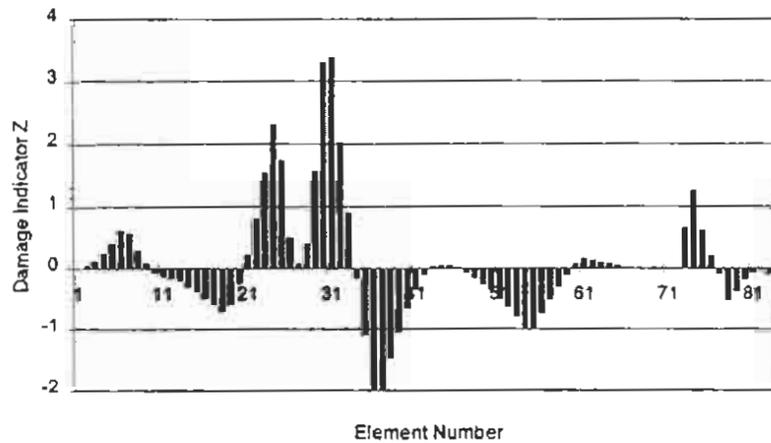
Figure 4.6 Damage Localization Results Using the Second Bending Mode in the Z-dir. (September 1998): (a) Result using the measurements along the west girder (W1-W13); (b) Result using the measurements along the east girder (E1-E13).

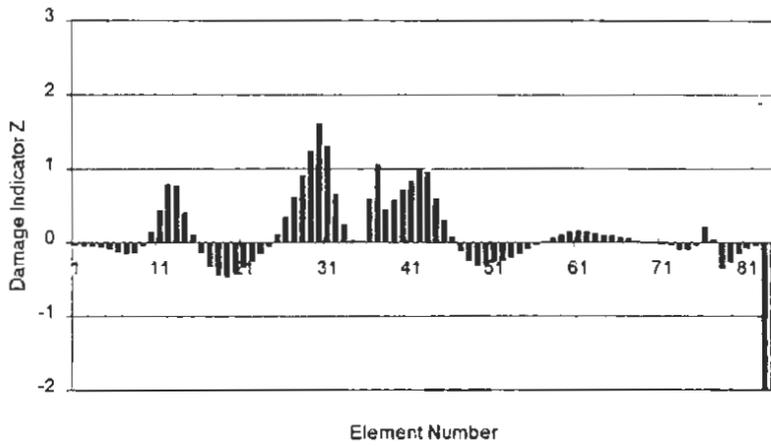
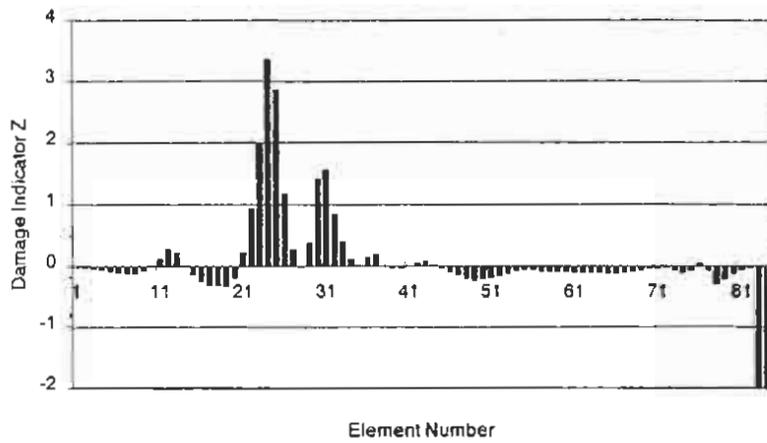
Figure 4.7 Damage Localization Results Using the Second Bending Mode in the Y-dir. (September 1998): (a) Result using the measurements along the west girder (W1-W13); (b) Result using the measurements along the east girder (E1-E13).

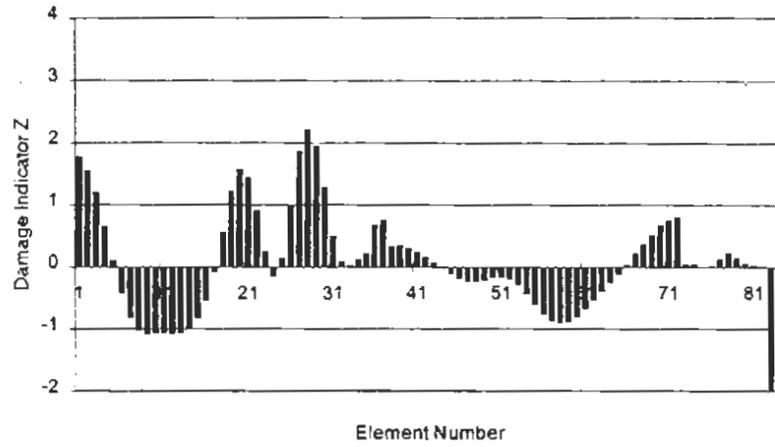
Figure 4.8 Damage Localization Results Using the First Torsional Mode (September 1998)

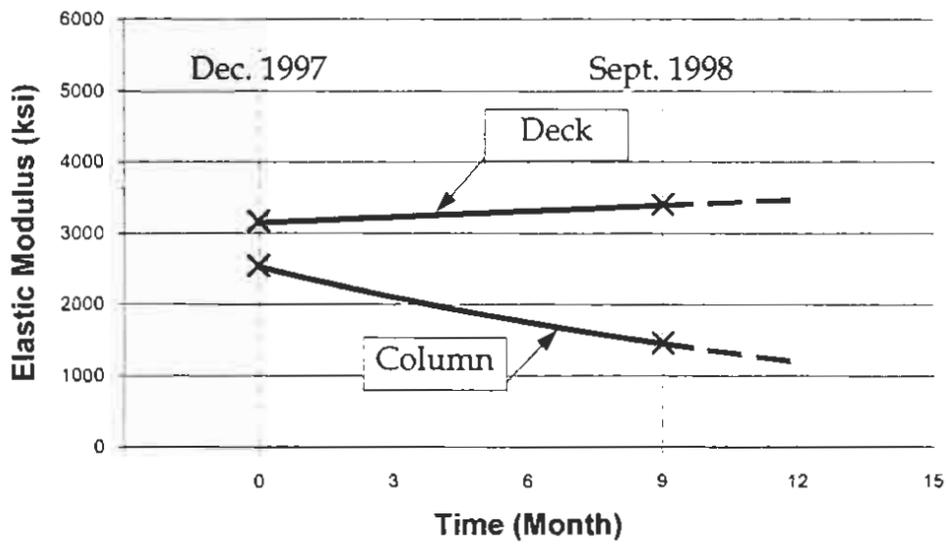
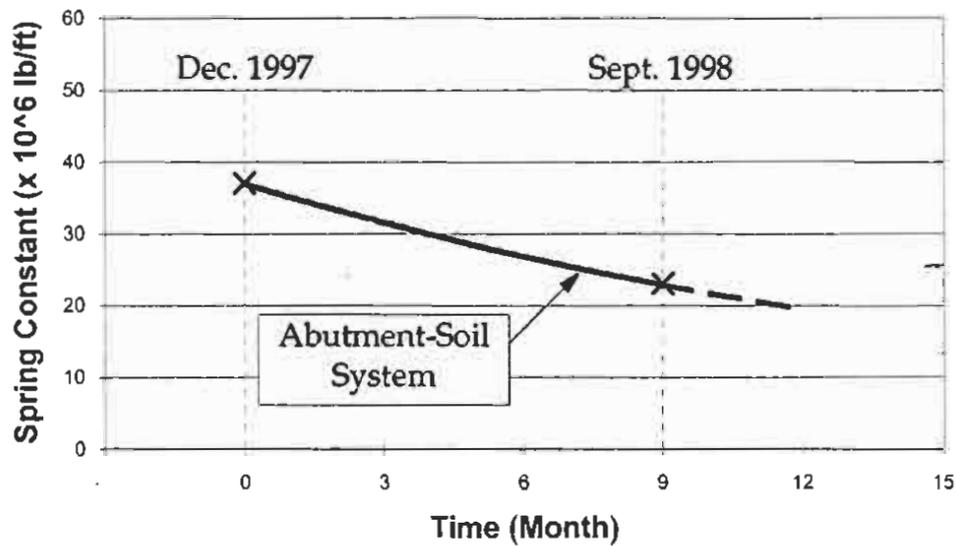
Figure 5.1 Changes in Average Stiffness Properties: (a) Elastic Modulus of the Deck and Column; (b) Spring Constant of Abutment-Soil System

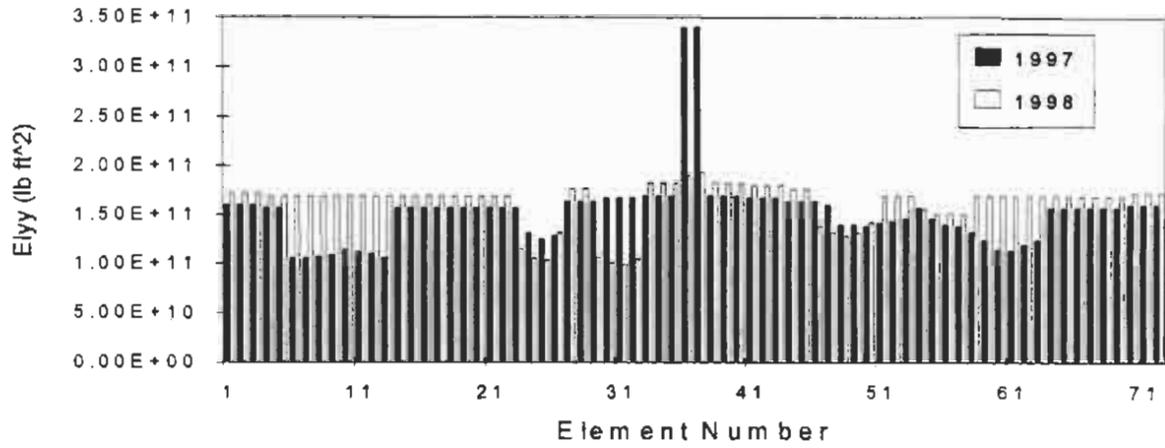
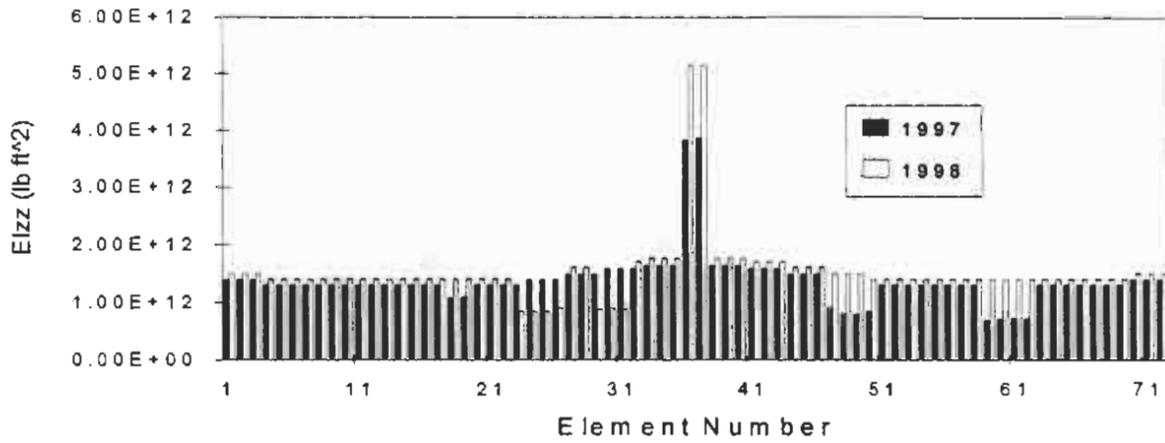
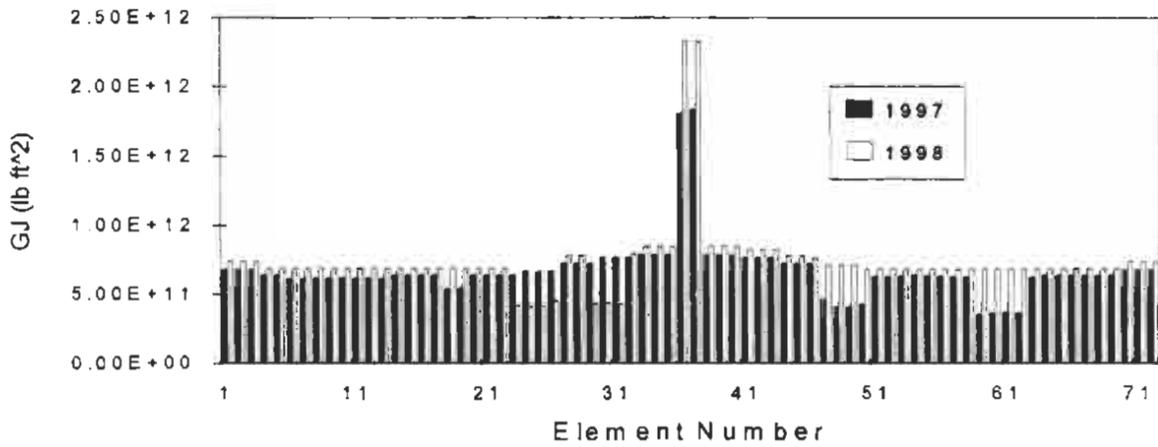
Figure 5.2 Stiffness Changes of the Deck: (a) EI_{yy} ; (b) EI_{zz} ; (c) GJ

deck elements are presented. A depression in the stiffness ratio, e.g., as indicated in Figure 5.2(a) in the region of Elements 6-13 is generally interpreted as a loss in stiffness. Note, however, the same depression could have been caused by an increase in mass in that region. It is seen that except for a few localized regions, the stiffness of the deck elements is essentially the same for the period under study.

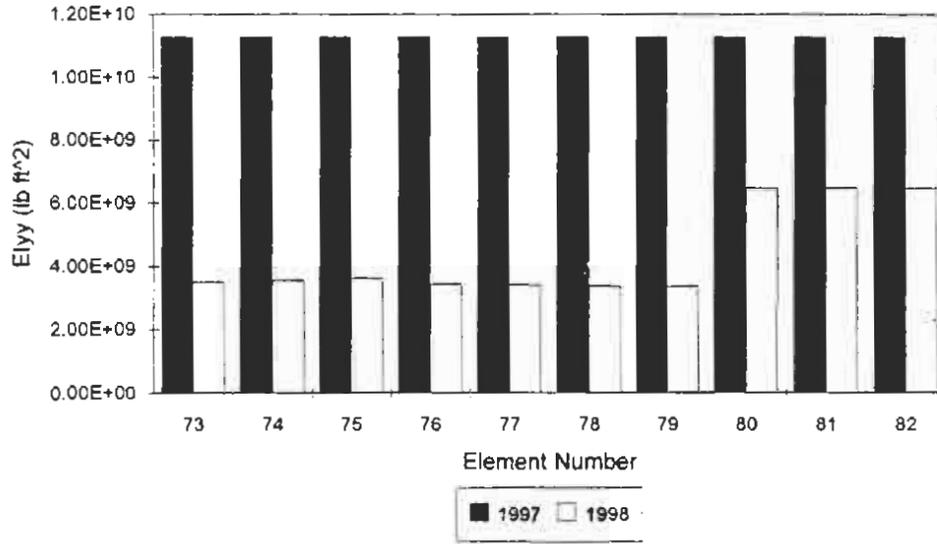
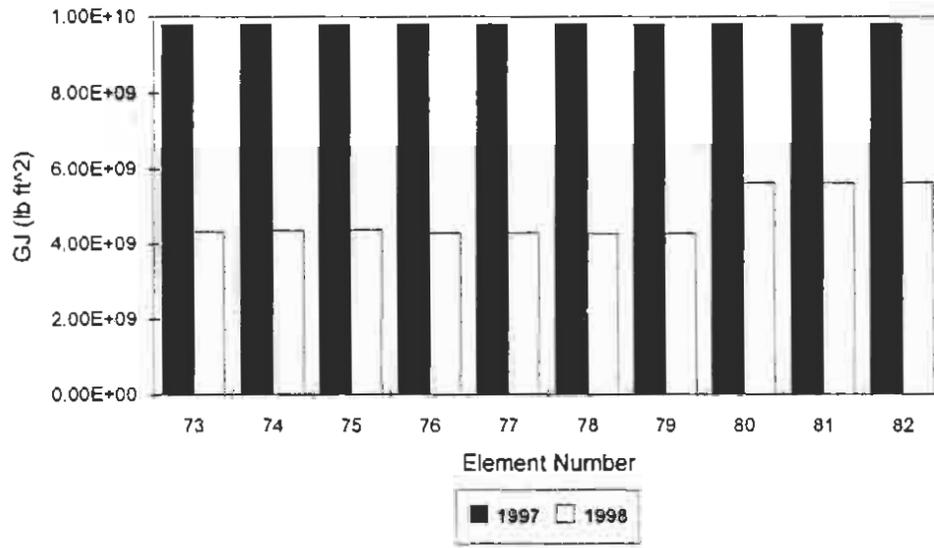
Figure 5.3 Stiffness Changes of the Column: (a) EI_{yy} ; (b) GJ

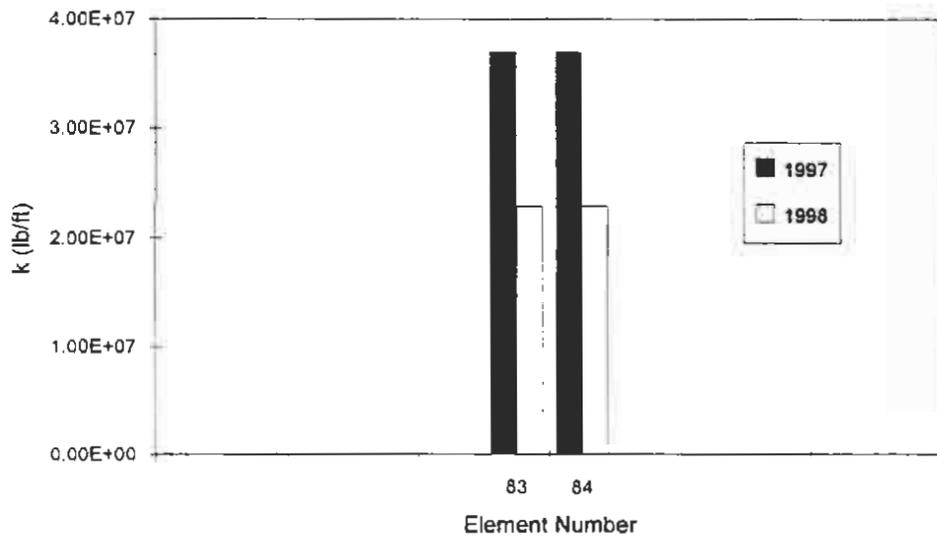
Figure 5.4 Stiffness Changes of the Abutments

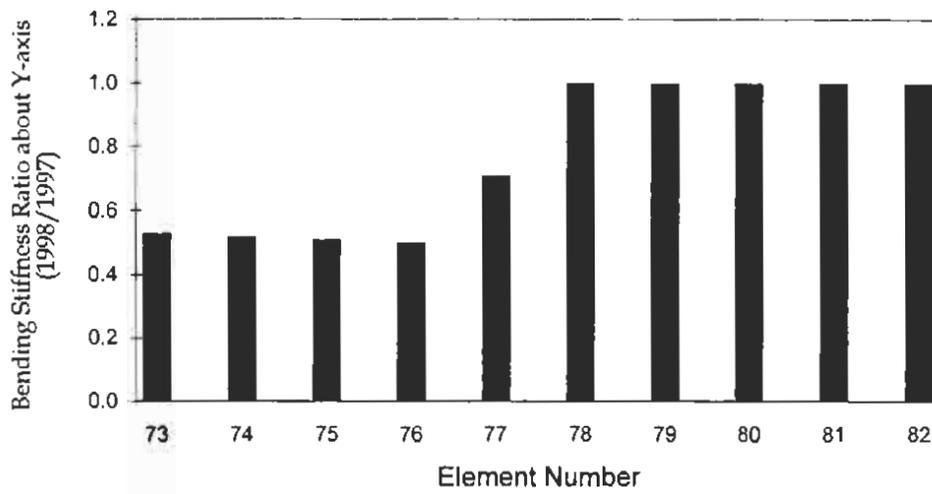
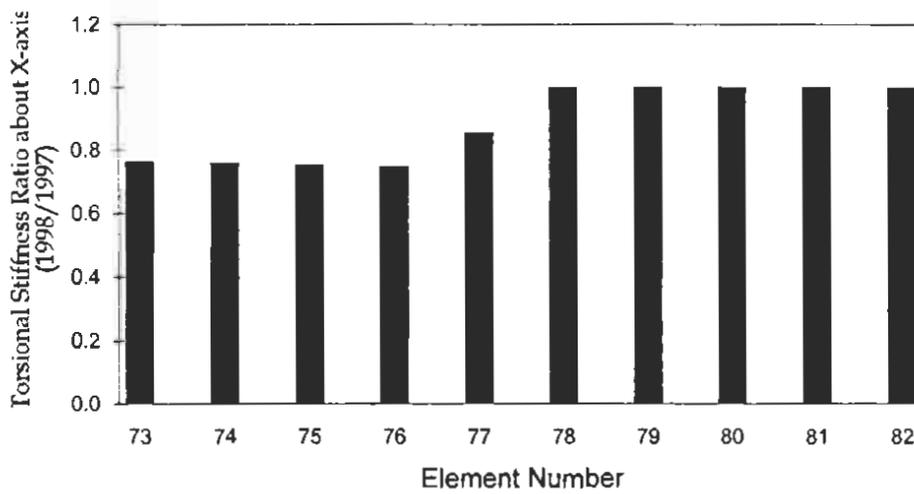
Figure 5.6 Estimated Stiffness Ratio of the Column from the 1997 and 1998 Field-Measured Data: (a) $EI_{yy, 1998}/EI_{yy, 1997}$; (b) GJ_{1998}/GJ_{1997}

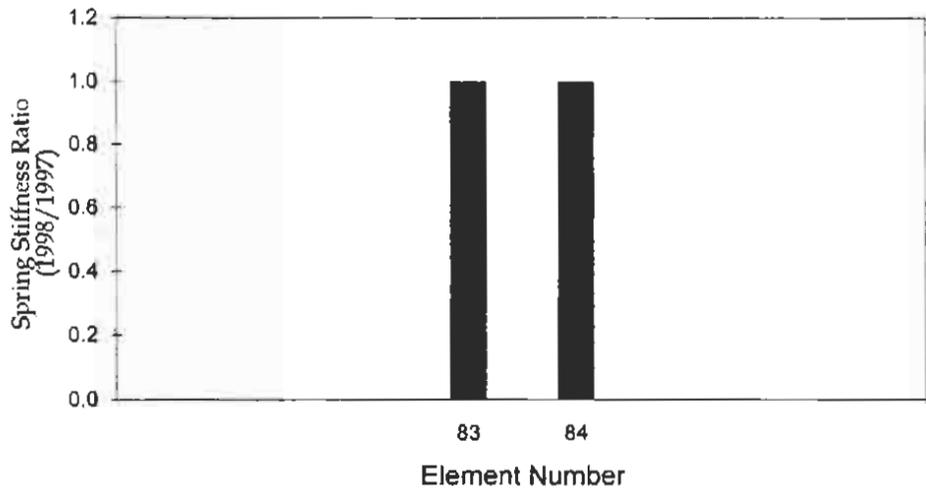
Figure 5.7 Estimated Stiffness Ratio (k_{1998}/k_{1997}) of the Abutments from the 1997 and 1998 Field-Measured Data

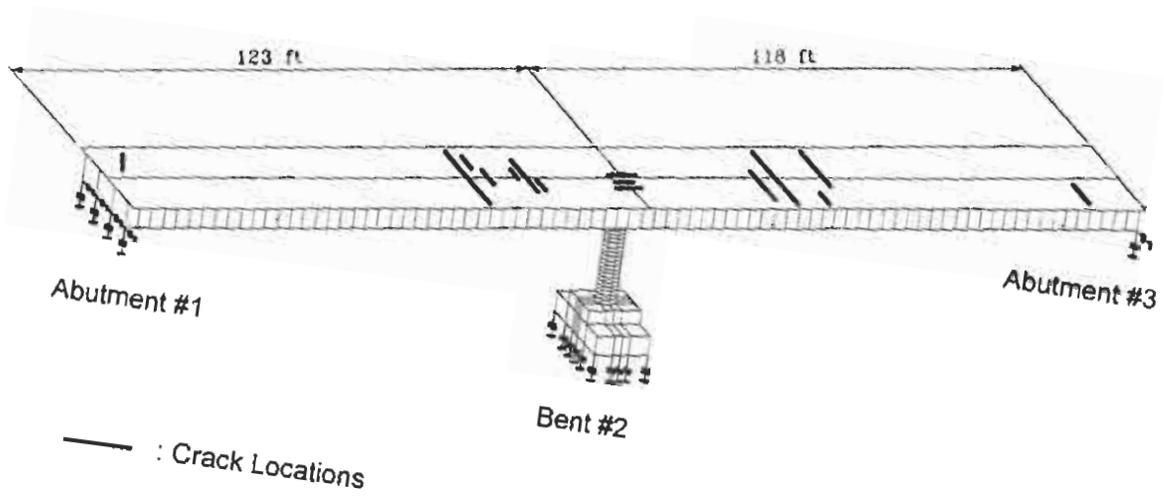
Figure 6.1 Surface Crack Pattern on the Deck

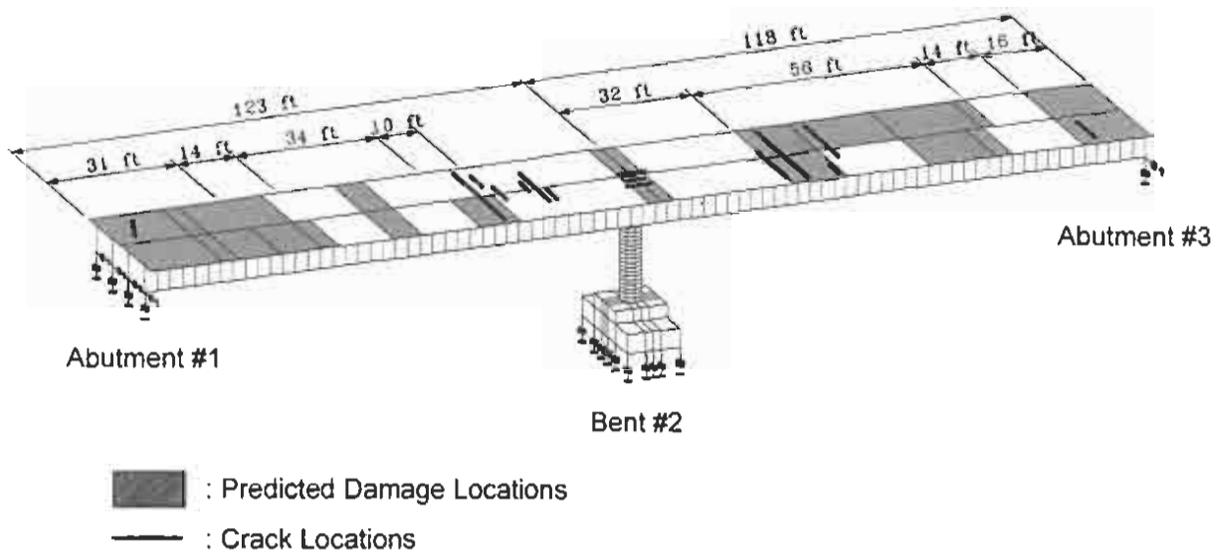
Figure 6.2 Comparison of Surface Cracks with Damage Localization Results using Superposition of All Modes from the 1997 Measurements

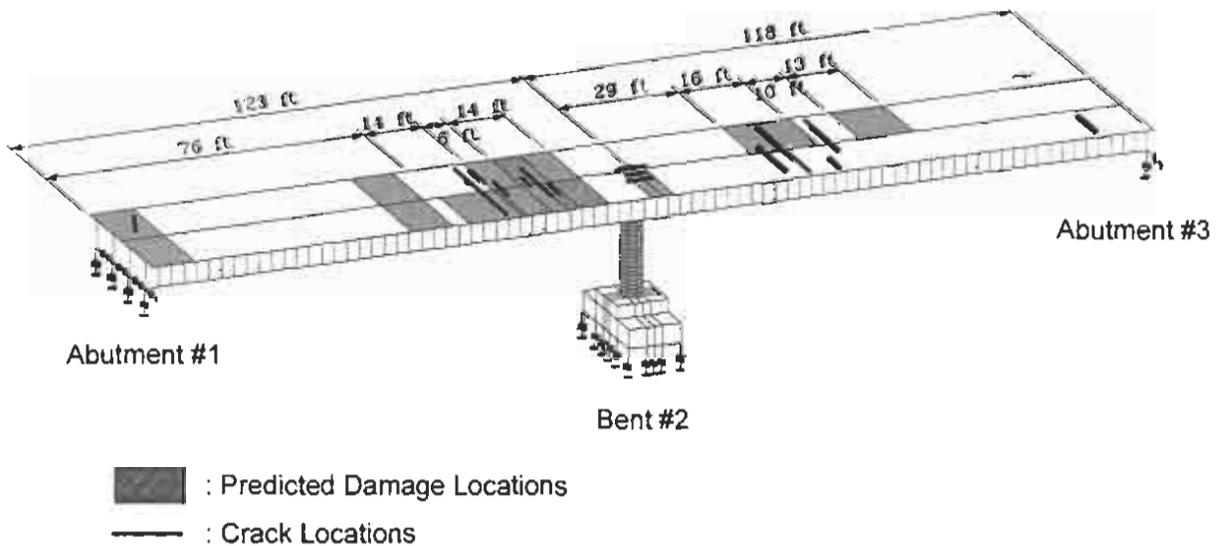
Figure 6.3 Comparison of Surface Cracks with Damage Localization Results using Superposition of All Modes from the 1998 Measurements

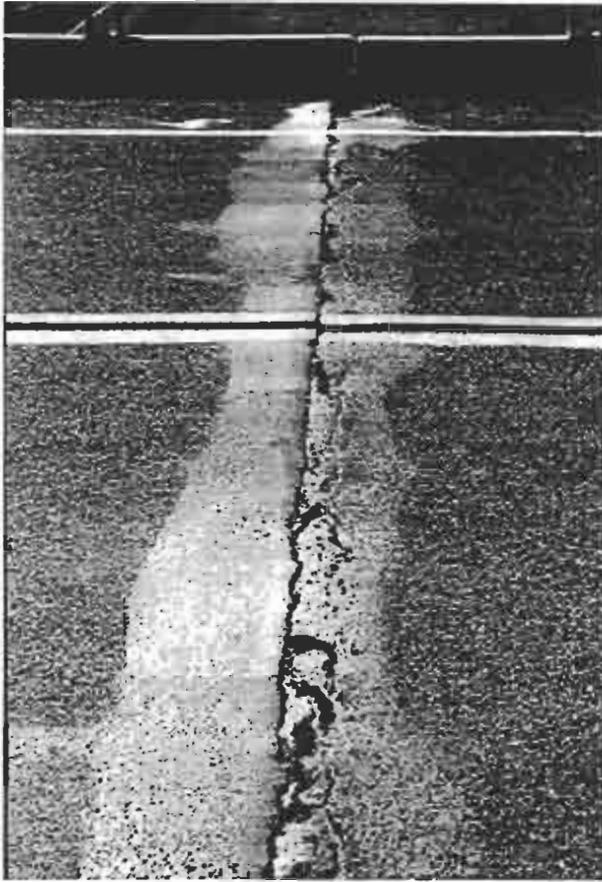
Figure B.5 Grouted expansion joint

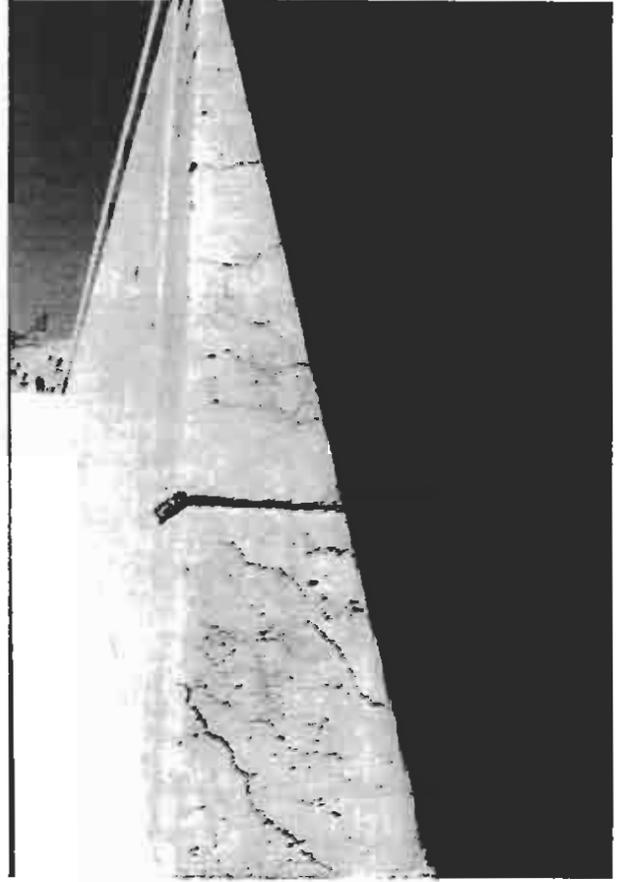
Figure B.6 Wingwall Deterioration

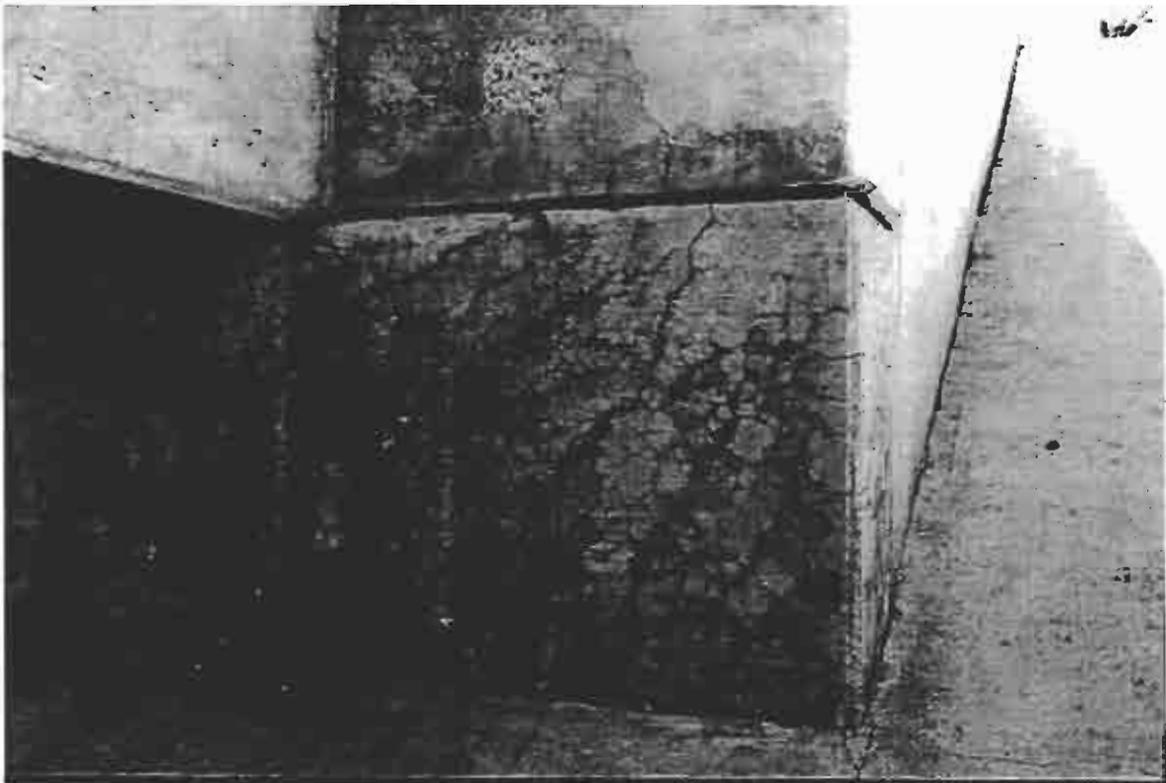
Figure B.7 Visible deterioration of abutment

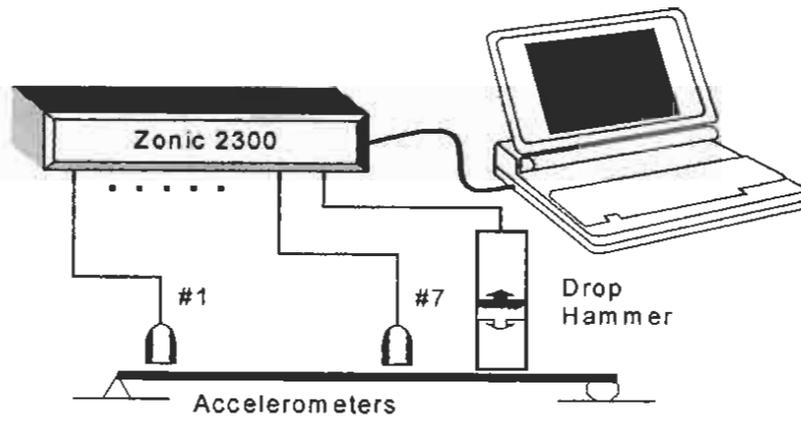
Figure B.8 Schematic of basic instrumentation setup

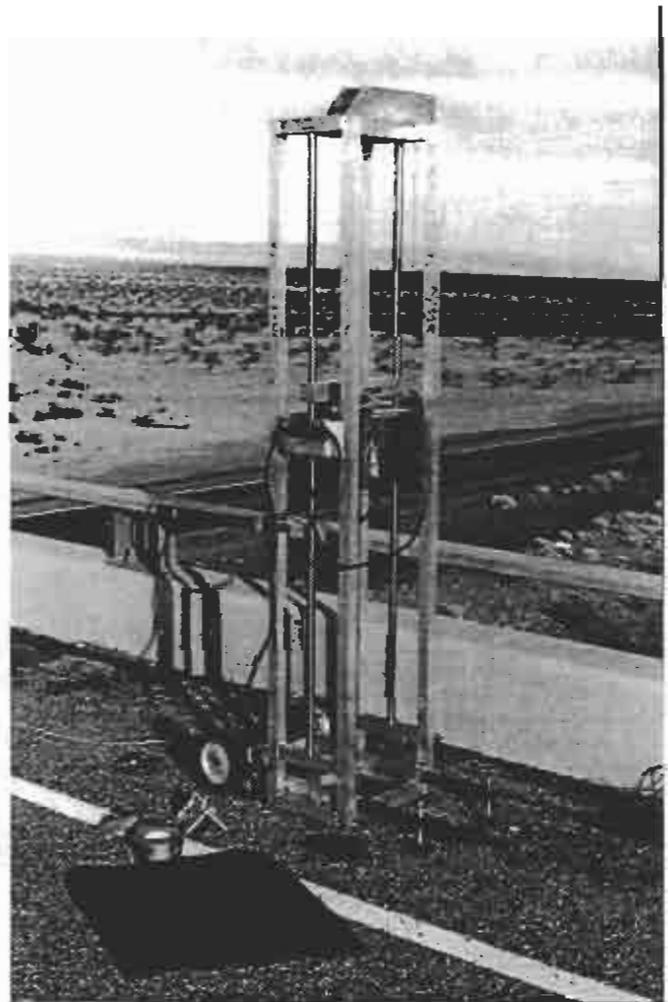
Figure B.11 Impact hammer

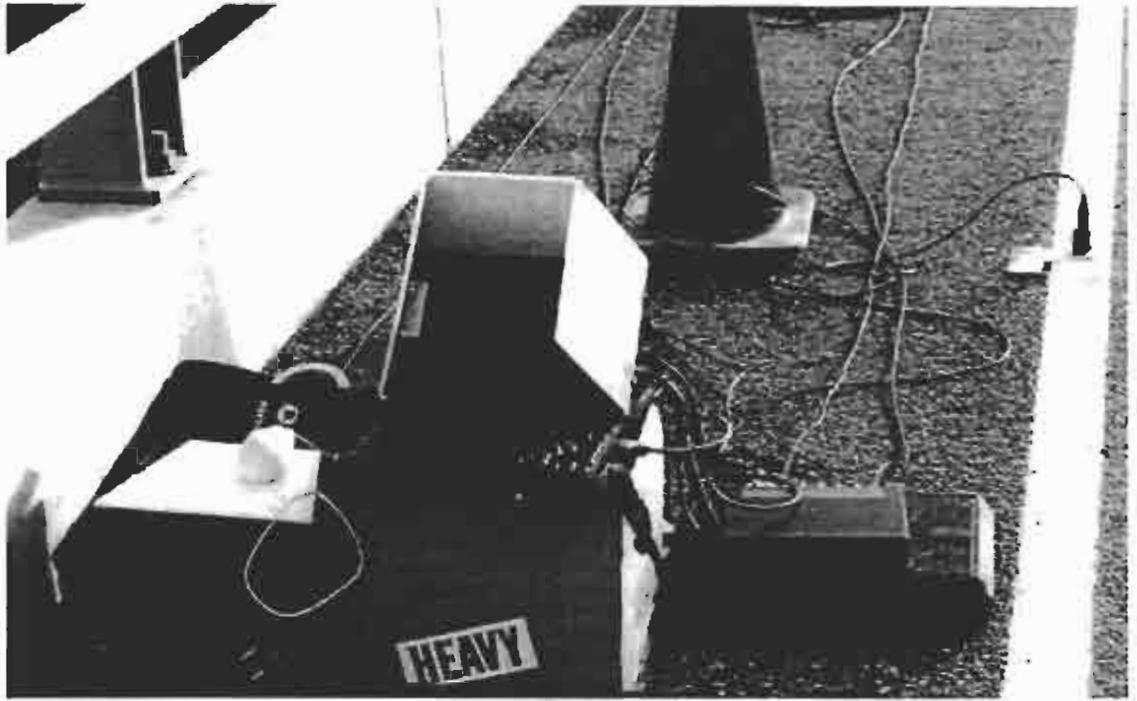
Figure B.12 Acquisition instrumentation for first field test

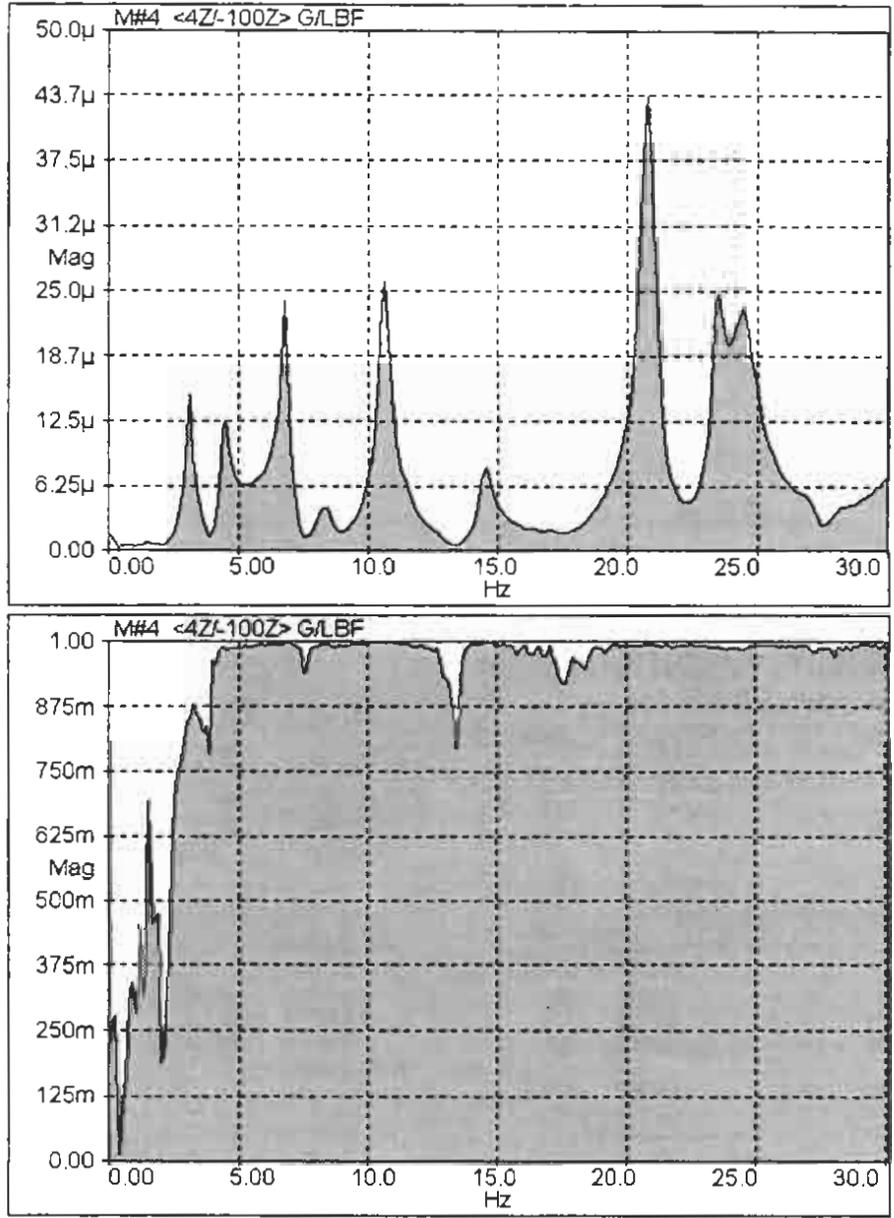
Figure B.19 Typical vertical FRF for deck response point and corresponding coherence function

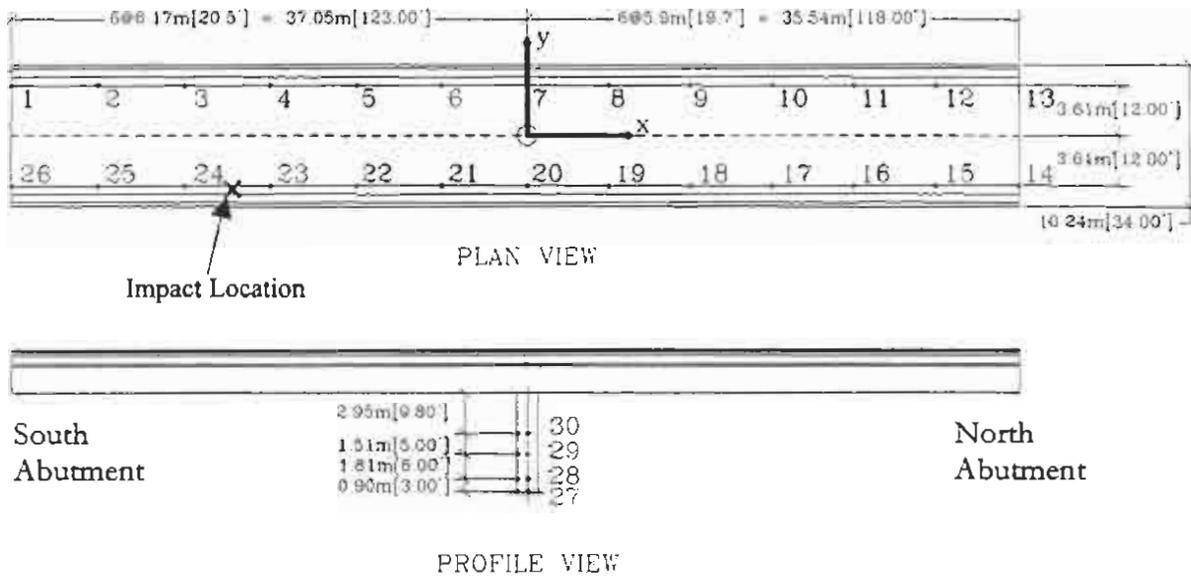
Figure B.20 Location of modal response points on superstructure
