Non-Destructive Estimate of the Rate of Change of Structural Degradation of the Lavic Road Overcrossing

October 1999

Texas Engineering Experimental Station
College Station, Texas 77843

California Department of Transportation,
Engineering Service Center

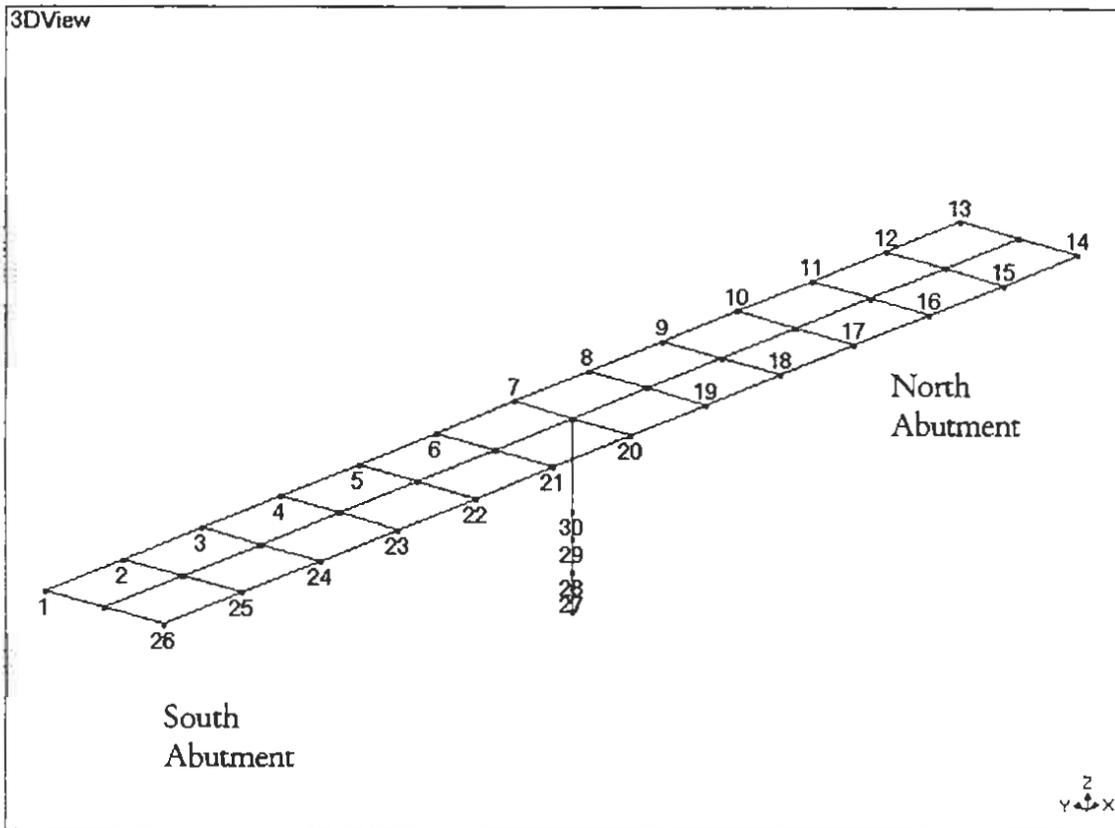
Figure B.21 Wireframe model for analysis of modal field data with response point locations shown

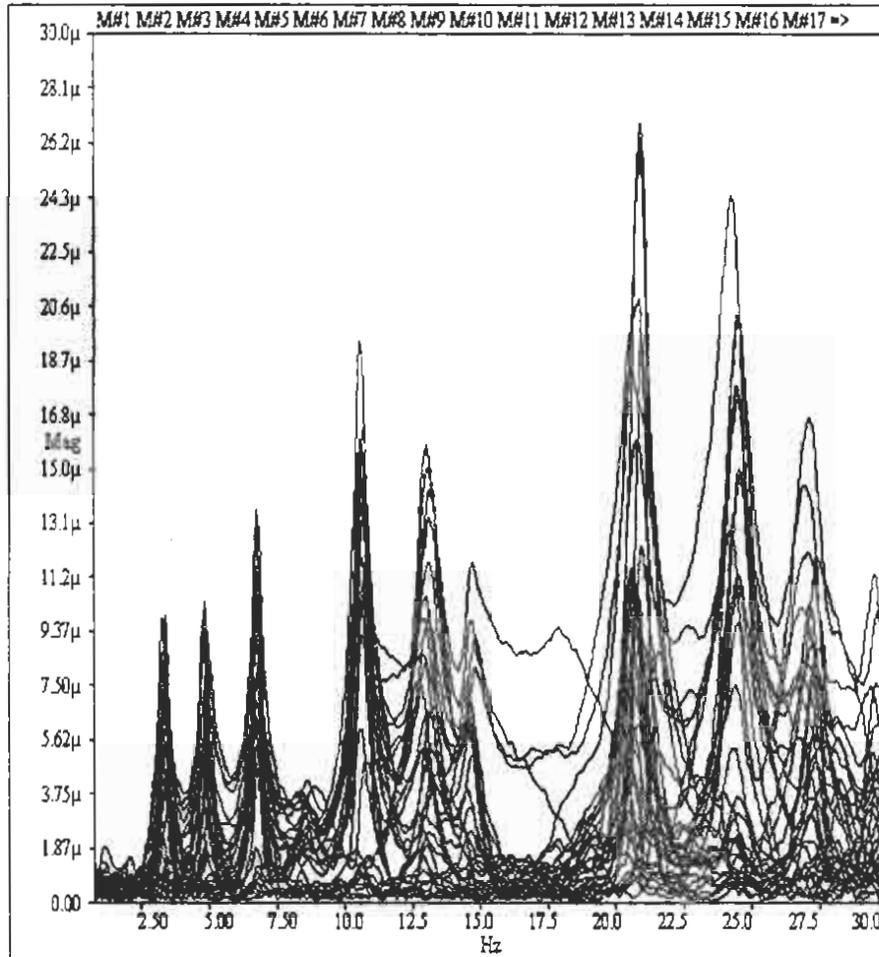
Figure B.36 Composite vertical motion FRF responses for 1998 field test

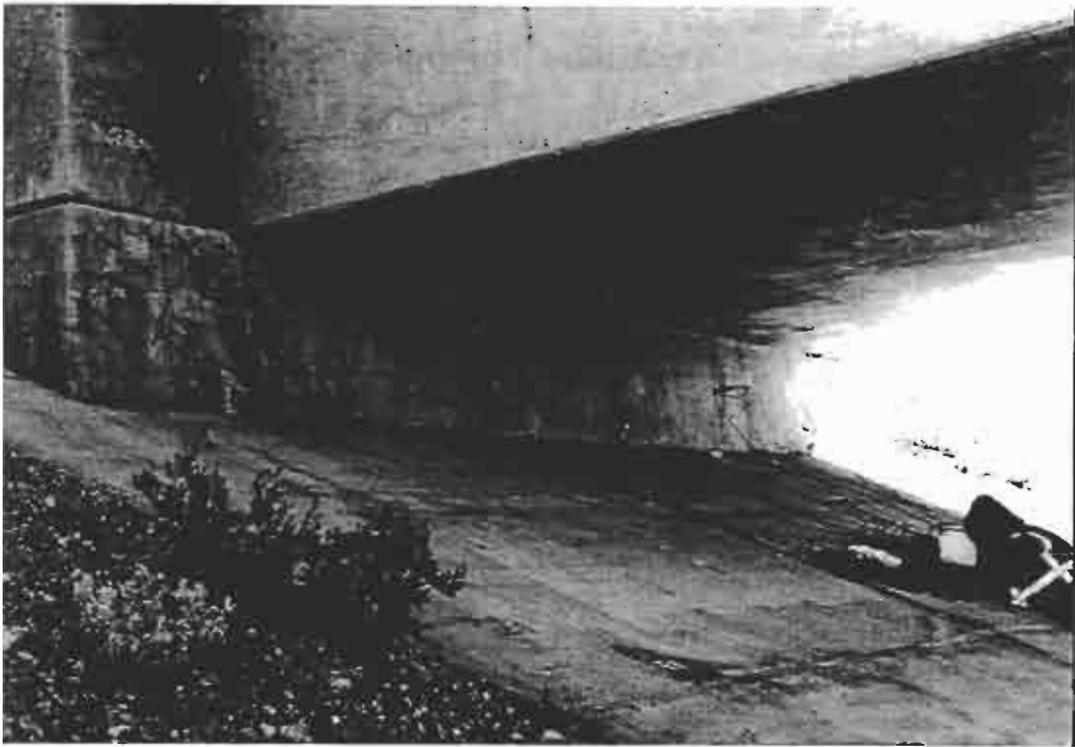
Figure C.1 Accelerometer layout on north abutment wall

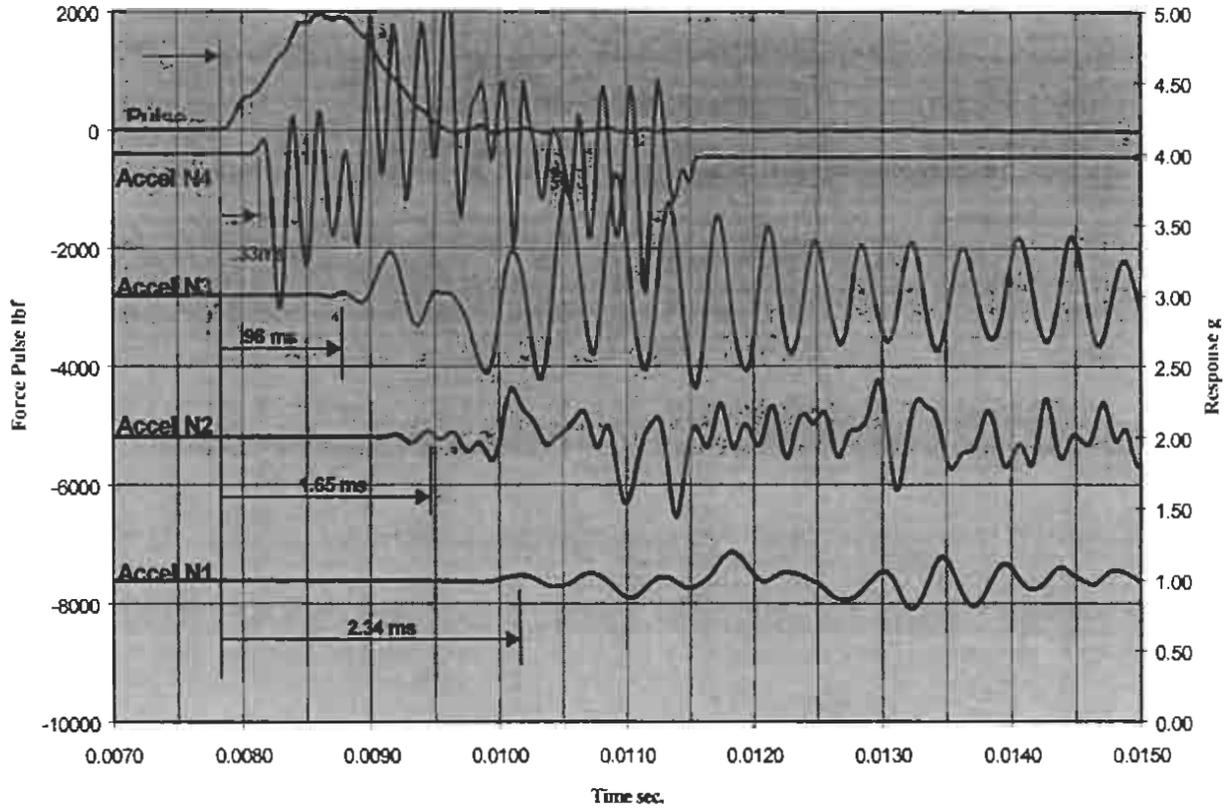
Figure C.2 Wave front times for accelerometers N1 through N4

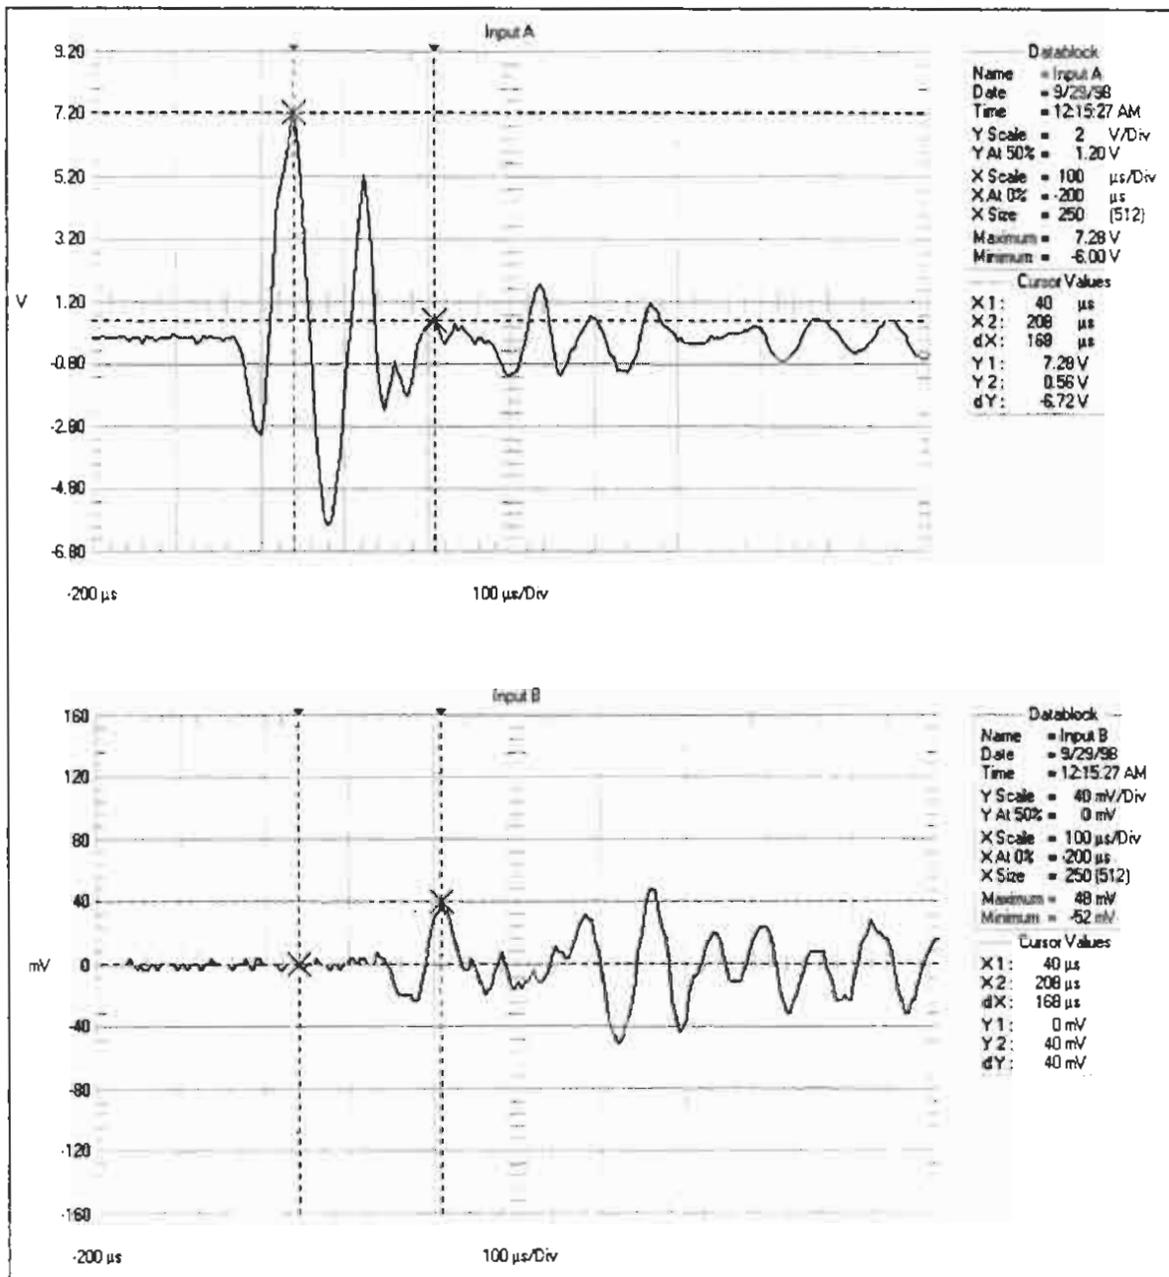
Figure C.3 Typical pulse response of PCB Microsensors
