Final Report Submitted to
The California Department of Transportation
Under Contract No: 59A0701

LONG-TERM STRUCTURAL PERFORMANCE MONITORING OF BRIDGES

Hardware Maintenance and, Long-term Data Collection/Analysis

Department of Civil & Environmental Engineering
University of California, Irvine

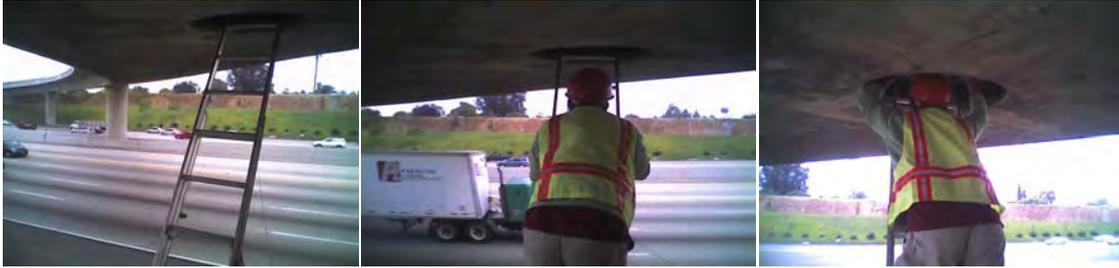
The major difficulty associated with the WSO monitoring system comes from the fact that the data logger was installed inside the box girder due to the unavailability of an easy-to-access outside space as shown in Figure 3. To access the data logger and retrieve the data recorded in the memory card, one needs to climb into the enclosed box-girder through a man hole, by placing and using a long ladder near the high-traffic I-5, which causes a safety concern. In addition, accessing the enclosed box girder requires supervision and presence of trained Caltrans personnel.

Figure 3. Access to the monitoring system inside the box girder at WSO Bridge.

To cope with this difficulty, efforts were made to install a wireless Ethernet router and a serial to Ethernet converter inside the box-girder of the WSO. Therefore, the recorded vibration data can be retrieved from the outside of the box girder. The data is transmitted to the commercially available wireless Ethernet router, which is placed close to the man-hole in the box girder, by wired connection. The wireless router establishes a Local Area Network (LAN) by using private IP address and broadcasts the vibration data to the outside box girder. A notebook computer can receive the broadcasted vibration data from the wireless LAN router without entering the enclosed box-girder. Although limitation of transmission distance of the wireless LAN router is 165ft according to its specification, it is possible to extend this distance by installing a wireless access point to provide more convenience. Unfortunately, the wireless transmission setup is unstable and it requires more work to improve the system.

In summary, the WSO monitoring system needs a reliable wireless communications solution for convenient and frequent data acquisition without accessing the data logger located inside the box girder.

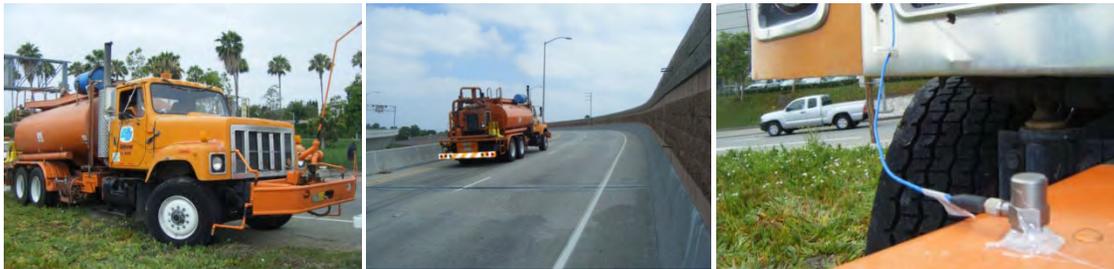
Figure 9. Water truck driven over the WSO bridge during the traffic controlled tests.

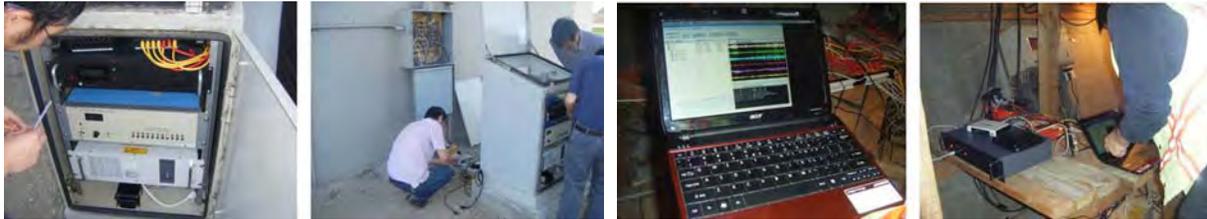
Figure 18. Replacement of the data-logger at FROO and WSO

For the three bridges the data loggers were replaced (see Figure 18). In addition the deteriorated rechargeable batteries in the JRO were replaced and the solar panel was cleaned to maintain its optimum performance. The out of order sensors were diagnosed and they will be repaired.
