Large Scale Laboratory Testing in Support of Seismic Bridge Design and Retrofit

Frieder Seible, Ph.D., P.E.

University of California, San Diego

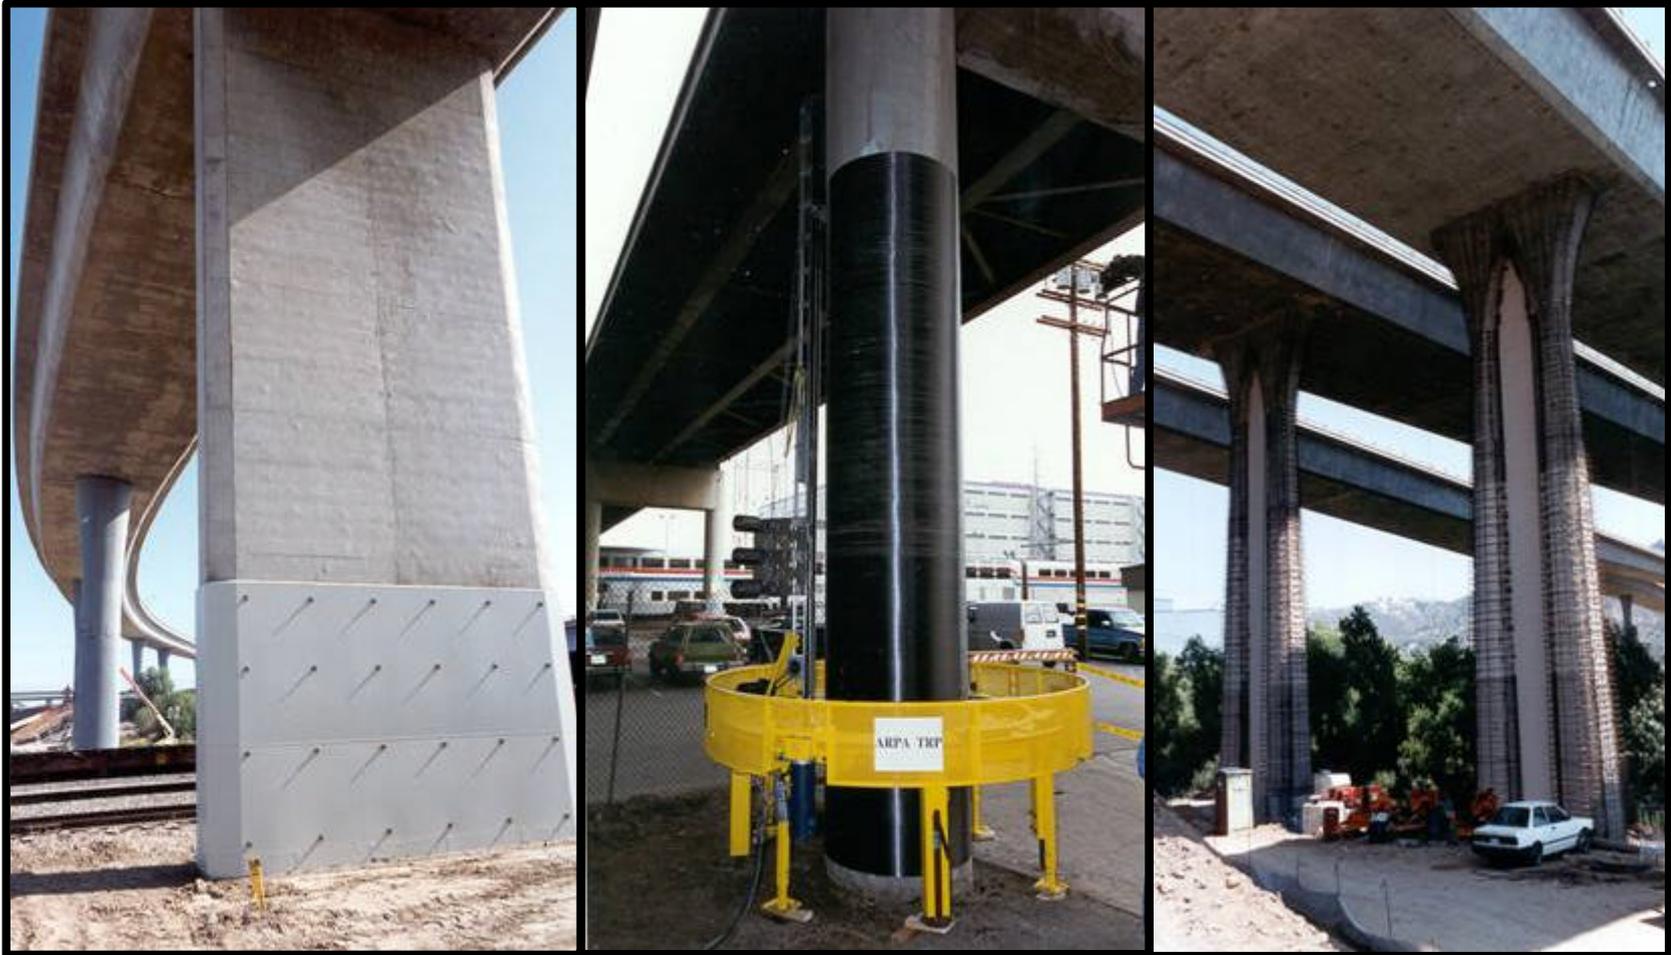
Column Jacket Retrofit

a) Steel Jacketing

b) Carbon Fiber Jacketing

c) Concrete Jacketing

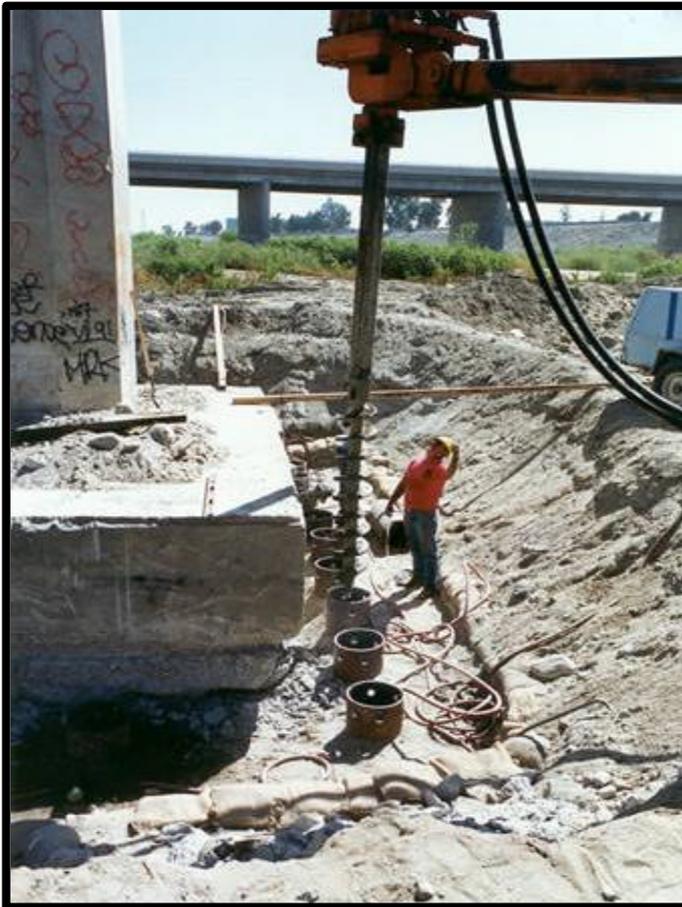
Foundation Retrofit

a) Addition of Piles

b) Reinforced Concrete Footing Overlay

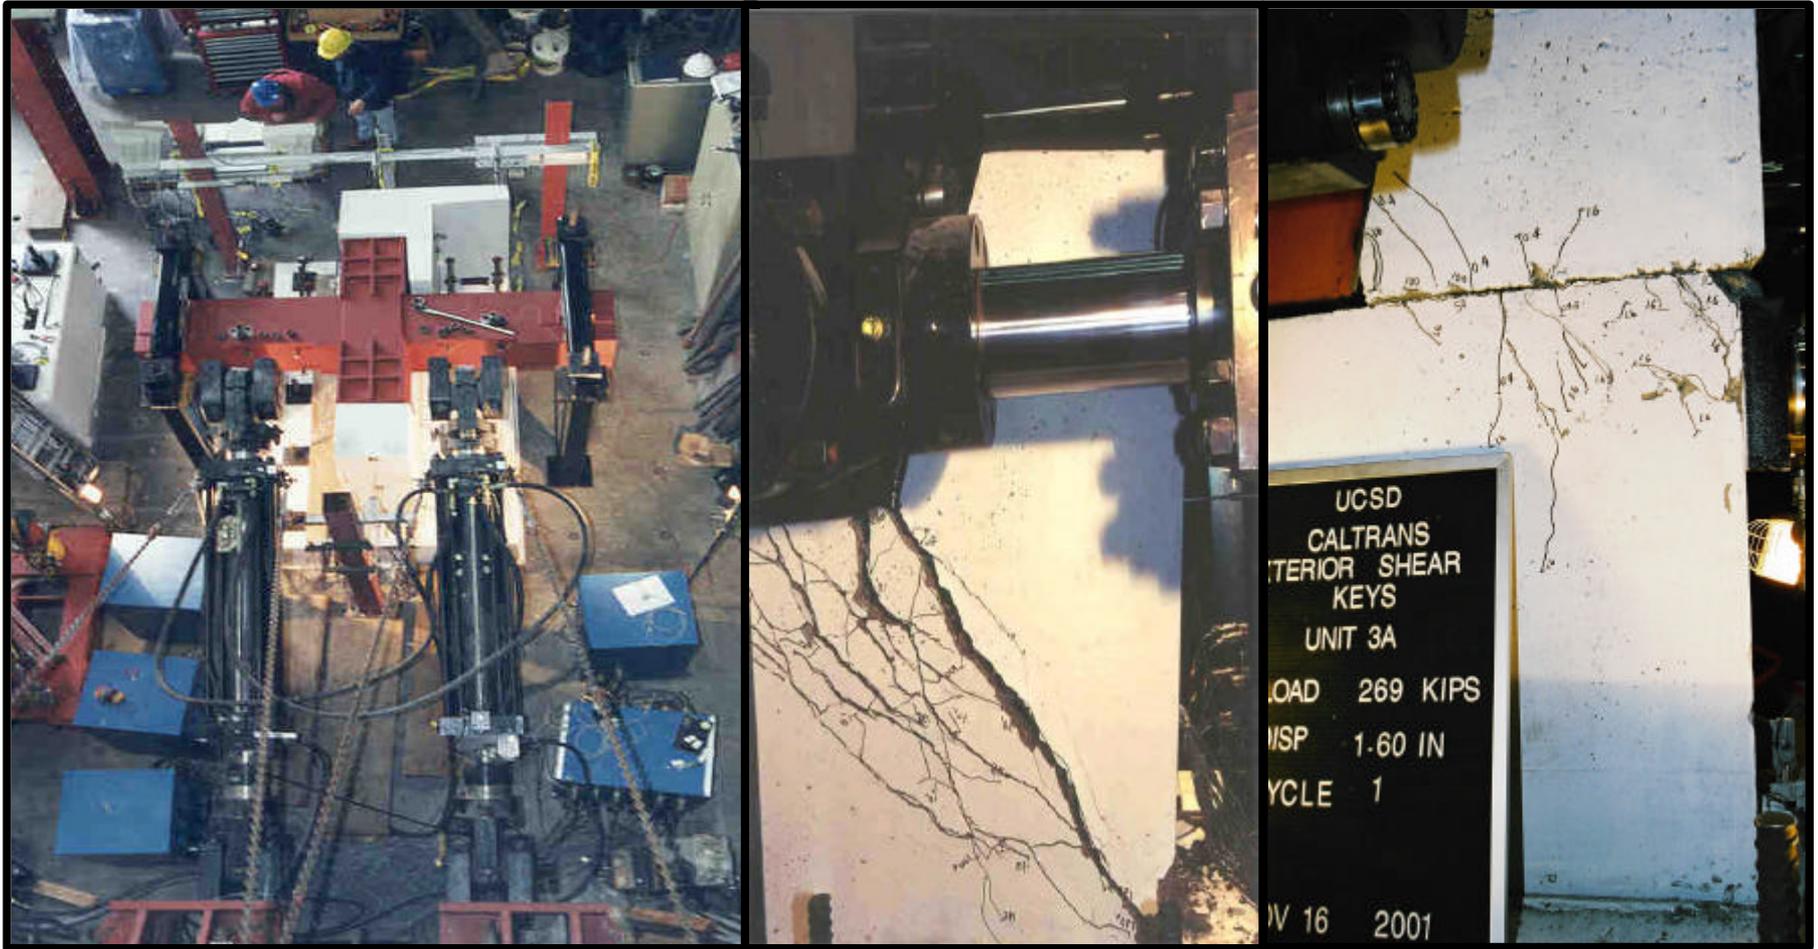
External Abutment Shear Key Testing

a) Test Setup

b) Shear Key Failure Modes

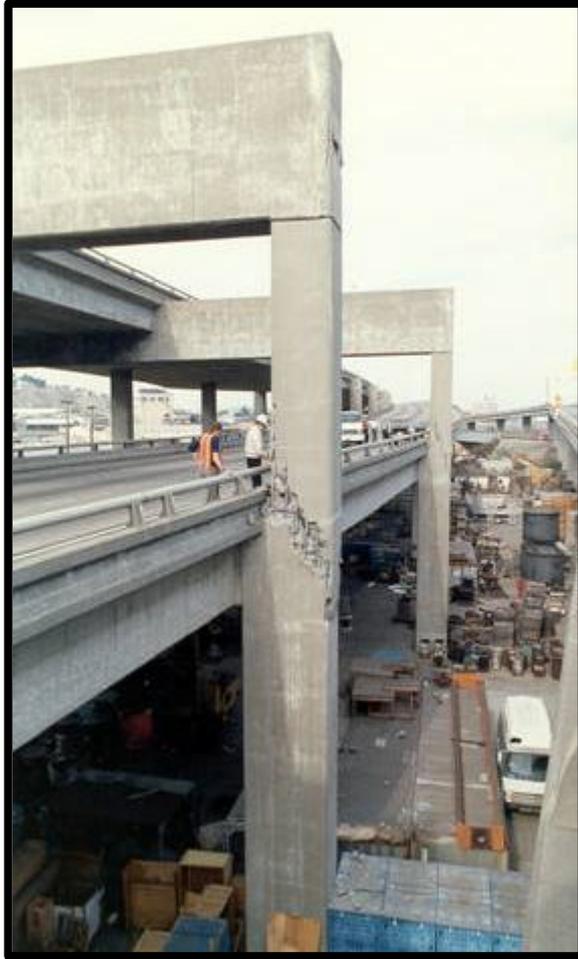
Joint Failures, Loma Prieta, 1989

a) I-280 Viaduct

b) I-880 Cypress Viaduct

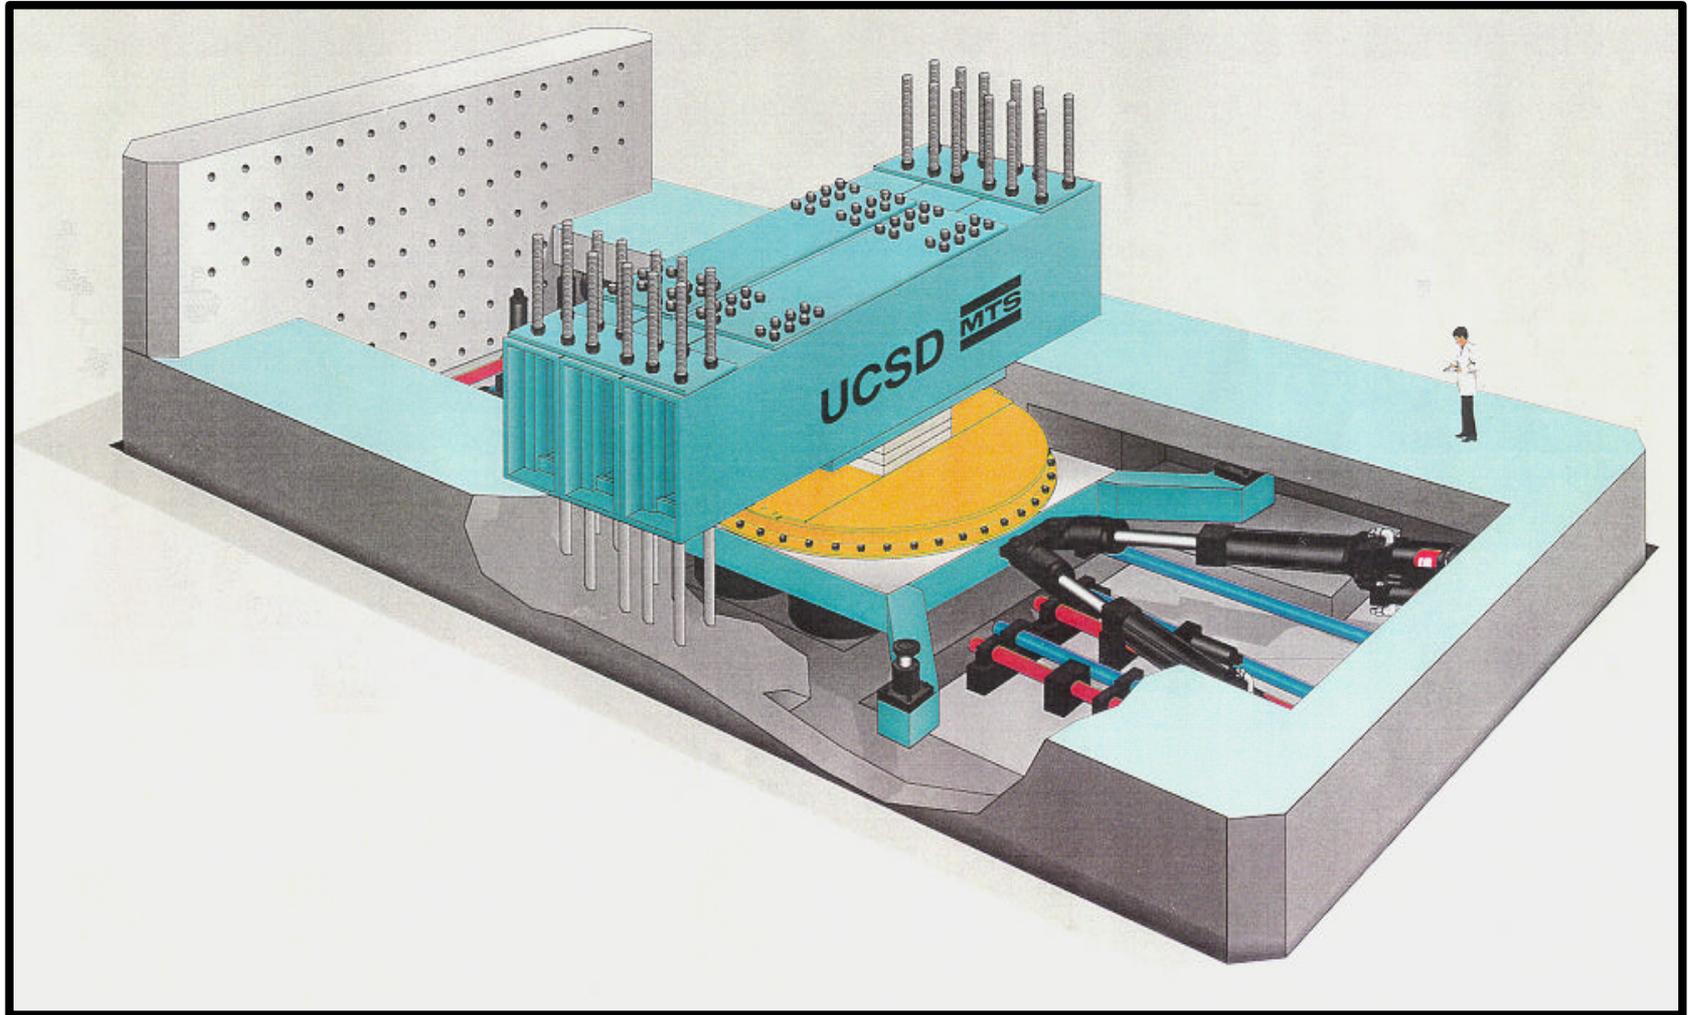
Schematic of SRMD Test System

<i>Vertical</i>	<i>Longitudinal</i>	<i>Transverse</i>
Force	53,400 kN (12,000 kips)	8,900 kN (2,000 kips)	4,450 kN (1,000 kips)
Displacement	± 0.127 m (5 in.)	± 1.22 m (48 in.)	± 0.61 m (24 in.)
Velocity	± 254 mm/s (10 in./s)	± 1778 mm/s (70 in./sec)	± 762 mm/s (30 in./sec)
Clearance	Up to 1.52 m (5 ft)		~ 4 m (13 ft)
Relative rotation	± 2°	± 2°	± 2°

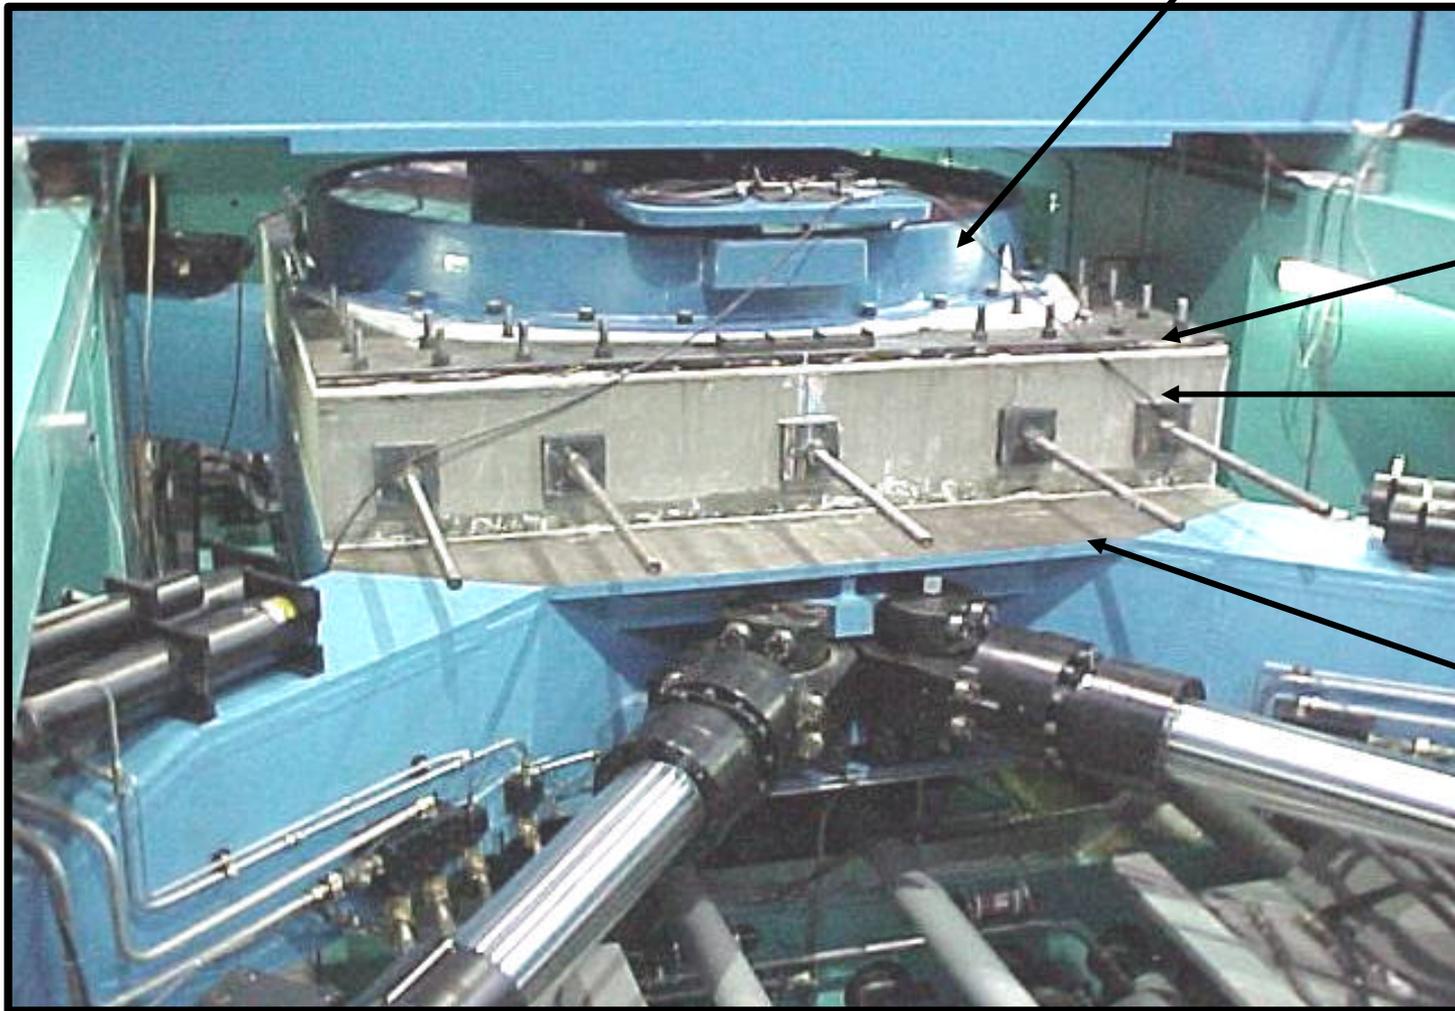
Bearing Specimen (Type 1)

Adapting Plate

Concrete
Spacer
Block

Platen

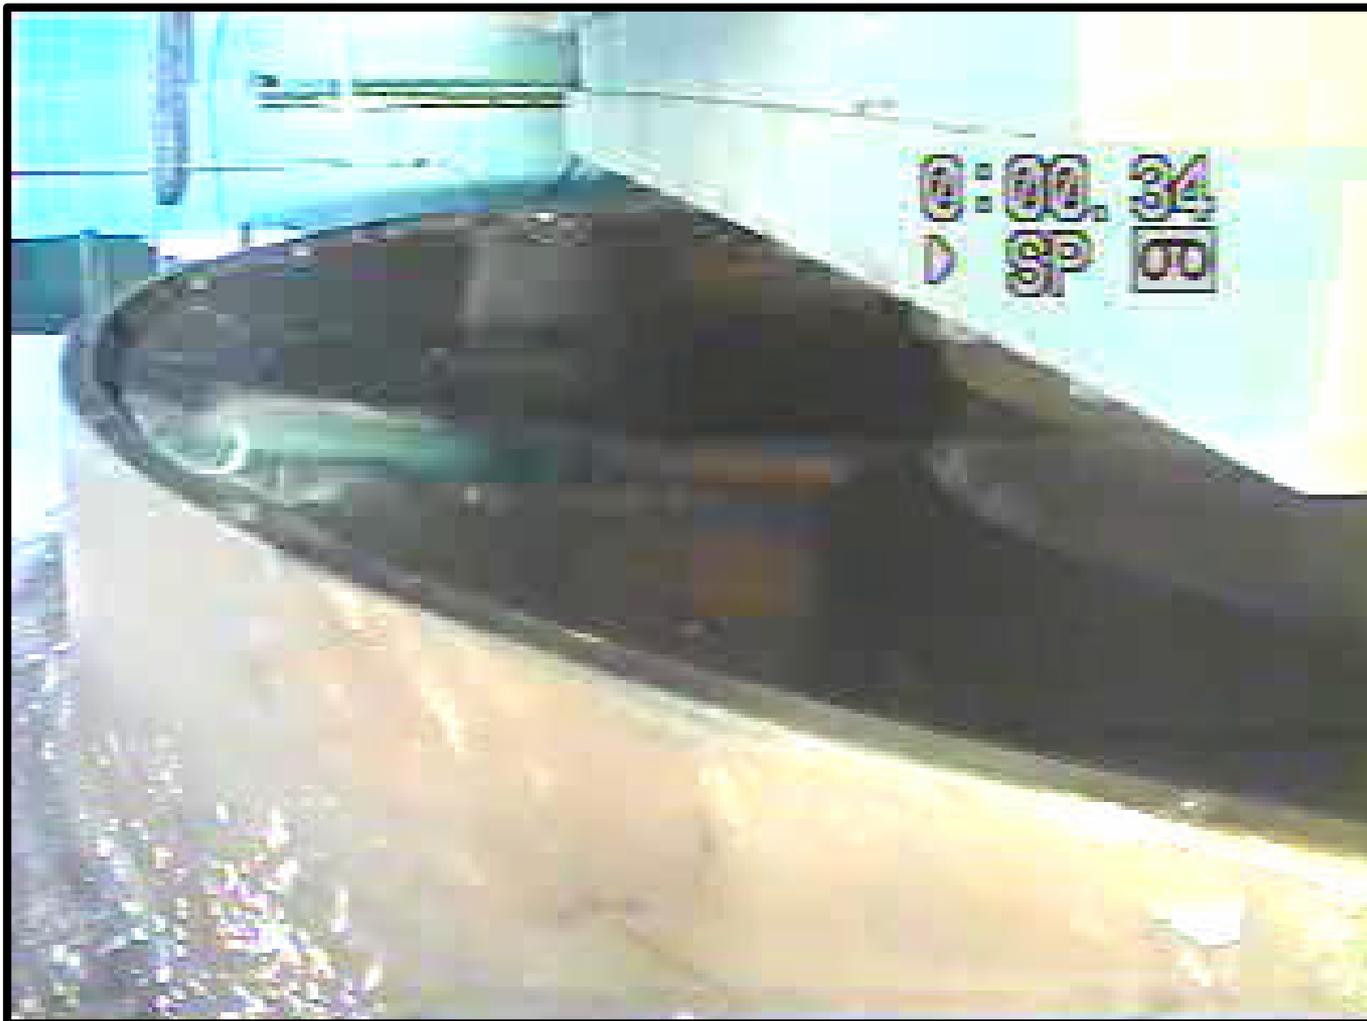
Isolation Bearing Test: Friction Pendulum Bearing

$P_z = 6000$ kips

$D_x = \pm 29$ inches

Vel = 60 in./sec.

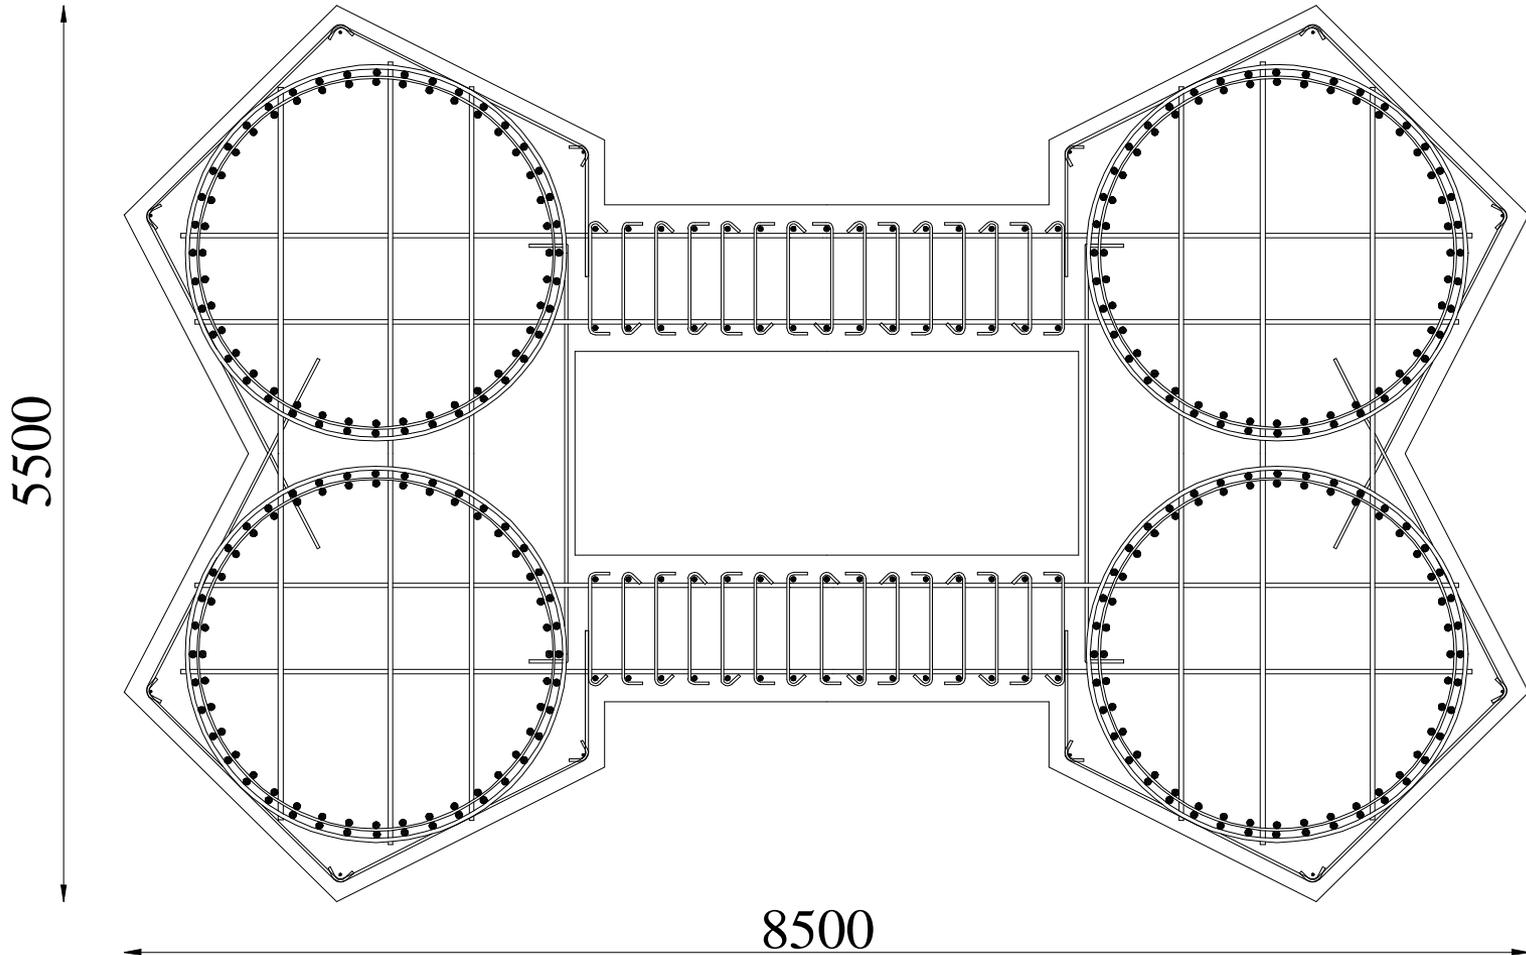
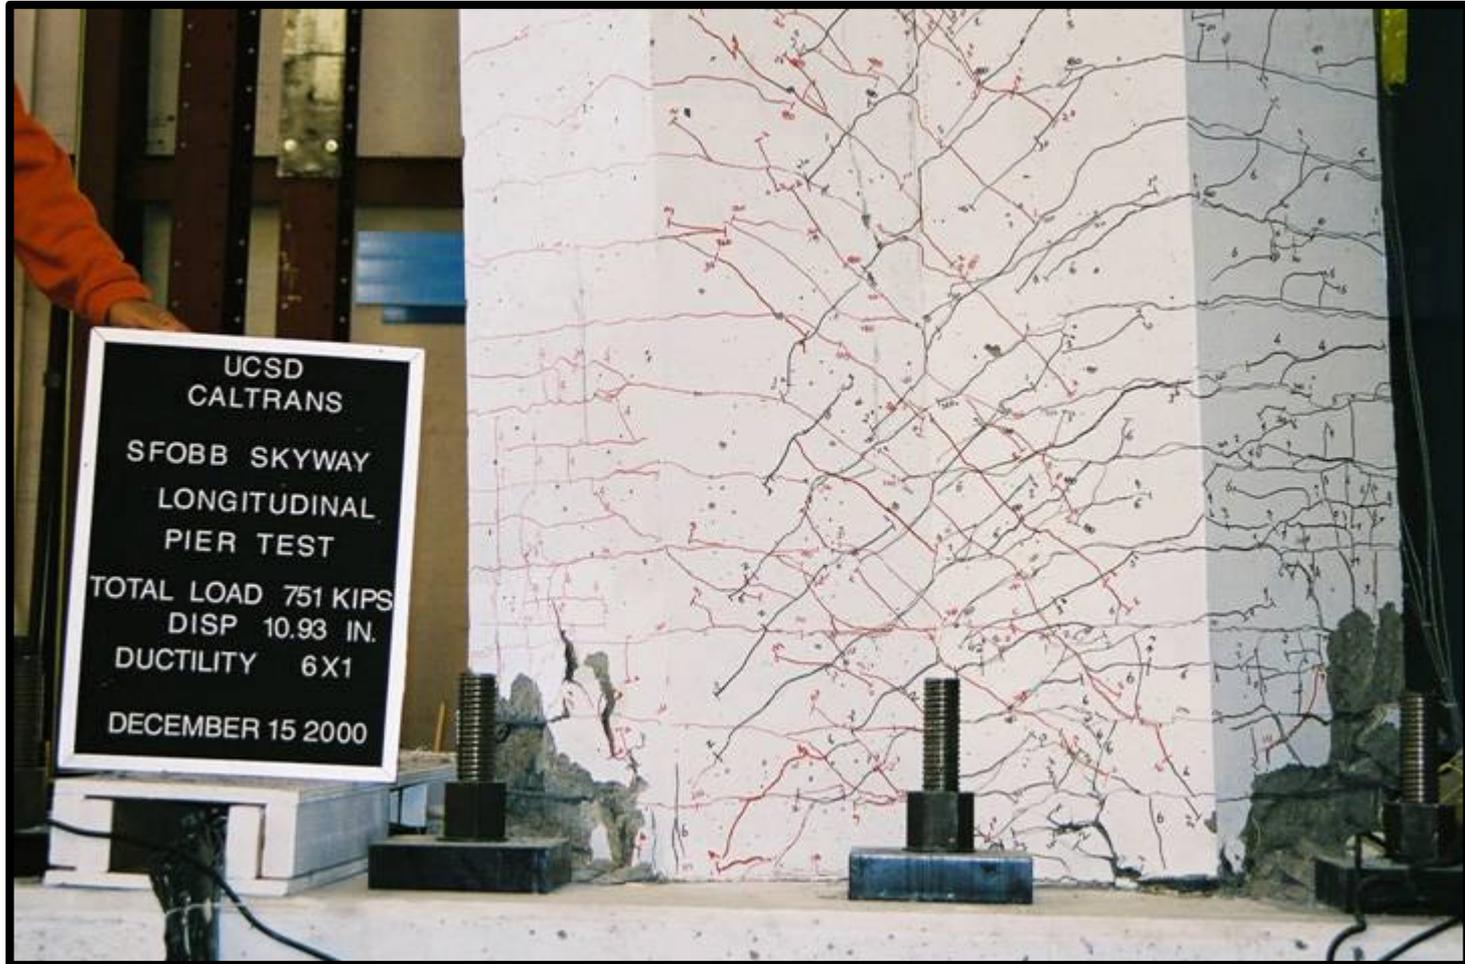
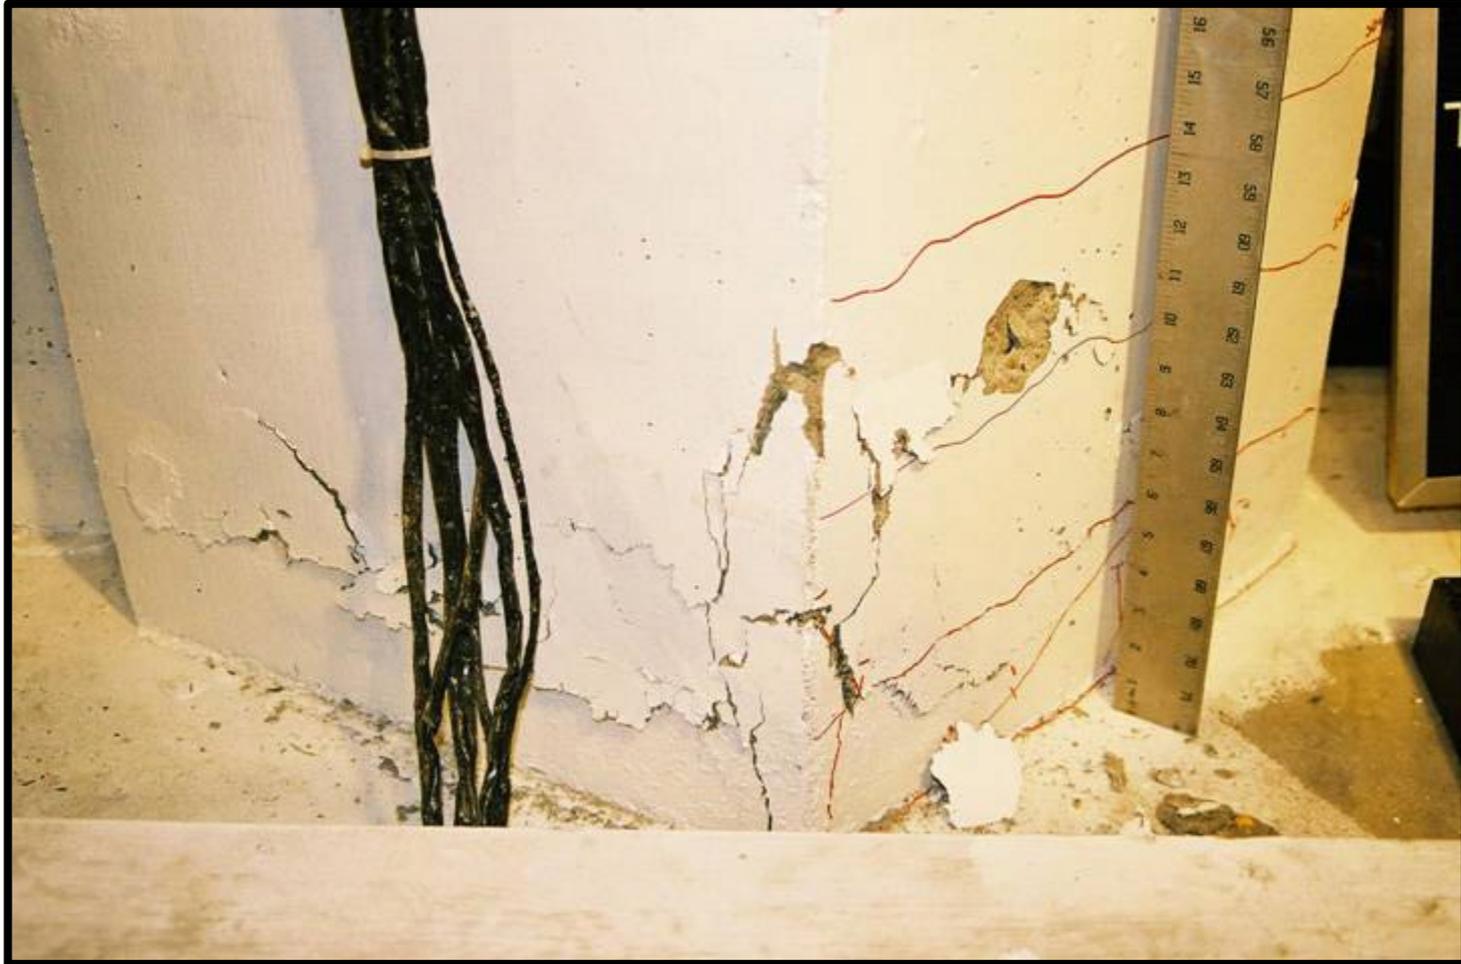
Prototype section for Longitudinal Pier Test

$$\mu_{\Delta} = 6 \times 1$$

$$\mu_{\Delta} = 2 \times 1$$

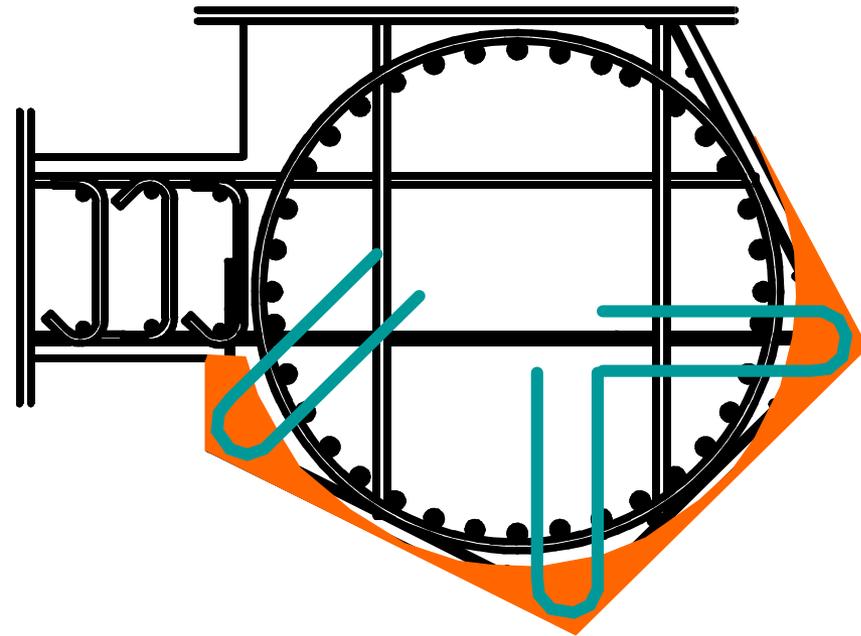
FEE Performance

$$m_D = 2$$

Spalling of the architectural concrete

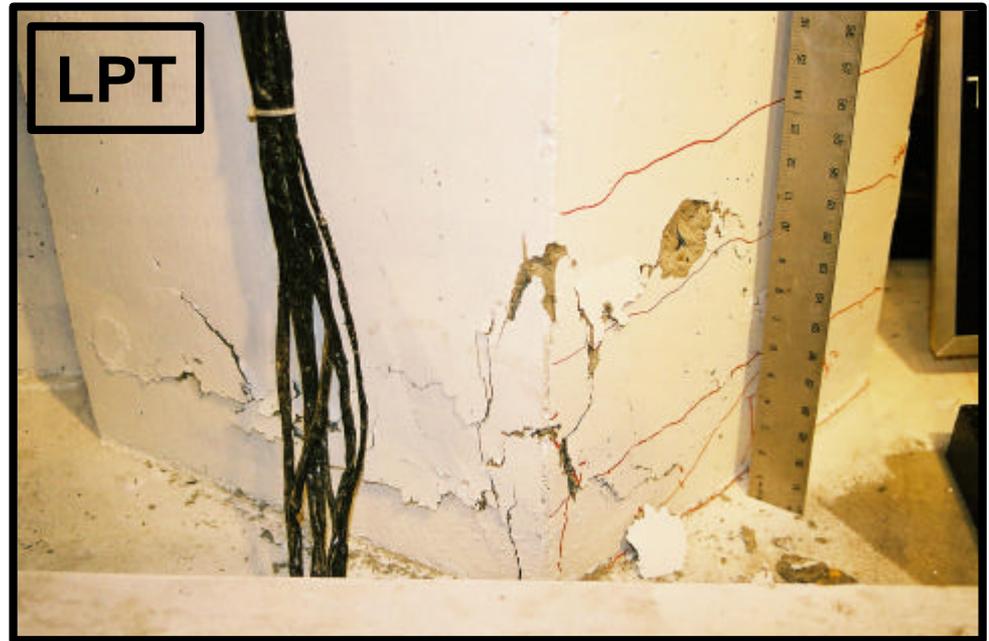
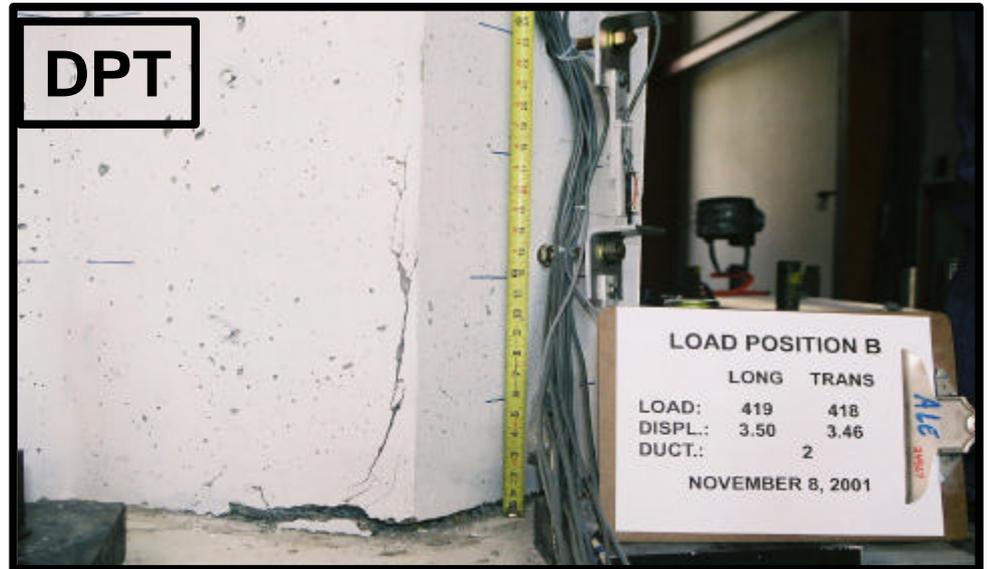
Column Damage

**Longitudinal Pier
Test**

No isolation gaps

**Diagonal Pier
Test**

With isolation gaps

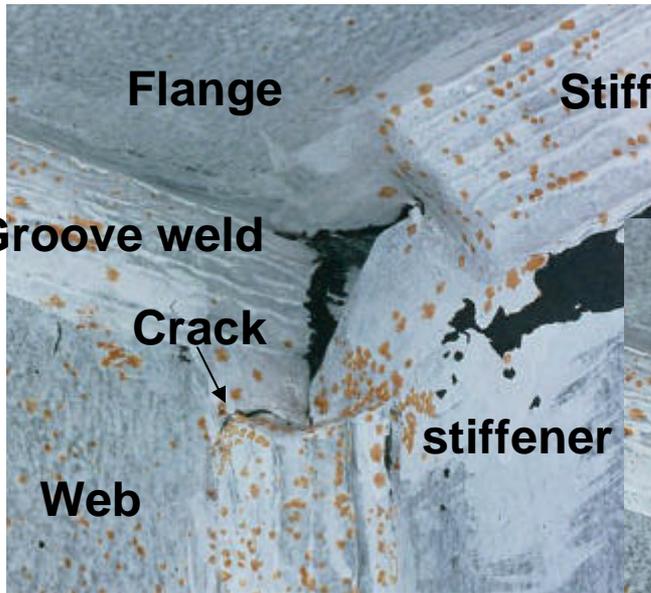
Shear Link Test: Failure development

Stiffener / web
fillet weld

$g = 0.04$ rad

$g = 0.05$ rad

On the way to
 $g = 0.069$ rad

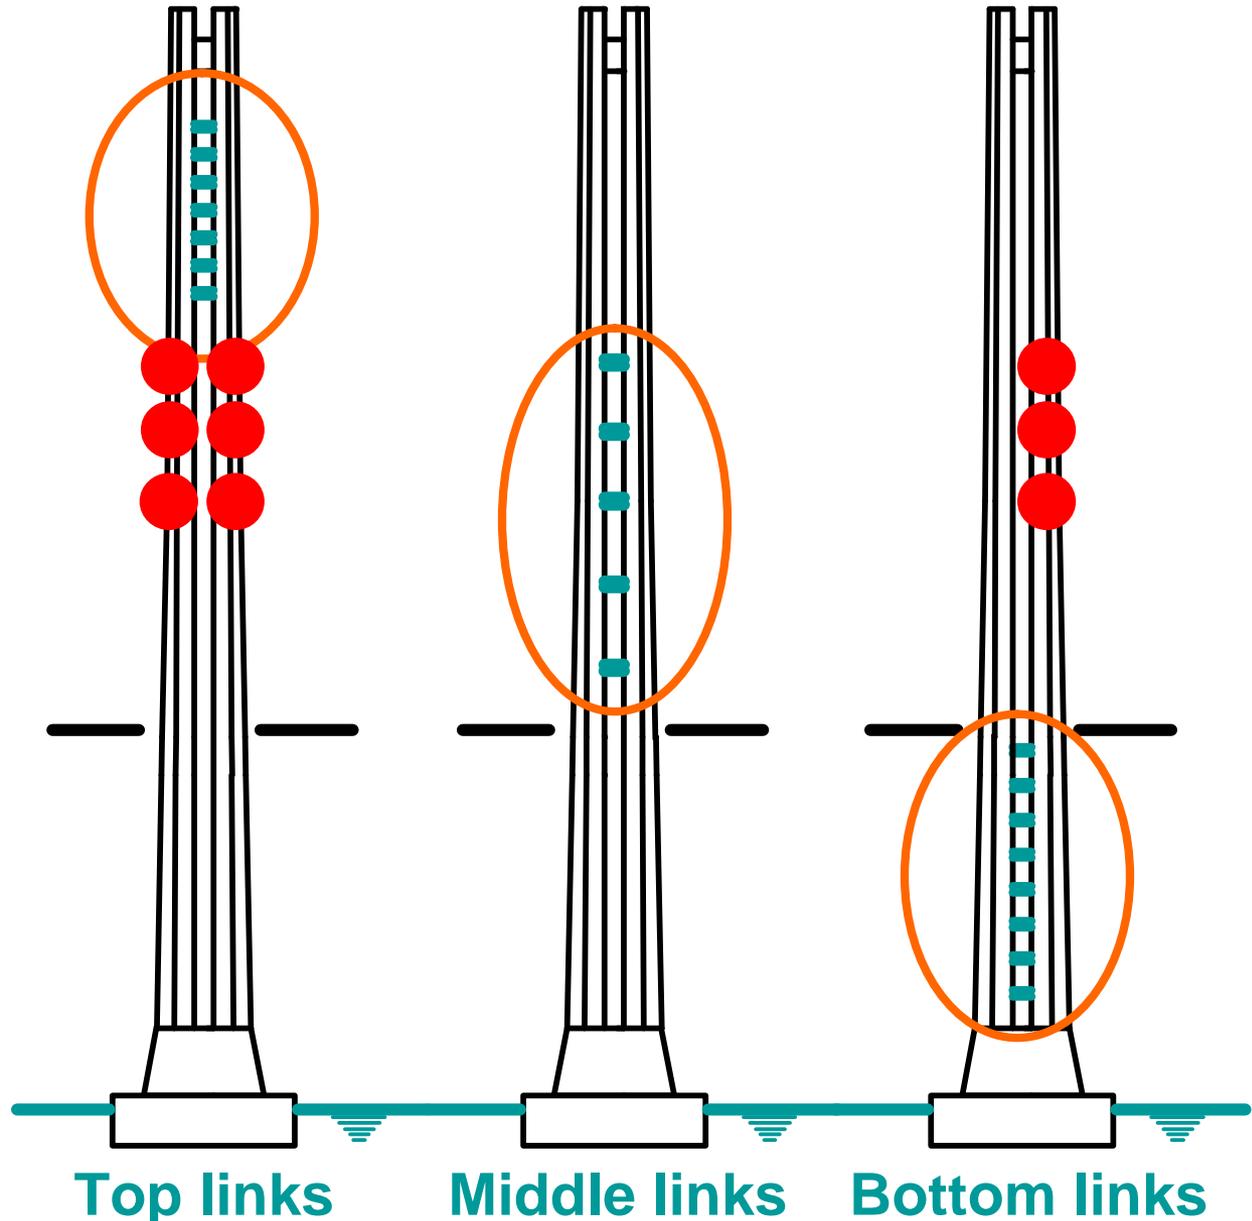
Influence of Tower Link Location

● Yielding of the tower shaft during SEE

Tune strength, stiffness and location of the links to achieve the optimum design

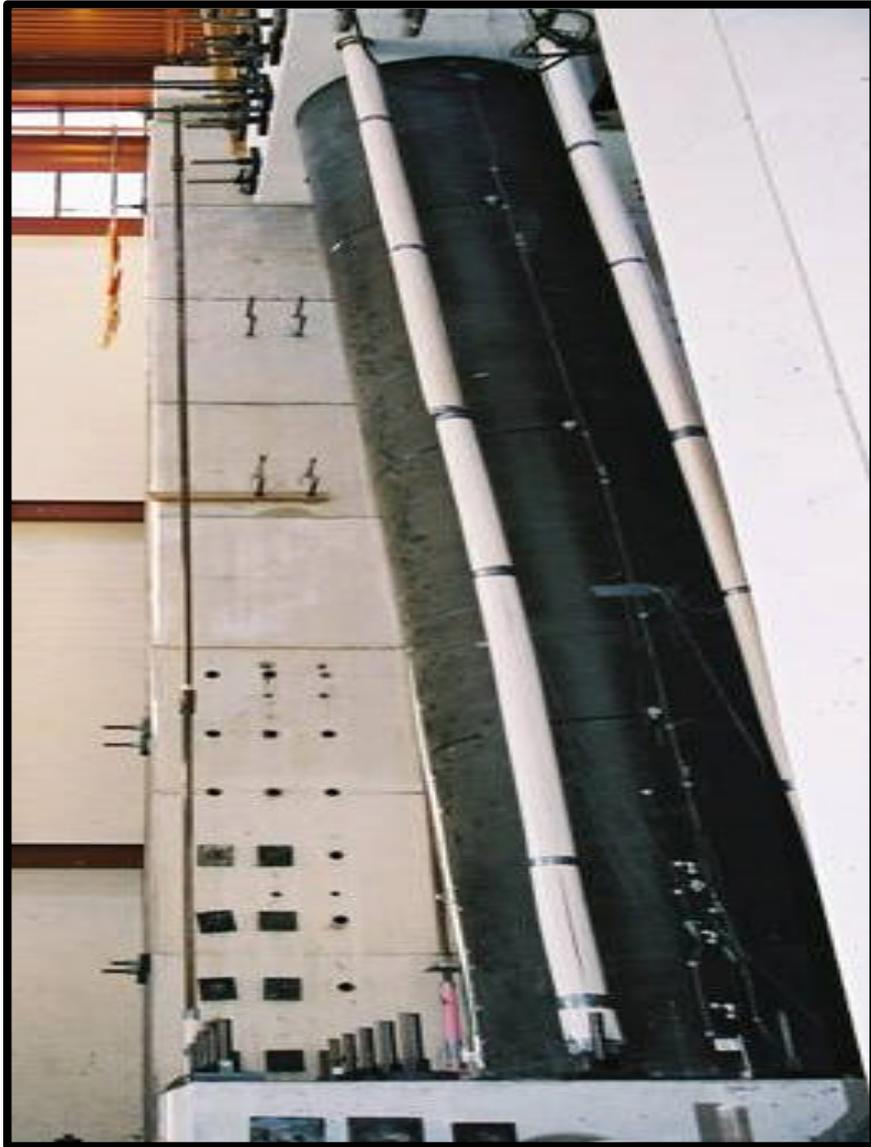
Extreme drift at displacement ductility 7

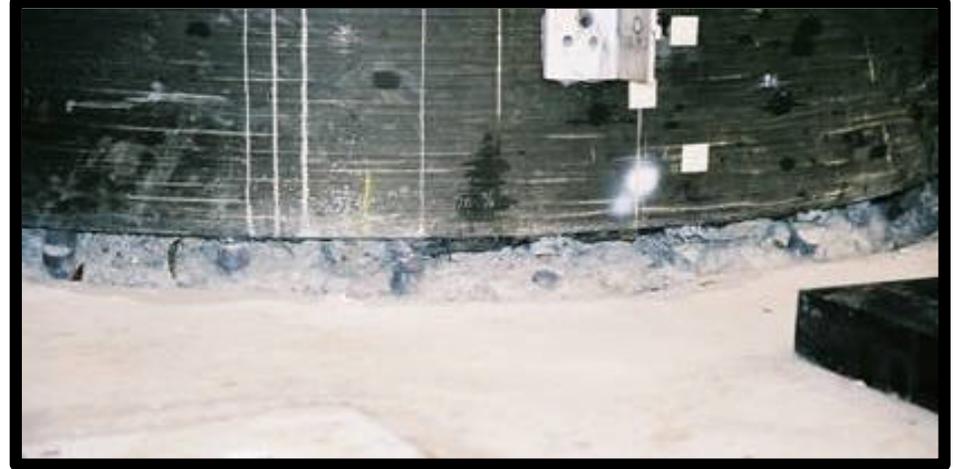
Ruptured bars at end of test (15 out of 30 bars ruptured w/minimal strength degradation)

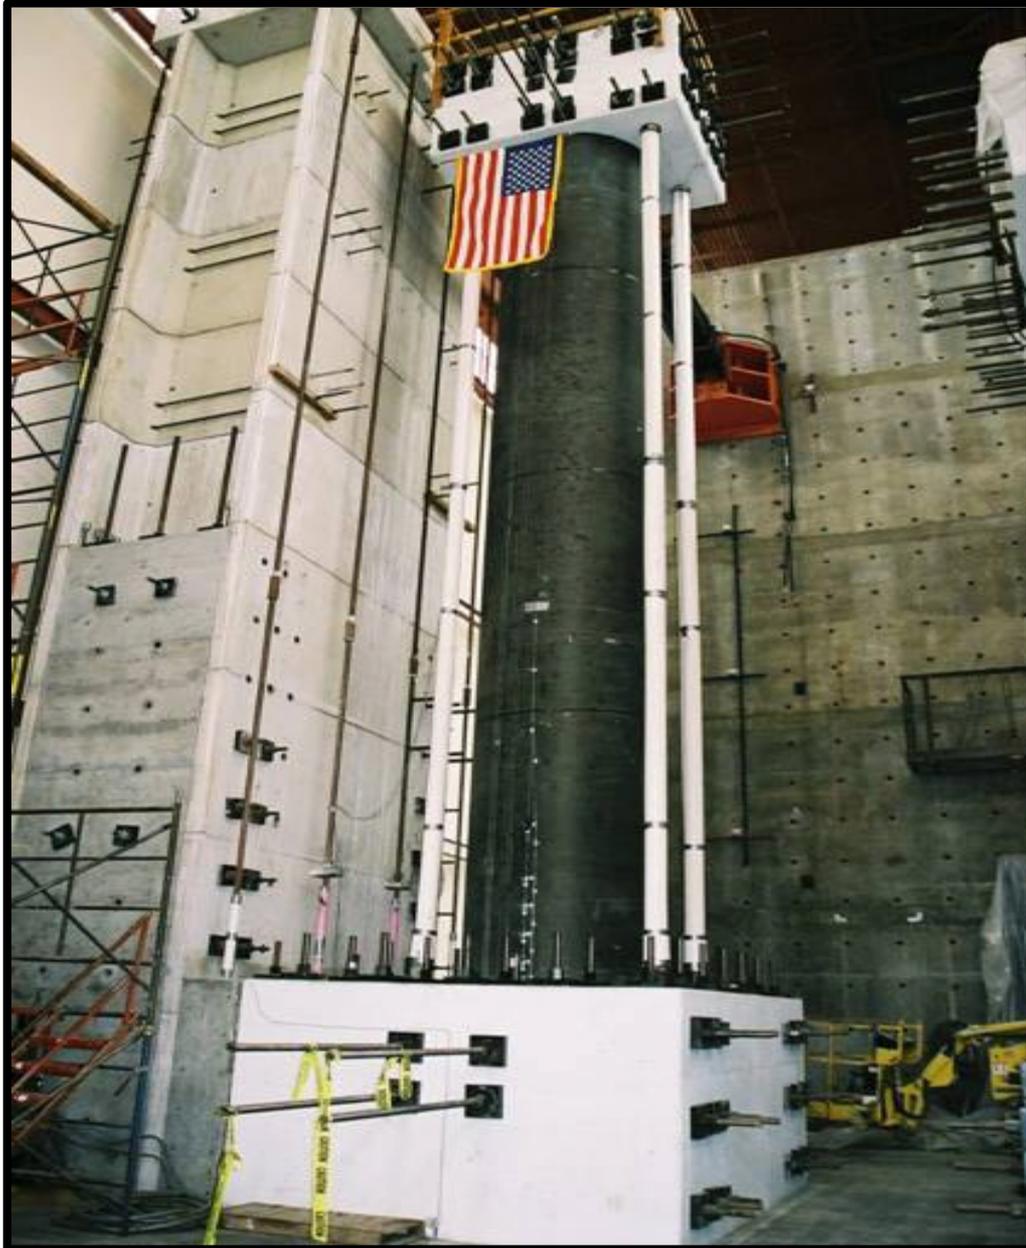
Column Protection For New Critical Facilities

Concrete core

Carbon composite shell with transverse and longitudinal fibers

Protection of columns on lower levels of building
