Caltrans District 3 Yolo 80 Corridor Improvement Project

Bat Species of Special Concern Habitat Assessment

Sacramento, Yolo, and Solano Counties, California

July 2022

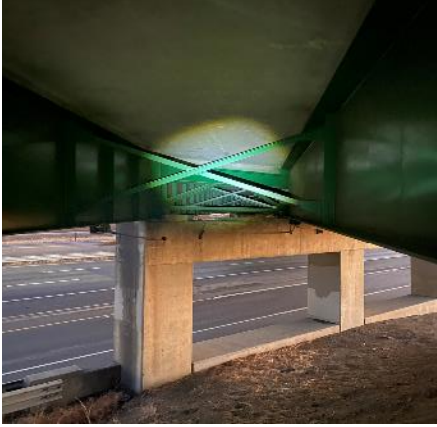
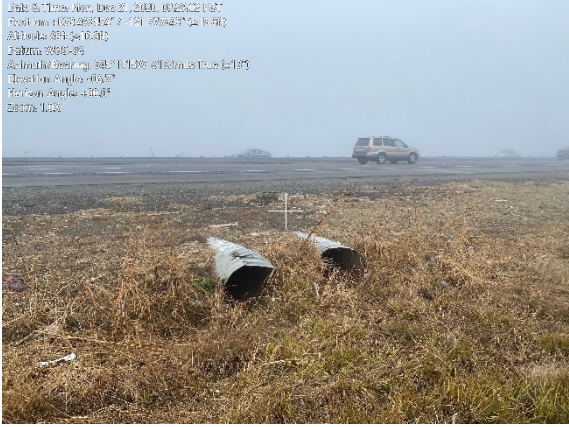
<p> Date & Time: Mon, Dec 21, 2020, 09:28:02 PST Position: 38.9288327° N / 121.7728113° W Altitude: 884.5m (2902) Datum: WGS-84 Azimuth/Heading: 88.3° (N) 38° (W) 88.3° (True) 121.77° Elevation/Angle: 0.55° Horizontal Scale: 4.37m Zoom: 11.0x </p>
<p>Photo 1. No expansion joints observed in steel girder bridge. Habitat surrounding bridge consists of perennial grasslands & orchards (Location #2). Taken facing south.</p>	<p>Photo 2. Habitat consists of small, corrugated steel pipes. Habitat surrounding corrugated steel pipes consists of perennial grasslands & orchards (Location #3). Taken facing northwest.</p>

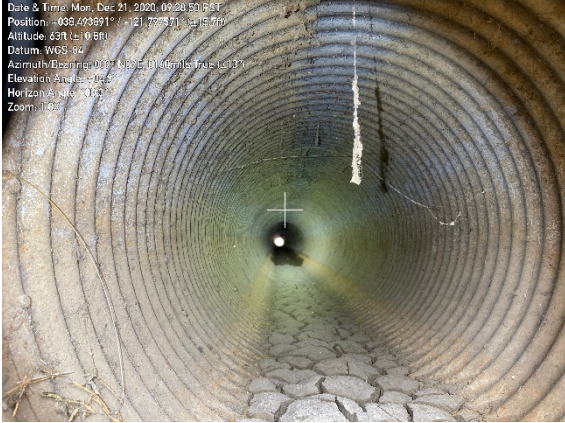
<p>Photo 3. Habitat consists of small, corrugated steel pipes, low roosting potential in culvert. Habitat surrounding bridge consists of perennial grasslands & orchards (Location #3). Taken facing northeast.</p>	<p>Photo 4. Concrete box bridge with weep holes present (Location #4). Taken facing northeast.</p>

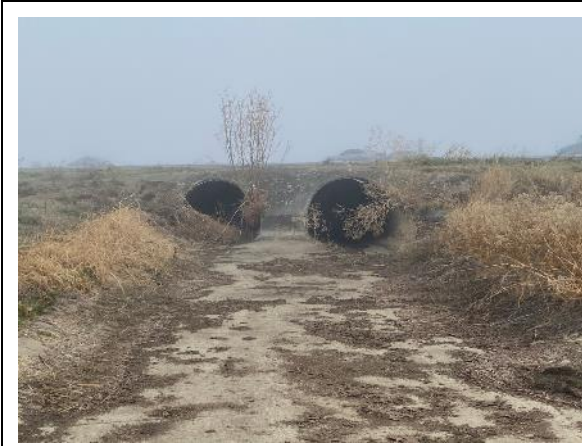
Photo 5. Multiple, large diameter corrugated steel culverts running below I-80 and adjacent frontage roads. Culverts below I-80 had signs of bat use, likely night roosting. (Location #5). Taken facing east.

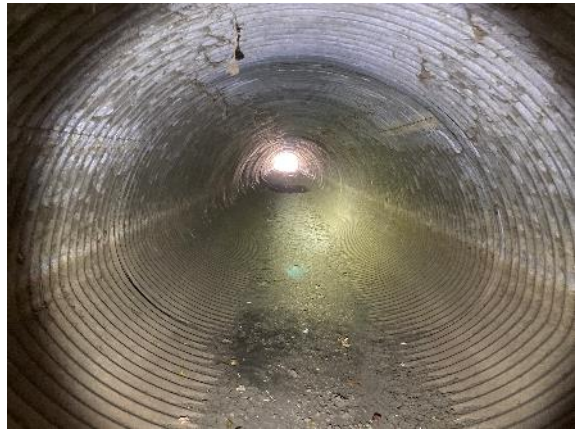
Photo 6. Multiple, large diameter corrugated steel culverts running below I-80 and adjacent frontage roads. Culverts below I-80 had signs of bat use, likely night roosting. Habitat surrounding bridge consists of perennial grasslands, orchards, and small stand of trees with clusters of dense leaf foliage and crevices for roosting bats (Location #5). Taken facing southeast.

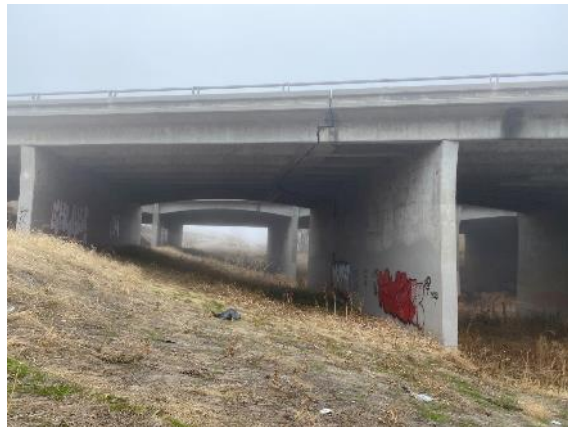
Photo 7. Habitat surrounding bridge consists of riparian vegetation (willow and cottonwood) along south Fork of Putah Creek, croplands, and orchard trees (Location #7). Taken facing northwest.

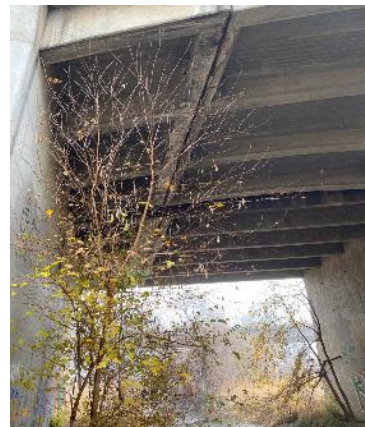
Photo 8. Bridge with multiple expansion joints along I-80 spanning the South Fork of the Putah Creek were occupied by Mexican free-tailed bats. Willow and cottonwood trees along creek provide suitable foliage roost for western red bat (Location #7). Taken facing north.

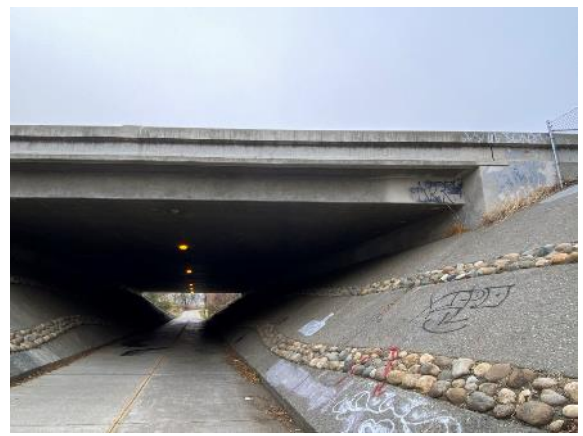
Photo 10. Habitat surrounding concrete box bridge with weep holes, consists of agricultural fields, trees along the roadside and green space along the Putah Creek with dense clusters of leaves and crevices for roosting bats adjacent to the bridge (Location #19). Taken facing northwest.

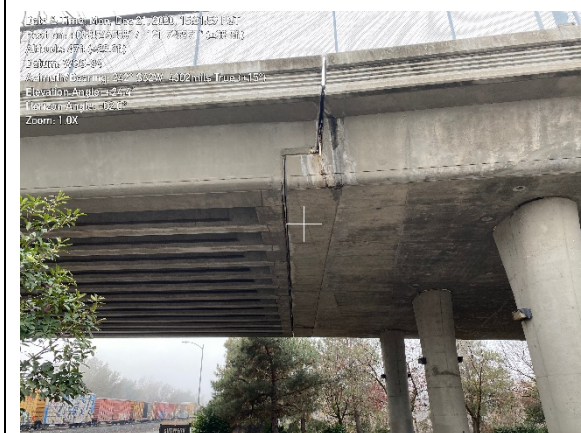
Photo 11. 318 Mexican free-tailed bat were observed roosting in the northern expansion joint of the Pole Line Road overpass (Location #22). Taken facing southwest.

Large colonies of wintering Mexican free-tailed bats were observed within bridge expansion joints at three locations in the ESL (see Table 1 in Appendix A). Numbers of Mexican free-tailed bats ranged from a few hundred (Locations 7 and 22) to approximately 3,000 individuals in the Yolo Bypass Wildlife Area (Location 29 and 30). Because of this, not all the habitat was surveyed, therefore this is almost certainly an underestimate of the total number of bats using the Yolo Bypass Wildlife Area for roosting during the winter season. During the maternity season, the Yolo Bypass Wildlife Area is home to an estimated 250,000 Mexican free-tailed bats, one of the largest colonies in California (Taylor 2013 and Ryan Byrnes personal observations). The two other locations had day roosting Mexican free-tailed bats. A total of 540 Mexican free-tailed bats were observed occupying I-80 bridge expansion joints spanning the South Fork of the Putah Creek just west of the City of Davis (Location 7, Appendix A), and 318 Mexican free-tailed bats were observed occupying expansion joints on the north side of the Pole Line Road I-80 overpass in the City of Davis (Location 22, Appendix A).

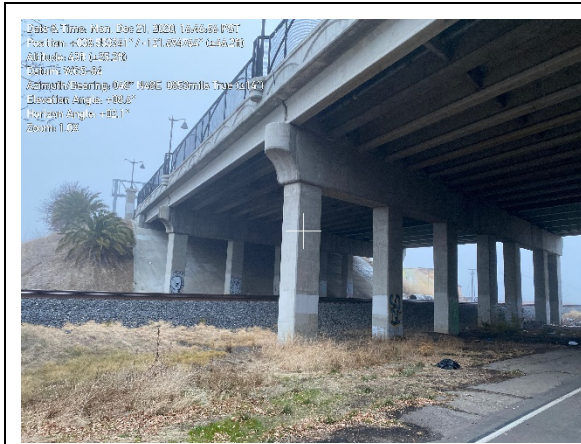
Photo 13. Habitat surrounding concrete girder/steel box bridge with expansion joints, utility boxes, bridge abutments (all potentially suitable bat roost habitat) consist of mowed annual grasses, industrial buildings, and potential tree roost habitat with dense clusters of leaves and crevices. (Location #25). Taken facing northeast.

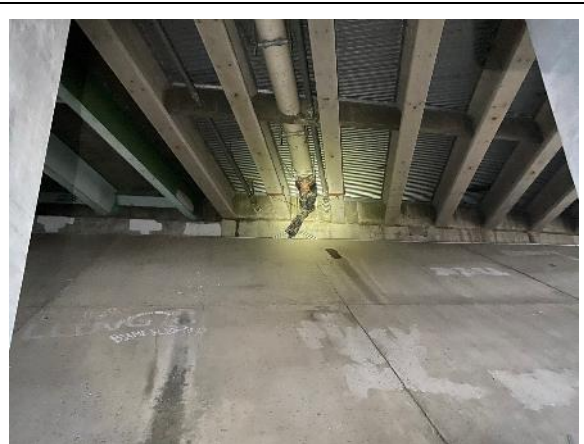
Photo 14. Habitat surrounding concrete girder/steel box bridge with expansion joints, utility boxes, bridge abutments (all potentially suitable bat roost habitat) consist of mowed annual grasses, industrial buildings, and potential tree roost habitat with dense clusters of leaves and crevices. (Location #25). Taken facing north.

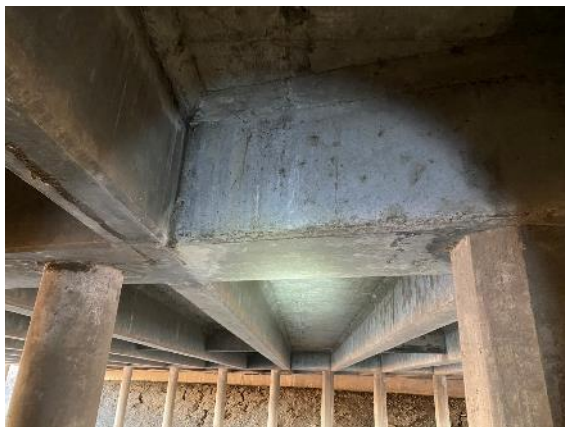
Photo 15. Signs of bat night roosting were observed throughout the bridge, including guano and staining spots along the bridge deck (Location #28). Taken facing east.

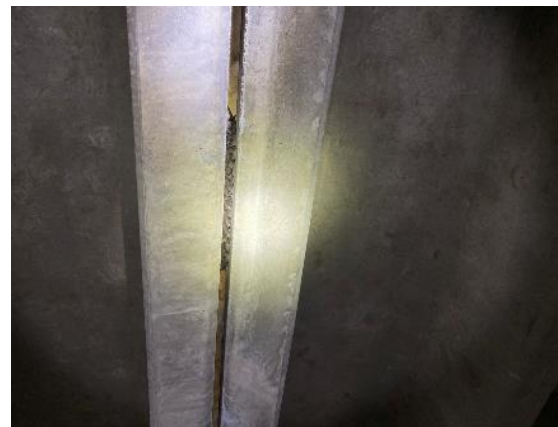
Photo 16. Habitat surrounding concrete girder bridge, and the gaps between girders (potentially suitable bat roost habitat), consists of annual grass, agricultural fields (rice) and potential tree roost habitat with dense clusters of leaves and crevices within Yolo Bypass (Location #29). One thousand five hundred Mexican free-tailed bats were counted in one section of the bridge. Taken facing up towards gaps in girders.

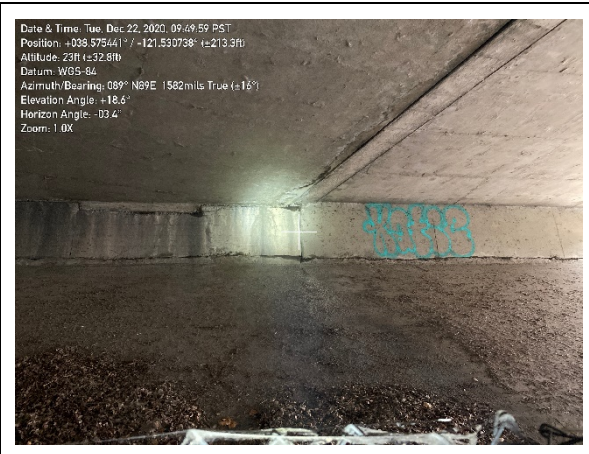
Photo 18. Potentially suitable bat roost habitat consists of concrete girder bridge construction with multiple expansion joints and some crevices observed along the bridge abutments. Bat guano was observed in crevices along the bridge abutment (Location #35). Taken facing northeast.

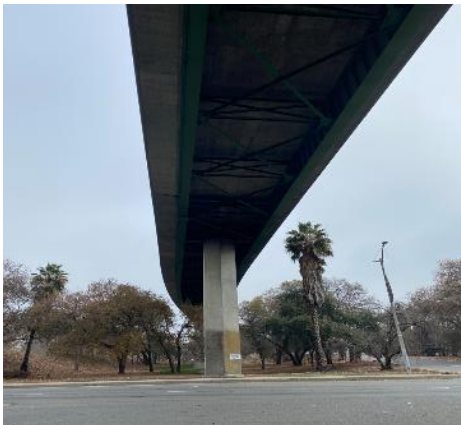
Photo 19. Habitat surrounding steel girder bridge with multiple expansion joints, and crevices along abutments, consists of landscaped lawns, mowed areas below bridge, residential/industrial buildings, and trees with clusters of dense leaf foliage and crevices for potential roost habitat (Location #37). Taken facing east.

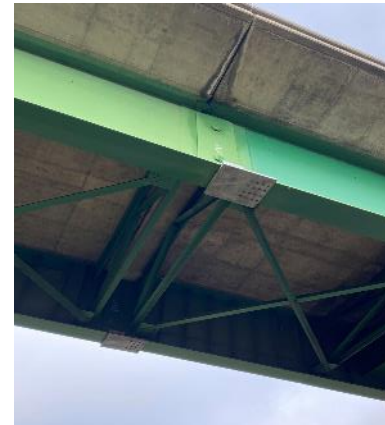
Photo 20. Bat guano was observed in crevices along the length of multiple expansion joints. Based on the amount of guano observed, the expansion joint could be occupied by a maternity colony during maternity season (Location #37). Taken facing northeast.

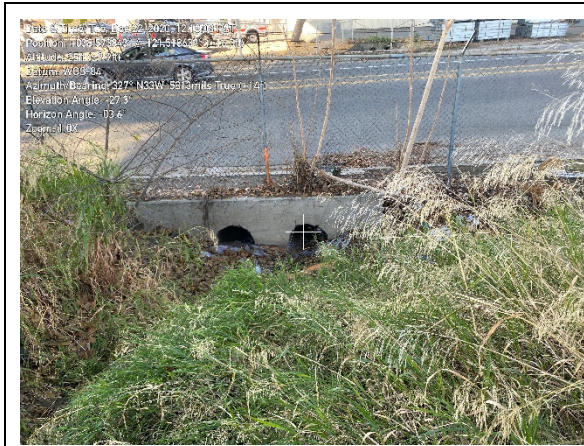
Photo 21. Habitat consists of small, corrugated steel pipes. Habitat surrounding corrugated steel pipes consists of industrial buildings, apartment buildings, construction yards, riparian habitats associated with the Sacramento River, and trees with clusters of dense leaf foliage and crevices for potential roost habitat (Location #40). Taken facing east.

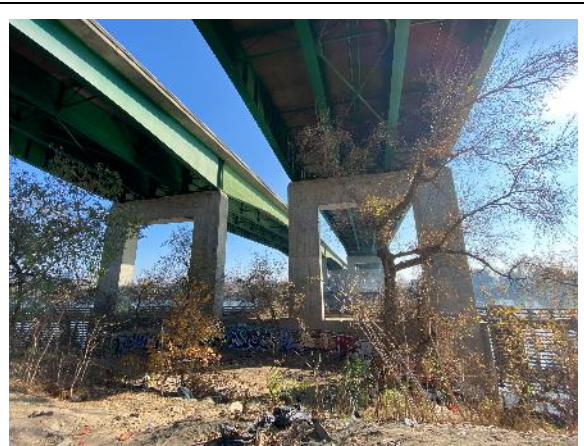
Photo 22. Steel girder bridge with multiple expansion joints, abutments with crevices spans the Sacramento River and leads to developed and disturbed area in Sacramento. Habitat surrounding the bridge consists of landscaped lawns, mowed areas below the bridge, residential and industrial buildings, homeless encampments, and potential tree roost habitat along the Sacramento River and urban street trees with dense clusters of leaves and crevices (Location #41). Taken facing southeast.

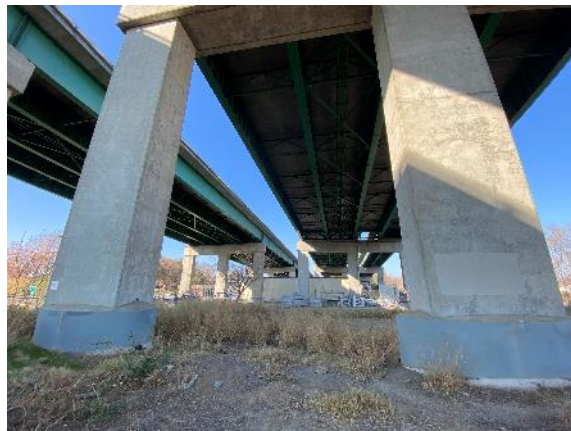
Photo 23. Potentially suitable bat roost habitat consists of steel girder bridge with multiple expansion joints and some crevices observed along the bridge abutments. Bat guano was observed in crevices of multiple expansion joints. Based on the amount of guano observed, the expansion joint could be occupied by a maternity colony during maternity season (Location #41). Taken facing northwest.

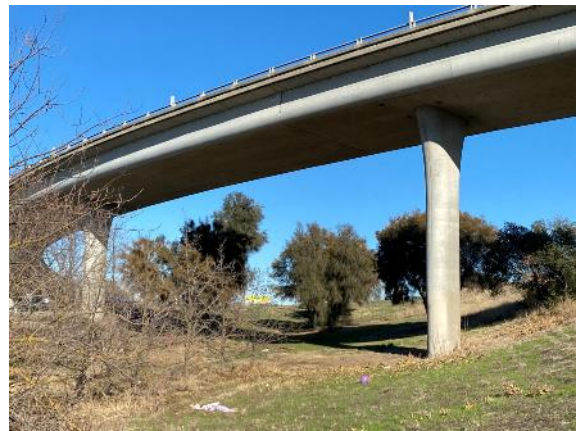
Photo 24. Habitat along multiple concrete box bridges with expansion joints consists of mowed annual grasses, industrial buildings, and potential tree roost habitat with dense clusters of leaves and some crevices, though most trees were small and unlikely to be occupied by bats, including some palm trees in adjacent to the bridges (Location #42). Taken facing east.

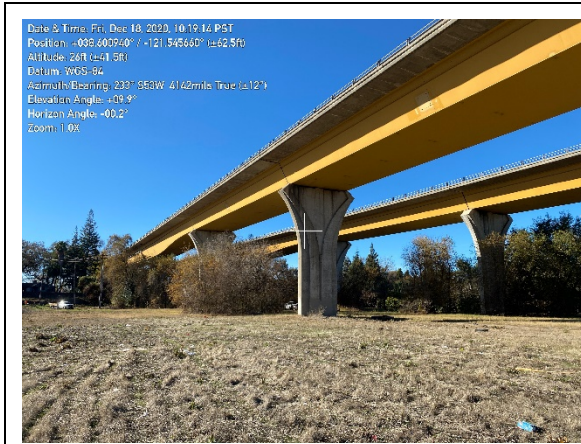
Photo 25. Habitat along steel box bridge with multiple expansion joints and crevices observed along the bridge abutment consists of landscaped lawns, mowed areas below the bridge, residential and industrial buildings, homeless encampments, and potential tree roost habitat along the Sacramento River and urban street trees with dense clusters of leaves and crevice (Location #46). Taken facing southwest.

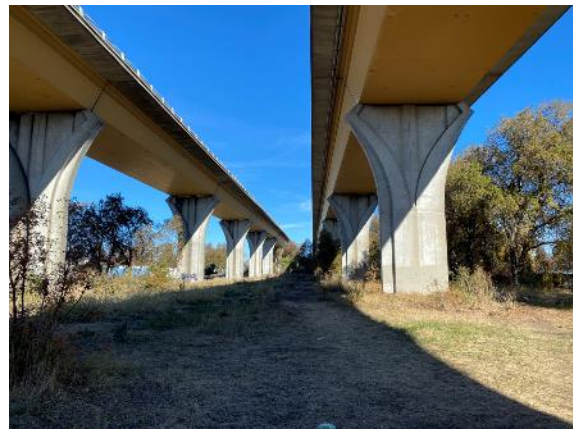
Photo 26. Habitat along steel box bridge with multiple expansion joints and crevices observed along the bridge abutment consists of landscaped lawns, mowed areas below the bridge, residential and industrial buildings, homeless encampments, and potential tree roost habitat along the Sacramento River and urban street trees with dense clusters of leaves and crevice (Location #46). Taken facing northeast.
