APPENDIX D

HB&T ENVIRONMENTAL INC.

REF: Asbestos Survey results for the:
San Francisco Bay Bridge
Administration Building
and
Warehouse/Maintenance
Building

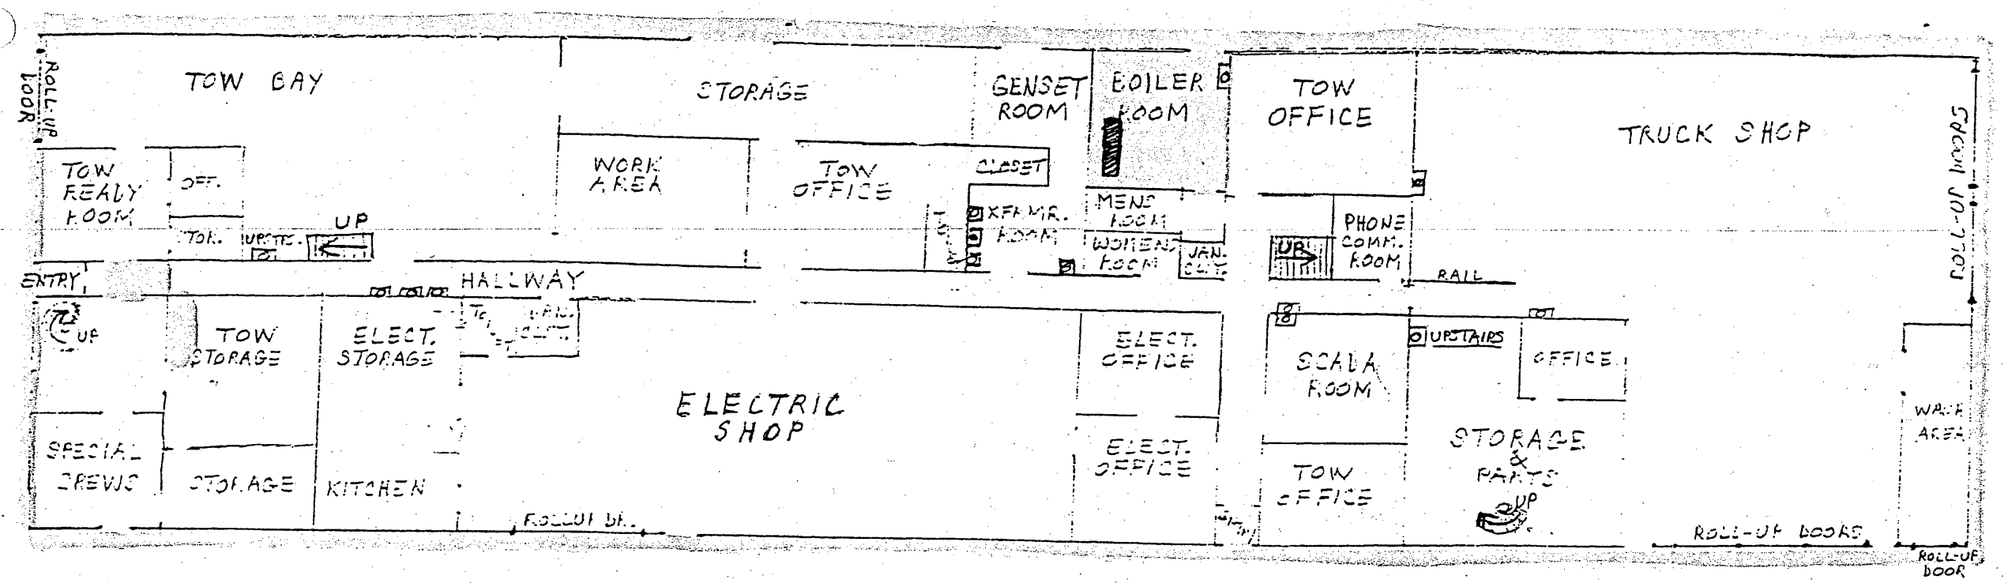
Warehouse/Maintenance Building
Rough sketch

- Floor Tile and Mastic
- (TSI) Thermal System Insulation
- Coated Corrugated Metal Siding
- Duct Expansion Jointcloth

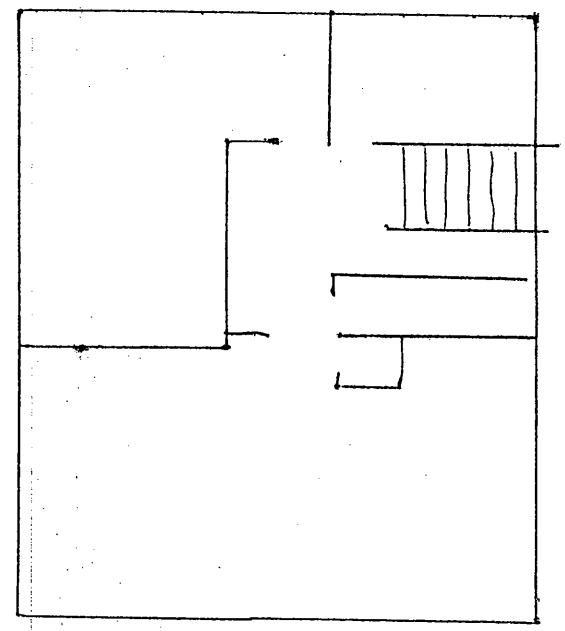
East End 2nd floor

ACM

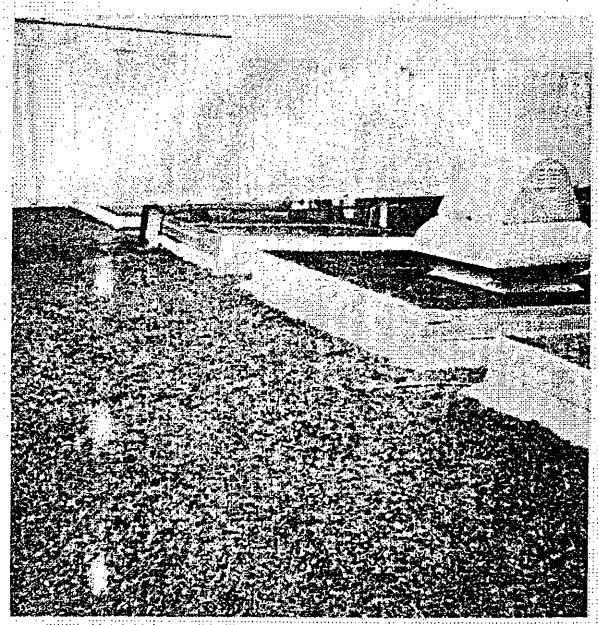
Silver and black roofing
admin. Building

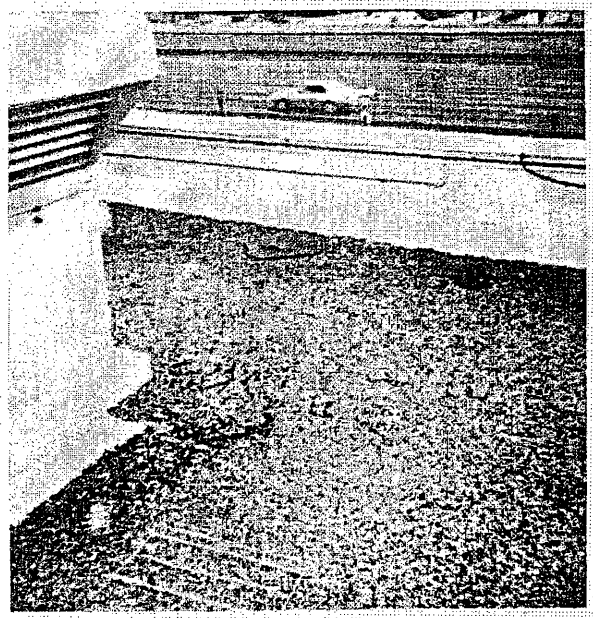
Silver and black roofing
admin. Building

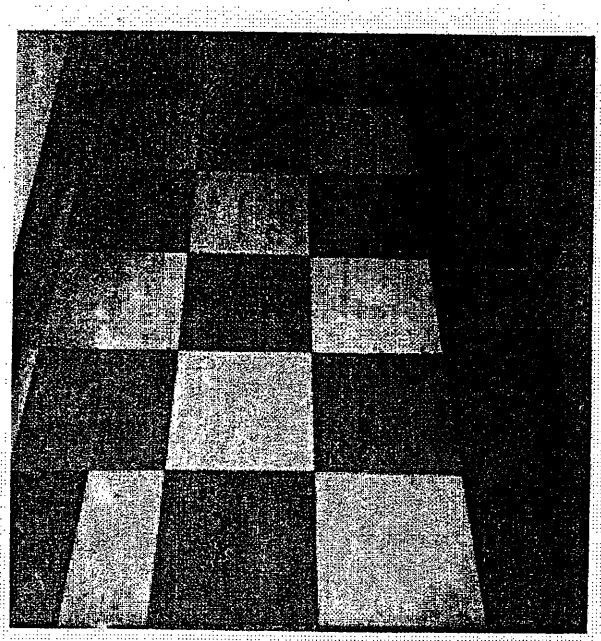
White, gray, and Dark Red
12"x12" floortile
admin. Building

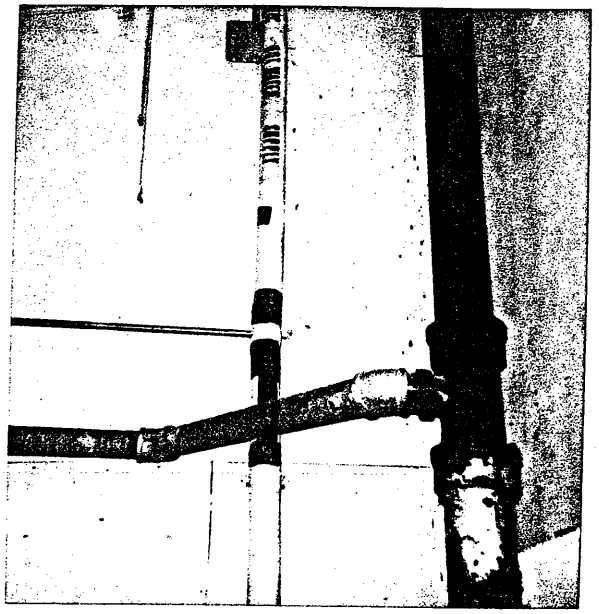
Duct Insulation (TSI) and
Duct Expansion Joint cloth
Warehouse/Maint. Building

Pipe Insulation (TSI)
Warehouse/Maint. Building

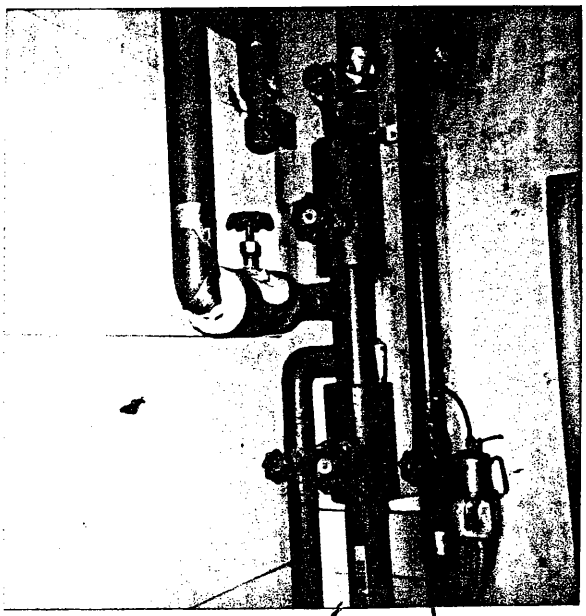
Pipe Insulation (TSI)
Warehouse/Maint. Building

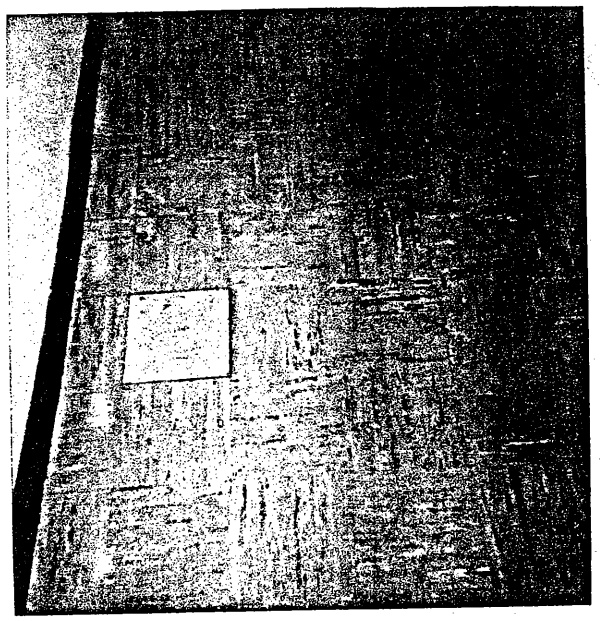
Green and Gray 9"x9" floortile
Maint./Warehouse Building

Green and Gray 9"x9" floortile
Admin. Building

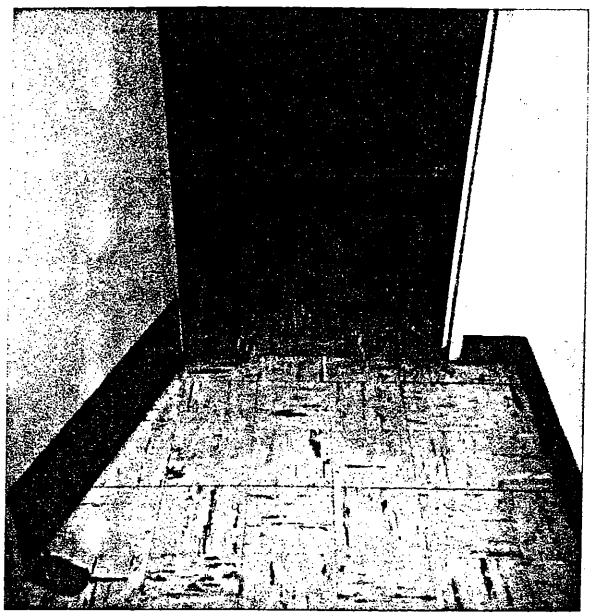
Green and Gray 9"x9" floortile
Warehouse/Maint. Building

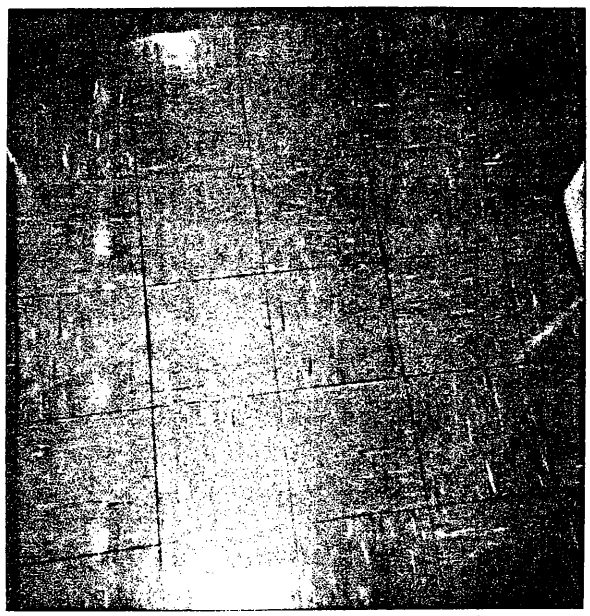
Green 9"x9" floortile
Admin. Building

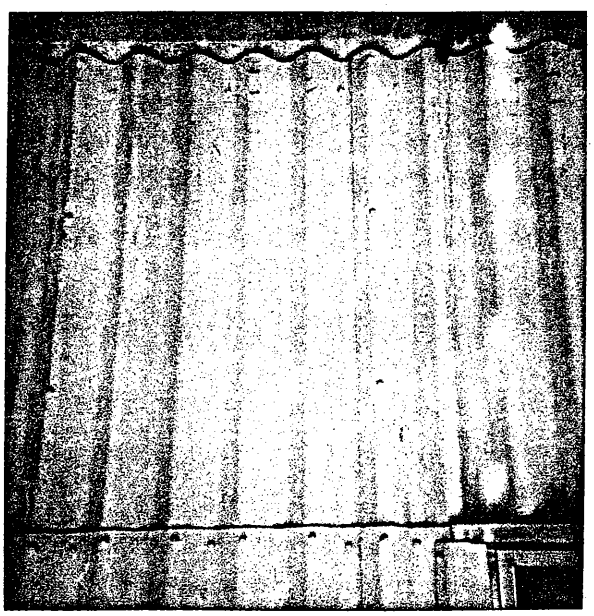
Exterior Siding Warehouse/Maint. Building
