STATE OF CALIFORNIA

Summary of SFOBB East Span Eye Bar Failure Analysis

March 17, 2010

04-0G8404
SFOBB Emergency Eye Bar Repair

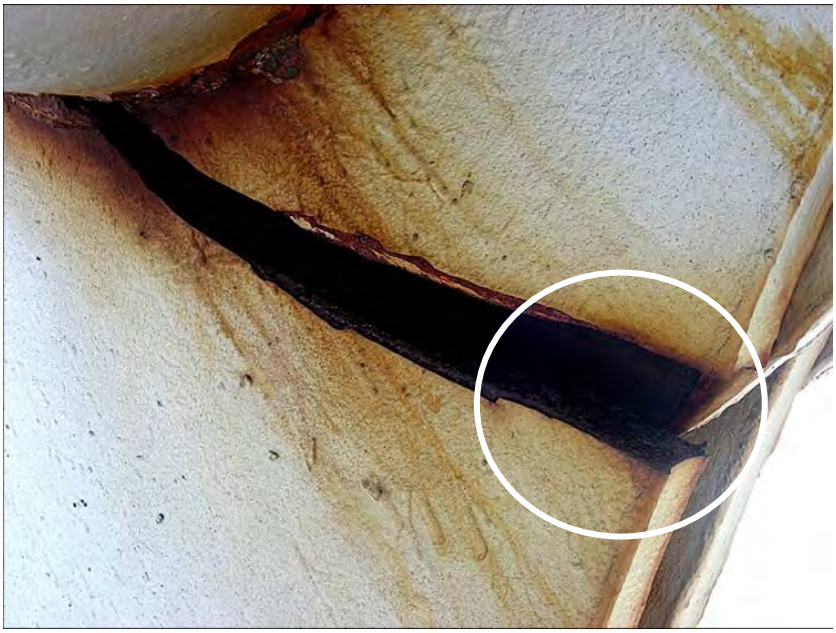
The failure analysis indicates that the fracture initiated at the outer edge of the eye bar, and then propagated inward to the center pin location. See the following three photographs for a close up view of the fracture location.

Figure 3: Failure initiation location is circled above and highlighted in following figures.

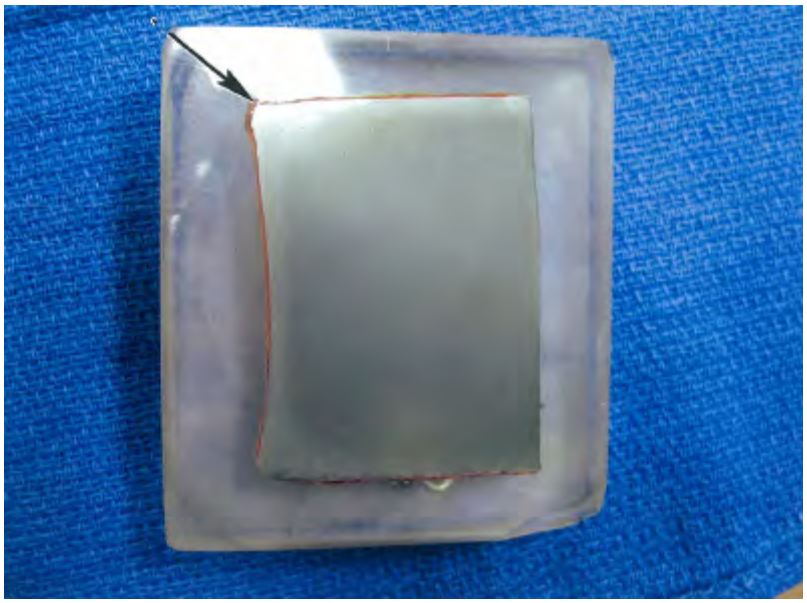
On the edge of the eye bar where the fracture initiated, the manufacturing process left a concave surface configuration that resulted in sharp corners at the top and bottom edge of the eye bar. Figure 6 is a microsection of the edge of the eye bar. Notice the concave surface on the left side of the picture and the arrow pointing to the fracture initiation location. This sharp corner created a point of stress concentration from which the fatigue crack initiated.

Figure 6: Microsection made below fracture surface. Arrow points to fracture initiation location.

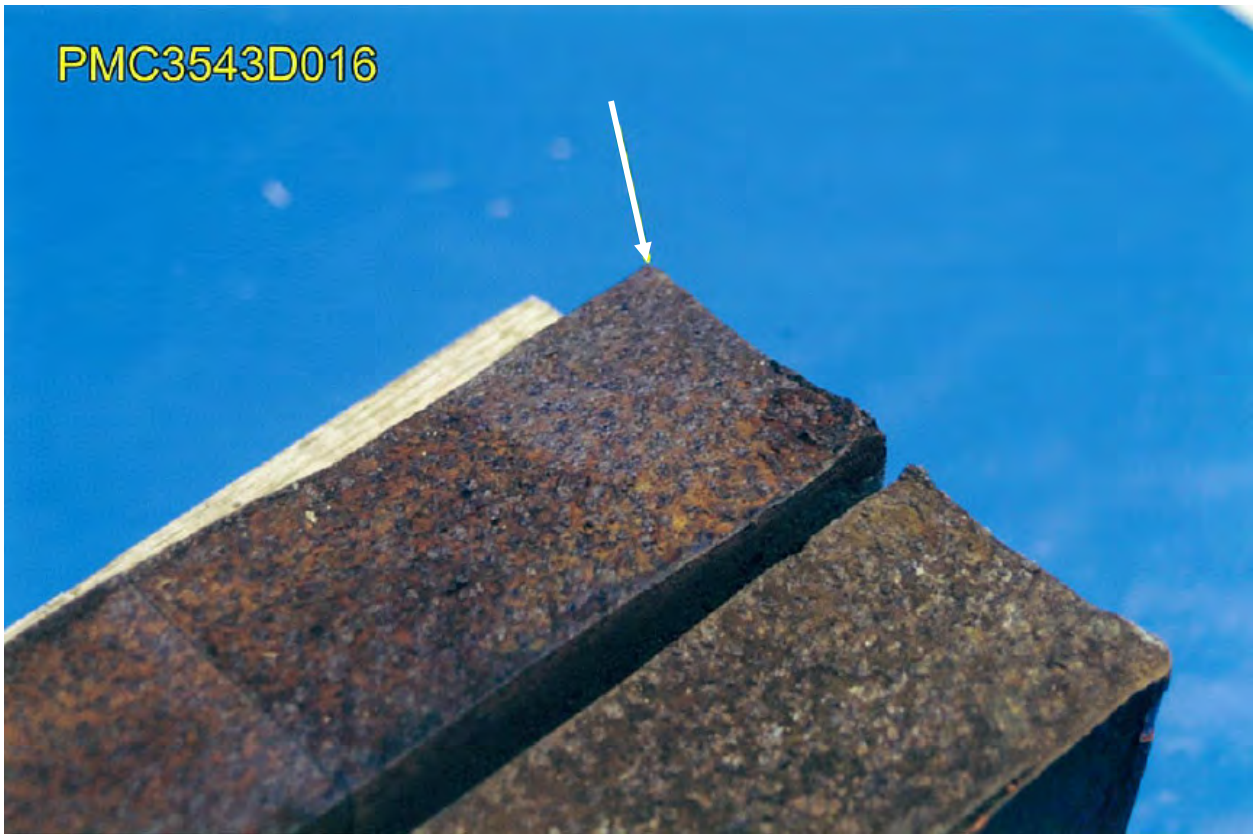
Figure 8 below shows the outer edge of the facture face with a white arrow pointing to the fatigue fracture origin. After partial cleaning, there remained a thumbnail area emanating from this corner indicative of fatigue fracture.

Figure 8: Mating fracture faces at the outer edge of the eye bar. Fracture origin at arrow location.

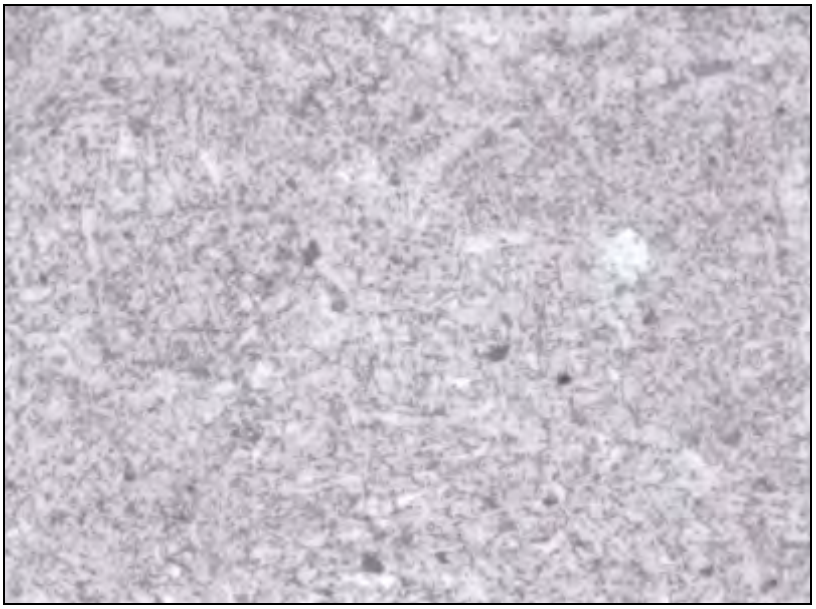
The microstructure near the top outer edge of the fracture (corresponding to the arrow location in Figure 6) is shown in the below Figure 10. The microstructure consists of a highly tempered martensitic type structure.

Figure 10: Microstructure near top corner of sample #1 in Figure 6. 500x Etched.

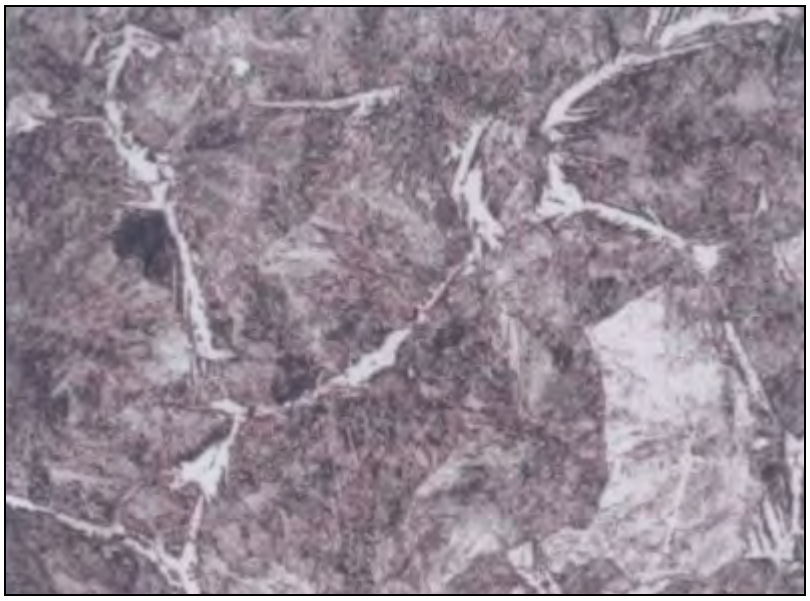
Inward toward the center from this area the core microstructure consisted of martensitic grains surrounded by ferrite. This is illustrated in Figure 11 below.

Figure 11: Core microstructure of sample #1 in Figure 10. 500x Etched.

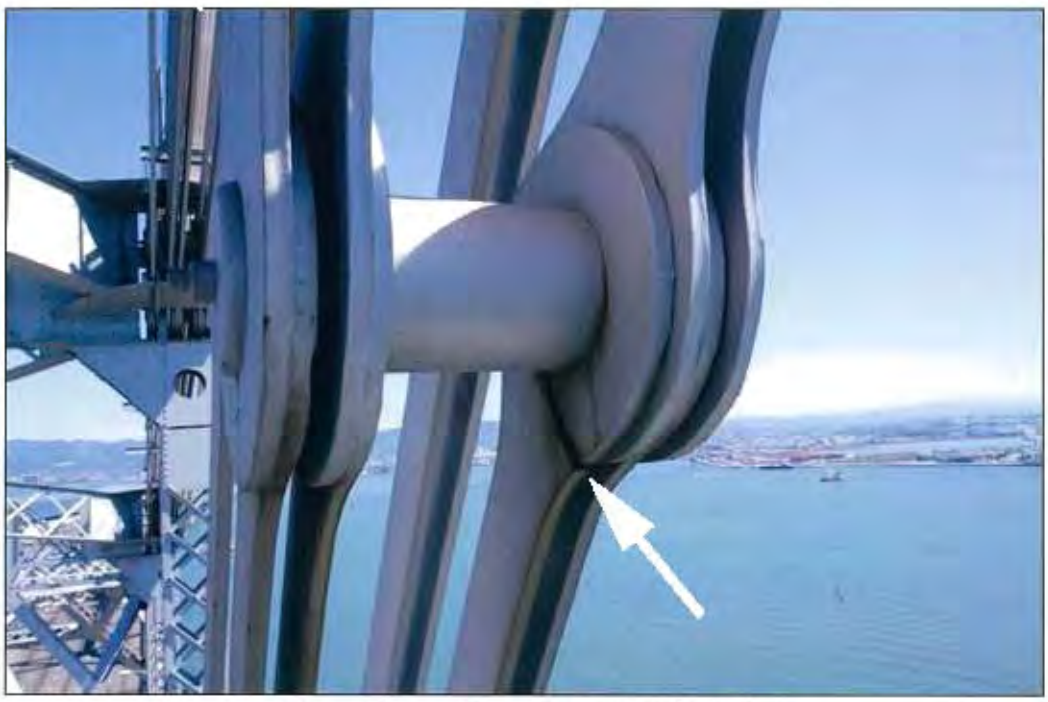
Fig. 2 Location of cracked eye bar. (Looking East)

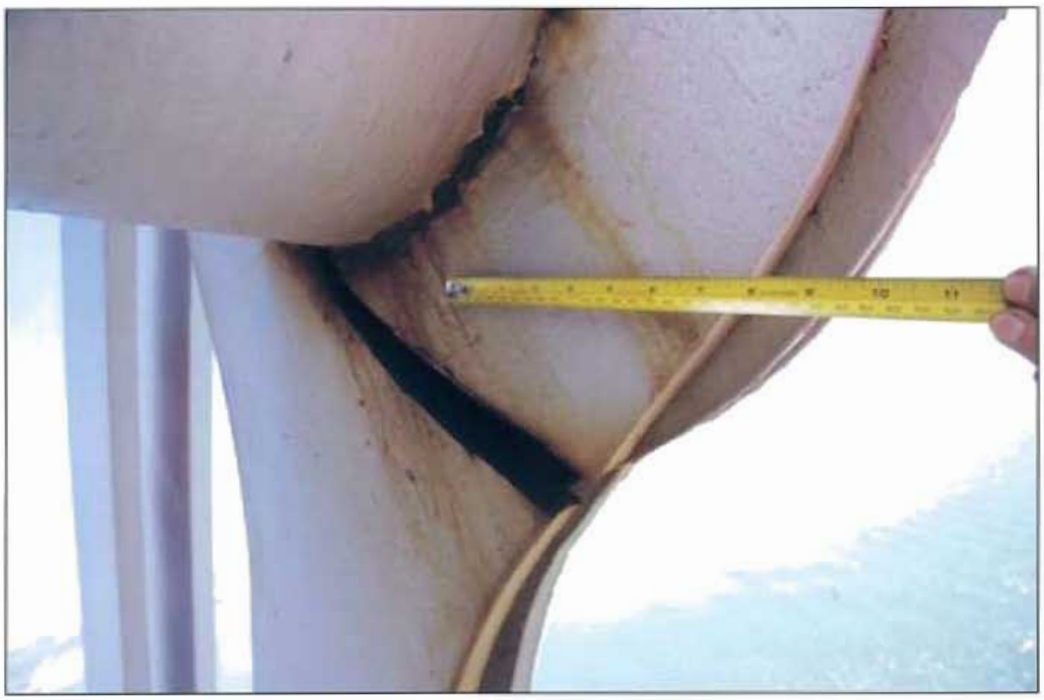
Fig. 3 Location of cracked eye bar.

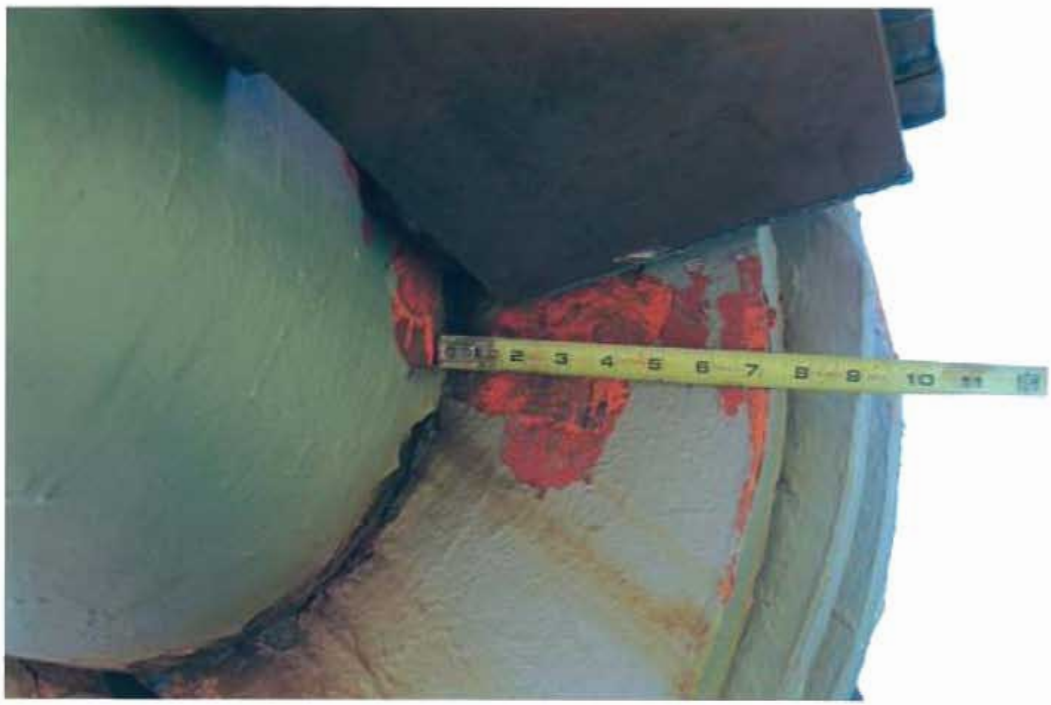
Fig. 6 Eye bar above crack location.

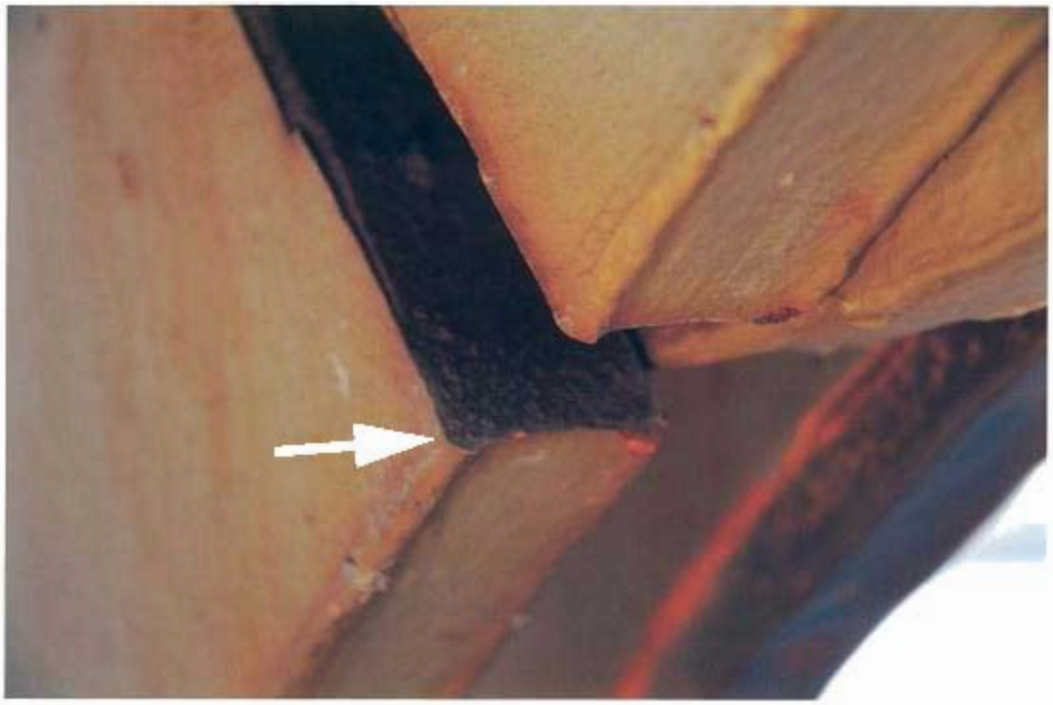
Fig. 7 Fracture face outer edge.

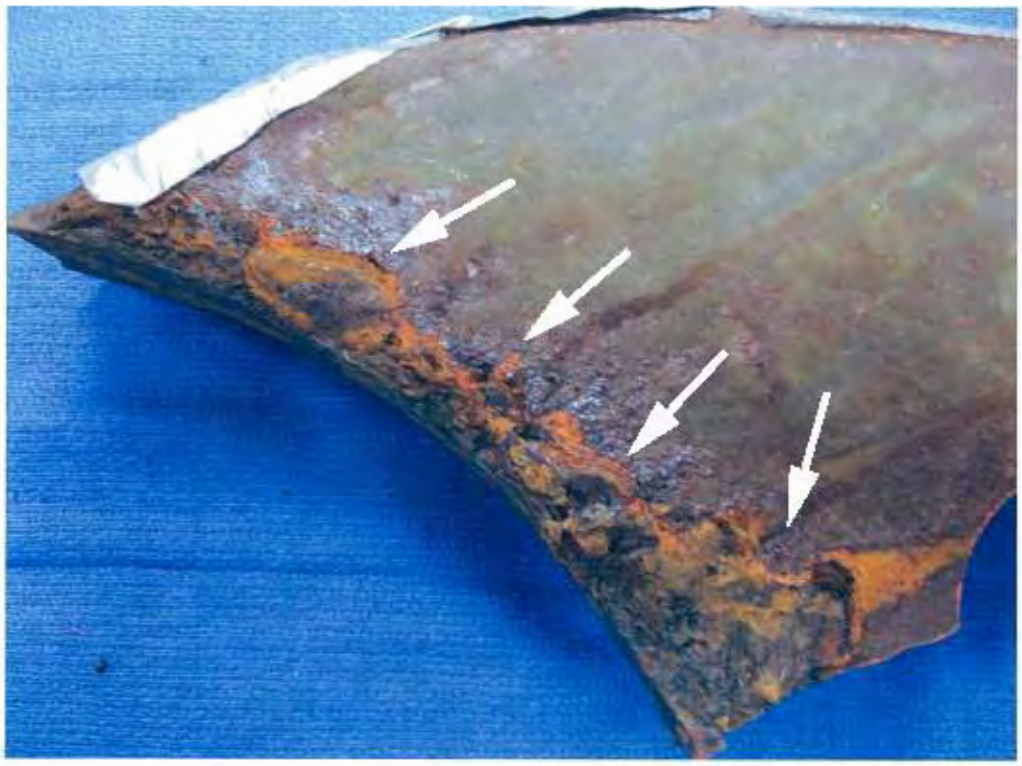
Fig. 11 illustrates the first segment of the fractured eye bar that was submitted to the laboratory with the duct tape covering the plane of fracture. Fig. 12 illustrates a close up of the oxidation and preferential wear on the surface of the eye bar where it interfaced with the end of the sleeve. Figs. 13 and 14 illustrate the oxidation and wear on the

Fig. 14 Corrosion and wear at sleeve location, opposite side.

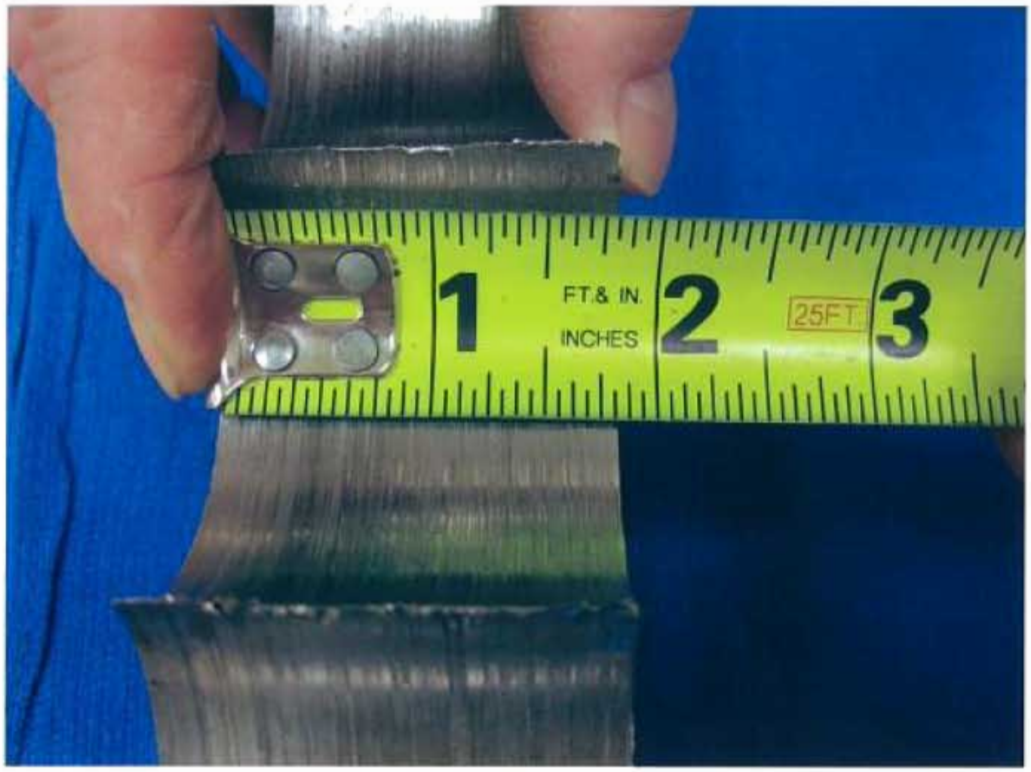
Fig. 17 Thickness of eye bar.

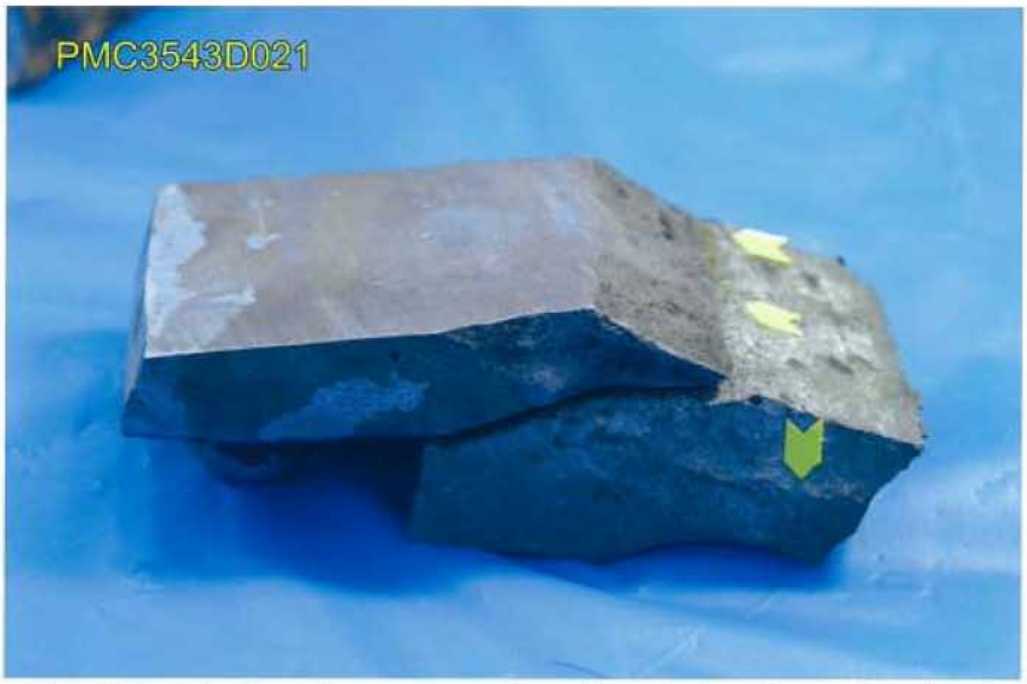
Fig. 41 Inside diameter surface of eye bar pin location, after cleaning of oxide layer.

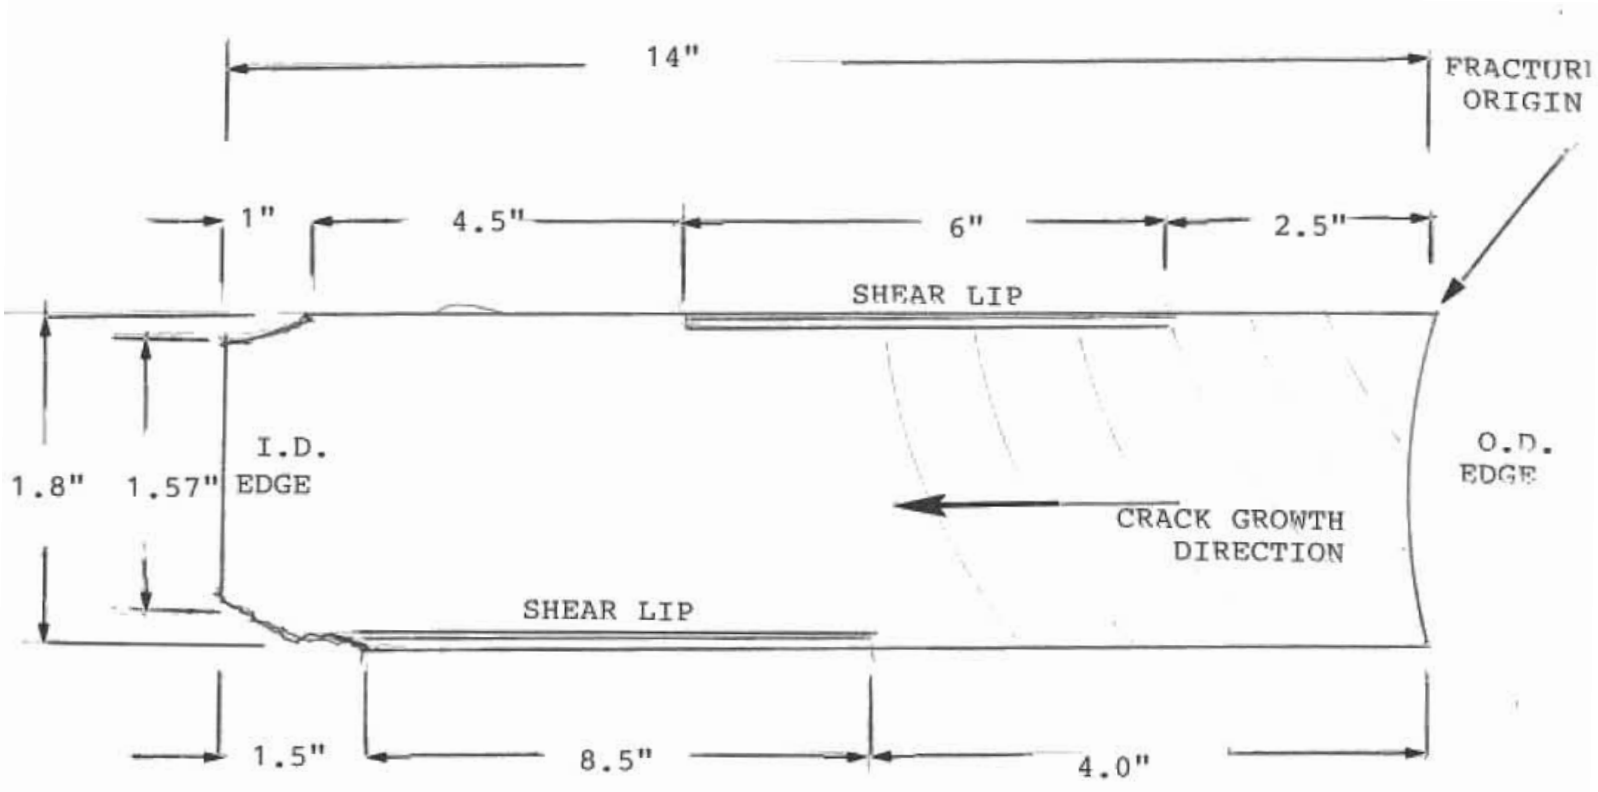
SKETCH A
FRACTURE FACE PROFILE

Sketch A, illustrates the fracture face profile from the outer edge to the inside diameter edge of the eye bar at the plane of fracture. Based on the SEM analyses the fracture origin was identified at the arrow location illustrated on the sketch and a fatigue crack than progressed from this location towards the inside portion of the eye bar. On one side there was a shear lip area of approximately 6" as illustrated in the sketch and at a different location at the bottom side there was an area of a shear lip approximately 8.5" in length. The worn and oxidized area of the top and bottom edges the eye bar near the pin location are illustrated to the left in the sketch which shows that the nominal thickness of the eye bar was 1. 8" but at the location where the eye bar interfaced with the sleeve the thickness had been reduced due to wear abrasion and oxidation to 1.57".

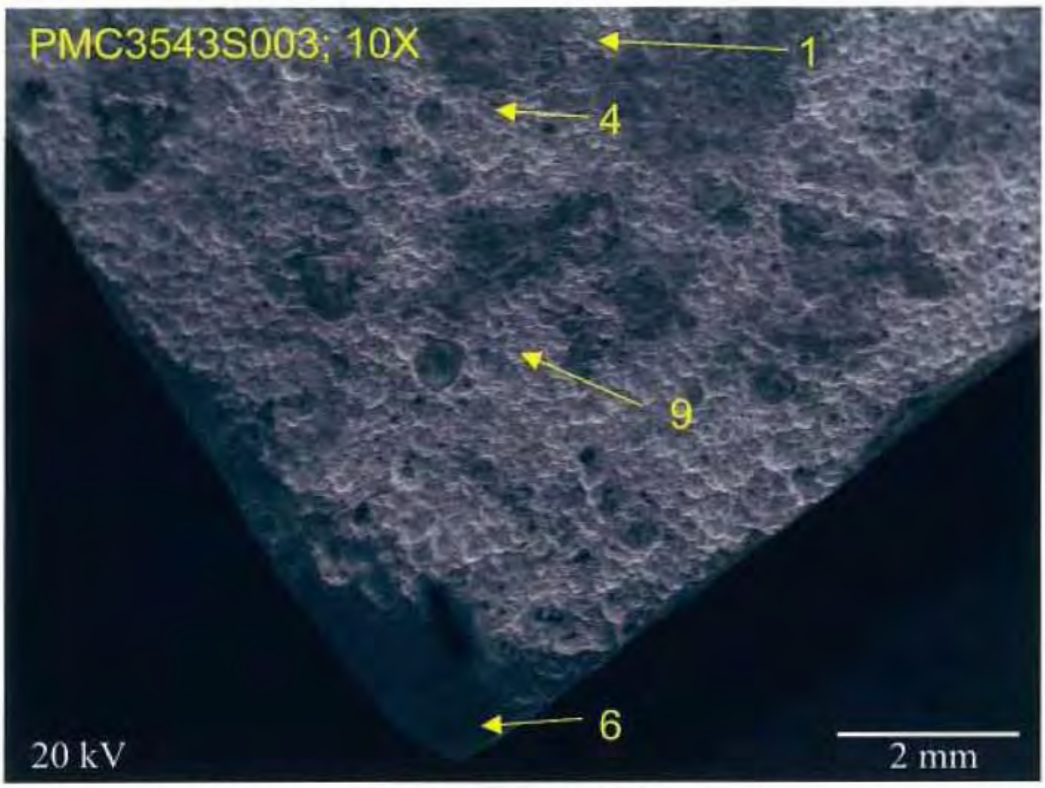
Based on the overall analyses of the plane of fracture the results indicate that the fracture origin definitely was at the outside corner edge of the eye bar and at the inboard diagonally from this corner there was evidence of fatigue and inboard on the plane of fracture. On other areas of the fracture there was heavy oxidation and traces of dimple rupture from tensile over load. At none of the locations on the plane of fracture was there any evidence of intergranular fracture, or cleavage type fracture mode identified.

Fig. 45 S.E.M photo of eye bar fracture surface at fracture origin. 10X.

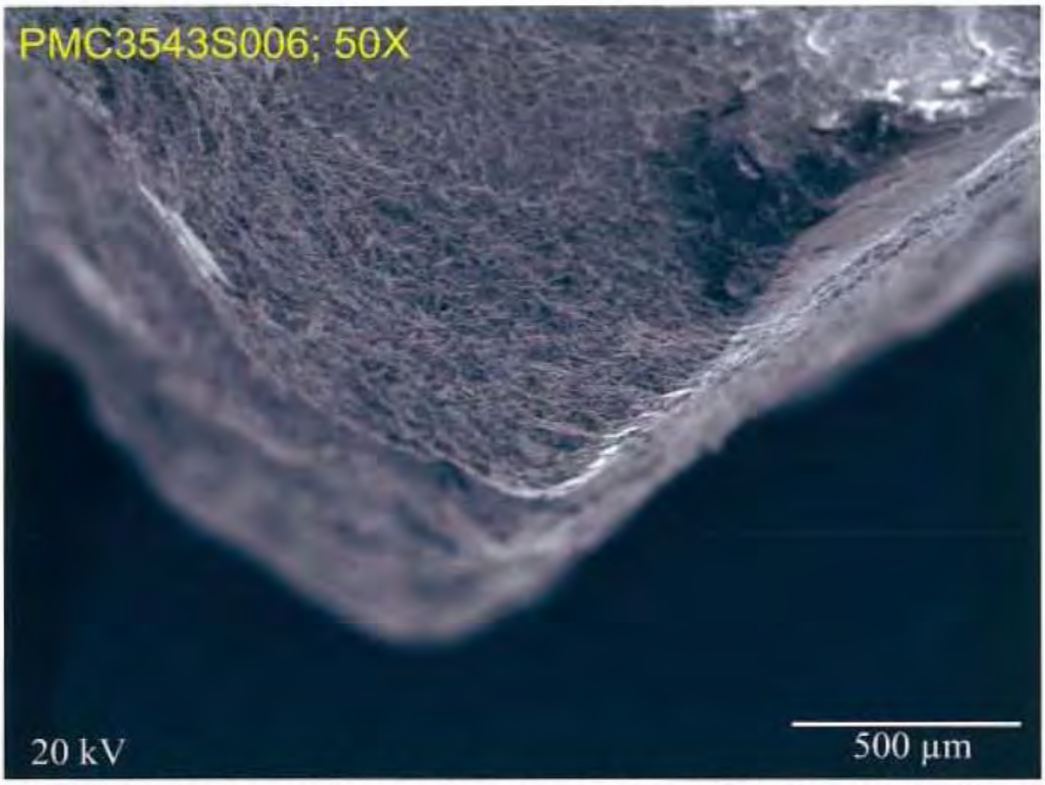
Fig. 46 S.E.M photo of eye bar fracture surface at fracture origin, location 6 in fig. 45. 50X.

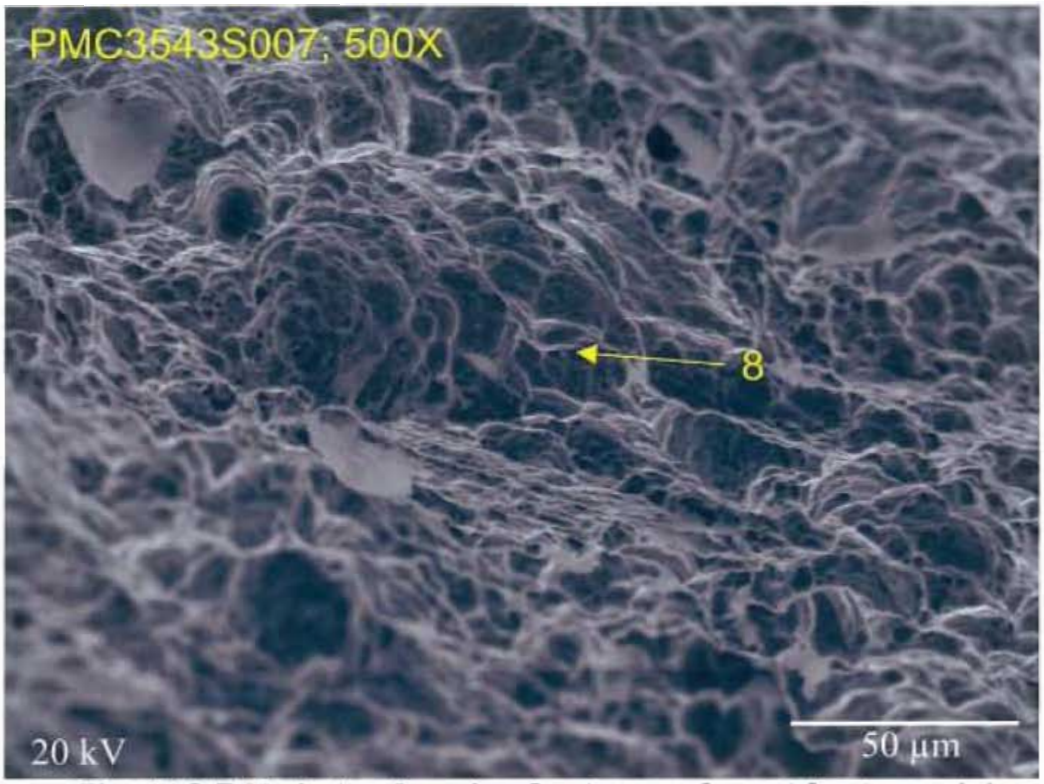
Fig. 47 S.E.M photo of eye bar fracture surface at fracture origin, in fig. 46. 500X.

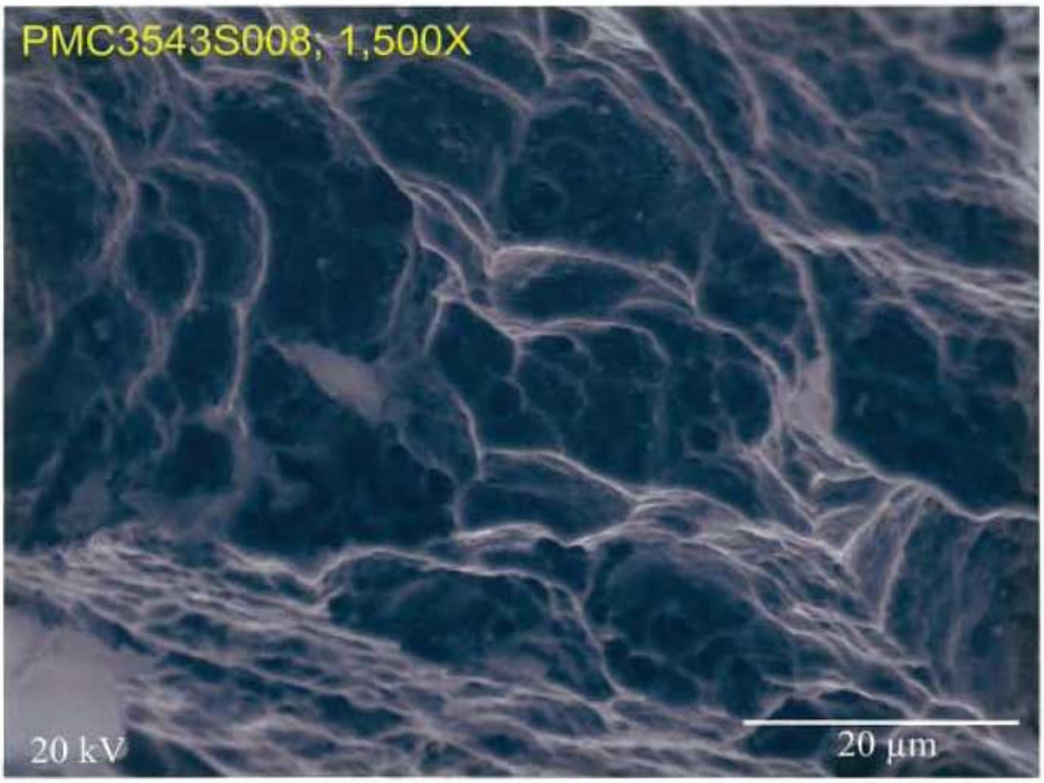
Fig. 48 S.E.M photo of eye bar fracture surface at fracture origin, location 8 in fig. 47. 1,500X.

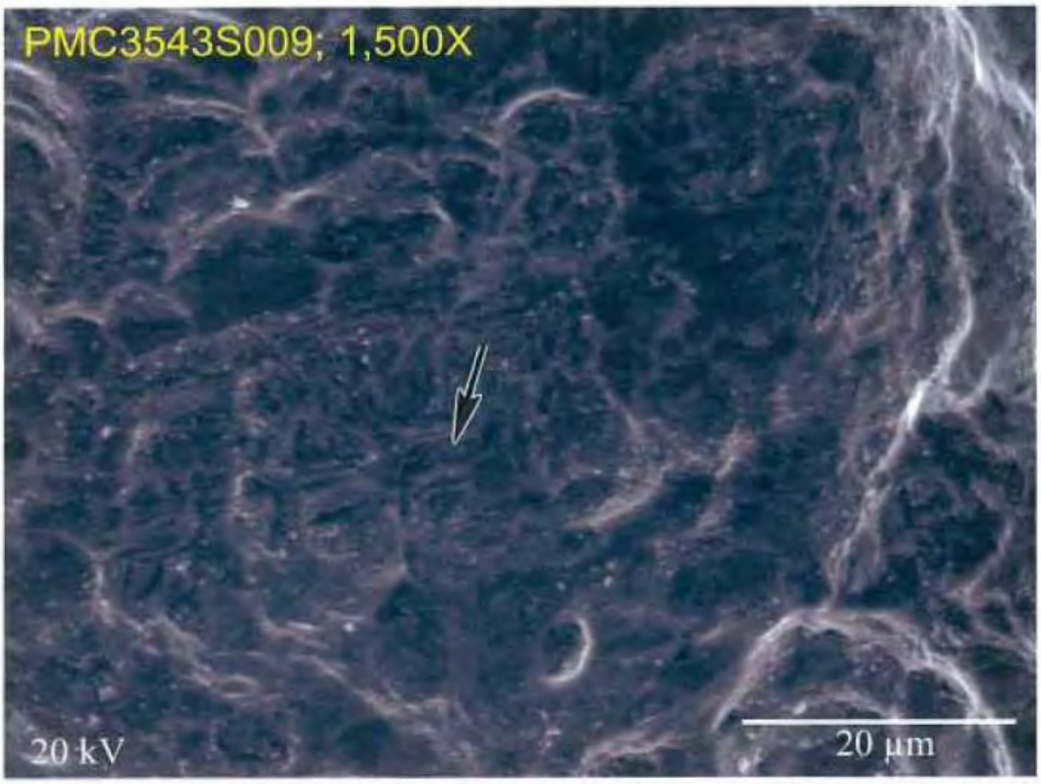
Fig. 49 S.E.M photo of eye bar fracture surface at fracture origin, location 9 in fig. 45. 1,500X.

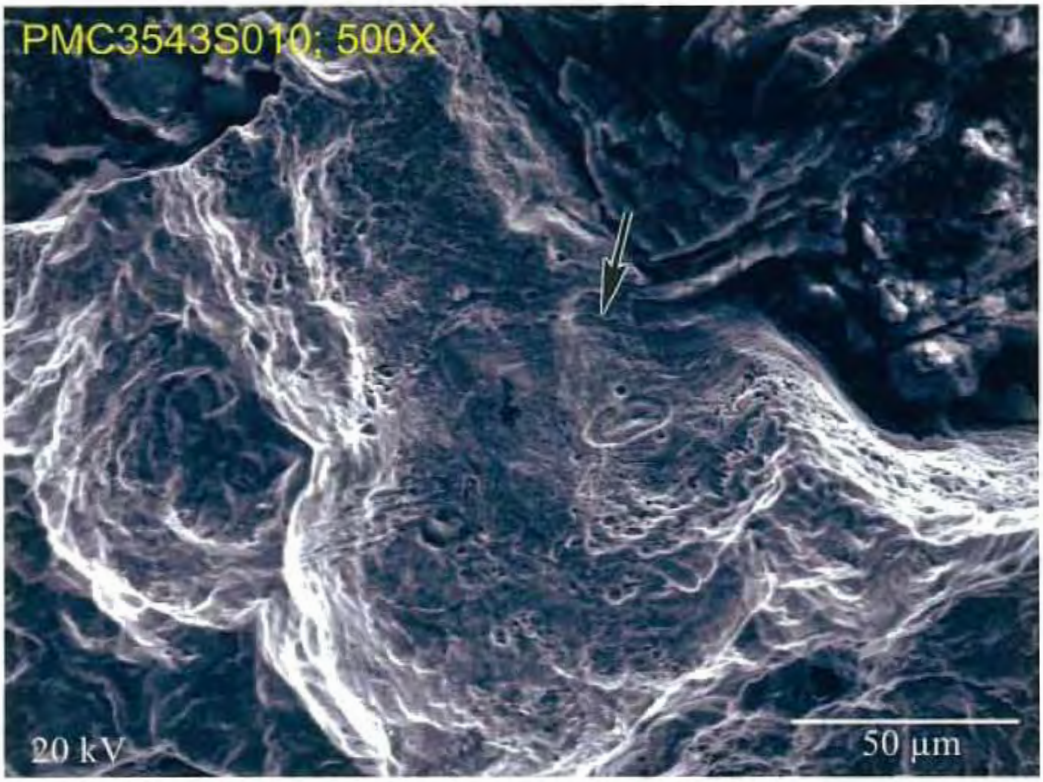
Fig. 50 S.E.M photo of eye bar fracture surface at fracture origin, in fig. 45. 500X.

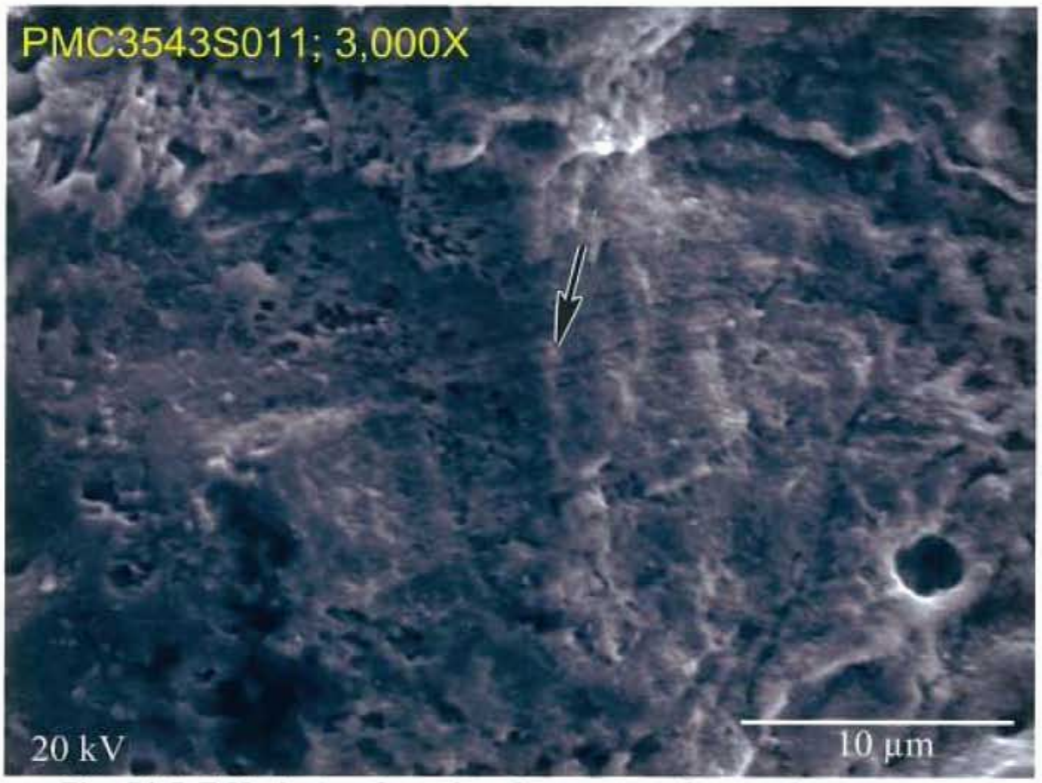
Fig. 51 S.E.M photo of eye bar fracture surface at fracture origin, in fig. 50. 3,000X

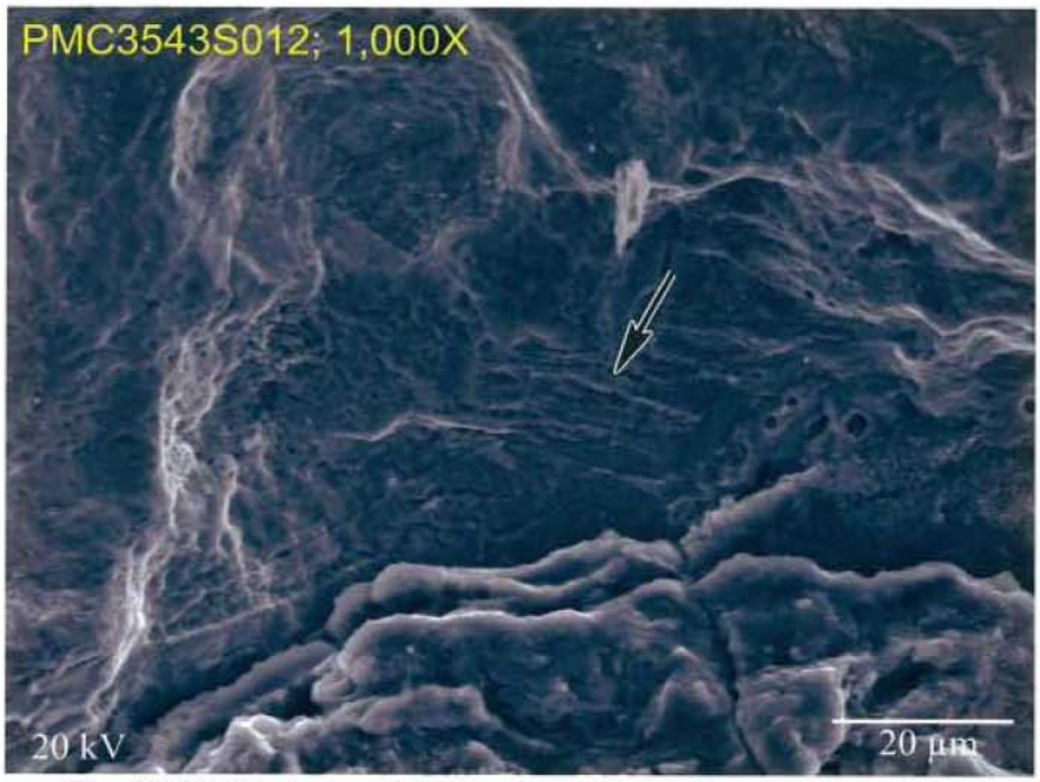
Fig. 52 S.E.M photo of eye bar fracture surface at fracture origin, in fig. 45. 1000X.

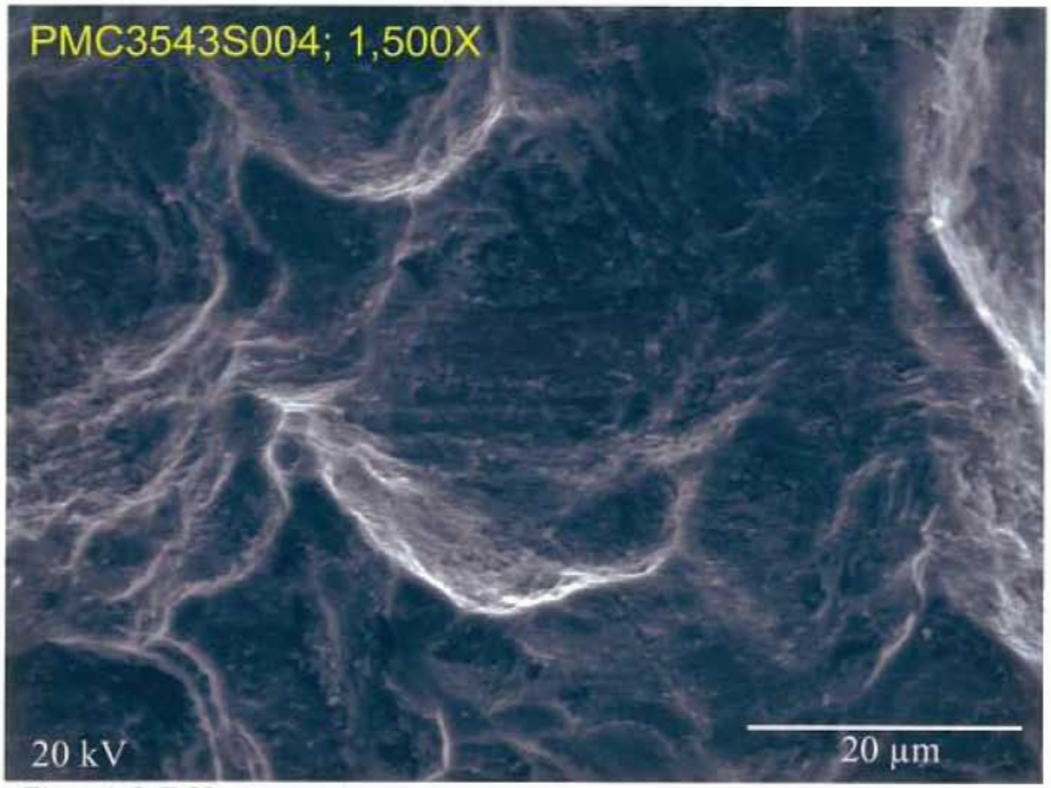
Fig. 53 S.E.M photo of eye bar fracture surface at fracture origin, location 4 in fig. 45. 1,500X.

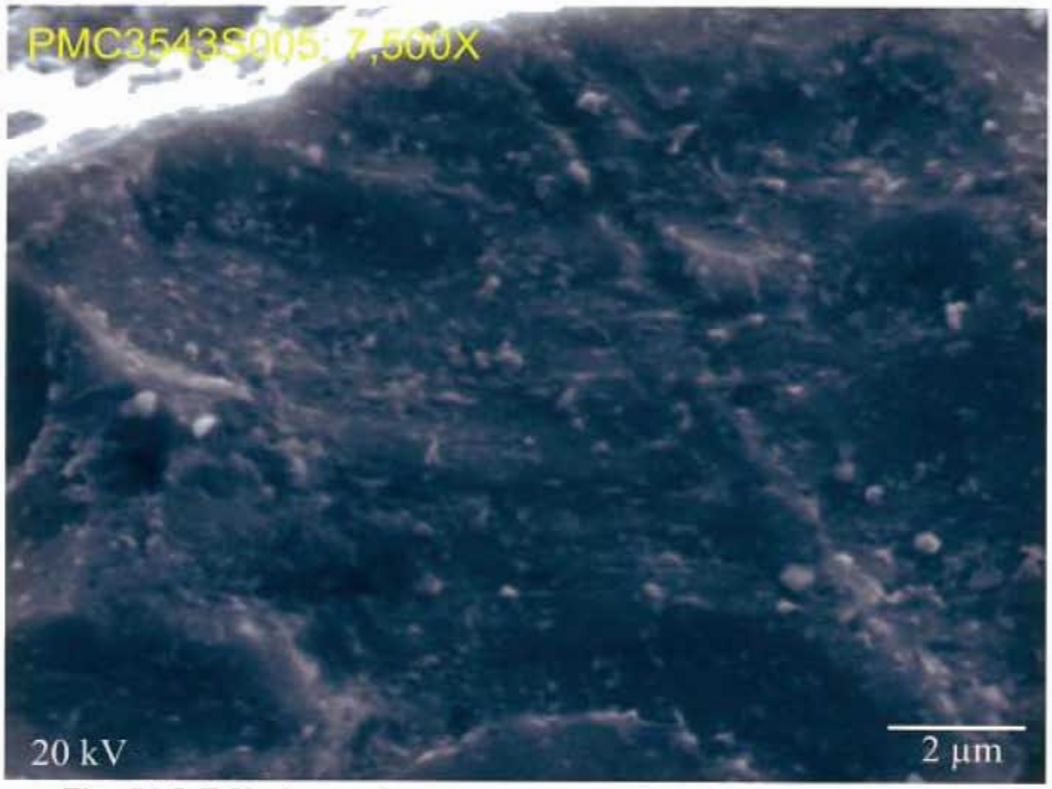
Fig. 54 S.E.M photo of eye bar fracture surface at fracture origin, in fig. 53. 7,500X.

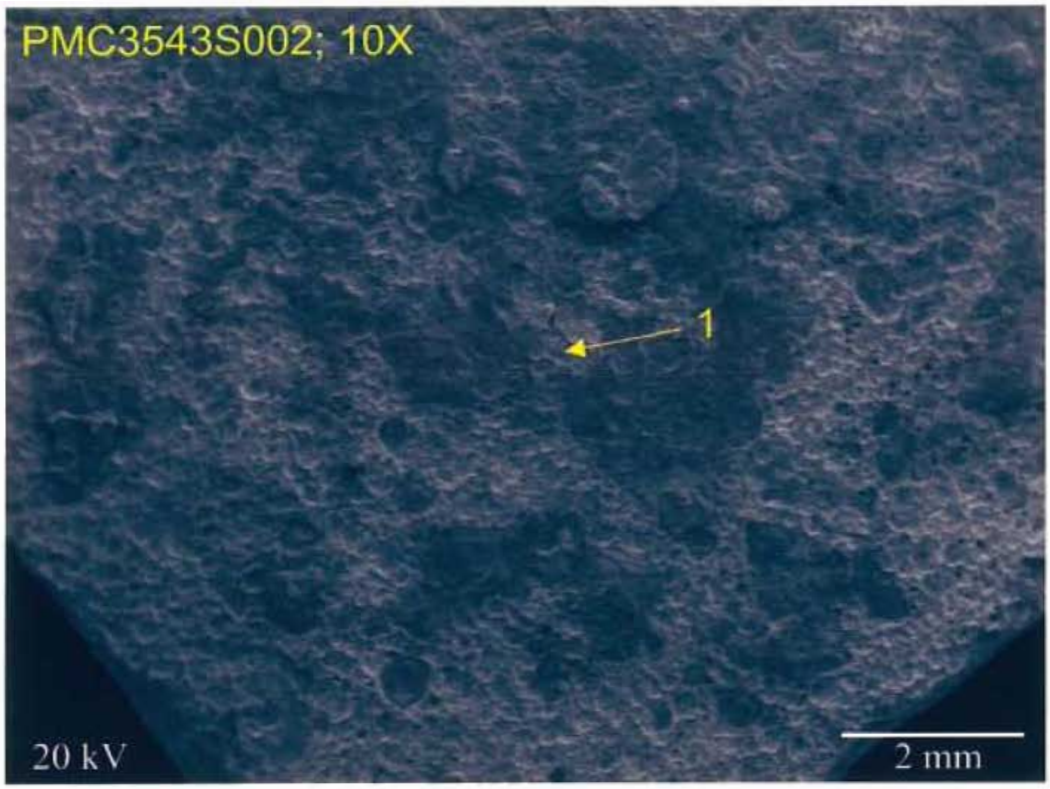
Fig. 55 S.E.M photo of eye bar fracture surface at fracture origin, location 1 in fig. 45. 10X.

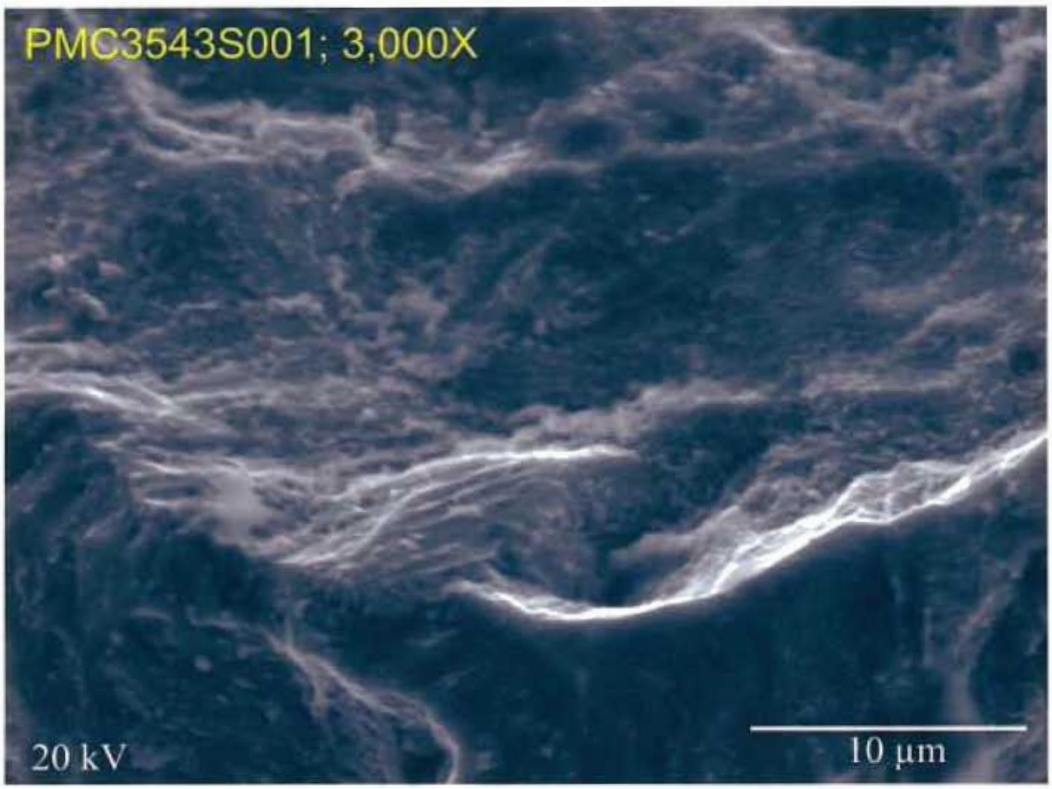
Fig. 56 S.E.M photo of eye bar fracture surface at fracture origin, location 1 in fig. 55. 3,000X.

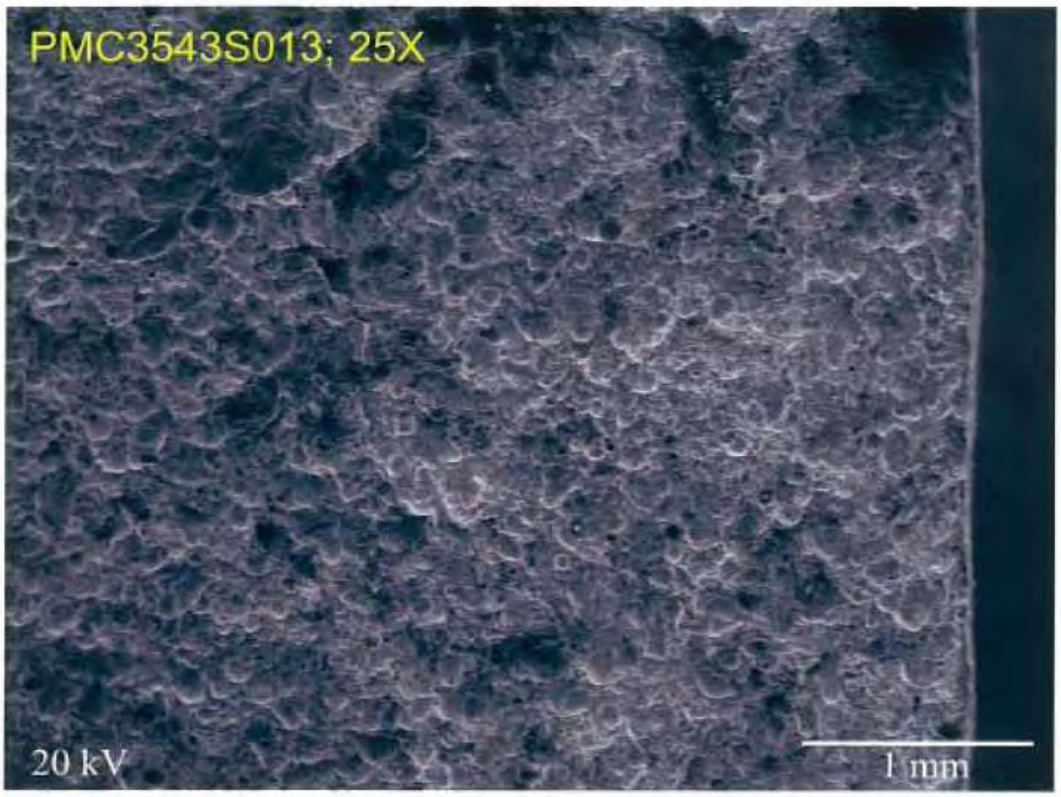
The second segment of the plane of fracture shown to the left in Fig. 35 was also placed in SEM after partial cleaning of the oxide layer and this examined for fracture mode. Fig. 57 illustrates a portion of the fracture face of this second segment, along the edge where there was evidence of cleaning of the oxide layer. At this location examination revealed etching effects but no clear evidence of fatigue or intergranular fracture or dimple rupture. Figs. 59 and 60 illustrates the appearance of the fracture in the central zone of the second segment which again showed no evidence of fatigue or intergranular of cleavage type fracture. There was extensive amount of rubbing and etch pitting in this area where the oxide had been cleaned. Figs. 61 and 62 illustrate the appearance of a shear lip area on the outer edge and at this location there was evidence of rubbing degradation and etch pitting from removal of oxide and slight evidence of dimple rupture. Fig. 63 and 64 showed additional views of the surface of the fracture in the second segment at the left hand edge which again shows evidence of edge pitting and oxidation and rubbing but no evidence of fatigue damage. There was also no evidence of intergranular, cleavage fracture or dimple rupture. In essence the clean areas where the oxide layer had been removed in this segment just showed etch pitted resulting form the removal of the oxide layer at random locations.

Fig. 57 S.E.M photo of eye bar fracture surface, 2nd segment in fig. 35 at location 2, right edge. 25X.

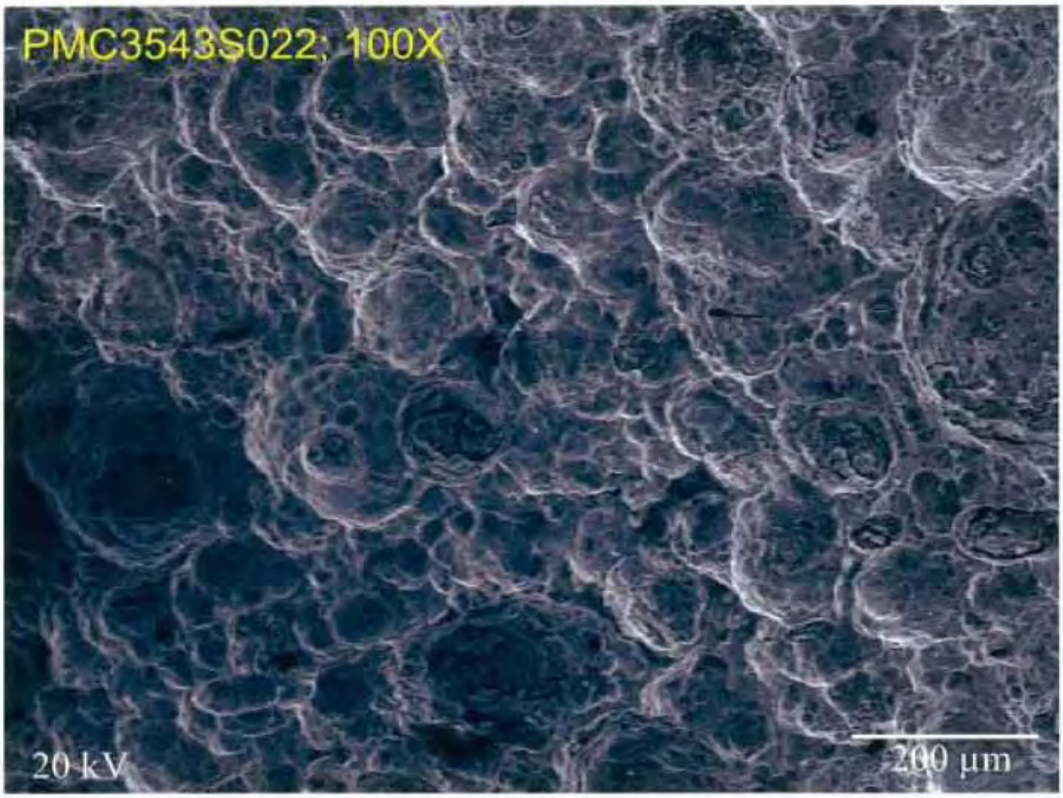
The fourth segment of the fracture face which is illustrated in Fig. 35 was also placed in the SEM. Figs. 65 and 66 illustrate the appearance of the fracture at the inside diameter edge of the eye bar close to the pin location where the fracture surface was relatively clean. This shows evidence of etch pitting and small traces of oxide on the plane of fracture. In the central portion of fracture segment No. 4 there were heavy oxide scale deposits which are illustrated in Figs. 67, 68, 69 and 70. In these photographs there was only slight evidence of dimple rupture and tensile overload. There was no evidence of fatigue, intergranular, fracture or cleavage.

Fig. 66 S.E.M photo of eye bar fracture surface, 4th segment in fig. 35 at location 4, top edge, area 1. 100X.
