STATE OF CALIFORNIA

Summary of SFOBB East Span Eye Bar Failure Analysis

March 17, 2010

04-0G8404
SFOBB Emergency Eye Bar Repair

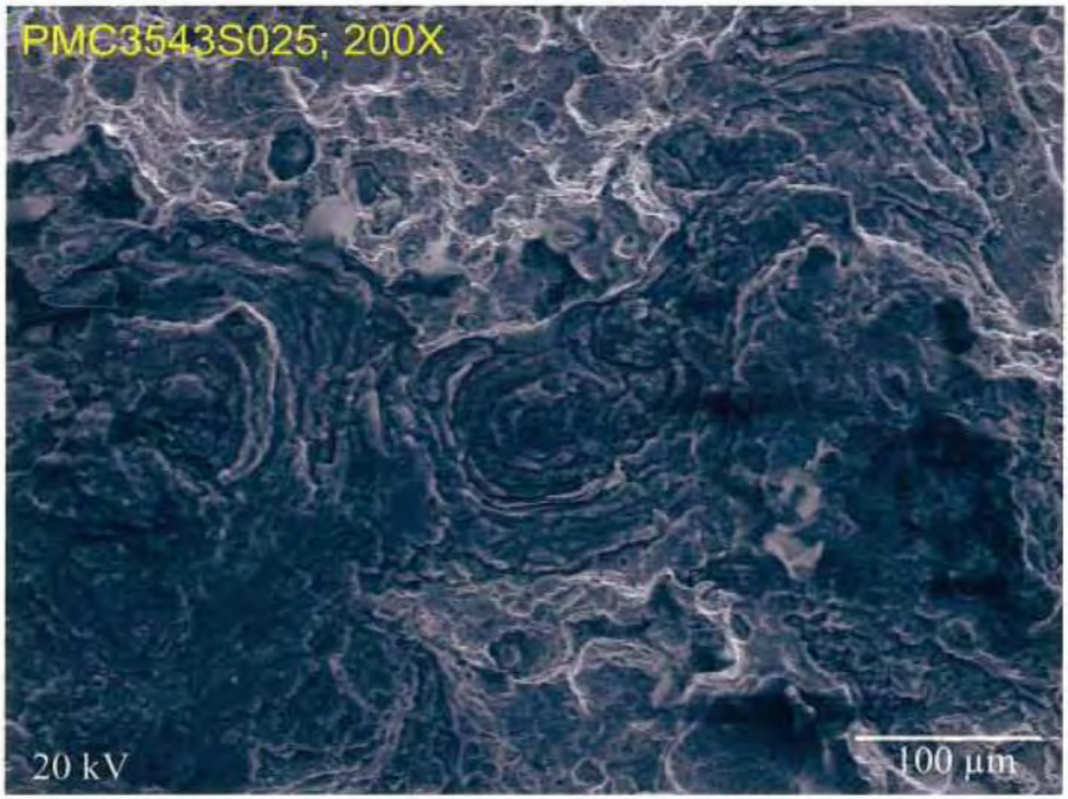
Fig. 69 S.E.M photo of eye bar fracture surface, 4th segment in fig. 35 at location 4, oxide on Fracture face, area 3. 200X.

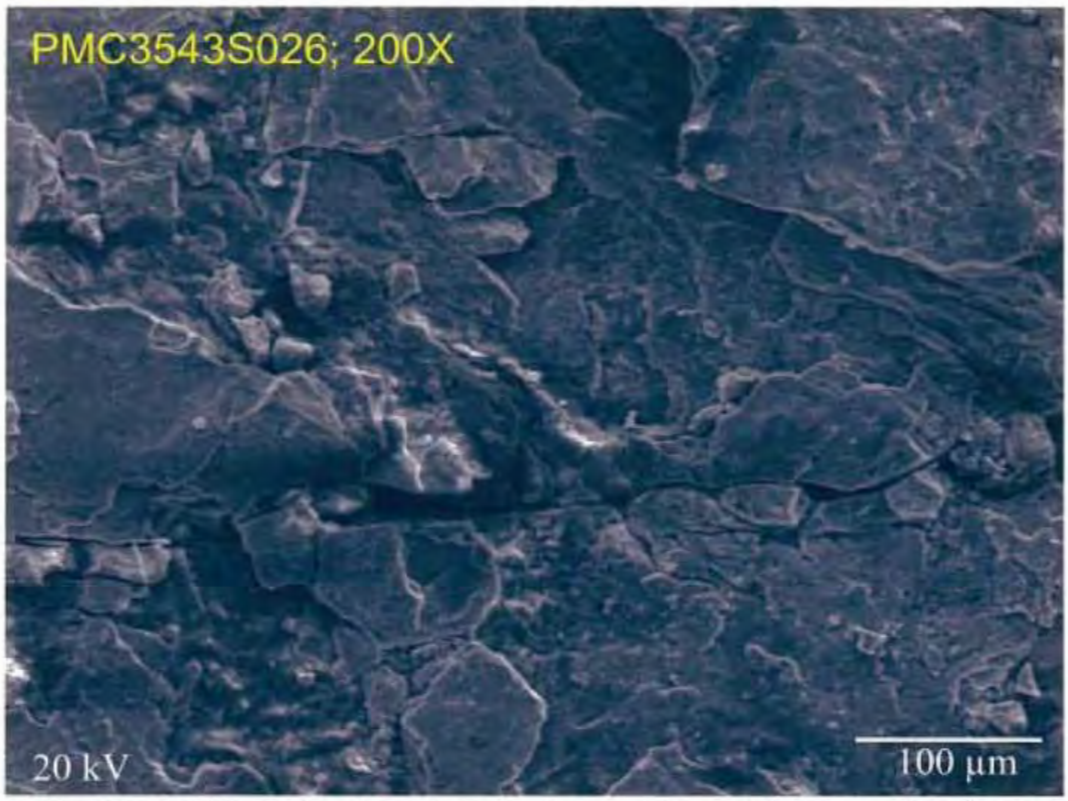
Fig. 70 S.E.M photo of eye bar fracture surface, 4th segment in fig. 35 at location 4, oxide layer in fig. 68. 200X.

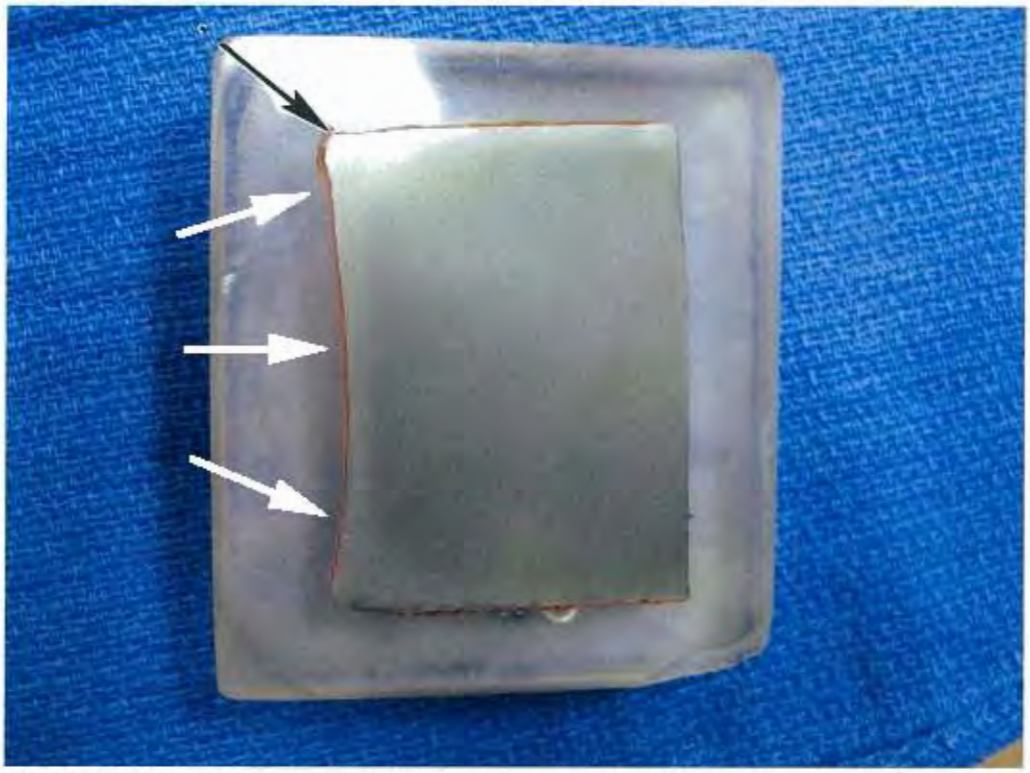
The microsections prepared at the location indicated in Fig. 20 were examined for microstructure and hardness. Fig. 71 illustrates the microsection prepared at location 1 in Fig. 20. The outer edge of the eye bar at this location is shown to the left in the photograph. The outer edge of the eye bar has a concave configuration as is illustrated in Fig. 71. The arrow at the sharp corner at the top indicates where the fatigue fracture initiated in the eye bar. The microstructure near the top outer edge is shown in Fig. 72 and 73. The microstructure consists of highly tempered martensitic type structure. Inboard from this area the core microstructure consisted of martensitic grains surrounded by ferrite. This is illustrated in Figs. 74 and 75. Fig. 76 illustrates the microsection prepared at location 2 shown in Fig. 20. Fig. 77 illustrates the core microstructure of this specimen at 200X. Fig. 78 illustrates the microsection prepared at location 3 in Fig. 20. The area to the right represents the surface that is against the pin in the assembly. Figs. 79 and 80 illustrate the appearance of the top surface near the pin location which shows evidence of extensive oxidation and pitting. Fig. 81 illustrates the microstructure and the microsection prepared perpendicular to the plane of fracture at location 4 in Fig. 20. Examination of this specimen in the unetched condition revealed longitudinal oriented inclusions such as illustrated in Fig. 82. This identifies the principal roll direction or grain flow direction of the bar which is perpendicular to the plane of fracture and parallel to the long axes of the eye bar. Fig. 83 illustrates the microstructure near the top surface of this sample and which is tempered martensite and

Fig. 71 Microsection made below fracture surface at location 1, in fig 20.

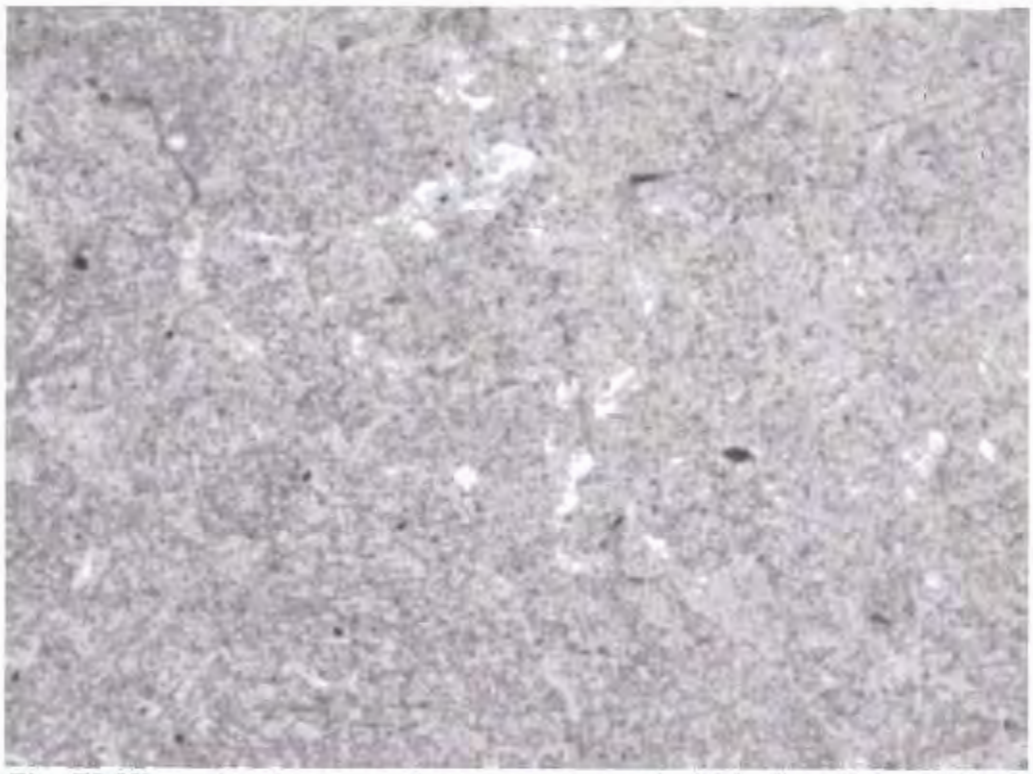
Fig. 72 Microstructure near top corner sample #1 in fig. 71. 200X Etched.

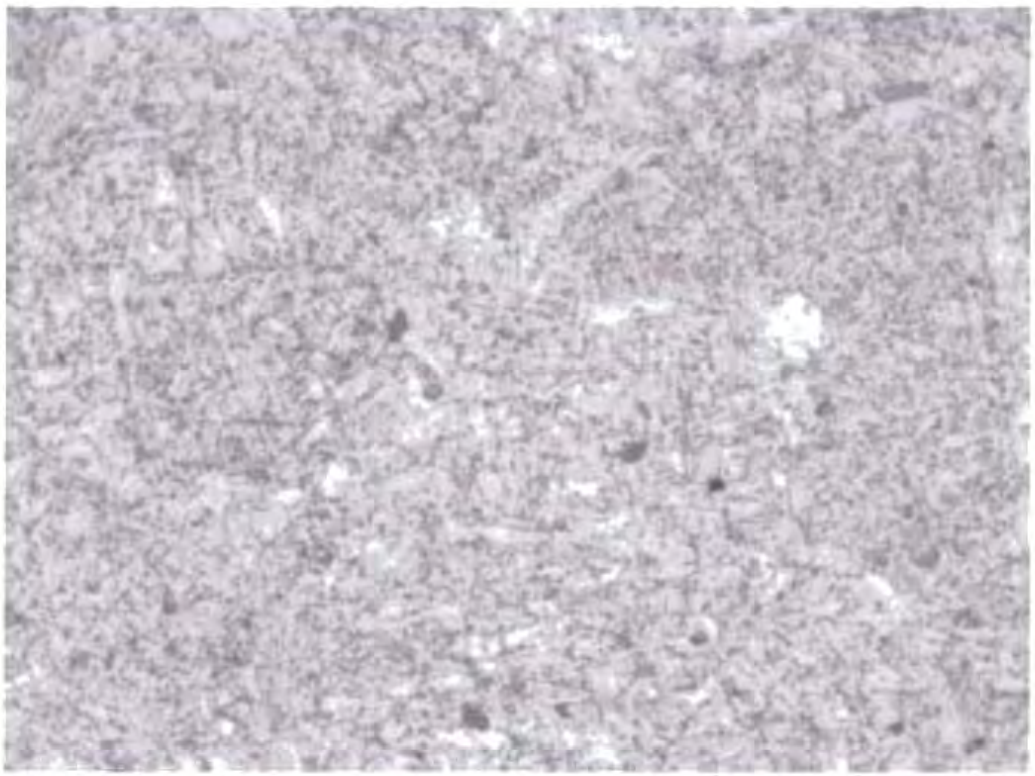
Fig. 73 Microstructure near top corner sample #1 in fig. 71. 500X Etched.

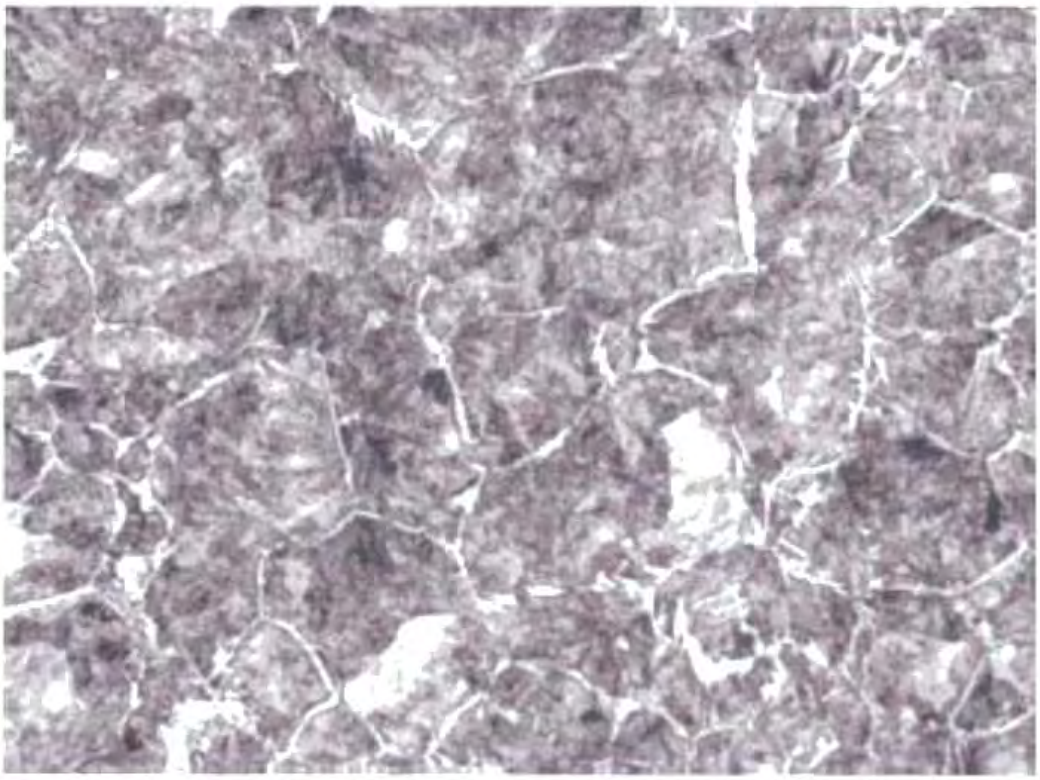
Fig. 74 Core microstructure of sample #1 in fig. 71. 200X Etched.

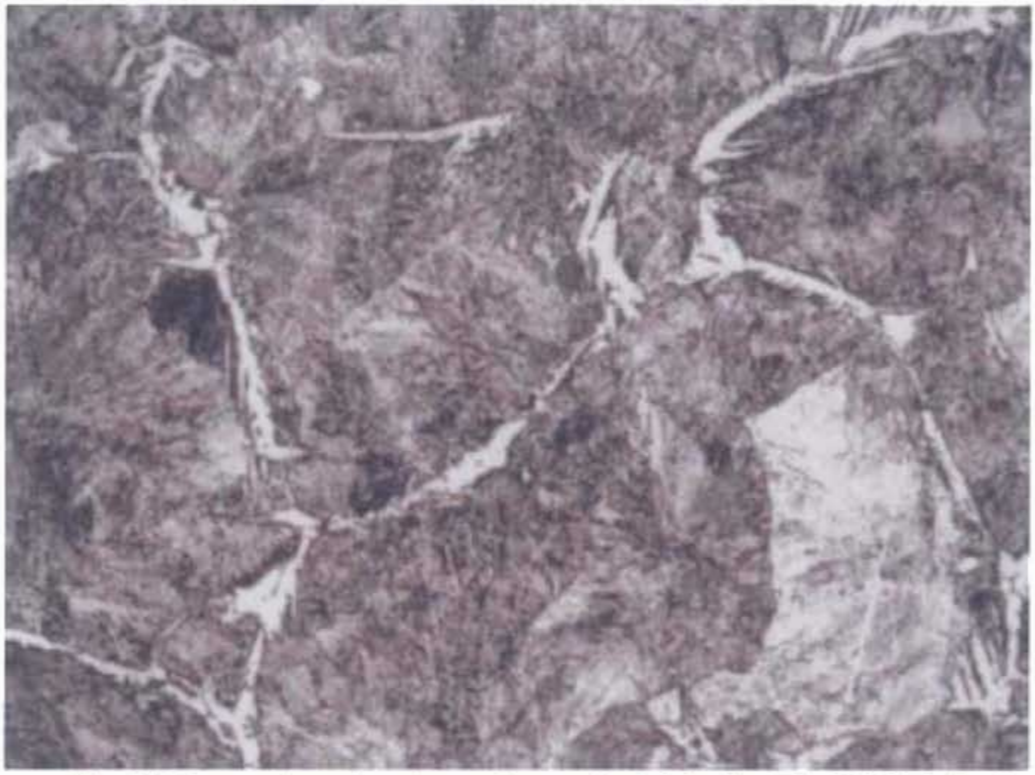
Fig. 75 Core microstructure of sample # 1 in fig. 71. 500X Etched.

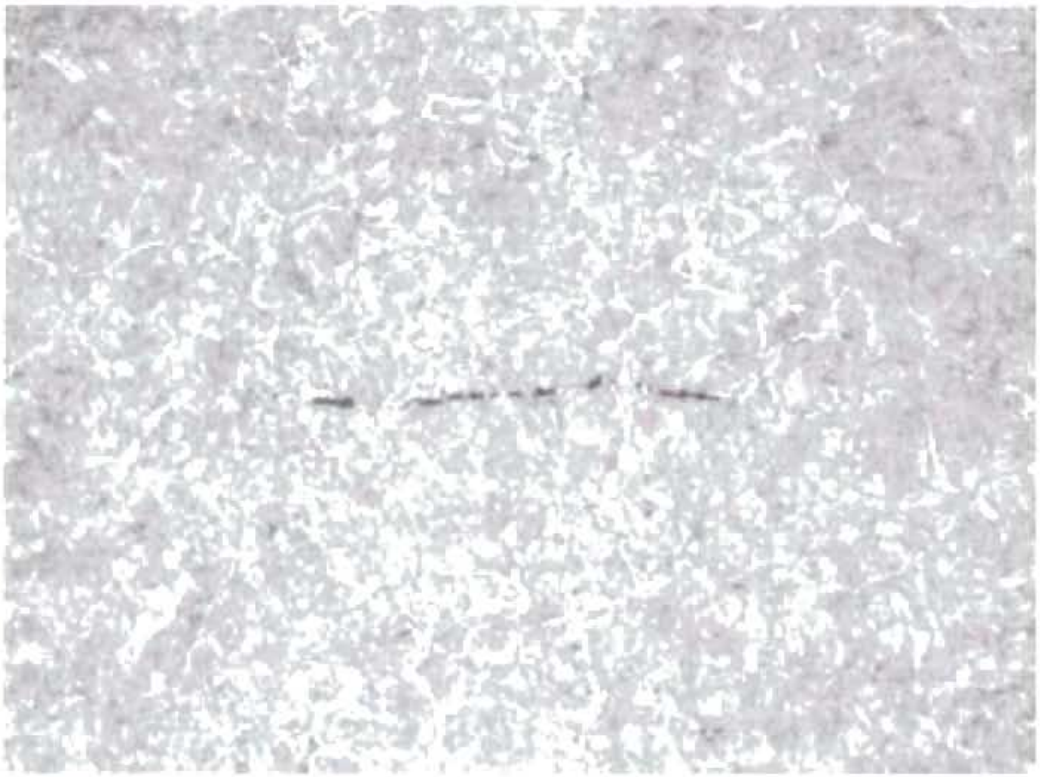
Fig. 84 illustrates the appearance of the longitudinal elongated inclusion in the core area that exhibits a different microstructure. Fig. 85 illustrates the microstructure at the location of the inclusion which shows martensitic grains surrounded by ferrite. Fig. 86 illustrates the microsection at location 5. Fig. 87 shows an elongated inclusion running perpendicular to the plane of fracture in this section.

Fig. 84 Microstructure of sample # 4 showing elongated inclusion. 100X. Etched.

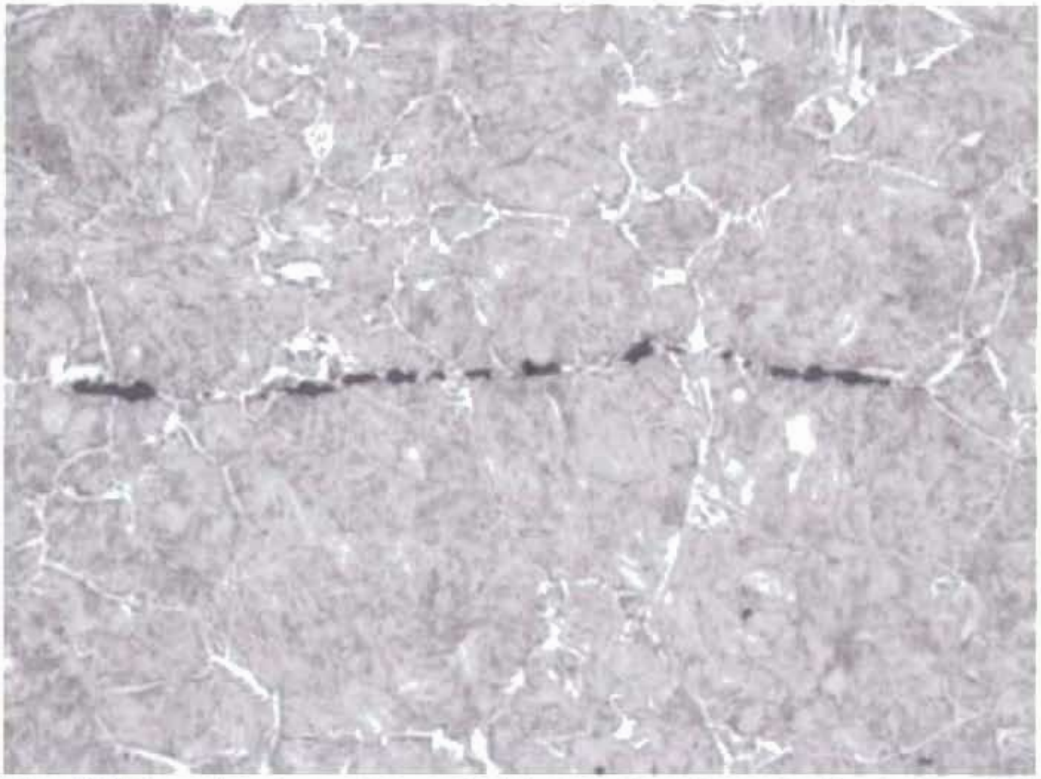
Fig. 85 Microstructure of sample # 4 showing elongated inclusion. 200X. Etched.

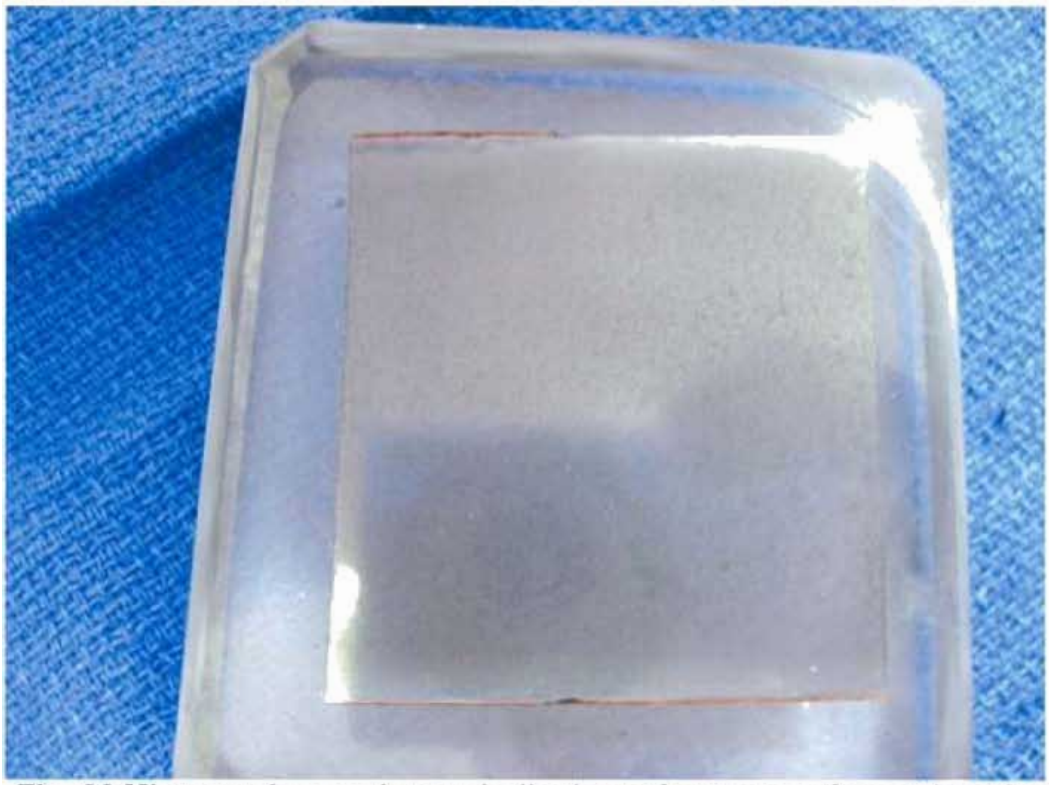
Fig. 86 Microsection made perpindicular to fracture surface at location 5 in fig. 20.

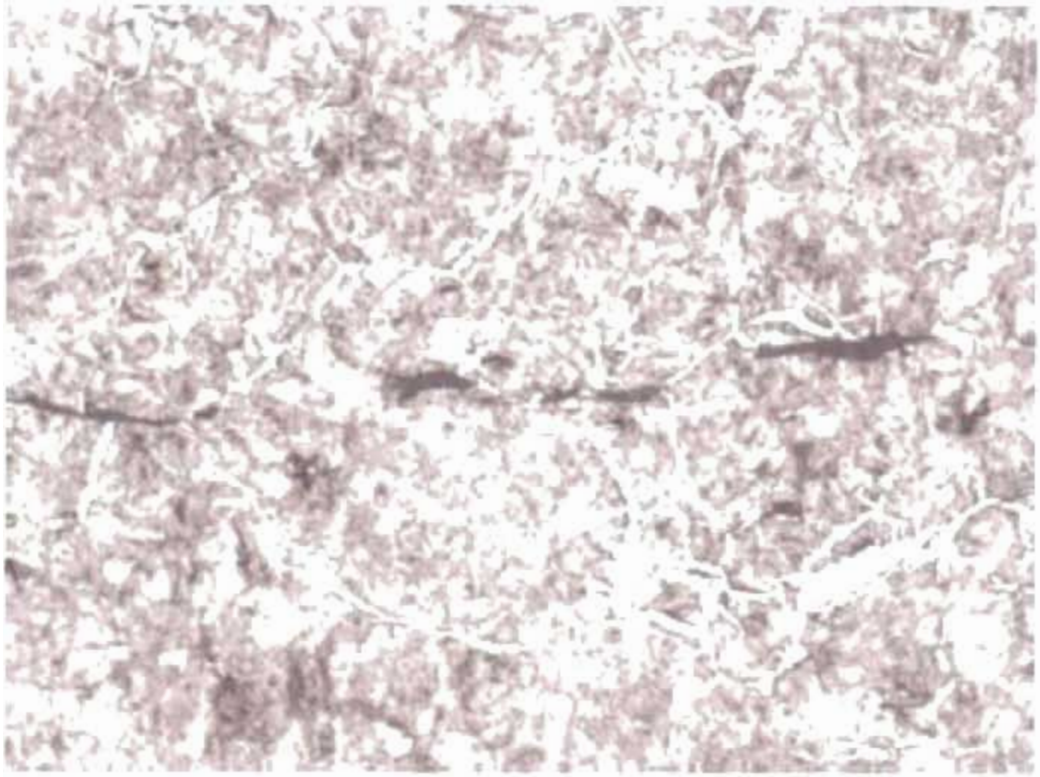
Fig. 87 Microstructure of sample # 5 200X. Etched.

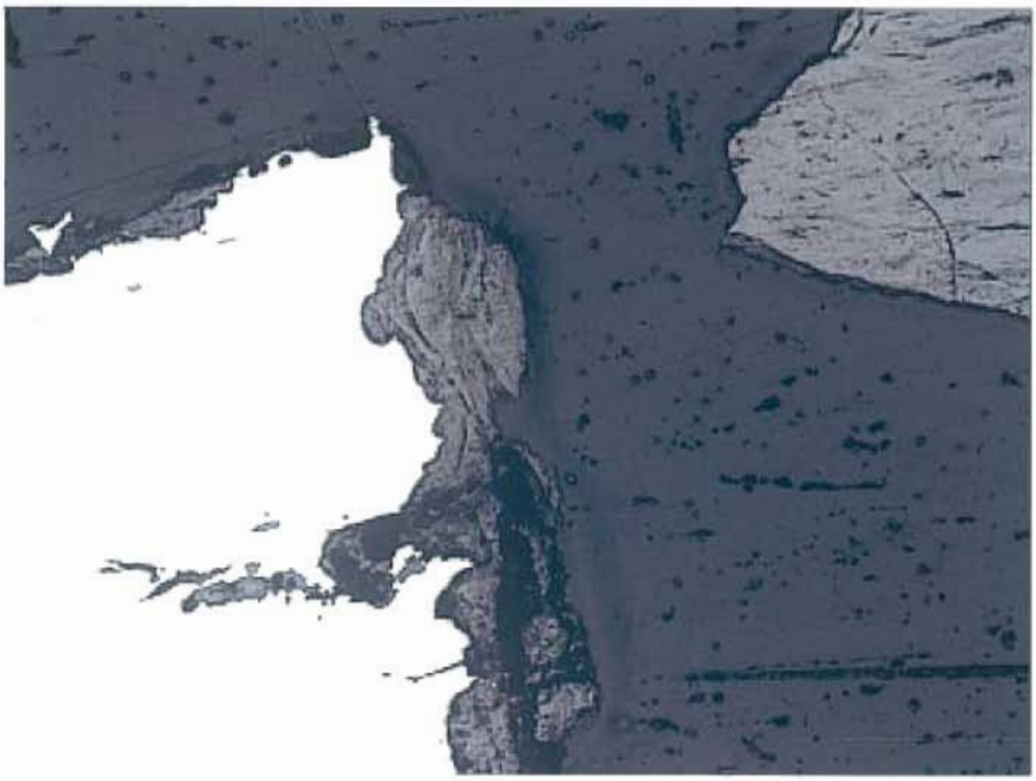
Fig. 92 Transverse cross-section made of eye bar near the center pin location, showing fracture face and scale. 100X.

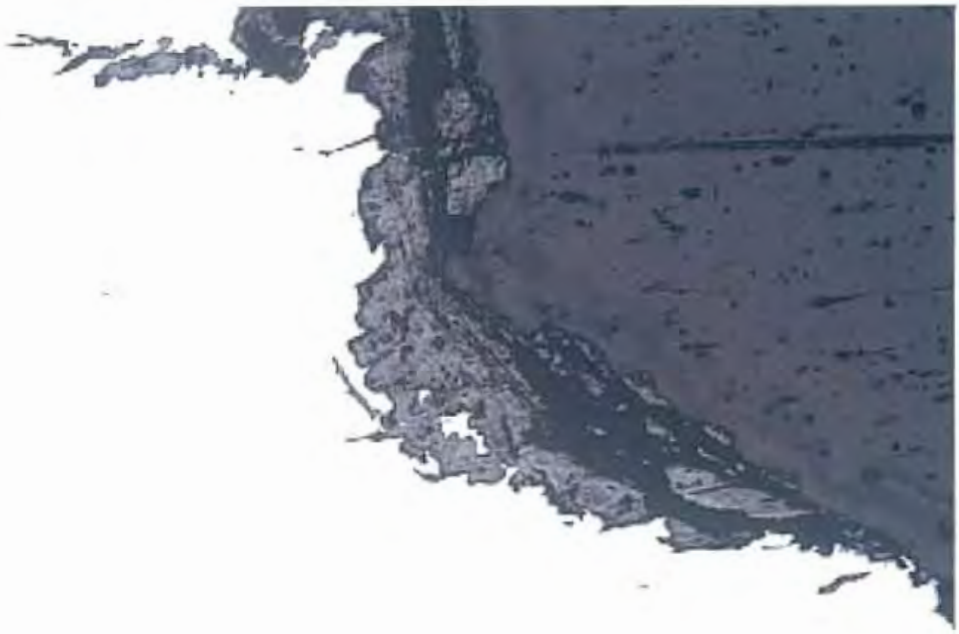
Fig. 93 Transverse cross-section made of eye bar near the center pin location, showing fracture face and scale. 100X.

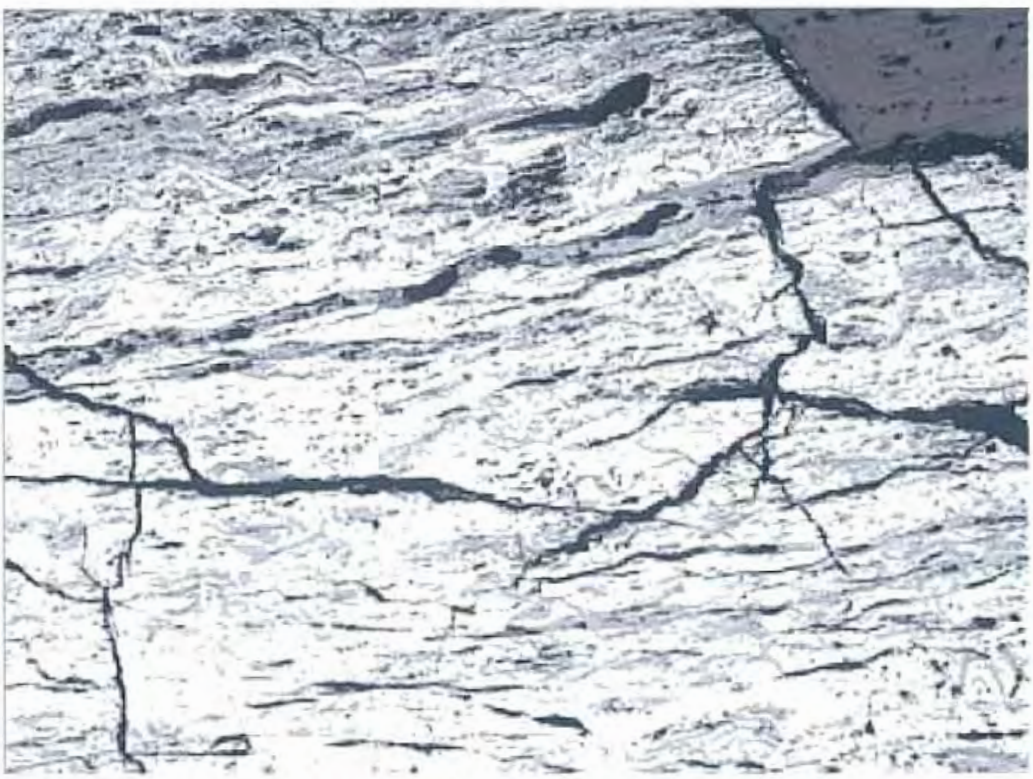
Fig. 94 Transverse cross-section made of eye bar near the center pin location, showing scale. 100X.

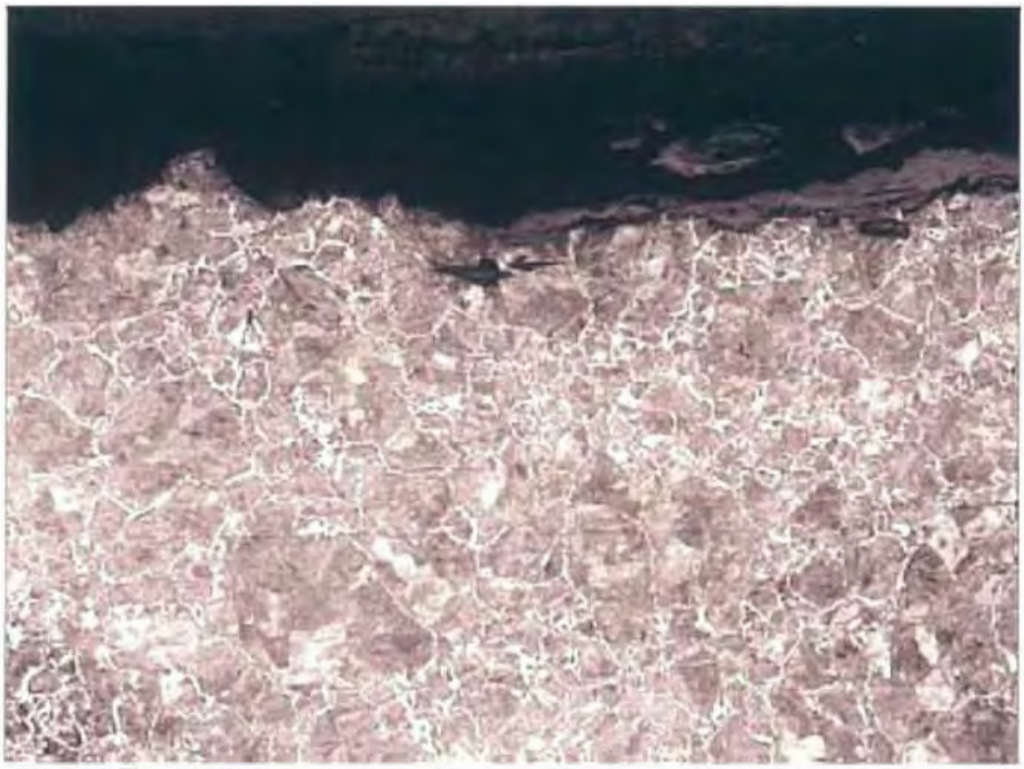
Fig. 95 Transverse cross-section made of eye bar near the center pin location, showing microstructure below fracture face. 100X. Etched.

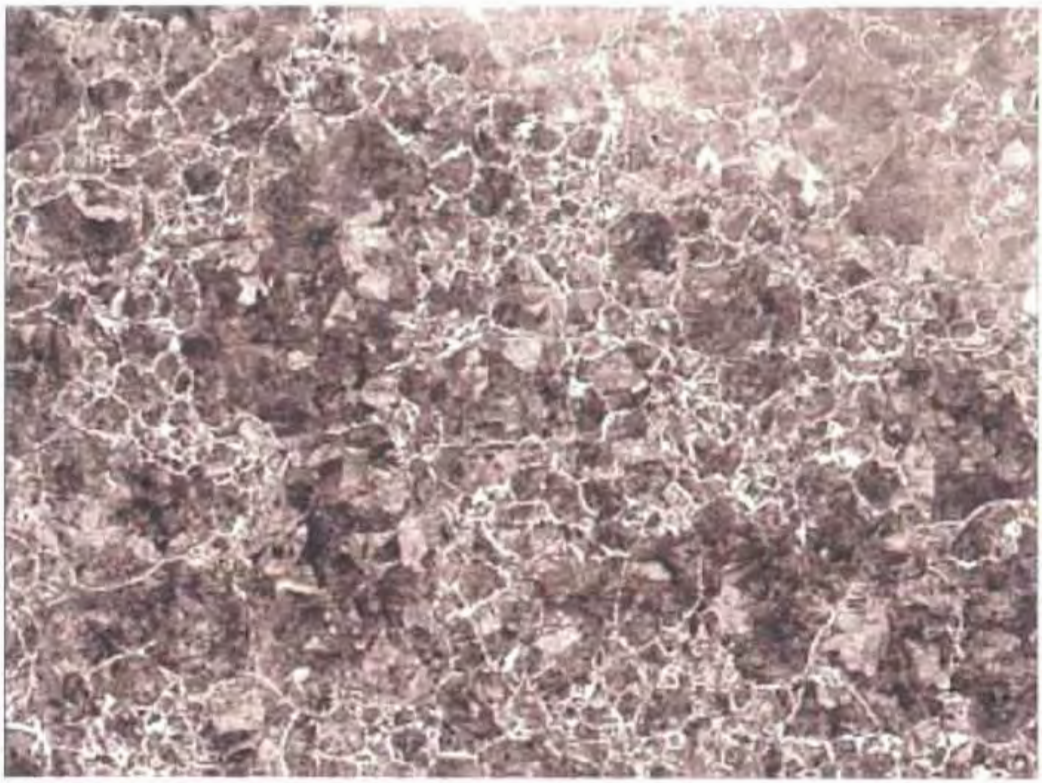
Fig. 96 Transverse cross-section made of eye bar near the center pin location, showing microstructure below fracture face. 100X. Etched.

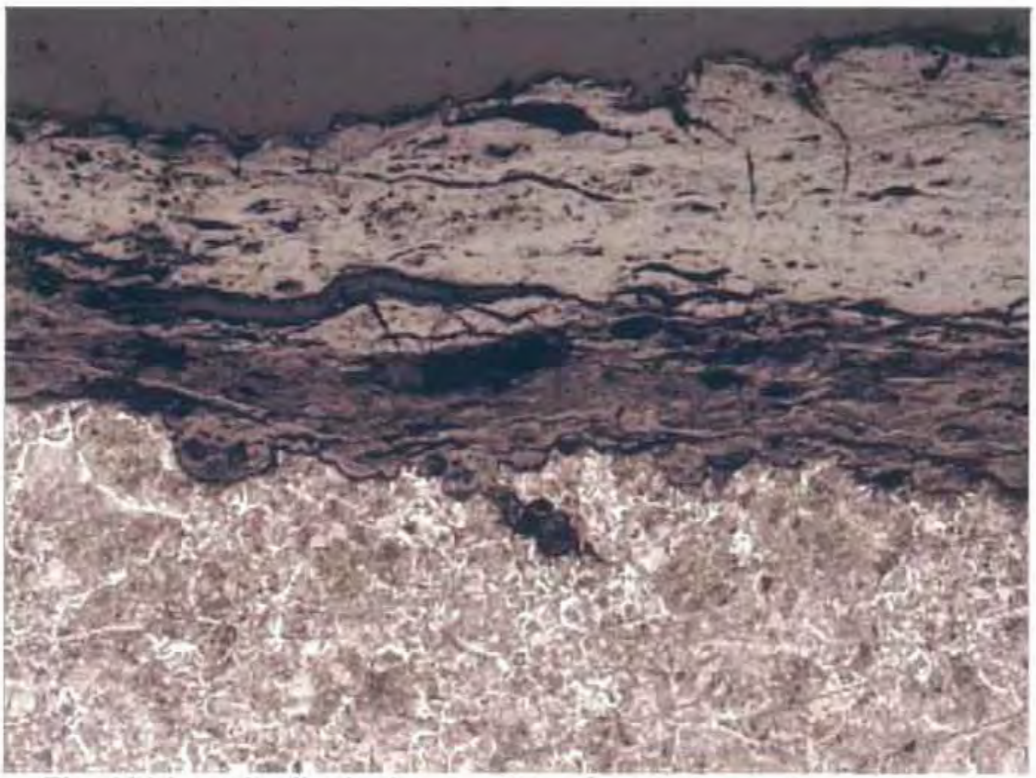
Figs. 99 and 100 illustrate the appearance of these microsections prepared in this direction. Fig. 101 illustrates the microsection along the plane of fracture and again shows no evidence of any decarburization layer or internal flaw below the oxide scale. Fig. 102 illustrates the etched microstructure which shows martensitic grains surrounded by ferrite. Figs. 103 and 104 show additional views of the microstructure which is consistent with the rest of the cross section. Fig. 105 illustrates the cross section taken at location B shown in Fig. 98 which again shows the plane of fracture and the oxidized fracture surface at the top portion.

Fig. 101 Longitudinal microsection of eye bar near the center pin location, in fig. 98, location A, showing fracture surface. 50X. Etched.

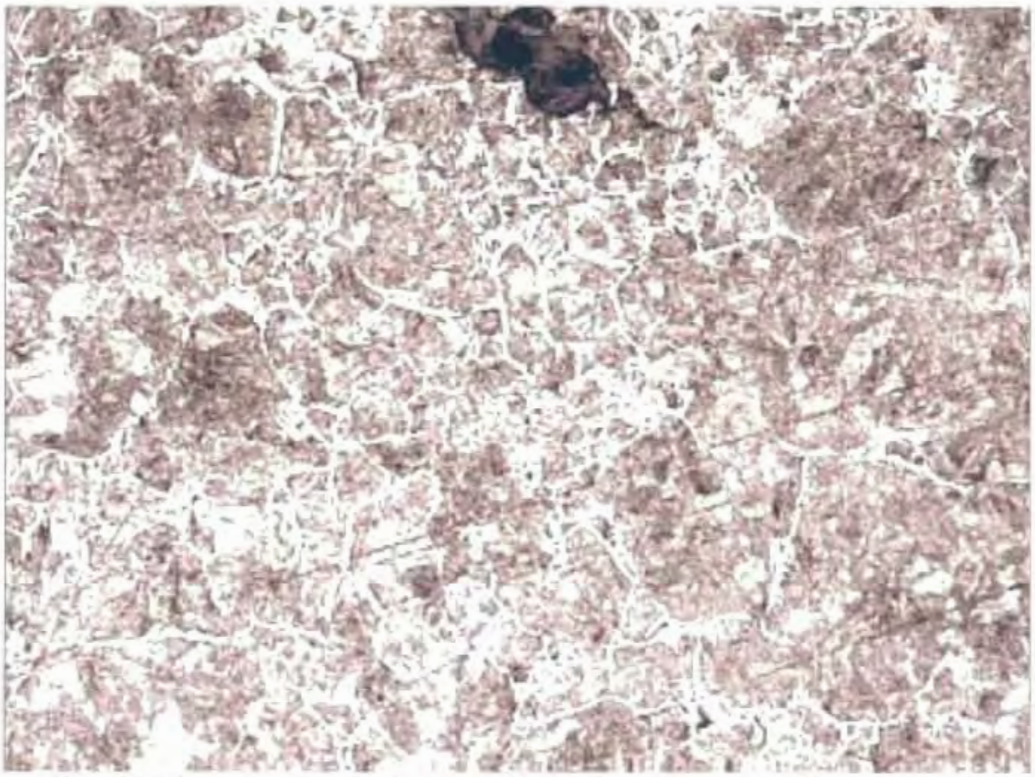
Fig. 102 Longitudinal microsection of eye bar near the center pin location, in fig. 98, location A, below fracture surface. 200X. Etched.

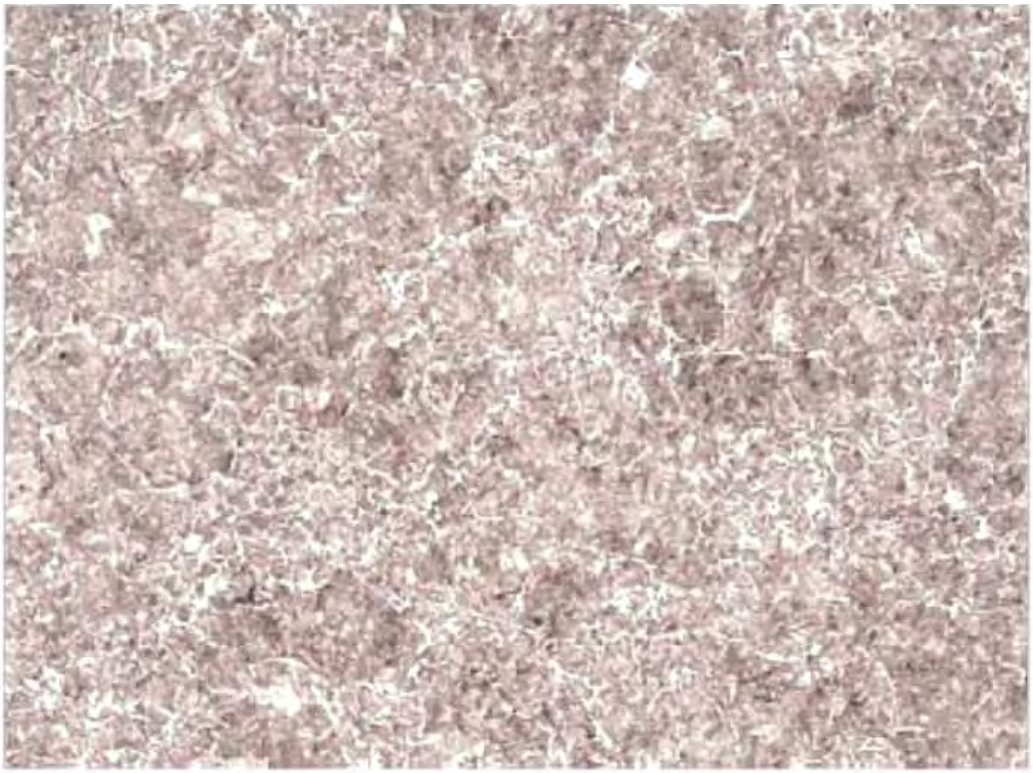
Fig. 103 Longitudinal microsection of eye bar near the center pin location, in fig. 98, location A, showing core microstructure. 50X.Etched.

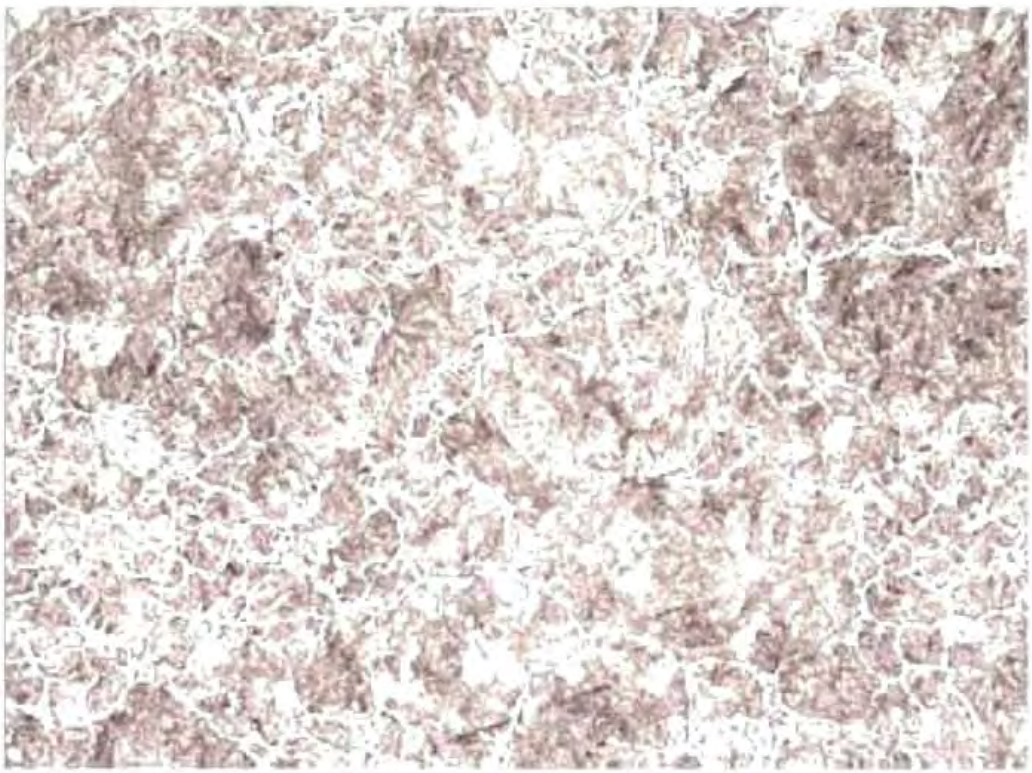
Fig. 104 Longitudinal microsection of eye bar near the center pin location, in fig. 98, location A, showing core microstructure. 200X.Etched.

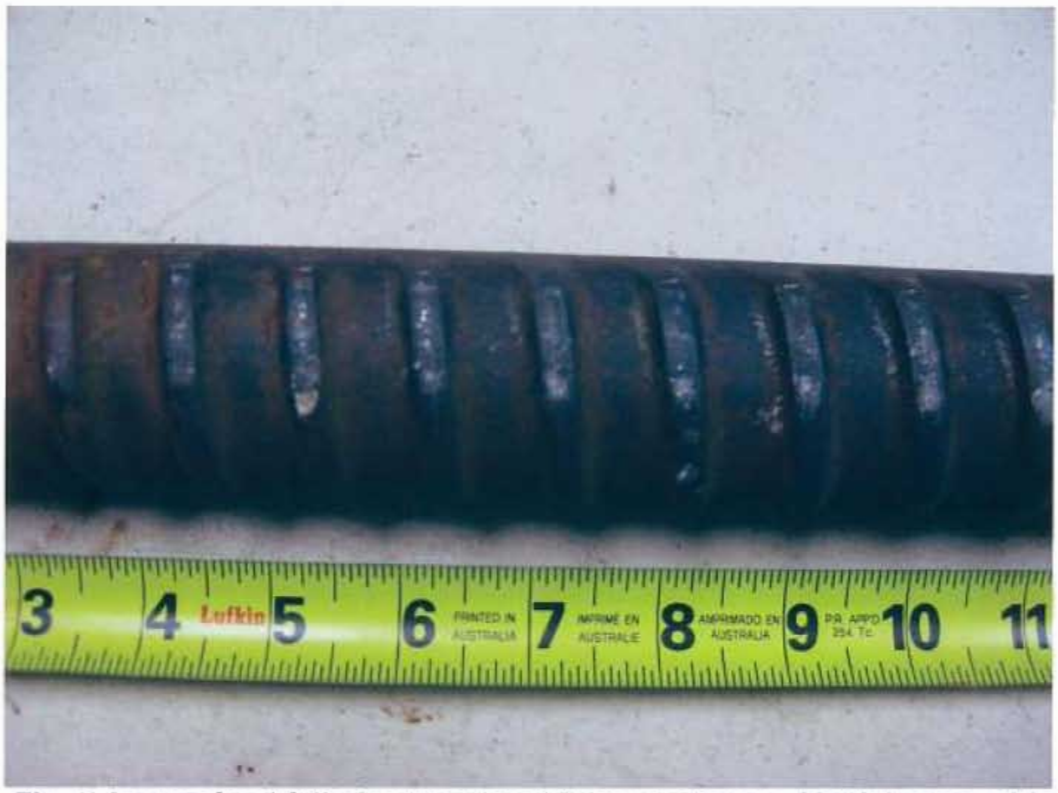
Fig. 5 As received failed support rod from east span. 12 O'clock position.

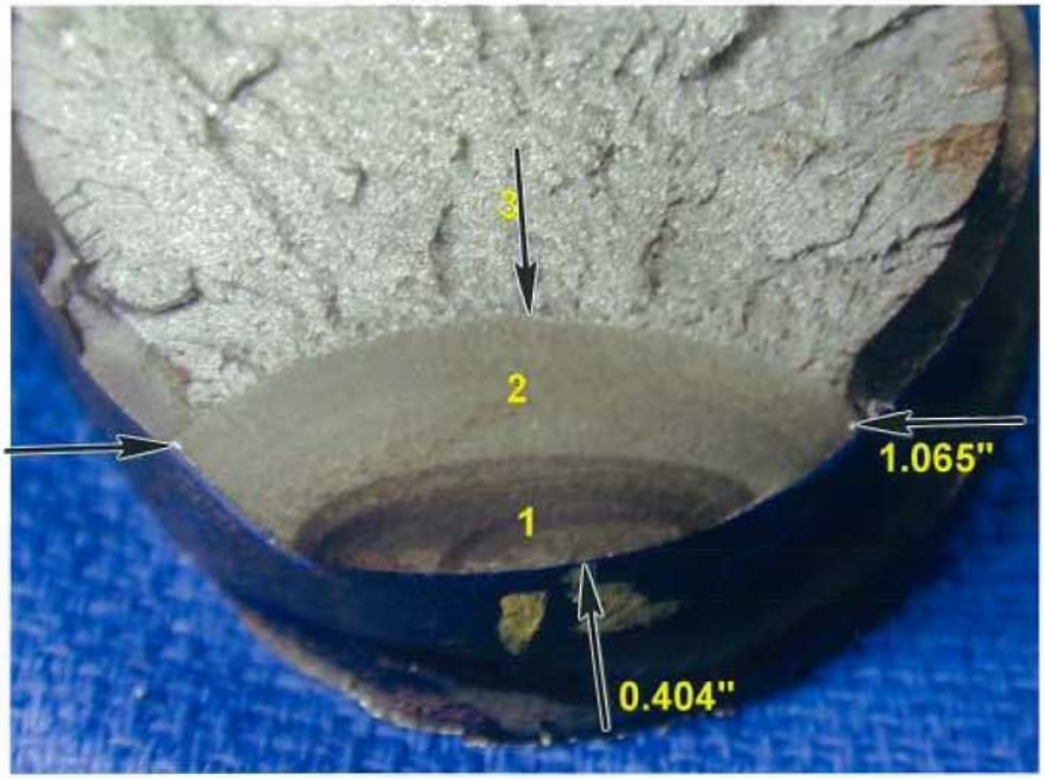
Fig. 17 As received failed support rod from east span. Fracture origin.

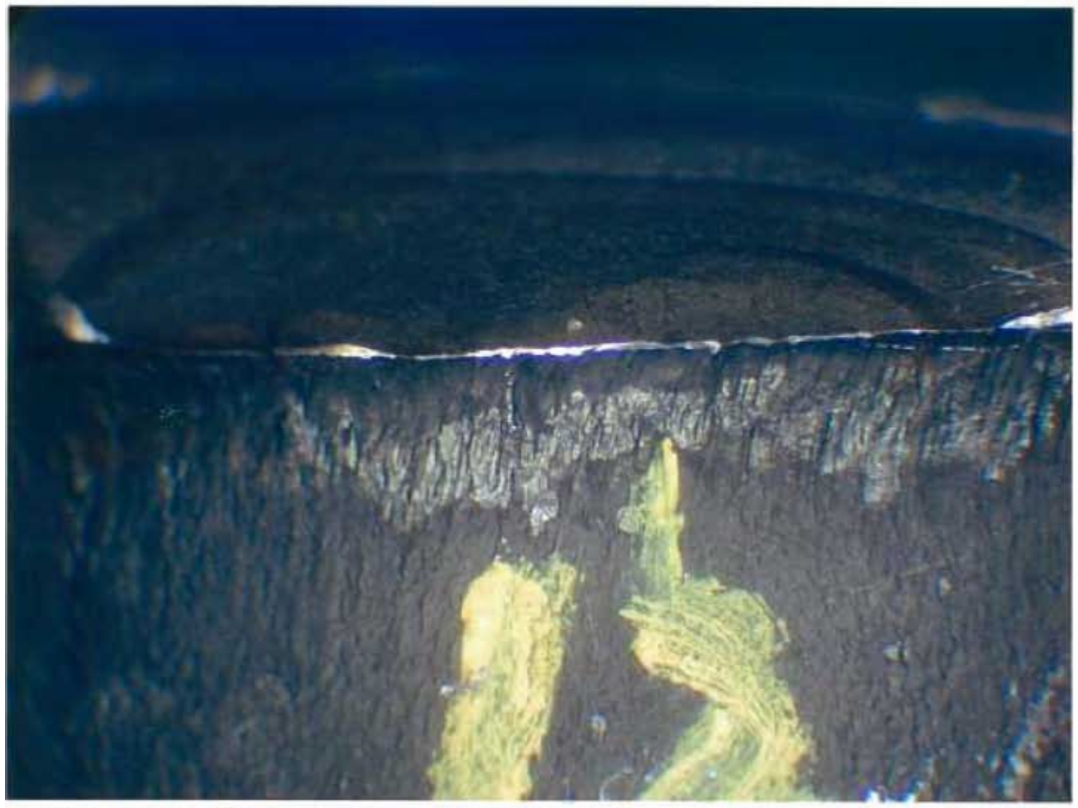
Fig. 20 As received failed support rod from east span. Fracture origin.

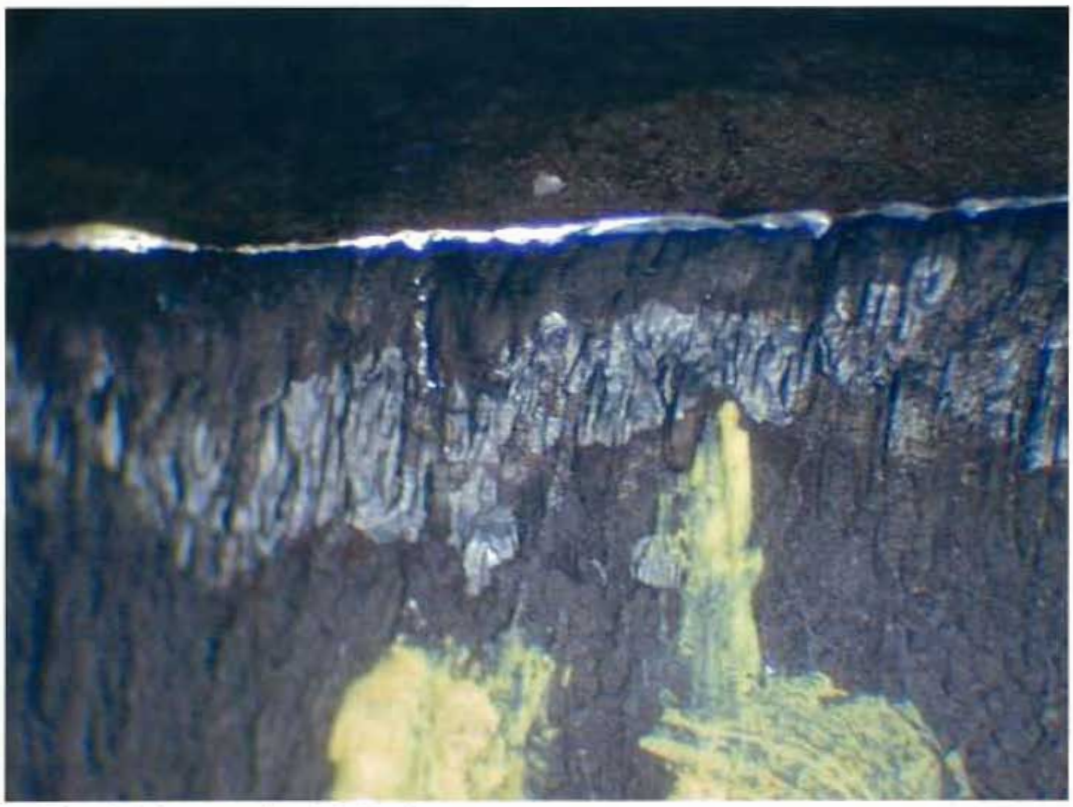
Fig. 21 As received failed support rod from east span. Fracture origin.

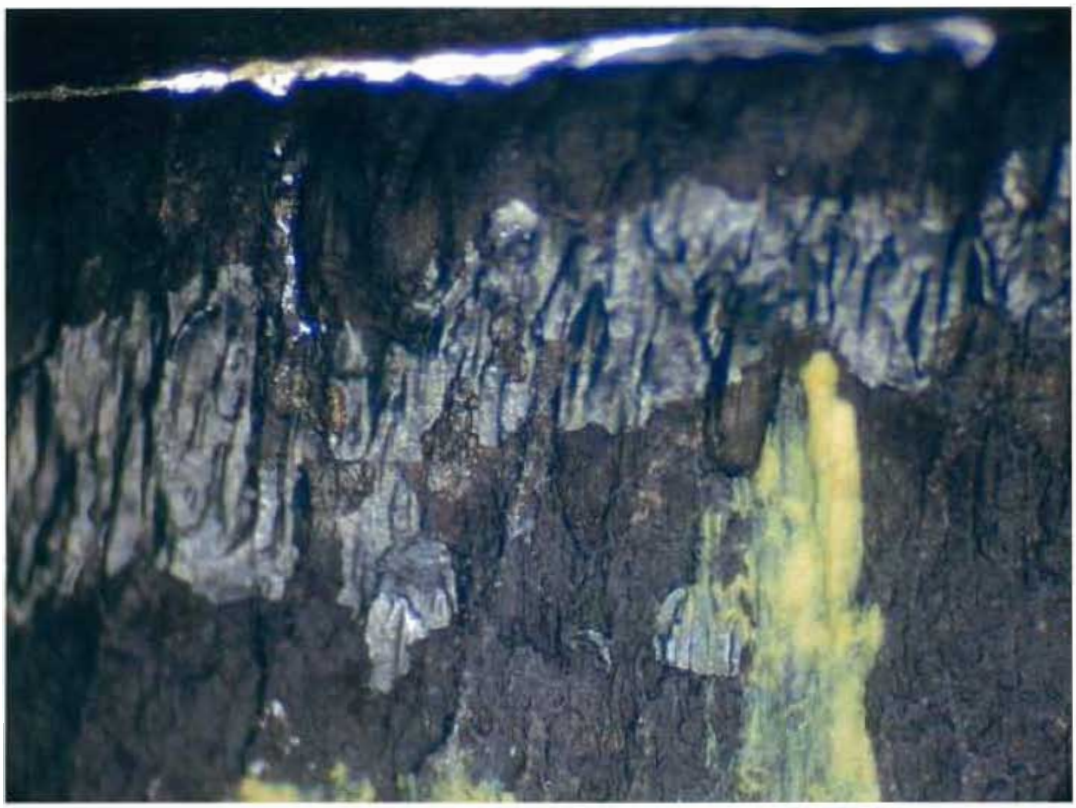
Fig. 22 As received failed support rod from east span. Fracture origin.

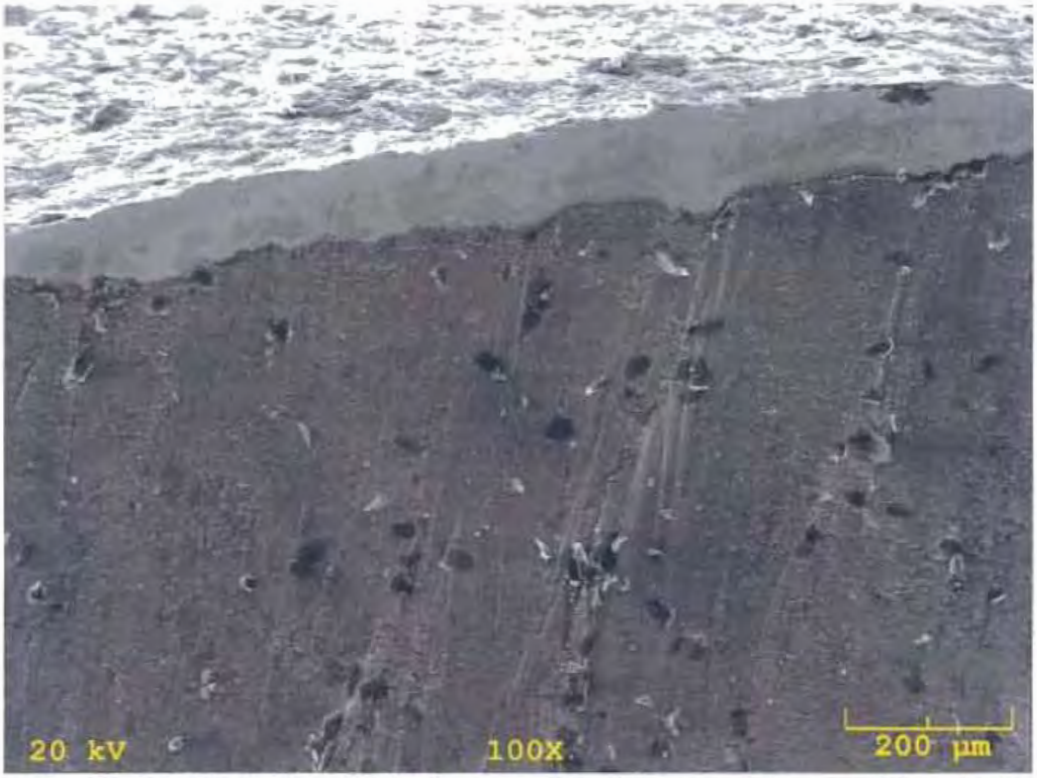
Fig. 23 S.E.M photo of failed support rod from east span. Edge, below fracture origin. 100X.
