STATE OF CALIFORNIA

Summary of SFOBB East Span Eye Bar Failure Analysis

March 17, 2010

04-0G8404
SFOBB Emergency Eye Bar Repair

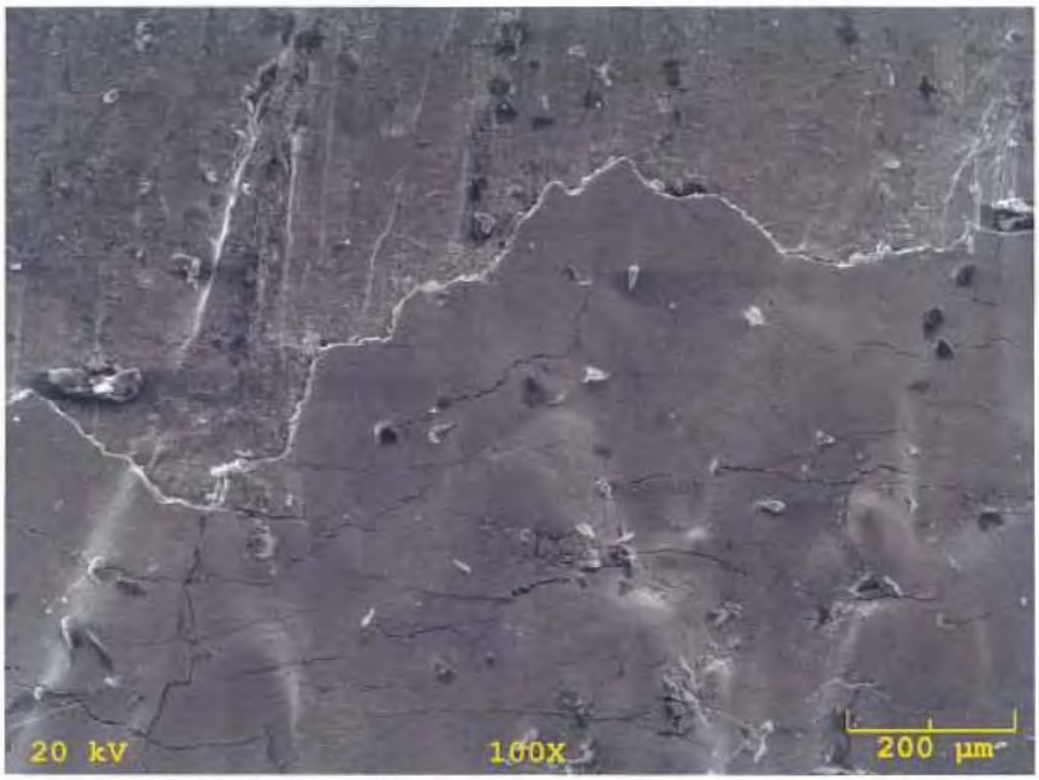
Fig. 24 S.E.M photo of failed support rod from east span. Edge, below fracture origin. 100X.

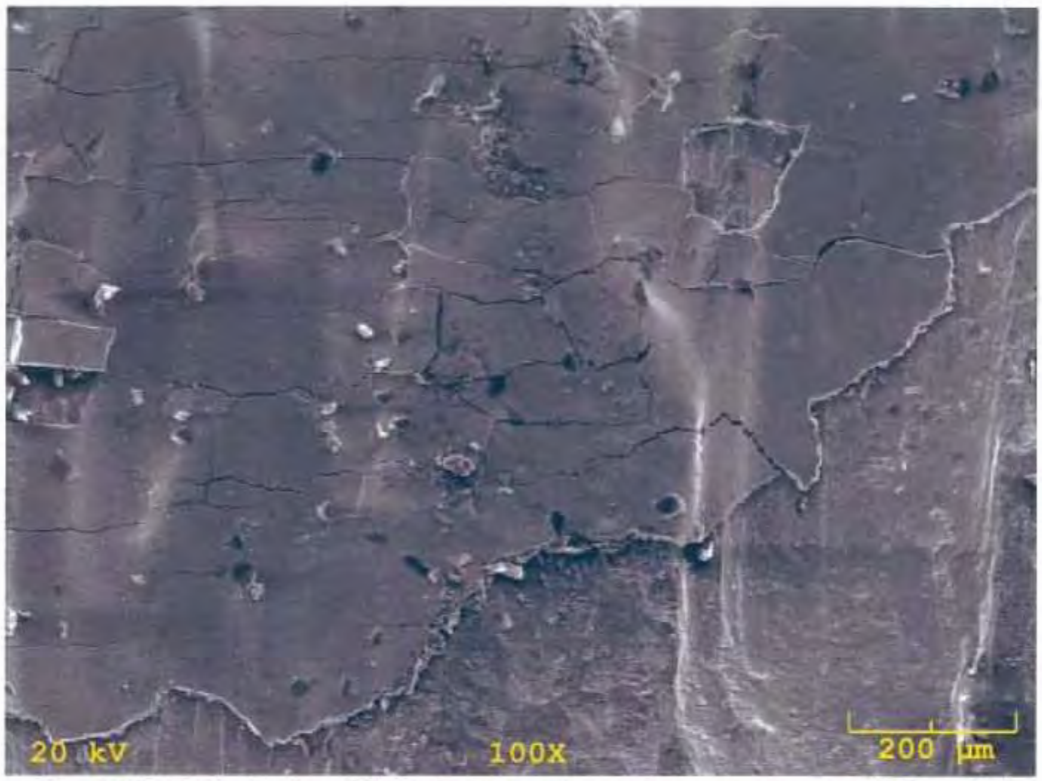
Fig. 25 S.E.M photo of failed support rod from east span. Edge, below fracture origin. 100X.

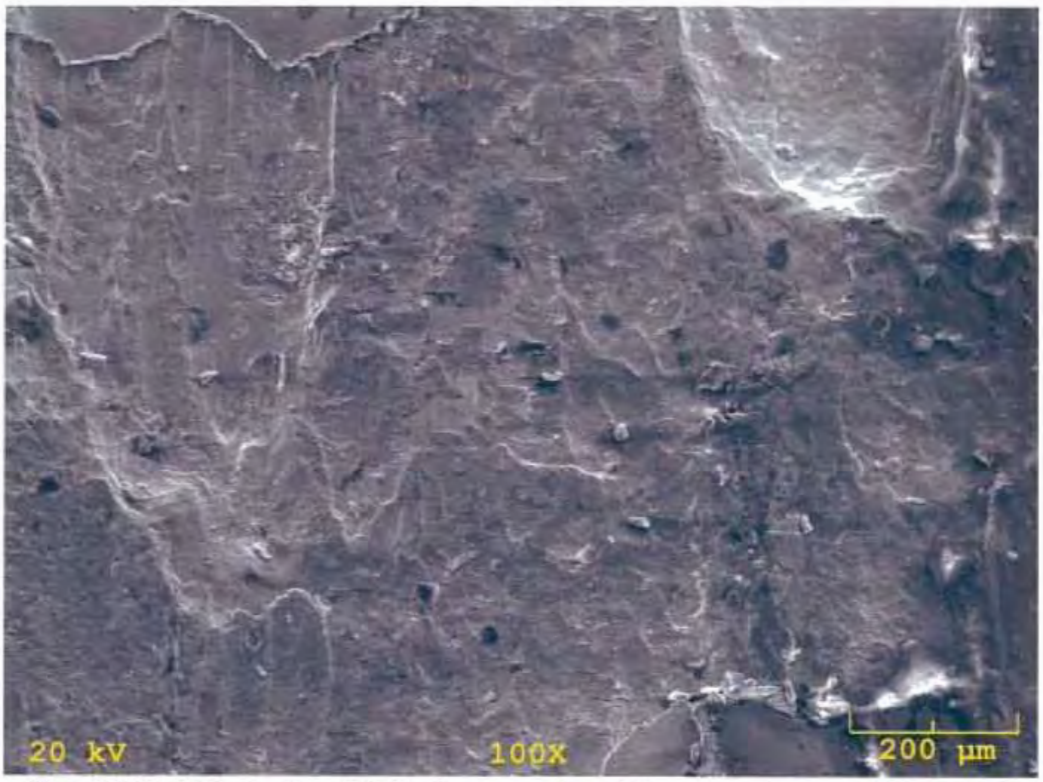
Fig. 26 S.E.M photo of failed support rod from east span. Edge, below fracture origin. 100X.

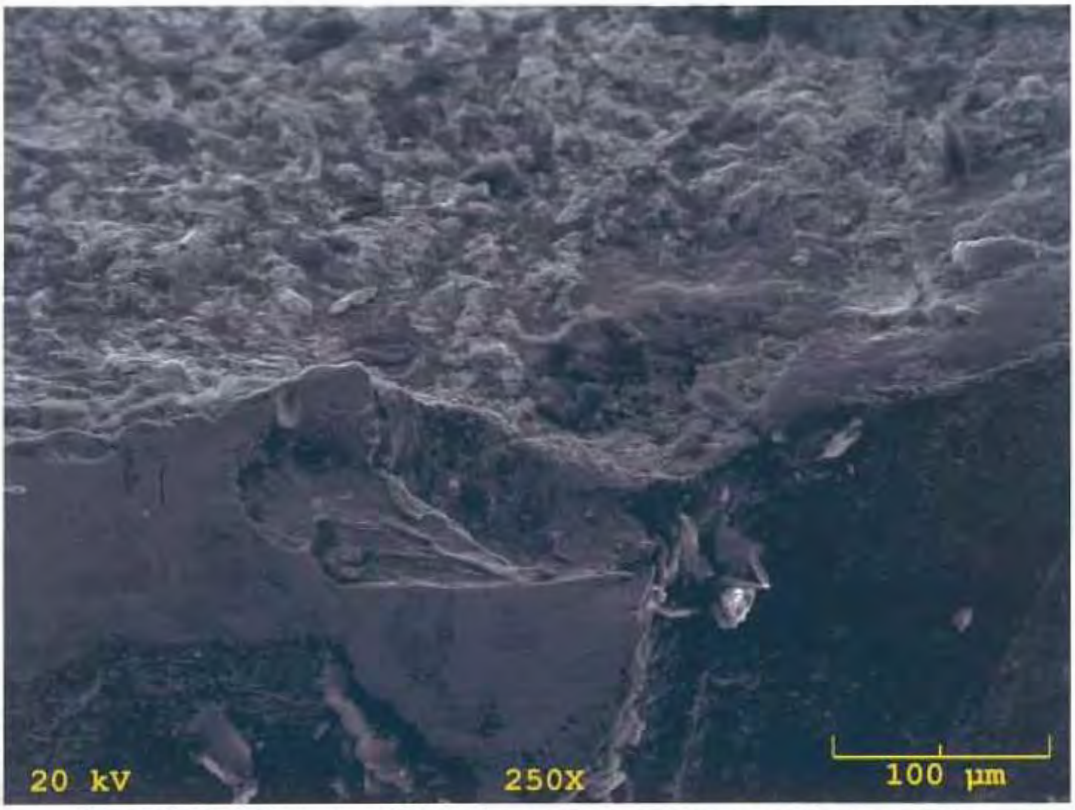
Fig. 27 S.E.M photo of failed support rod from east span. Edge, at fracture origin. 250X.

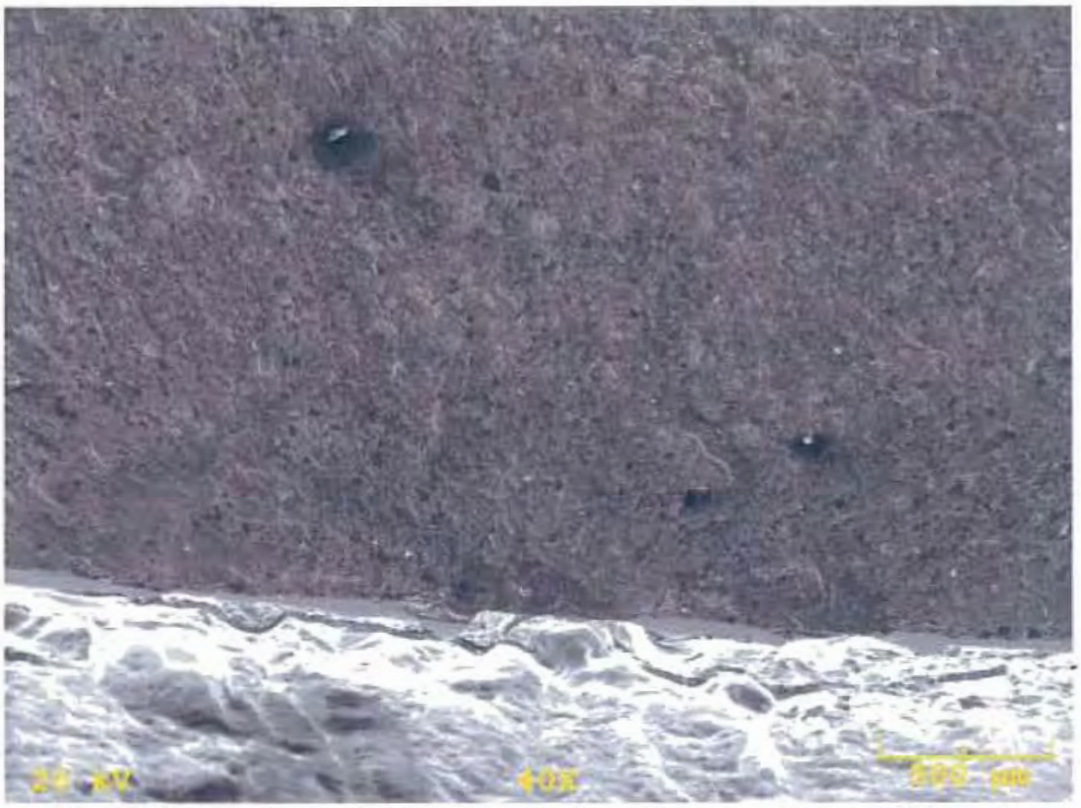
Fig. 28 S.E.M photo of failed support rod from east span. Edge, at fracture origin. 40X.

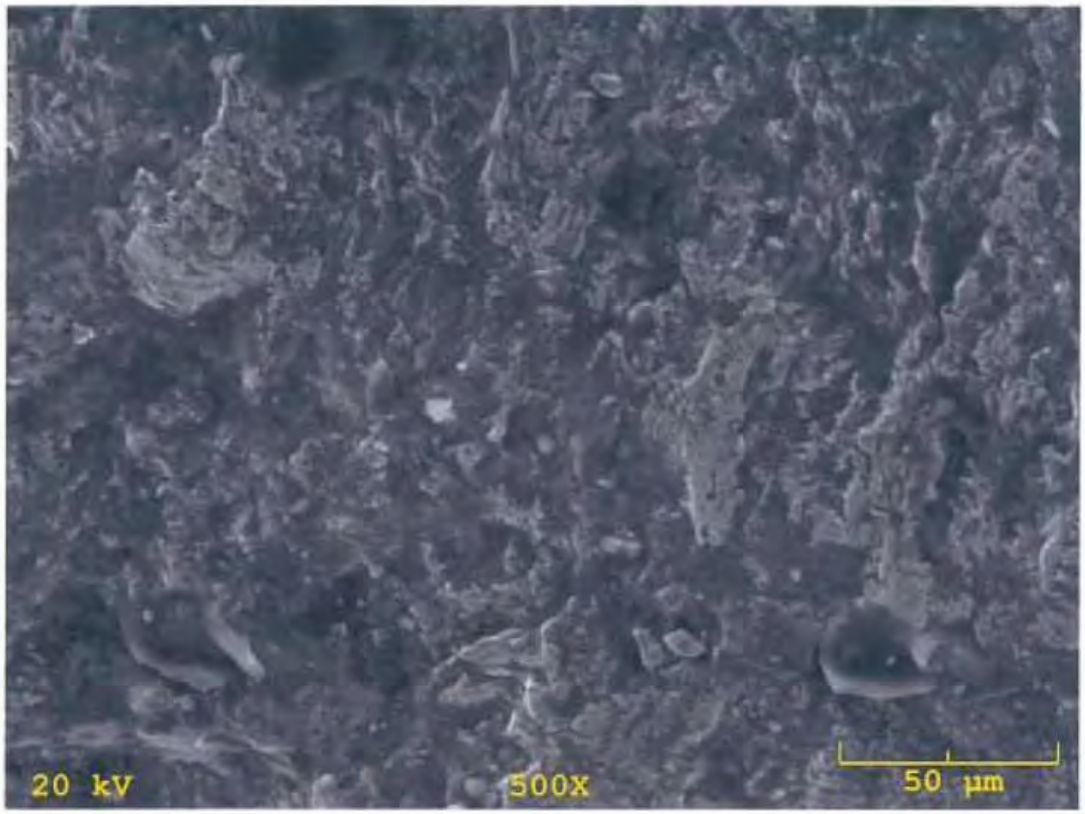
Fig. 29 S.E.M photo of failed support rod from east span at fracture origin. 500X.

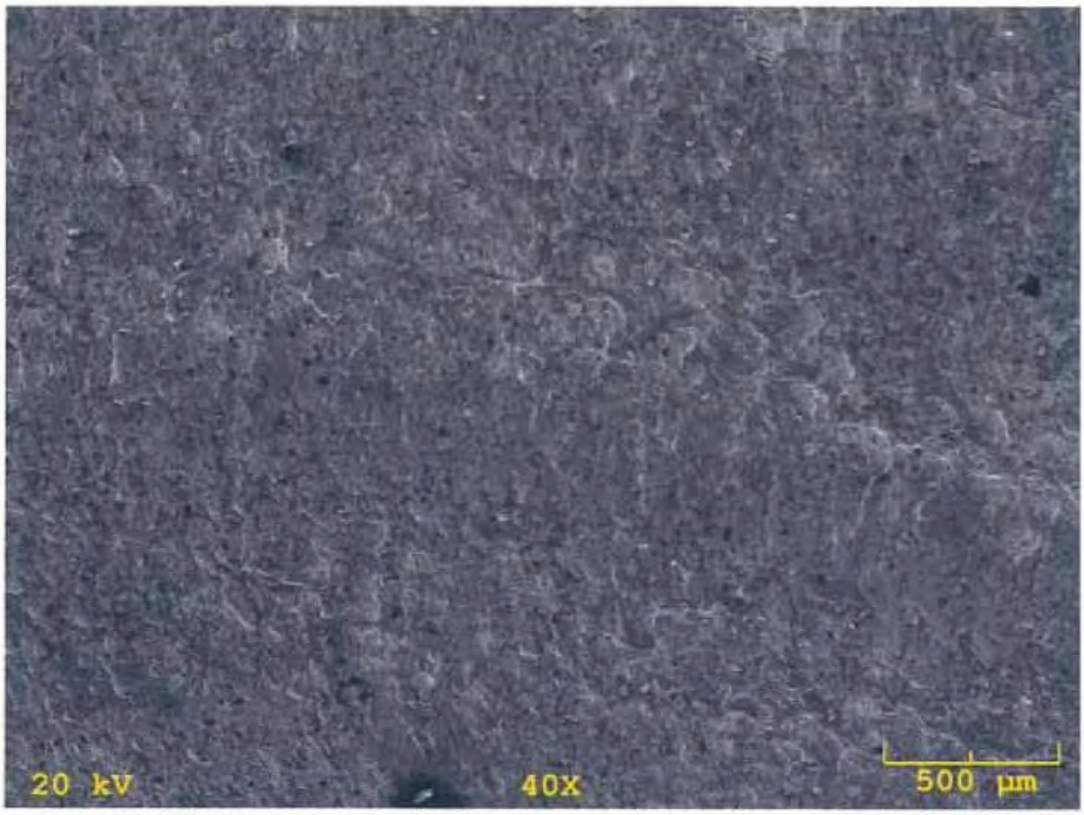
Fig. 30 S.E.M photo of failed support rod from east span. inboard from fracture origin. 40X.

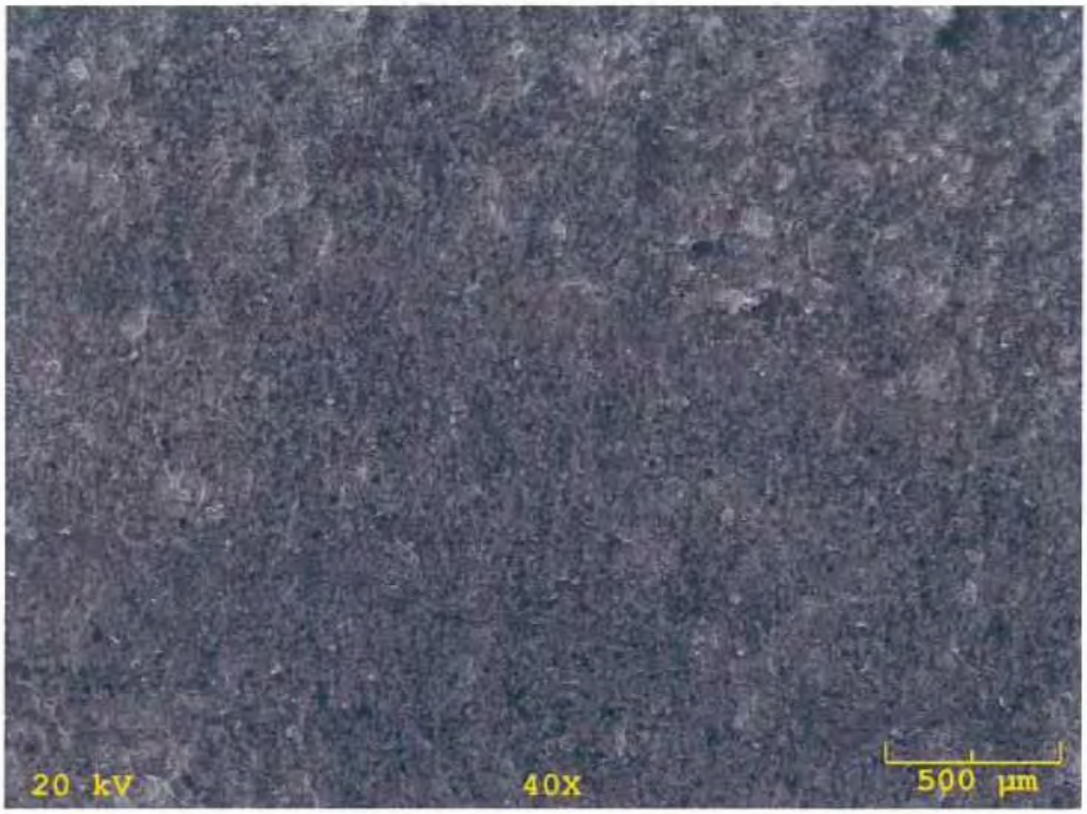
Fig. 31 S.E.M photo of failed support rod from east span at fracture origin. Zone 1. 40X.

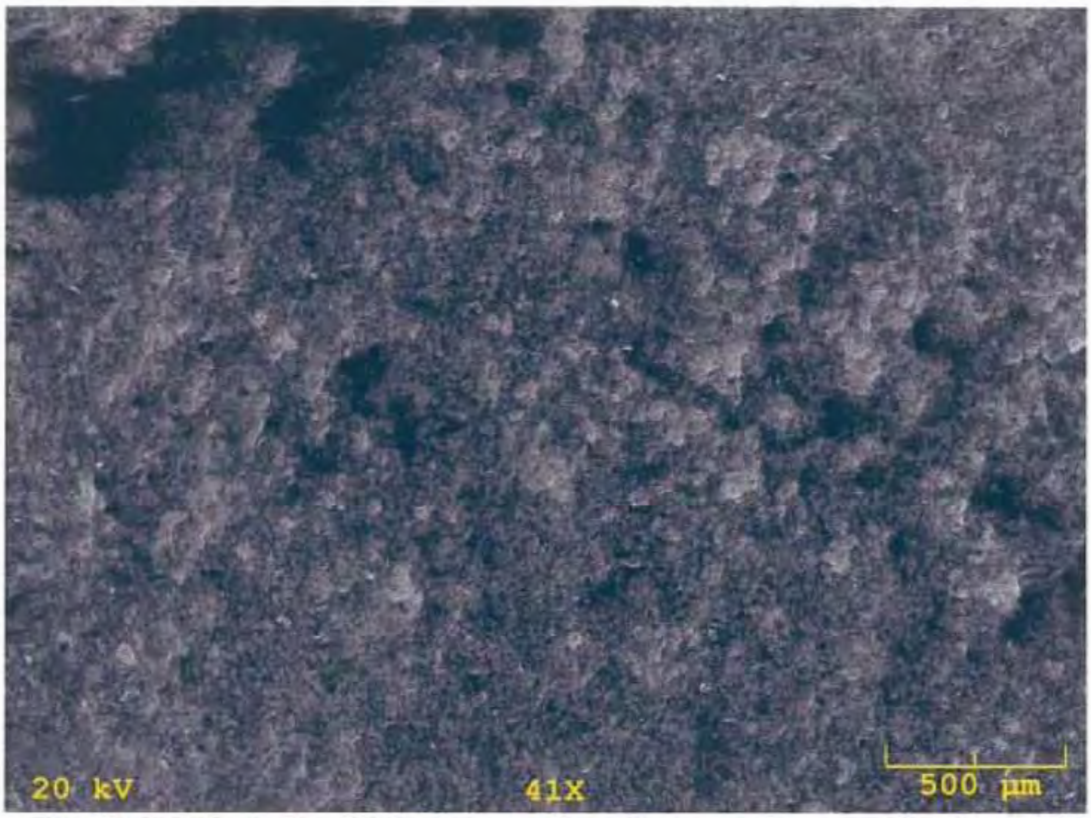
Fig. 32 S.E.M photo of failed support rod from east span at fracture origin. Zone 2. 41X.

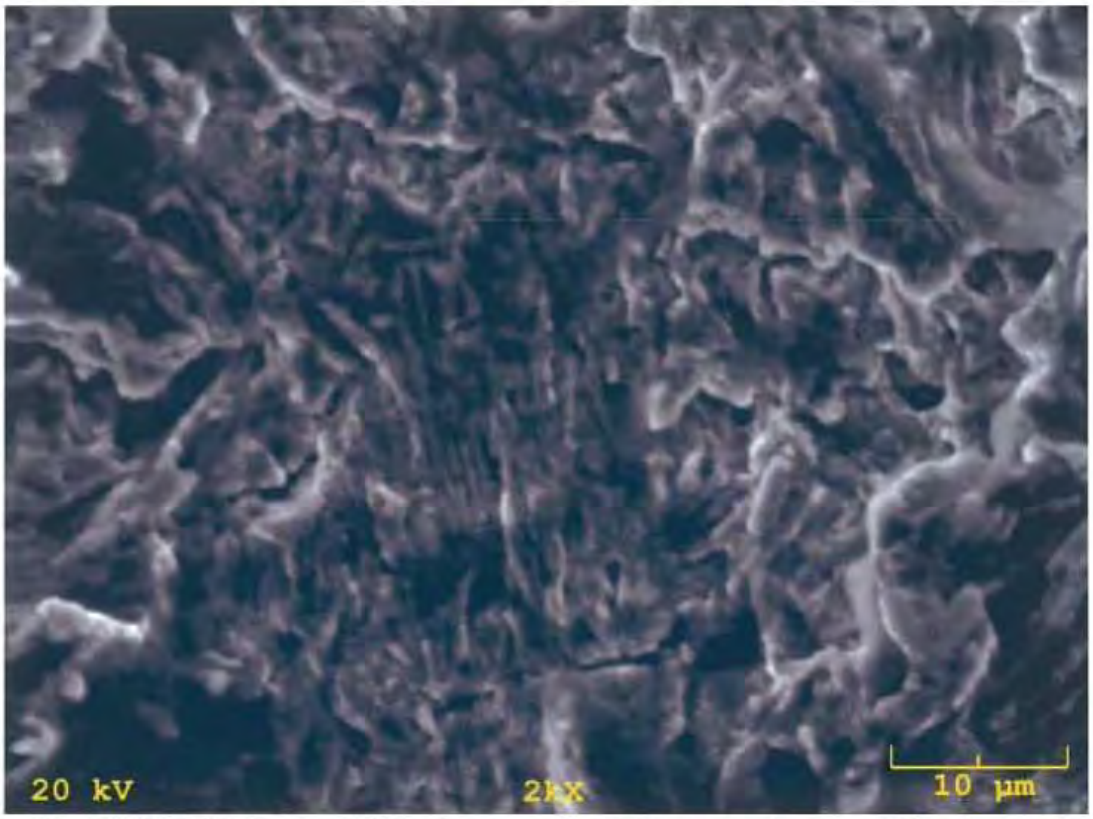
of fracture and the length of the fatigue crack zone measured 1.065". At this location the diameter of the bar at the plane of fracture measured 1.844". The arrow in Fig. 18 illustrates the primary fatigue crack origin location. One can see radiating beach marks propagating away from this particular point. A small secondary fatigue crack is indicated by the small arrow shown in the left in Fig. 18. Fig. 19 illustrates an additional view of the fatigue fracture origin area. Figs. 20, 21 and 22 illustrate the appearance of the markings at the corner of the rib coincident with the fracture origin location. The oxide in this area was chipped and cracked apparently due to the interaction with the thread zone in the nut. Figs. 23, 24, 25 and 26 illustrate the appearance of the mill scale oxide and the cracking of the mill scale below the fracture origin location. This was caused by bearing against the threads of the nut. Fig. 27 illustrates the fracture origin location which shows evidence of rubbing degradation and also rubbing on the plane of fracture. Fig. 28 illustrates the appearance of the fracture origin. Fig. 29 illustrates the appearance of the fracture surface which shows evidence of rubbing and oxidation. Fig. 30 illustrates the appearance of the fracture inboard from the fracture origin which again shows significant evidence of rubbing degradation and oxidation. Fine fatigue striations could not be identified in this area although the fracture mode is fatigue. The first zone at the plane of fracture origin is shown in Fig. 17 and Fig. 31. Fig. 32 illustrates the appearance of the fracture in zone 2 which is the second step in the fatigue zone. Fig. 33 and 34 illustrate definite evidence of fatigue cracking damage in this area. Fig. 35

Fig. 34 S.E.M photo of failed support rod from east span at fracture origin. Zone 2. 2000X.

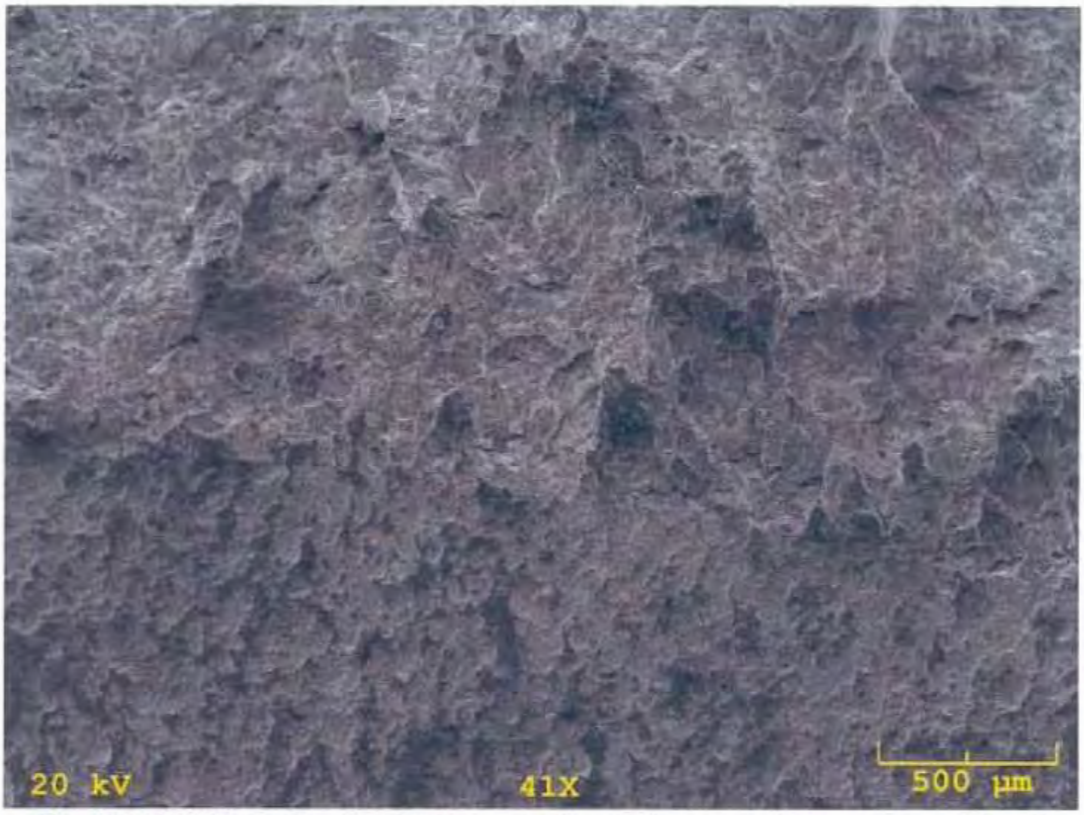
illustrates the transition from the end of the fatigue zone and progressing into the overload region, zone 3, on the fracture. One can see a line running across the photograph which defines the end of the fatigue zone. Fig. 36 illustrates the appearance of the fatigue fracture towards the end of the fatigue crack and Figs. 37 and 38 show additional higher magnification views of the fatigue zone which shows evidence of cracking and fatigue striations. Figs. 39 and 40 illustrate progressively the appearance of the fracture moving from the end of the fatigue zone across the plane of fracture and Fig. 41 illustrate the appearance of the fracture approximately ¾ of the way across the fracture face on the overload region. The fracture mode in the overload region was clearly cleavage fracture which indicates brittle propagation beyond the fatigue zone. At the other side of the cross section 180° away from the fatigue fracture origin there was evidence of a very small shear lip which exhibited dimple rupture. This is illustrated in Fig. 42.

Fig. 35 S.E.M photo of failed support rod from east span. Transition Zone 2-3. 41X.

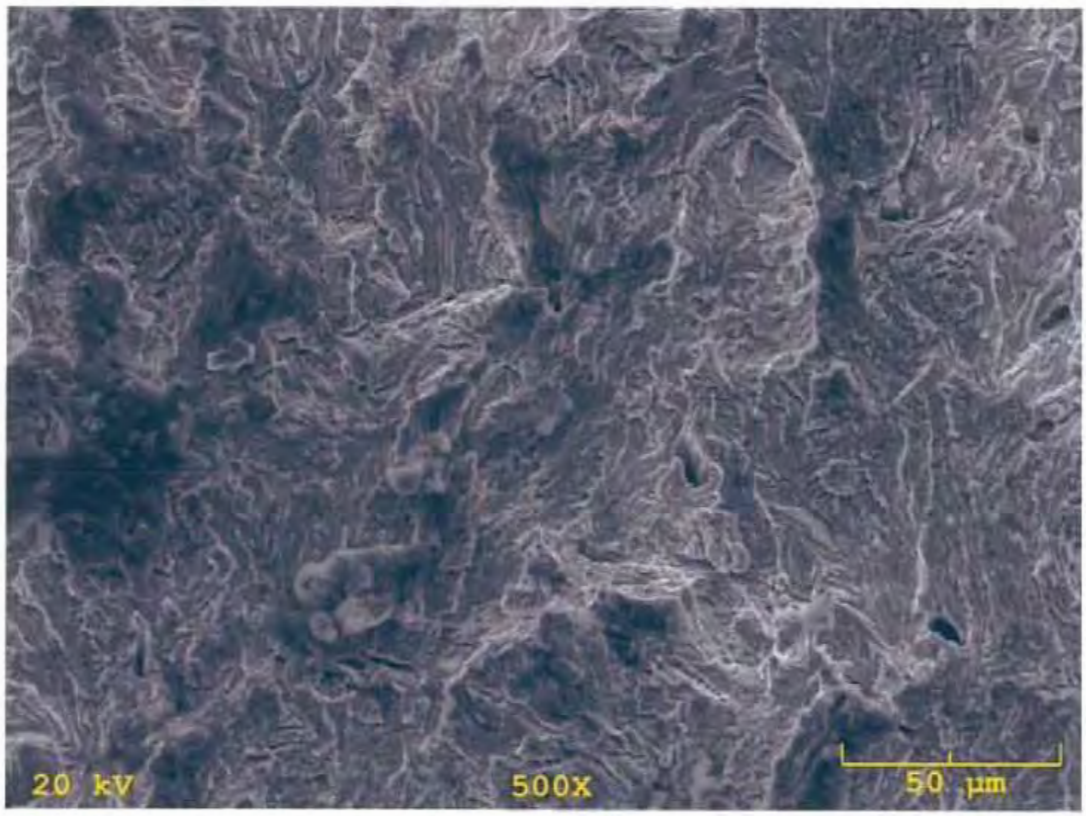
Fig. 36 S.E.M photo of failed support rod from east span at fracture surface. Fatigue. Zone 2. 500X.

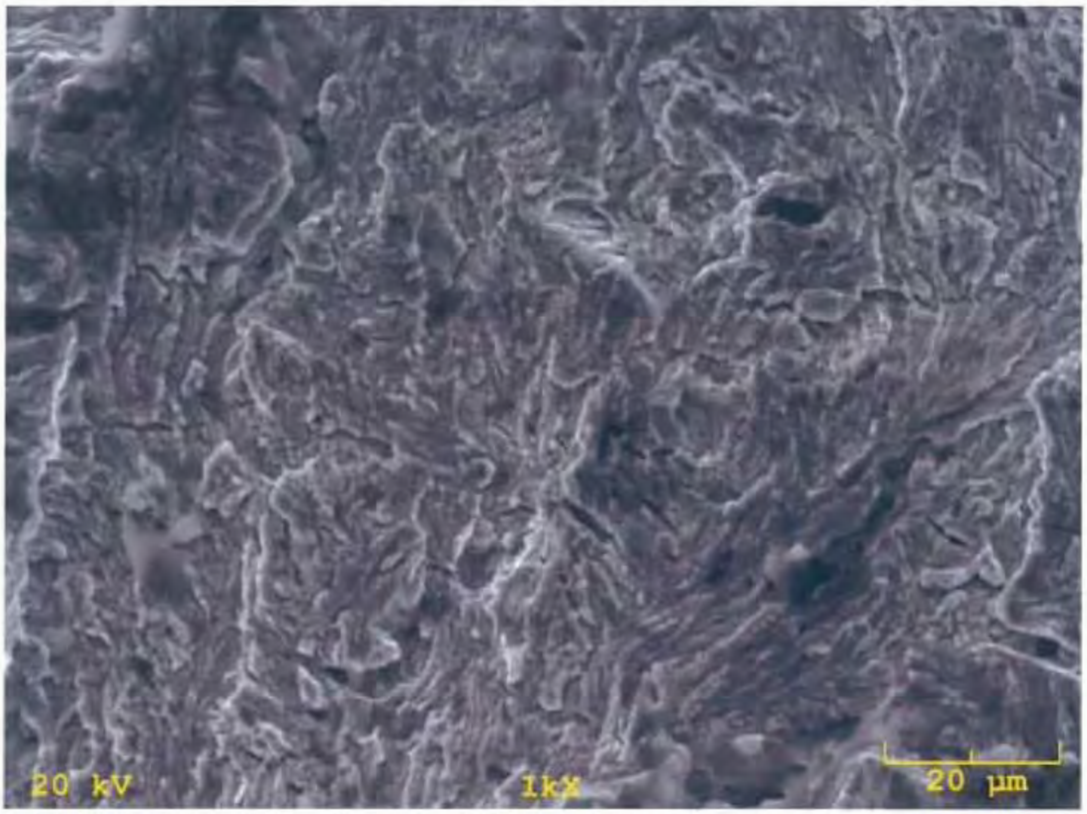
Fig. 37 S.E.M photo of failed support rod from east span at fracture surface. Fatigue. Zone 2. 1000X.

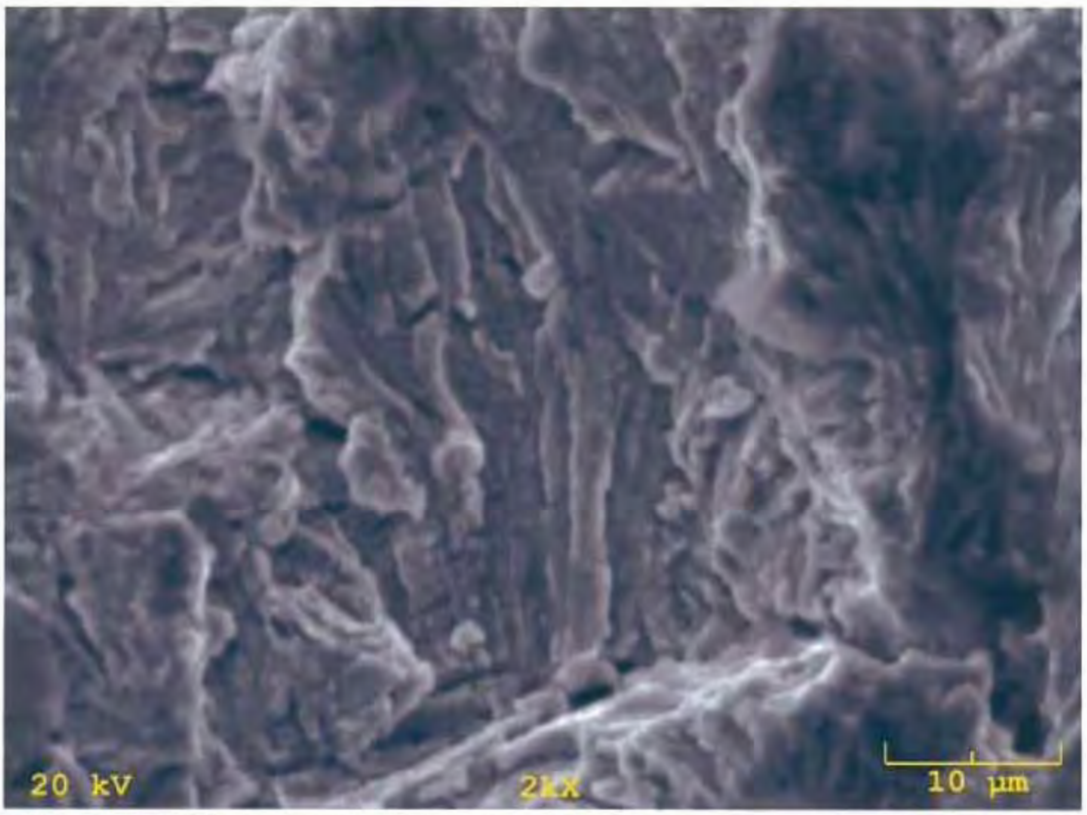
Fig. 38 S.E.M photo of failed support rod from east span at fracture surface. Fatigue. Zone 2. 2000X.

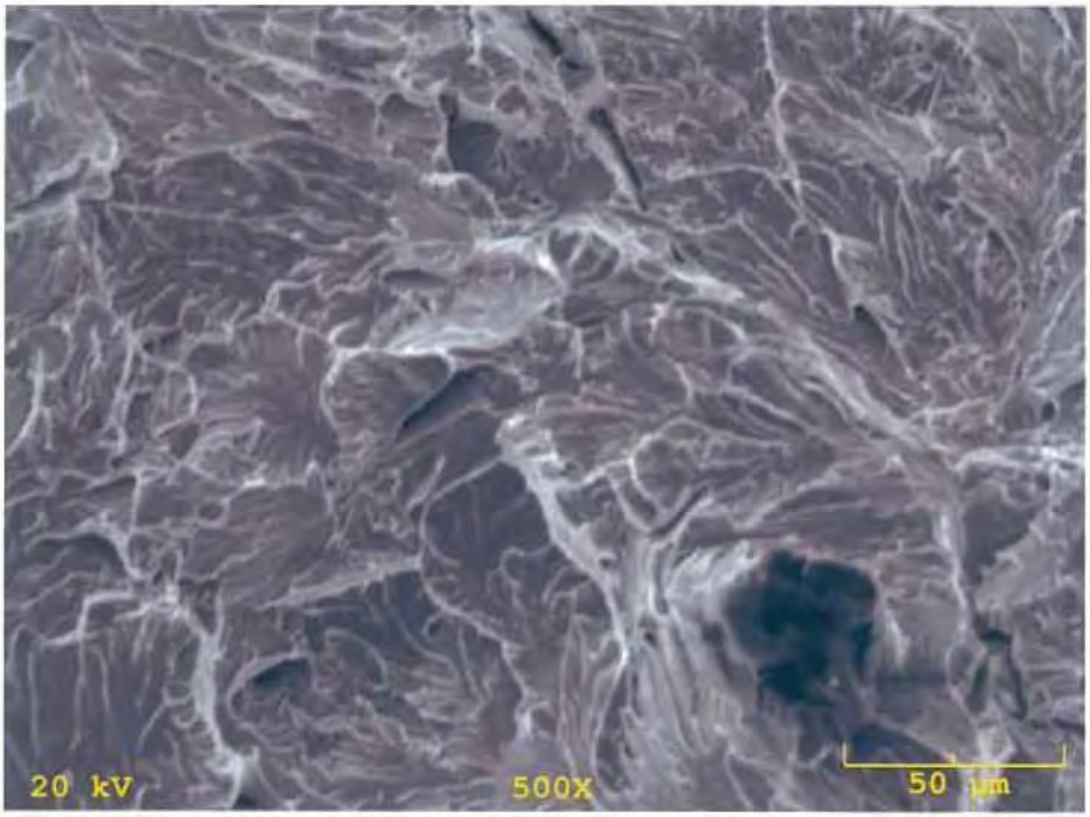
Fig. 40 S.E.M photo of failed support rod from east span middle of fracture surface. 500X.

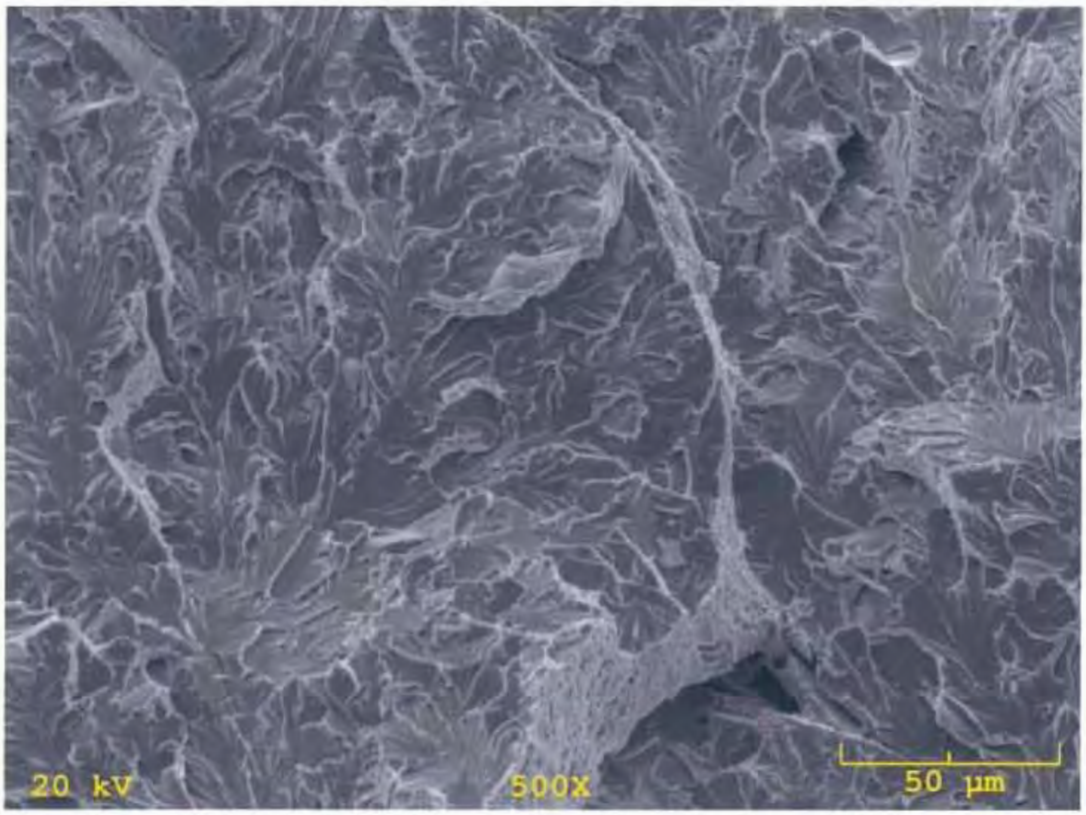
Fig. 41 S.E.M photo of failed support rod from east span 3/4 across on fracture surface. 500X.

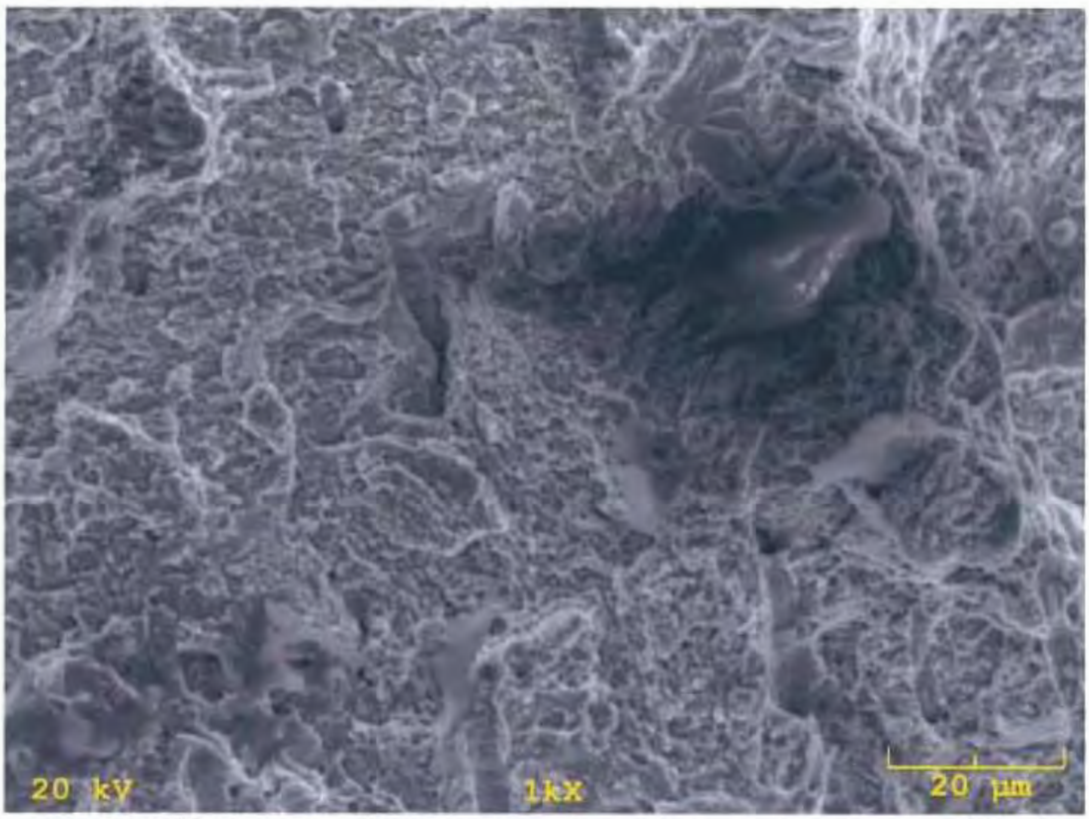
Fig. 42 S.E.M photo of failed support rod from east span shear lip edge, 1000X.

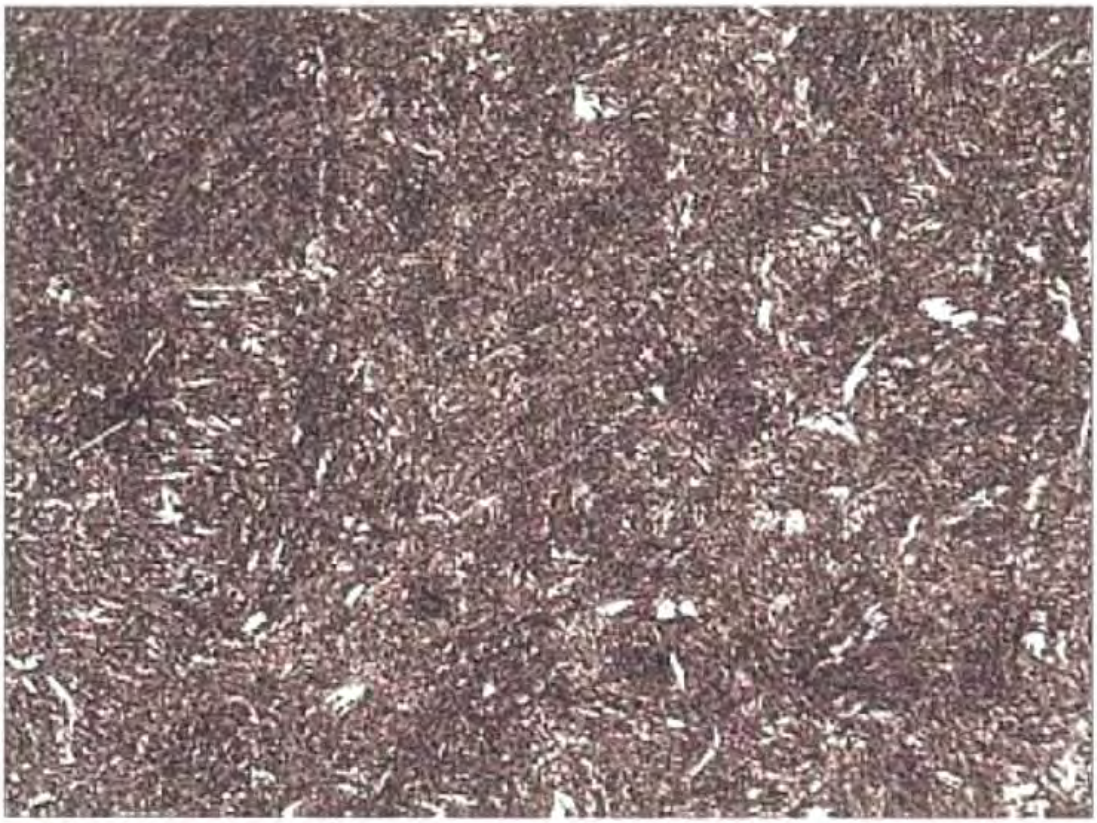
Fig. 43 illustrates cross section of the bar below the plane of fracture showing the ribs on the two sides. Photographs of the microstructure were taken at locations 1, 2 and 3 as illustrated in Fig. 43 and these are illustrated in Figs. 44, 45 and 46. In all cases the microstructure was martensitic but the microstructure near the surface was more fully martensitic and contains less ferrite than the microstructure at location 2 and 3. Microhardness test were conducted along the rib area near the outside surface and at

Fig. 44 Longitudinal cross-section of failed support rod from east span. Microstructure at location 1 in fig. 43. 500X. Etched.

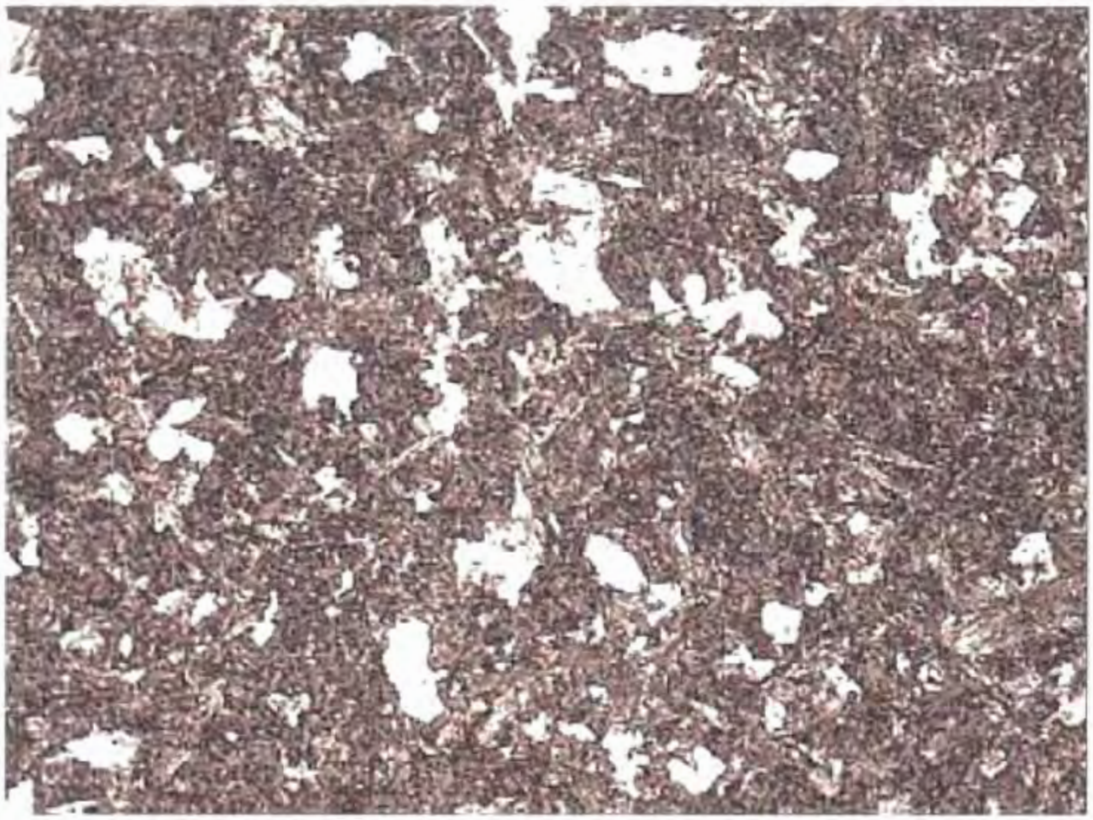
Fig. 45 Longitudinal cross-section of failed support rod from east span. Microstructure at location 2 in fig. 43. 500X. Etched.

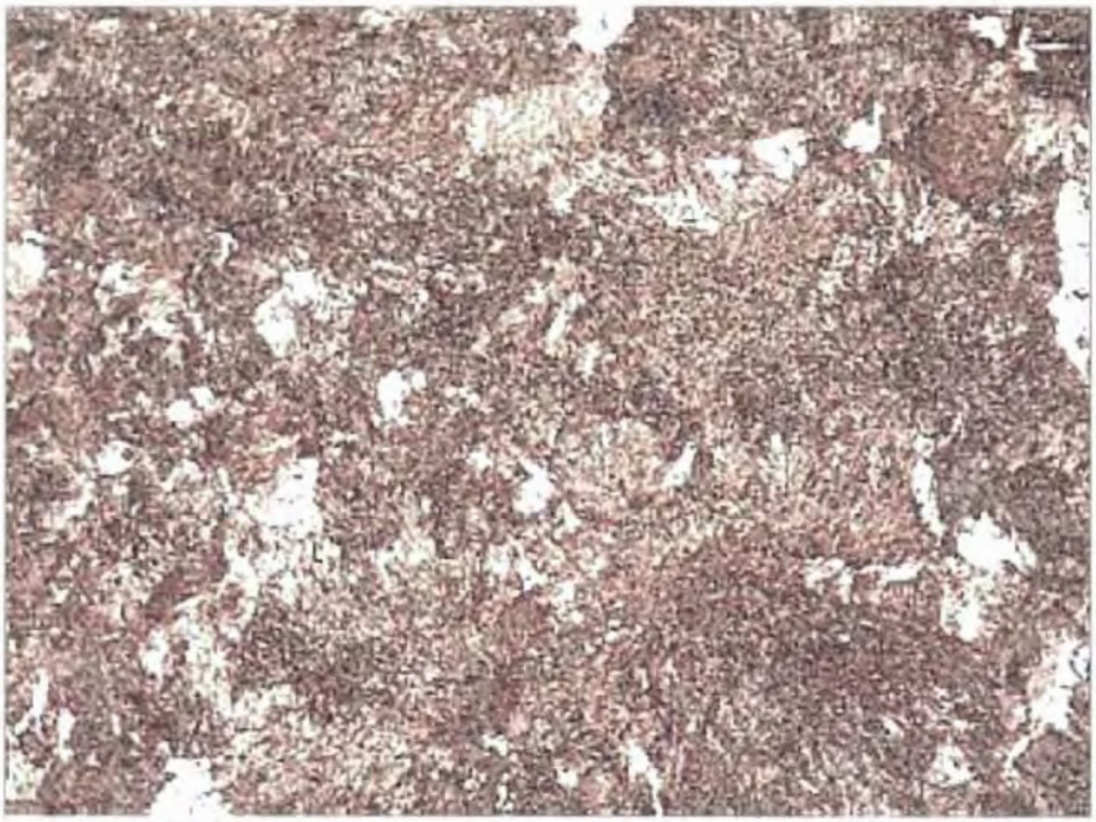
Fig. 46 Longitudinal cross-section of failed support rod from east span. Microstructure at location 3 in fig. 43. 500X. Etched.

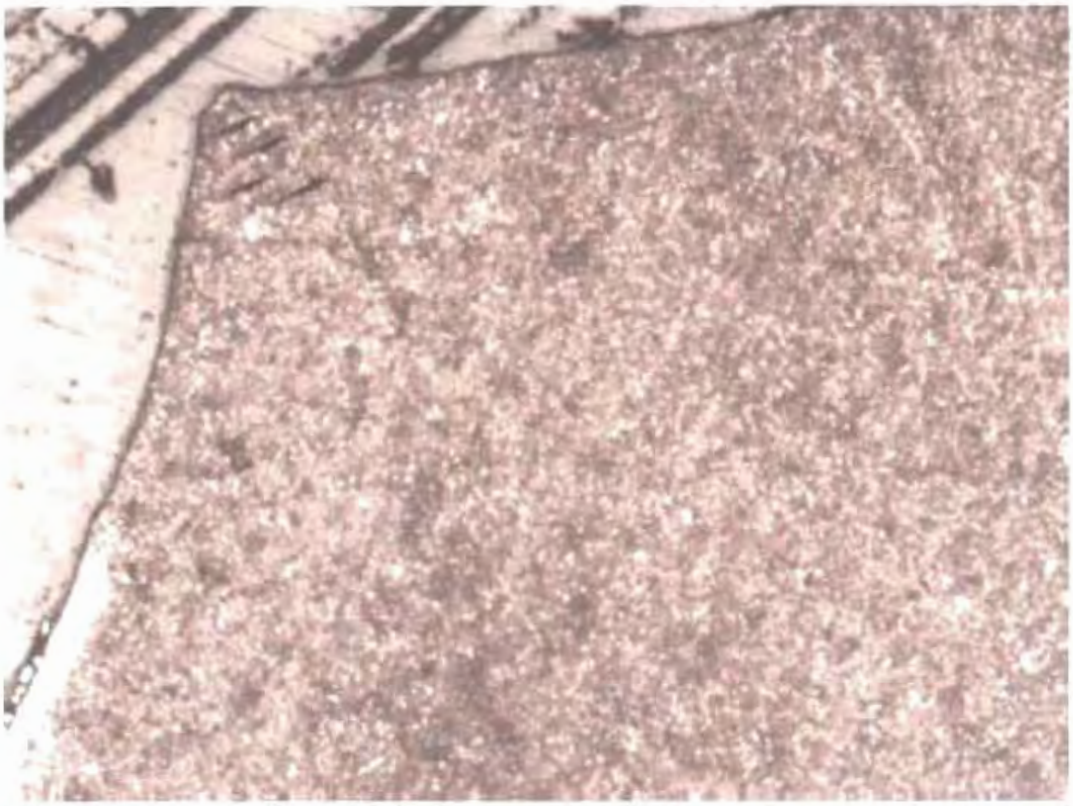
Fig. 49 Cross-section of failed support rod from east span at fracture origin in fig. 16. 50X. Etched.

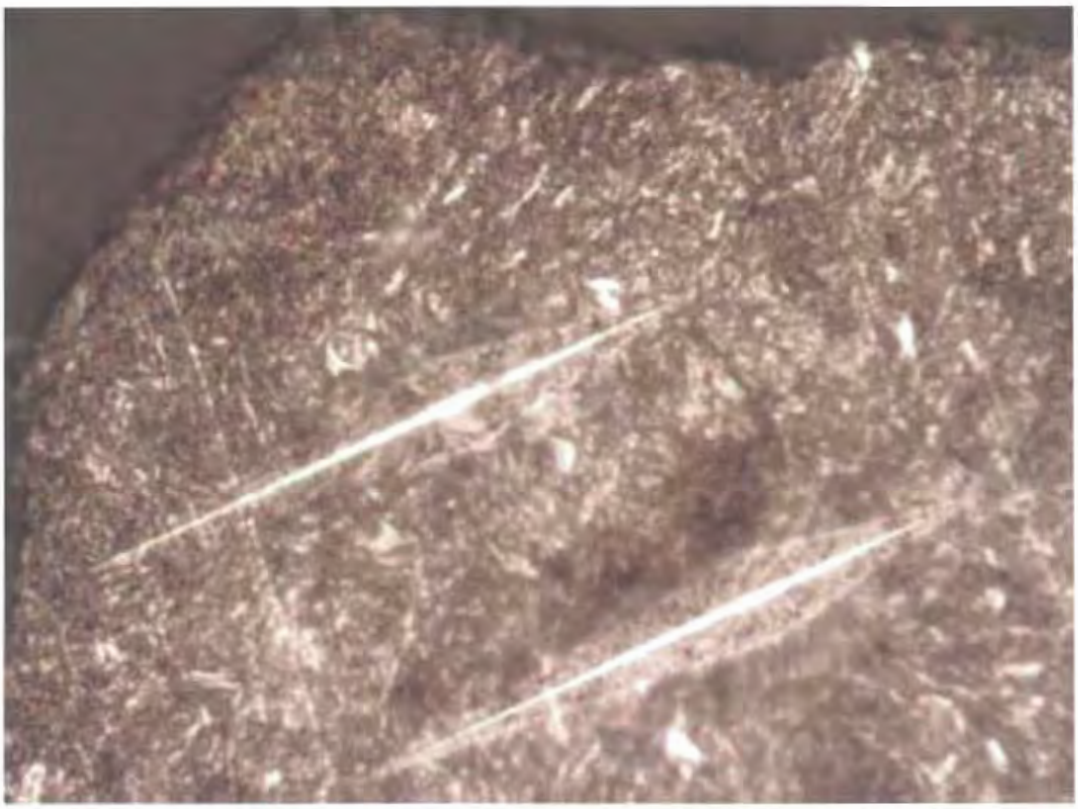
Fig. 50 Cross-section of failed support rod from east span at fracture origin in fig. 16. 500X. Etched.

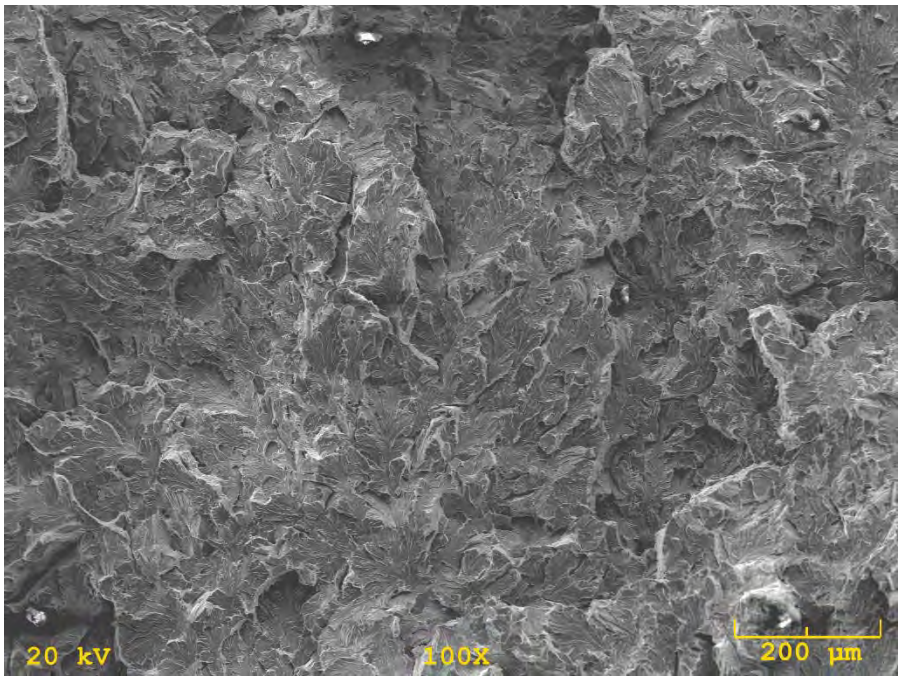
Fig 3

The appearance of the un-notched fracture face is shown in figure 1 and fracture face of the notched bar is shown in figure 2. The two fractures were placed in the Scanning Electron Microscope (SEM) and fracture mode determined. Figures 3, 4 and 5 illustrate the fracture mode in the un-notched bar and figures 6, 7, and 8 illustrate the fracture mode in the notched bar. In both cases the fracture mode was found to be cleavage as documented in SEM photographs. These results are exactly comparable to the overload portion of the fracture on the saddle bar that had the fatigue crack in it and which had broken on the bridge.
