REPORT NO. FHWA-CA-TL-78-15

EVALUATION OF COLD PLANERS FOR GRINDING PCC PAVEMENTS

FINAL REPORT

SEPT, 1978

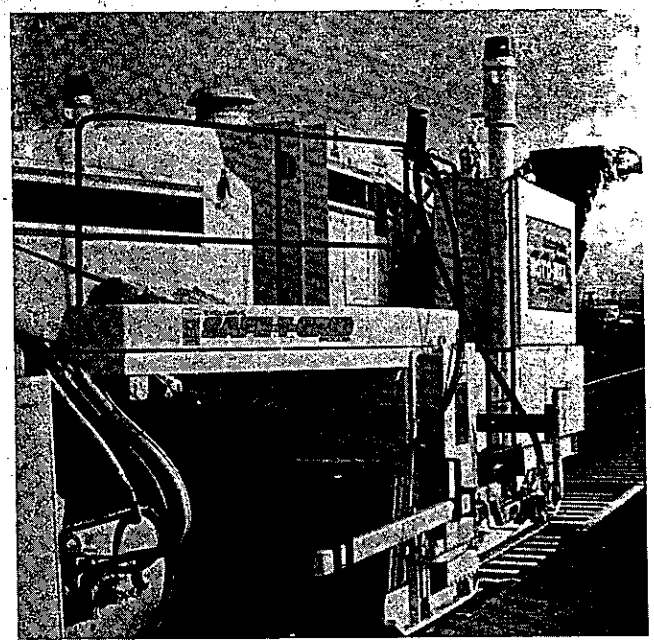
Fig. 1
PR 375 Rotomill

The equipment used by PR Systems was a CMI Rotomill PR-375 (see Figure 1) with a cutting head length of 9 ft 2 in. (2.8 m) which was equipped with new cutting points before the test began. The location was on the outside, or number 3 lane, of westbound I-80 at approximately Post Mile 4.0 in Yolo County. The pavement in this area was faulted only about 0.13 inch (3.3 mm) but was considered to be suitable for a fair trial of the equipment (see Figure 2).

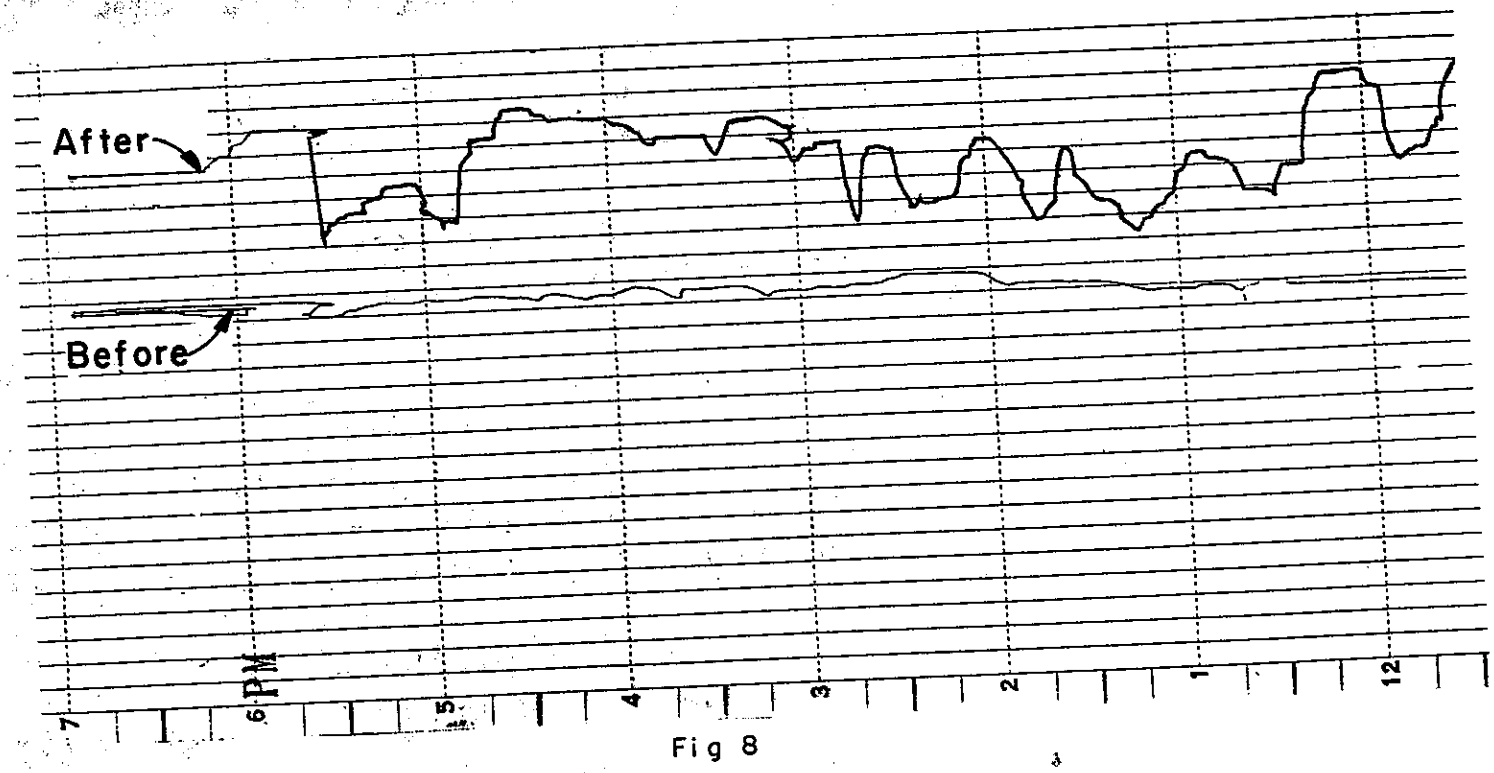
Fig 8

Figure 8 shows before and after transverse profiles of the texture made with a laboratory developed texture profilometer.

BEFORE AND AFTER TEXTURE PROFILES (TRANSVERSE)
CMI PROJECT
03-YOL-80-4.0

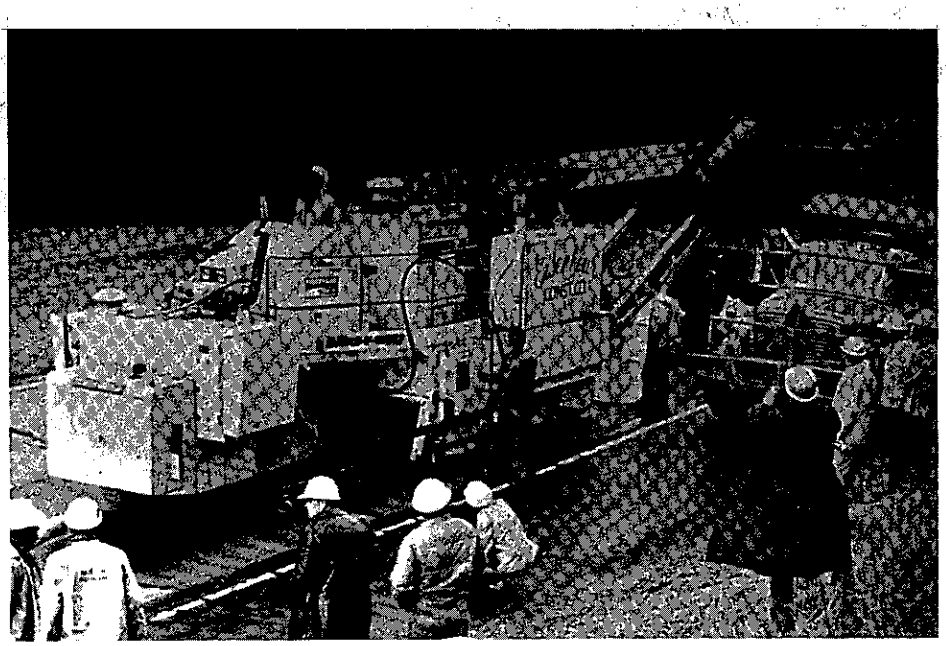
Fig. 9
PR-575 Rotomill

The equipment used on this project by Eisenhour was a CMI Rotomill PR-575 (see Figure 9). The cutting head was the same length as the other machine and was also equipped with new cutting points. Two locations were selected on northbound SR-101, one near Post Mile 62, the other near Post Mile 73, both in Santa Barbara County. Transverse joints on both sections were badly faulted (see Figure 10), averaging about 0.25 in. (6 mm) with some joints faulted about 0.4 in. (10 mm).

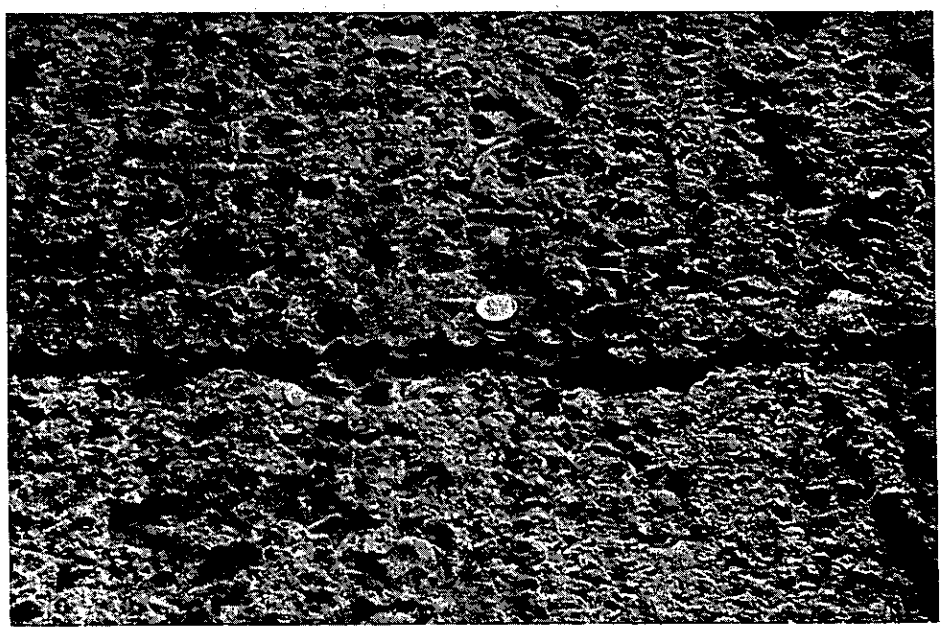
Fig. 11
Steel Joint Insert After Milling

strips placed to form weakened planes at every fourth joint (see Figure 11) did break off a few of the cutting tips. About 1200 lineal ft (366 m) of pavement (approximately full lane width) was milled.

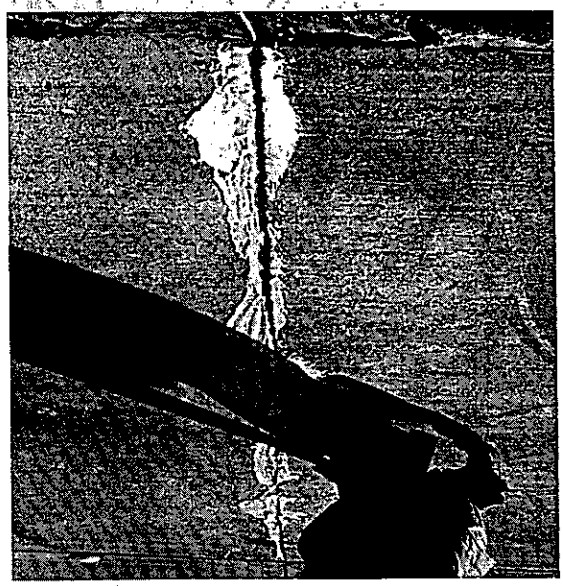
Results of the milling were approximately the same as the previous tests. While the filled joints show less damage than those unfilled, it is still considered that damage is too severe. Figures 14 through 21 show prepared joints and one random crack before and after milling. Figure 22 shows a diamond grinding operation, with no damage being incurred at the joint edges.

Fig. 15
Joint Filled With Casting Plaster

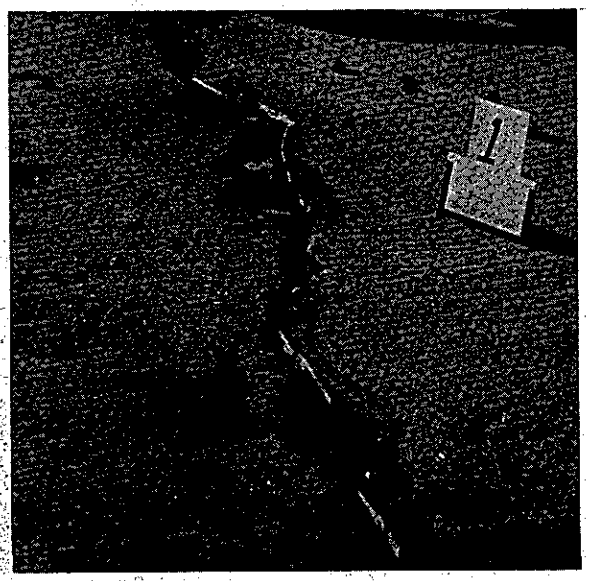
Fig. 16
Routed Random Crack

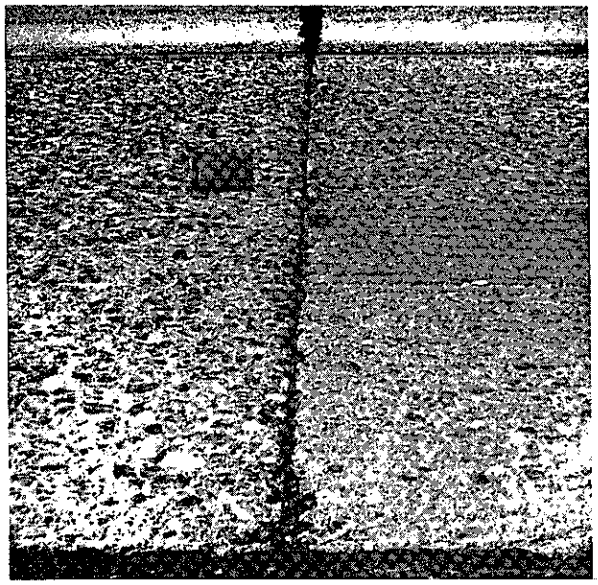
Fig. 19
Filled Joint After Milling

Unless an agency is willing to accept badly spalled joints, as shown in the pictures in this report, the cold planer, as represented by the CMI Rotomill, is not considered a satisfactory substitute for diamond blade grinding.
