Report No.
SSRP–2001/01

SEISMIC PERFORMANCE OF CIRCULAR HOLLOW COLUMNS SUBJECTED TO HIGH SHEAR

Final Report Submitted to Caltrans under Contract No. 59A0051

March 2001

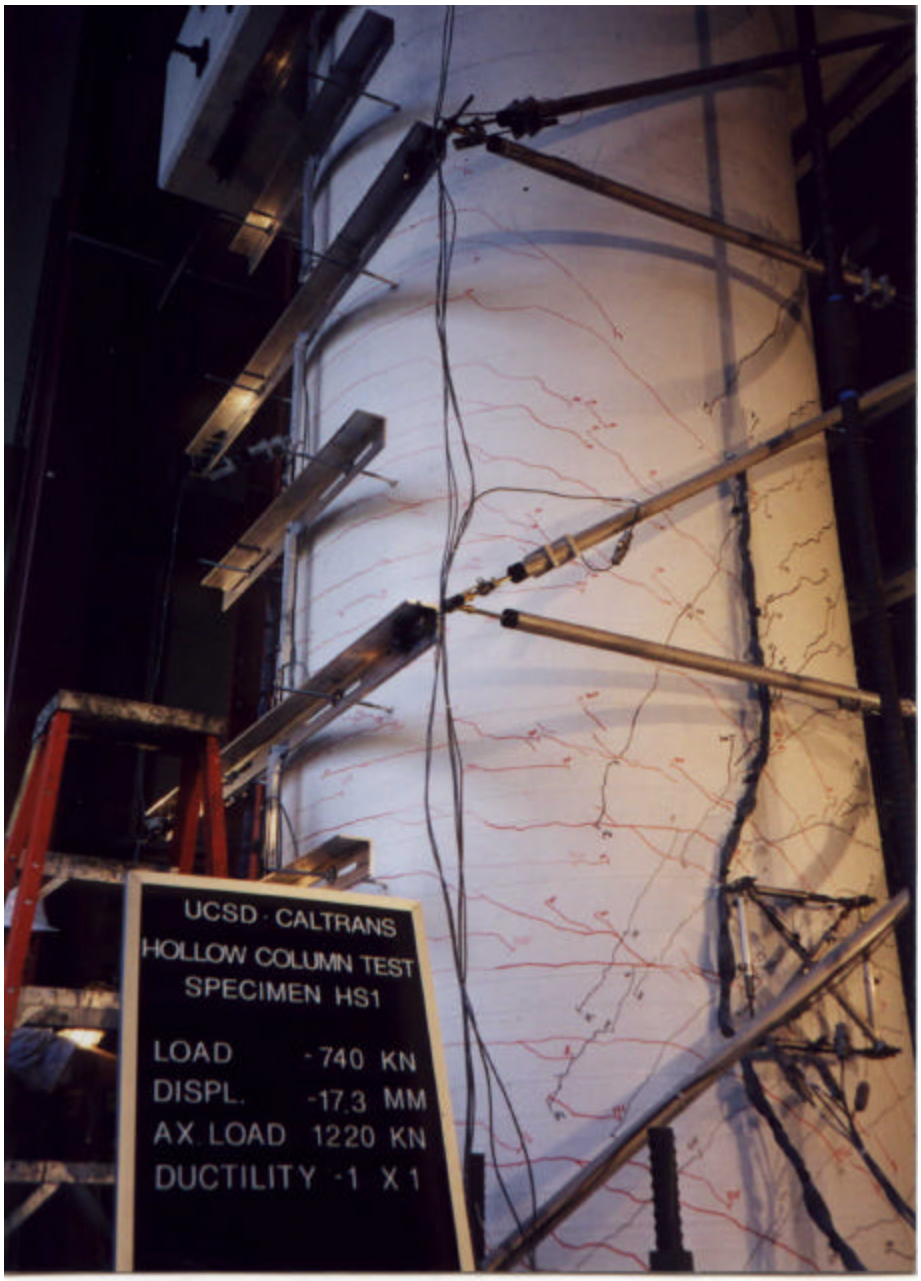
along the west and east generators ranged 0.45-0.65 mm. New shear and flexural cracks formed in the upper part of the column, up to a height of 2700 mm from the base. The new shear cracks had the same average inclination of approximately 35 degrees (see Figure 4.5 and Figure 4.6)

Figure 4.5 Unit HS1 Condition After 1 Cycle to $\mu_\Delta = 1$. (Side View)

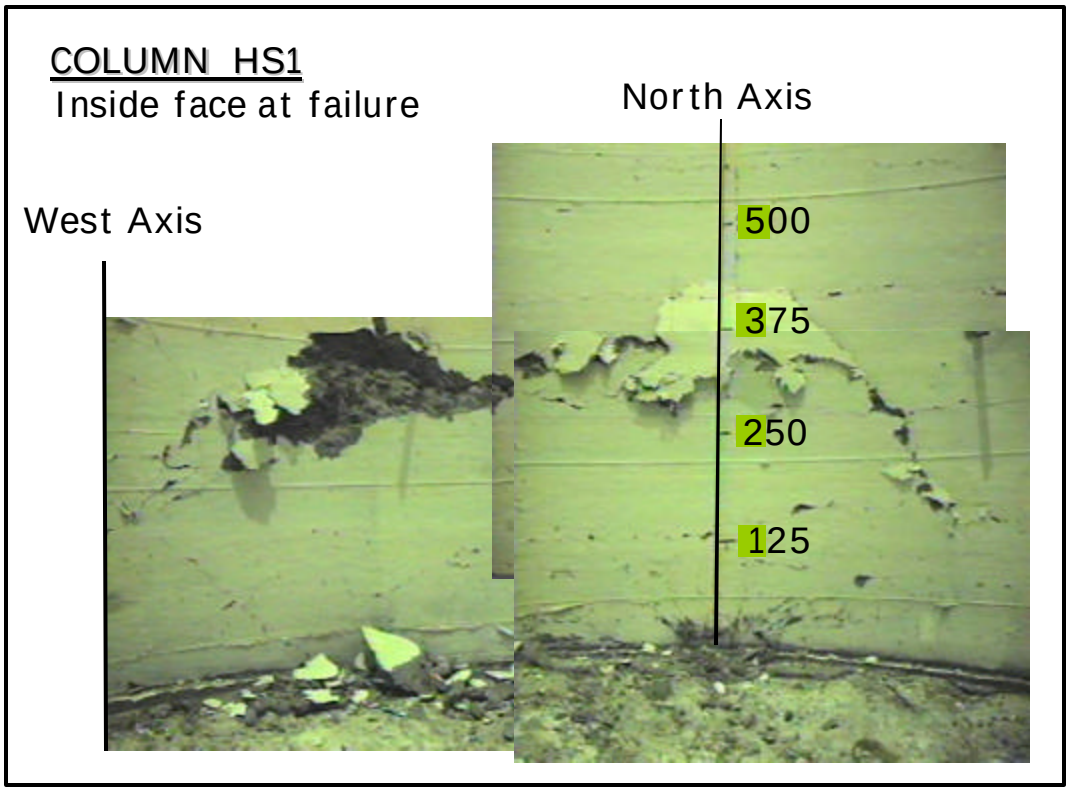
Figure 4.9 Unit HS1 – Composite Photo of Inside Face Spalling After 3 Cycles to $\mu_\Delta = 6$

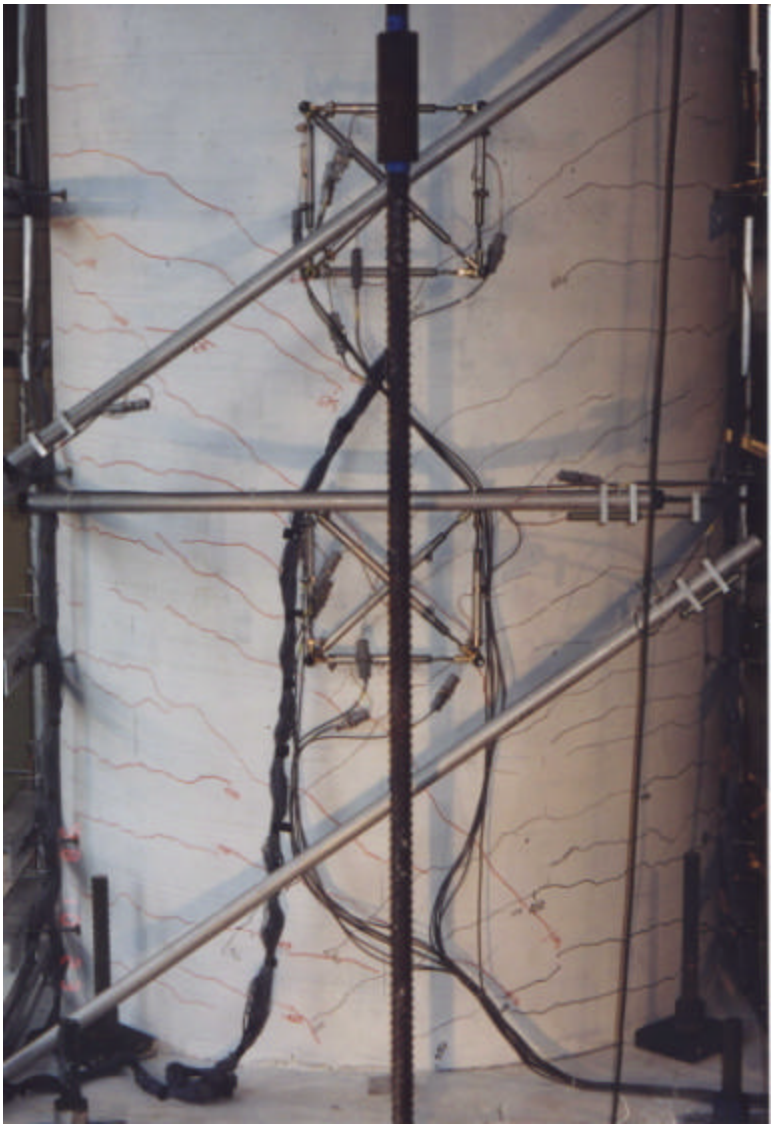
Figure 4.40 Unit HS2 Crack Pattern at 75% of First Yield (Side View)

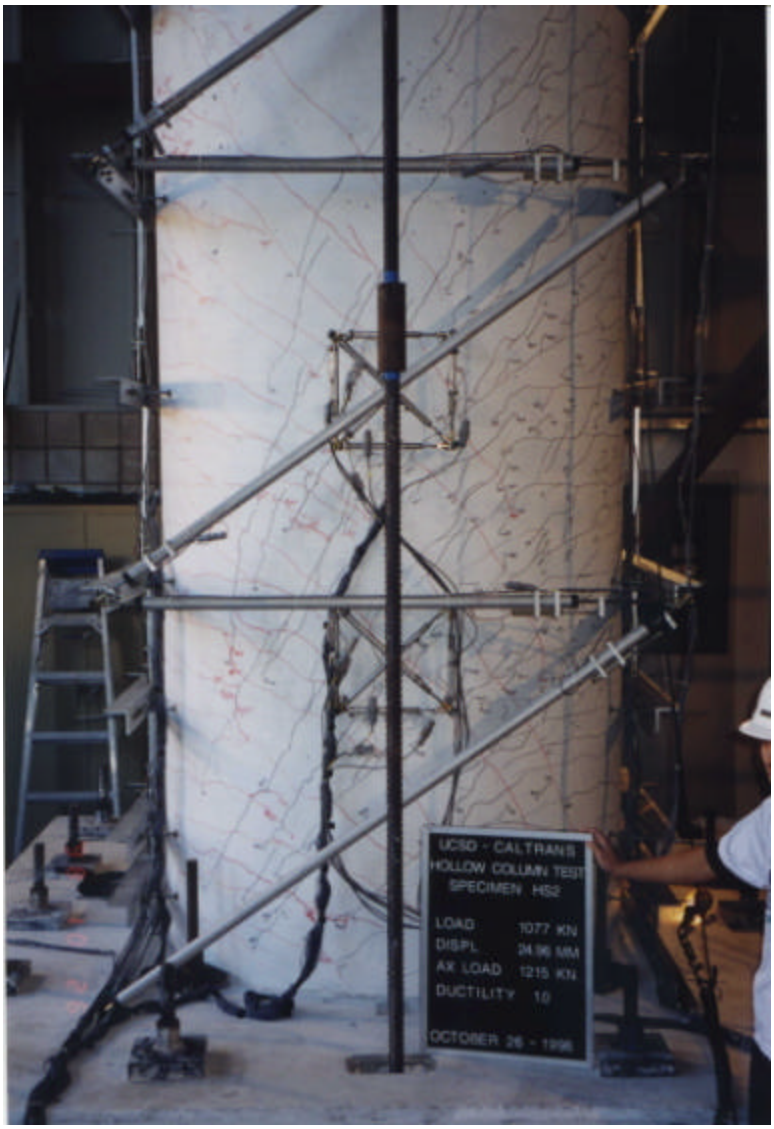
Figure 4.41 Unit HS2 Crack Pattern at Ductility 1 (Side View)

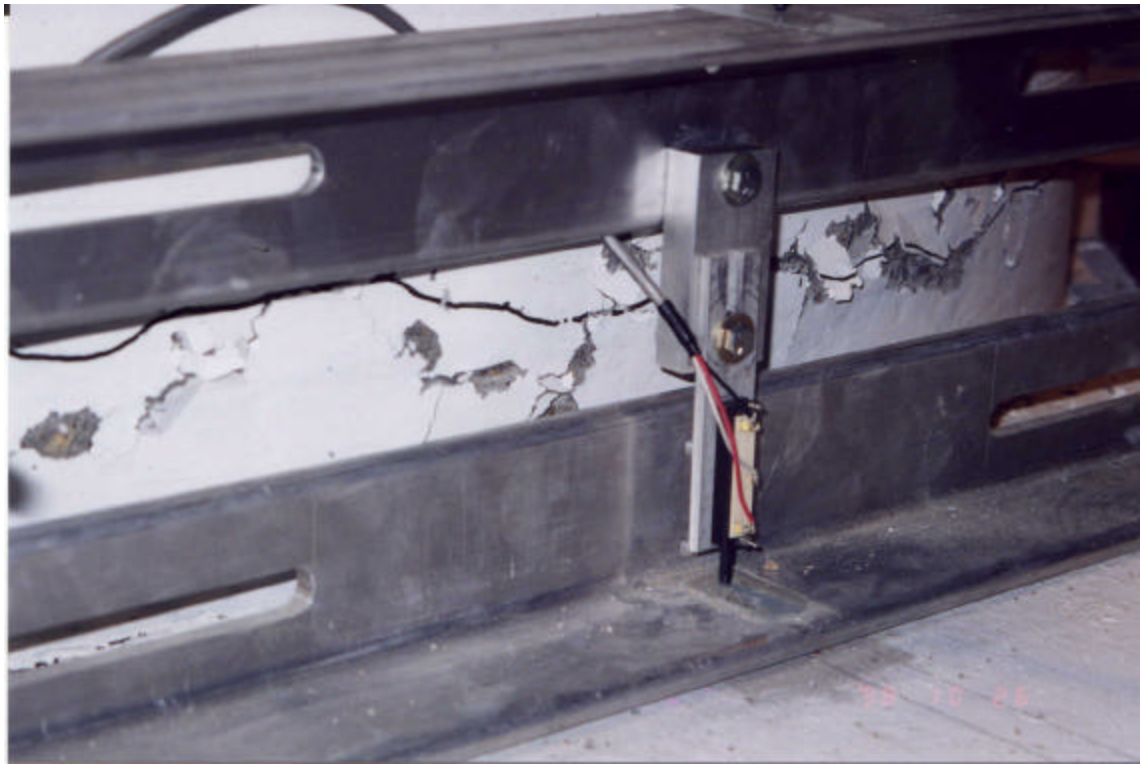
Concrete spalling occurred in the outside face (Figure 4.42) but no significant rebar buckling was observed. Strength degradation among the three cycles was limited to less than 10%. Strain in the transverse reinforcement reached a peak of 5300 $\mu\varepsilon$. At the column base, longitudinal strains in the vertical bars reached 1.4% in tension and 0.53% in compression, indicating a compression depth of at least 400mm.

Figure 4.42 Unit HS2 Concrete Spalling on Compression Zone, Outside Surface at μ_Δ = 2.0

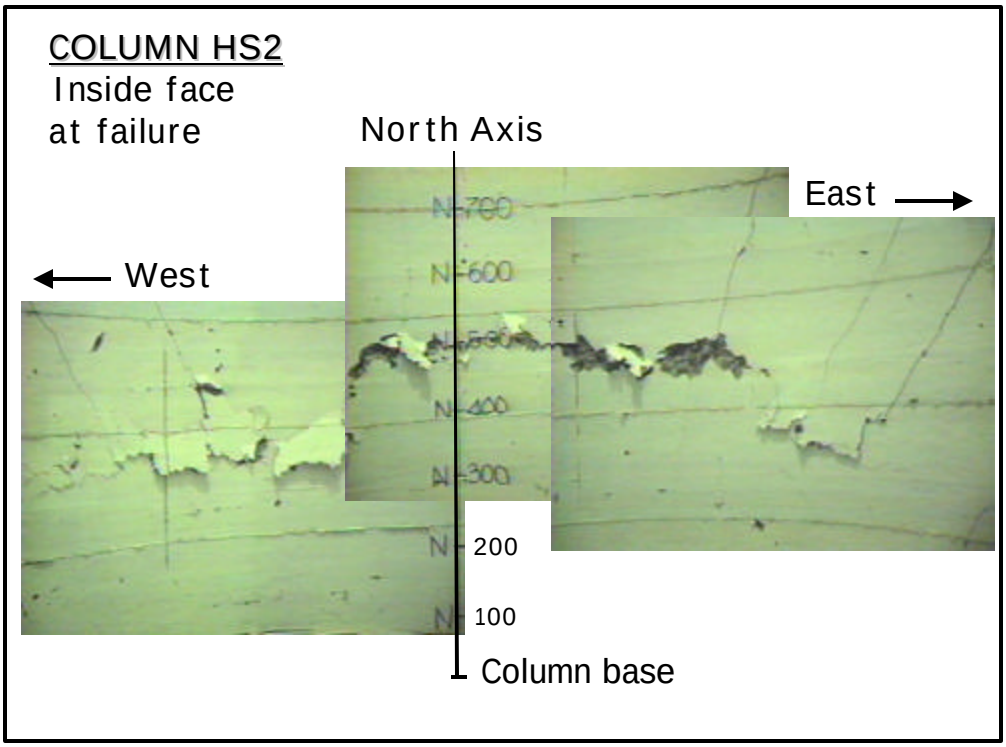
The subsequent cycle at ductility 3.0 caused longitudinal rebar buckling in the base region, where a reduced spacing of transverse reinforcement (35mm) had been adopted to prevent it. It has to be noted that rupture of transverse steel in the compression region (see Figure 4.44) did not occur exactly in the North and South direction, but in a location about 30 degrees away from it (symmetrically on both sides). This was probably due to the presence of large and steep inclined compressive concrete struts for shear. The same compressive struts are clearly visible from the inside shown in Figure 4.43.

Figure 4.43 Unit HS2 Spalling of Inside Surface of Compression Zone at $\mu_? = 3.0$, First Cycle

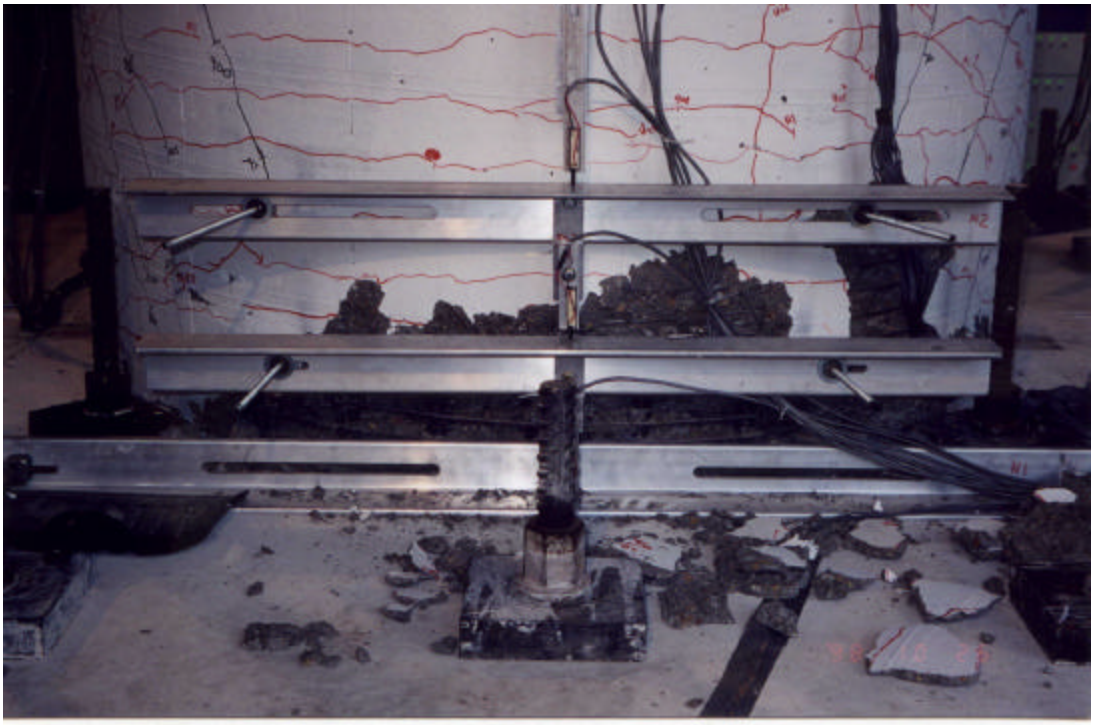
Figure 4.44 Unit HS2 Spalling and Crusing of Compression Zone, and Rebar Buckling, at $\mu_? = 3.0$, Second Cycle

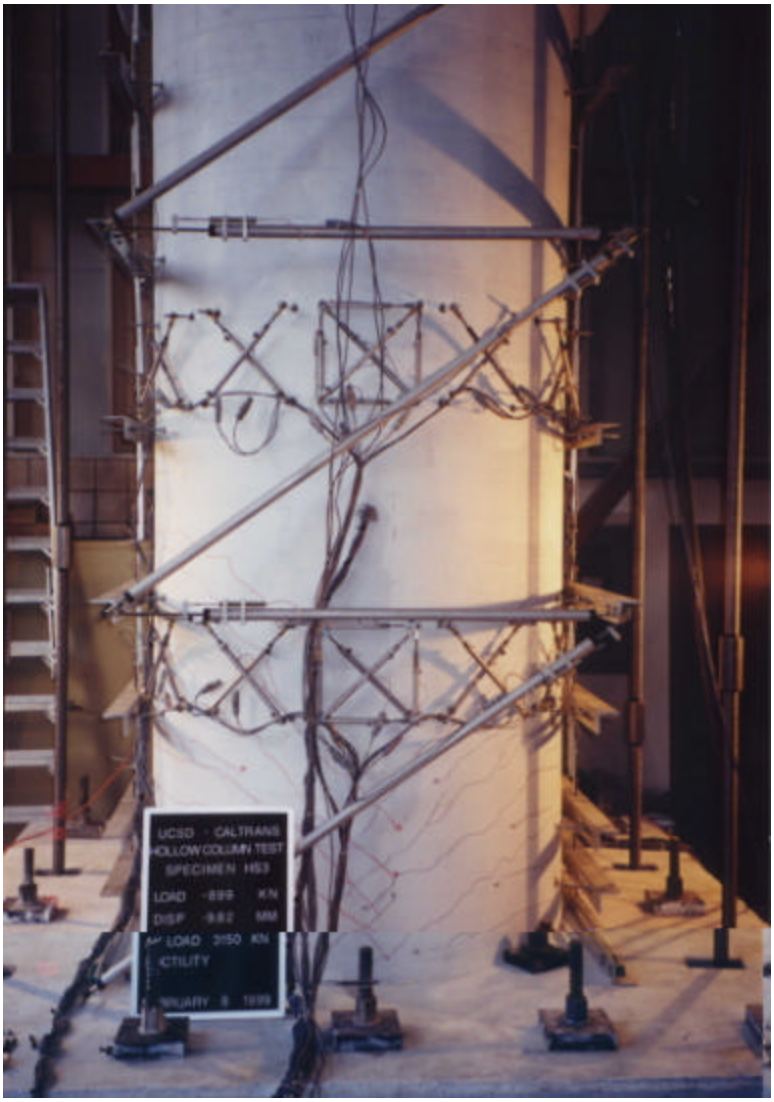
Figure 4.78 Unit HS3 Crack Pattern at 75% of First Yield (Side View)

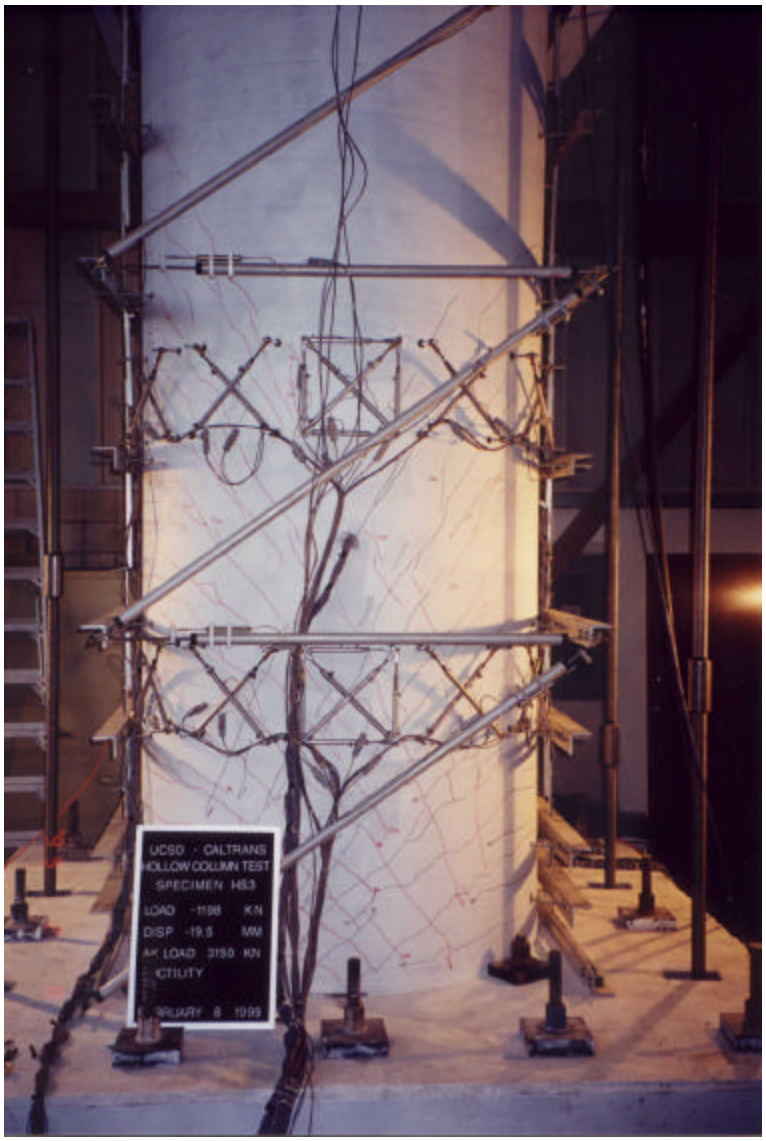
Figure 4.79 Unit HS3 Crack Pattern at First Yield (Side View)

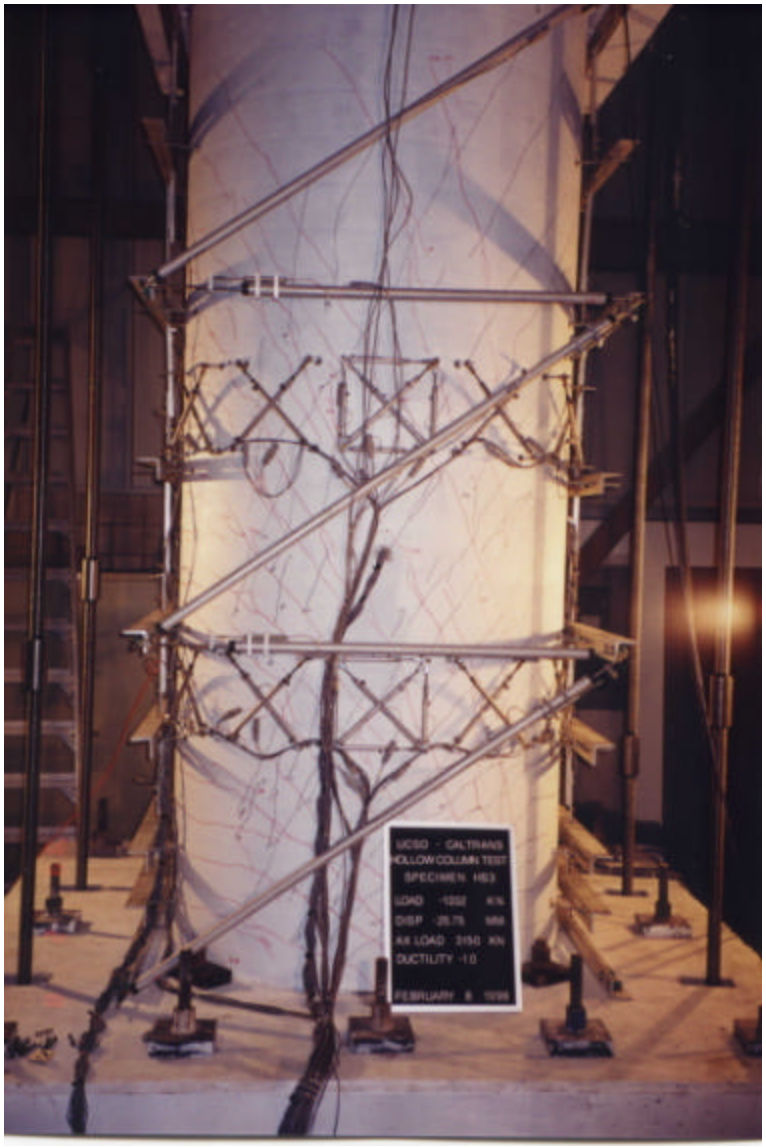
Figure 4.80 Unit HS3 Crack Pattern at Ductility 1 (Side View)

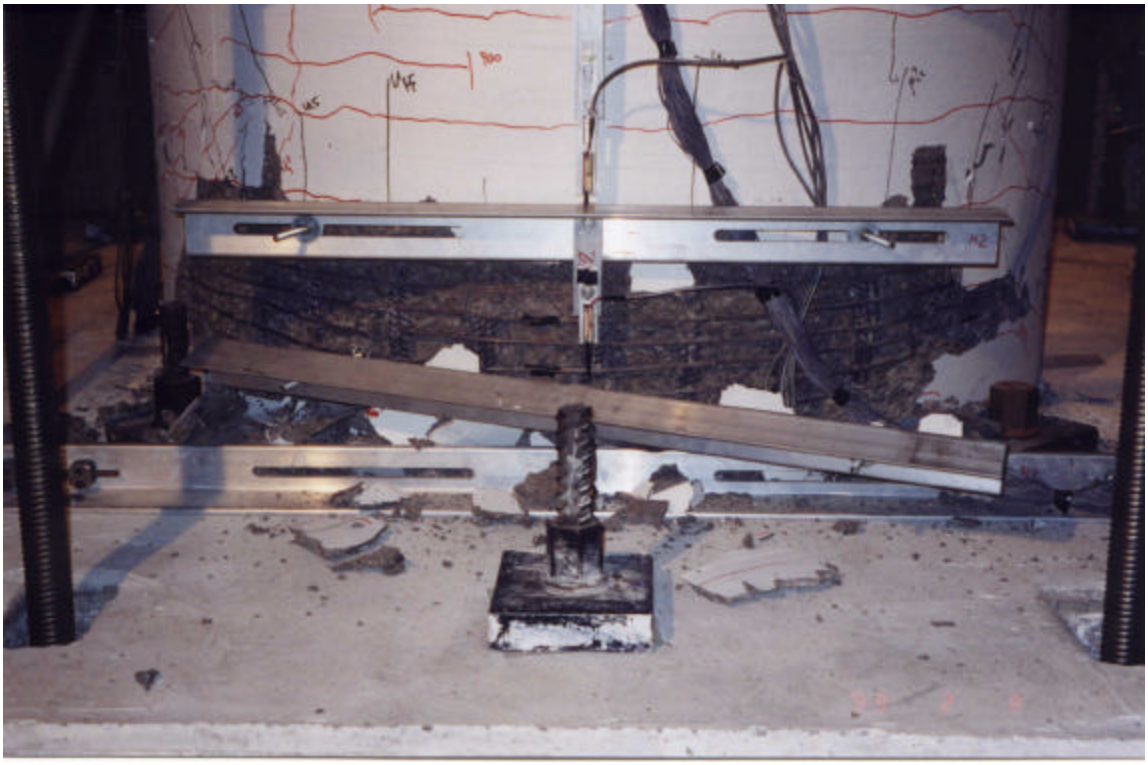
Figure 4.82 Unit HS3 Failure of Compression Zone at Ductility 2

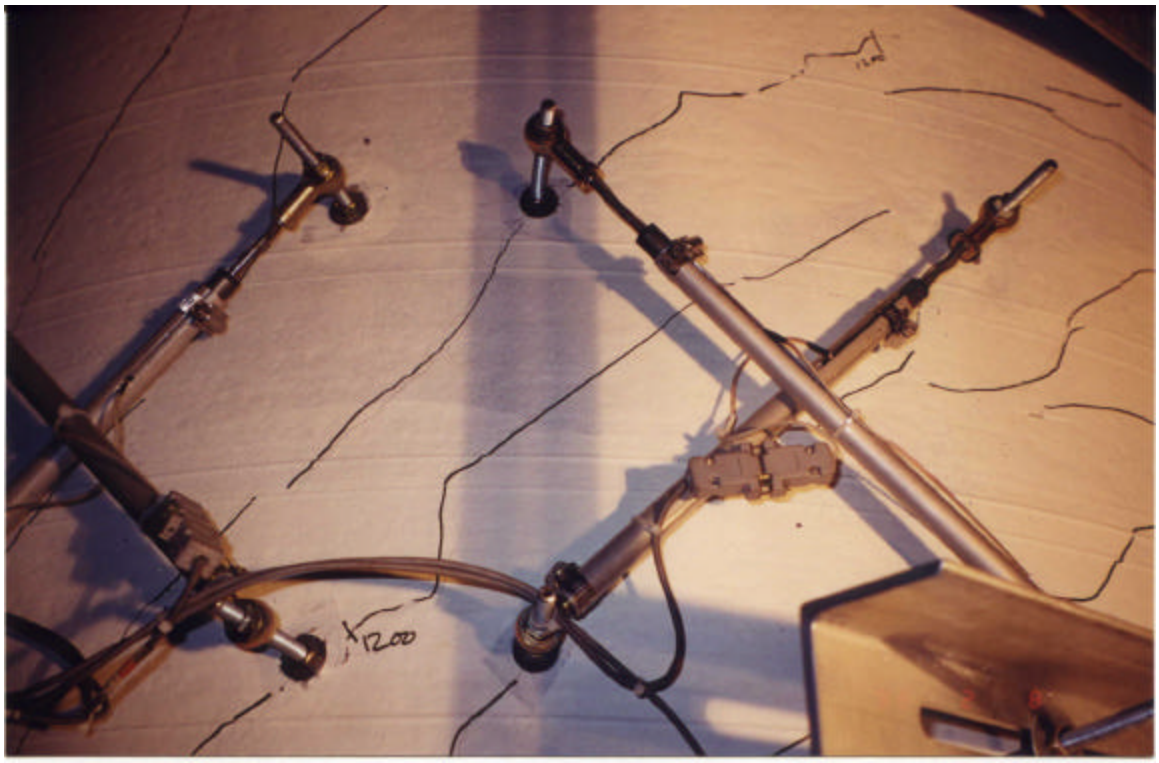
Figure 4.109 Crack Pattern in Small Instrumental Shear Panels
