Report No.
SSRP–2001/01

SEISMIC PERFORMANCE OF CIRCULAR HOLLOW COLUMNS SUBJECTED TO HIGH SHEAR

GIULIO RANZO
M.J. N. PRIESTLEY

March 2001

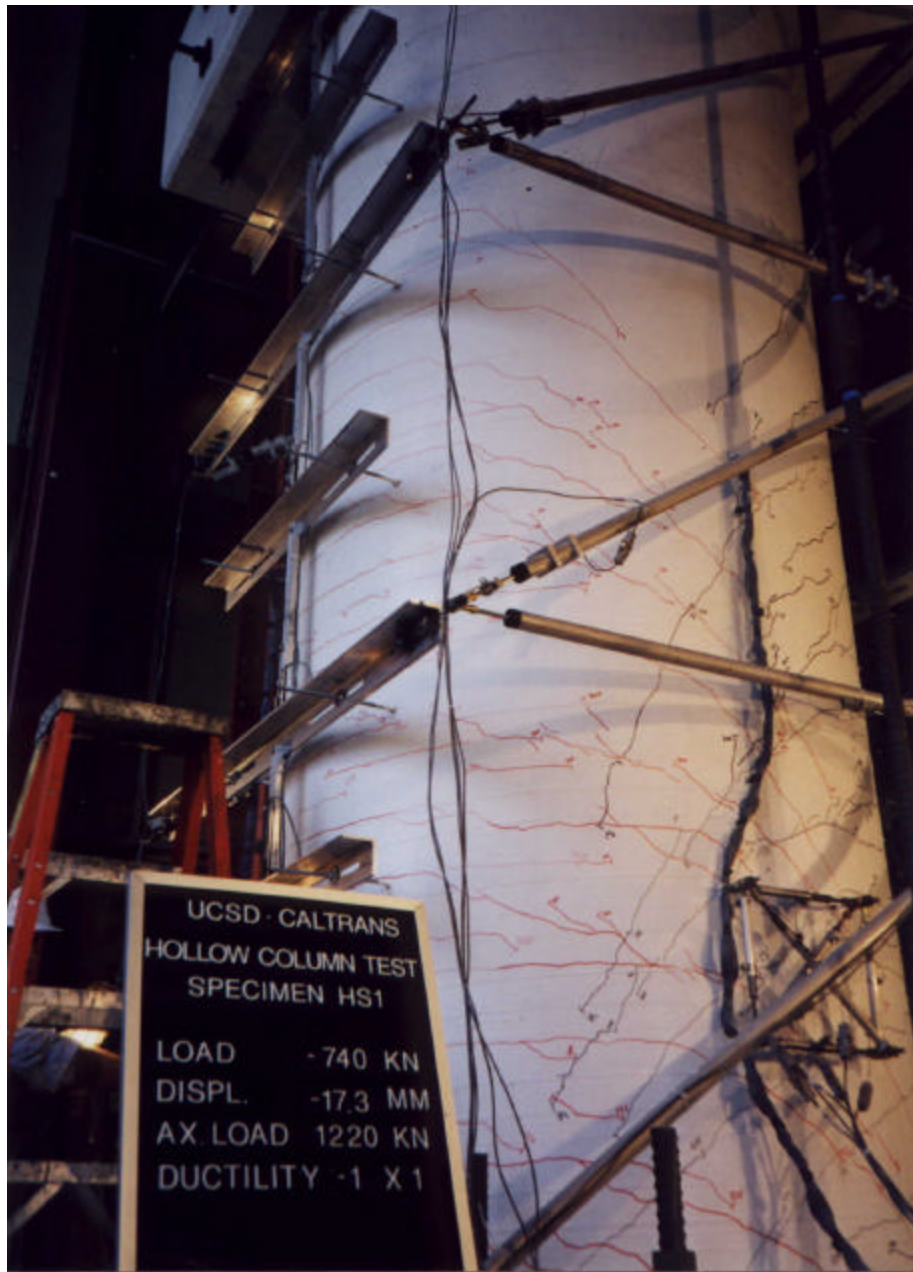
along the west and east generators ranged 0.45-0.65 mm. New shear and flexural cracks formed in the upper part of the column, up to a height of 2700 mm from the base. The new shear cracks had the same average inclination of approximately 35 degrees (see Figure 4.5 and Figure 4.6)

Figure 4.5 Unit HS1 Condition After 1 Cycle to $\mu_\Delta = 1$. (Side View)

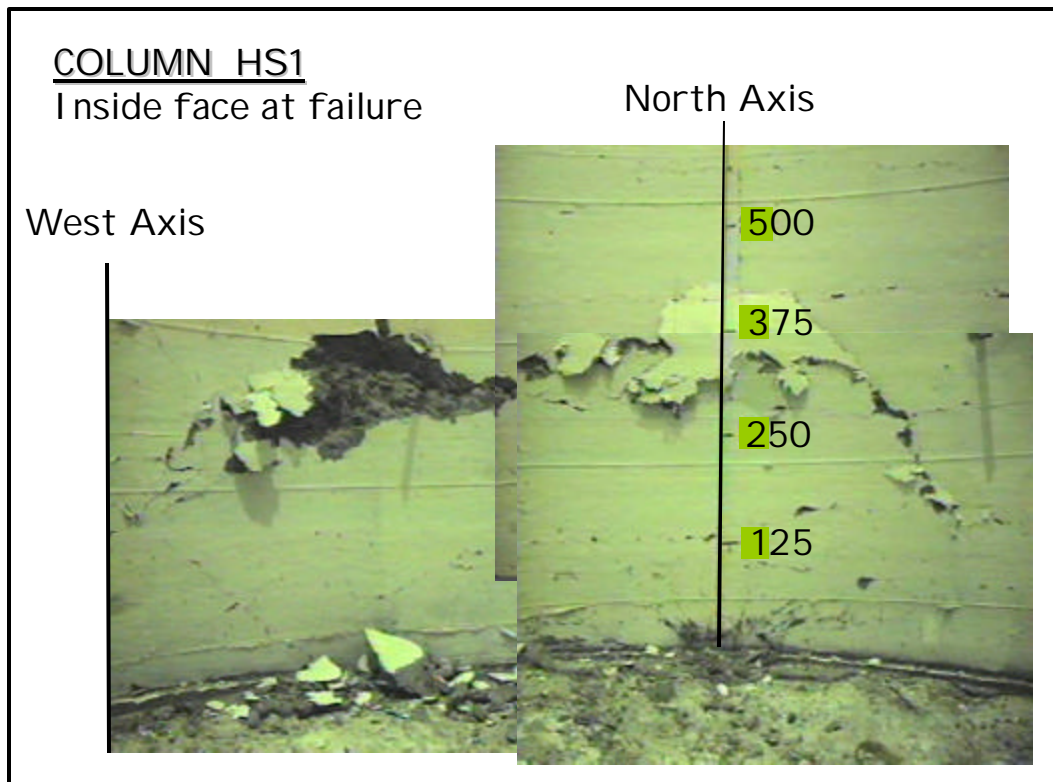
Figure 4.9 Unit HS1 – Composite Photo of Inside Face Spalling After 3 Cycles to $\mu_\Delta = 6$

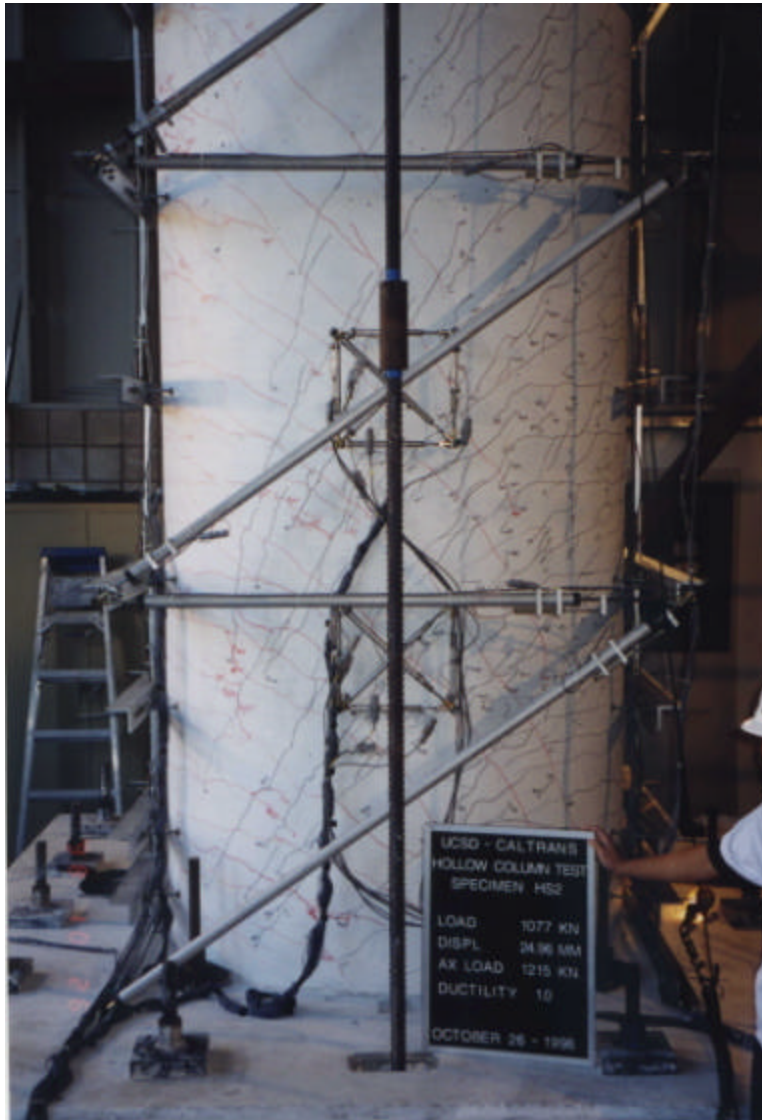
Figure 4.41 Unit HS2 Crack Pattern at Ductility 1 (Side View)

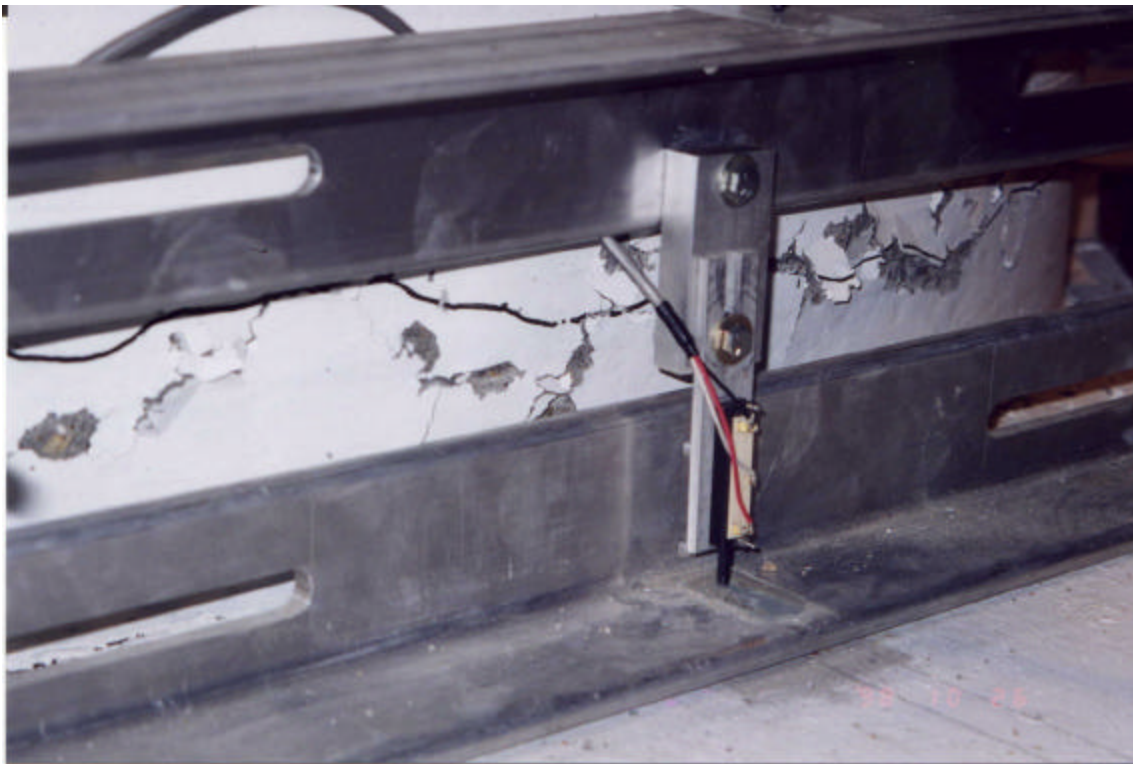
Concrete spalling occurred in the outside face (Figure 4.42) but no significant rebar buckling was observed. Strength degradation among the three cycles was limited to less than 10%. Strain in the transverse reinforcement reached a peak of 5300 $\mu\varepsilon$. At the column base, longitudinal strains in the vertical bars reached 1.4% in tension and 0.53% in compression, indicating a compression depth of at least 400mm.

Figure 4.42 Unit HS2 Concrete Spalling on Compression Zone, Outside Surface at $\mu_\Delta =$ 2.0

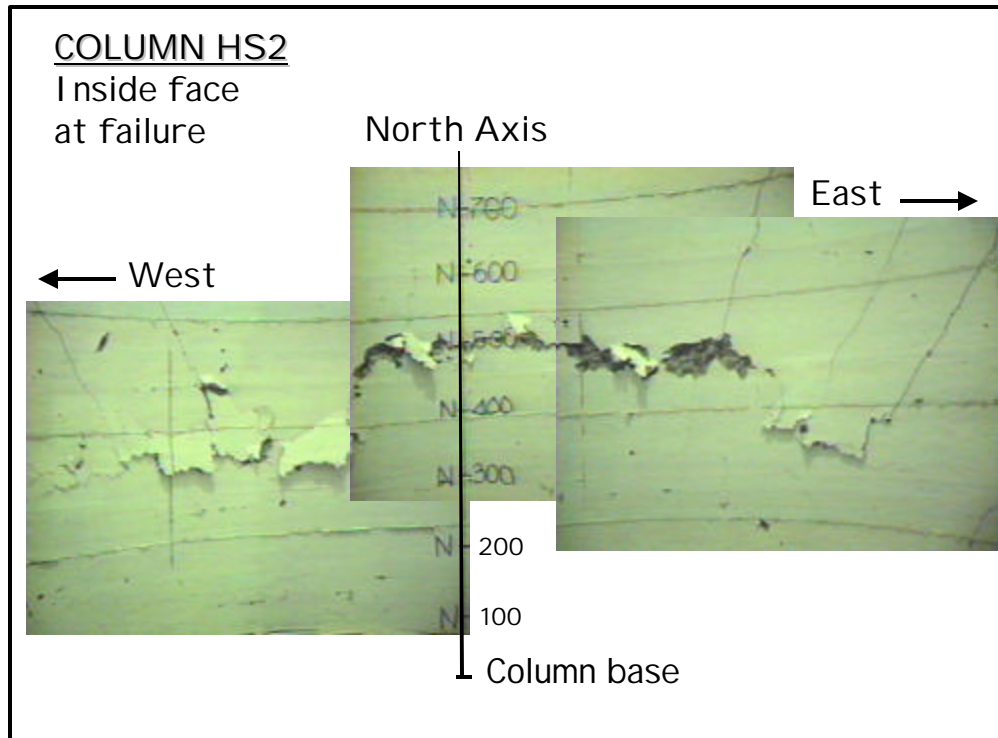
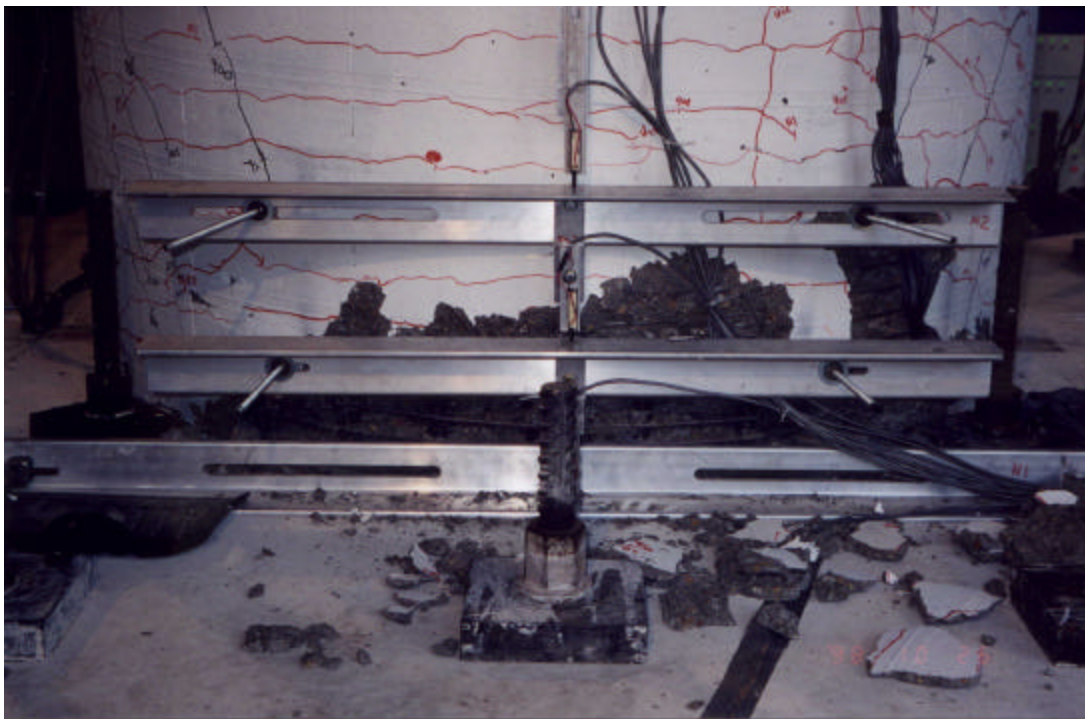
The subsequent cycle at ductility 3.0 caused longitudinal rebar buckling in the base region, where a reduced spacing of transverse reinforcement (35mm) had been adopted to prevent it. It has to be noted that rupture of transverse steel in the compression region (see Figure 4.44) did not occur exactly in the North and South direction, but in a location about 30 degrees away from it (symmetrically on both sides). This was probably due to the presence of large and steep inclined compressive concrete struts for shear. The same compressive struts are clearly visible from the inside shown in Figure 4.43.

Figure 4.43 Unit HS2 Spalling of Inside Surface of Compression Zone at $\mu_? = 3.0$, First Cycle

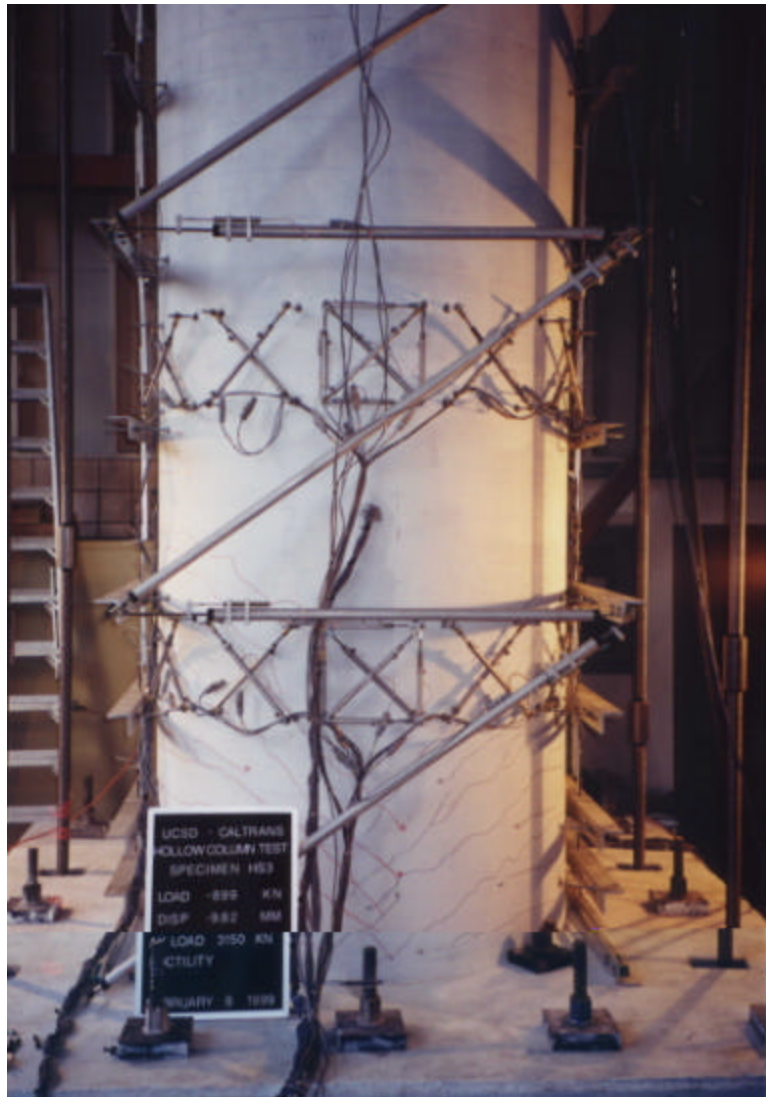
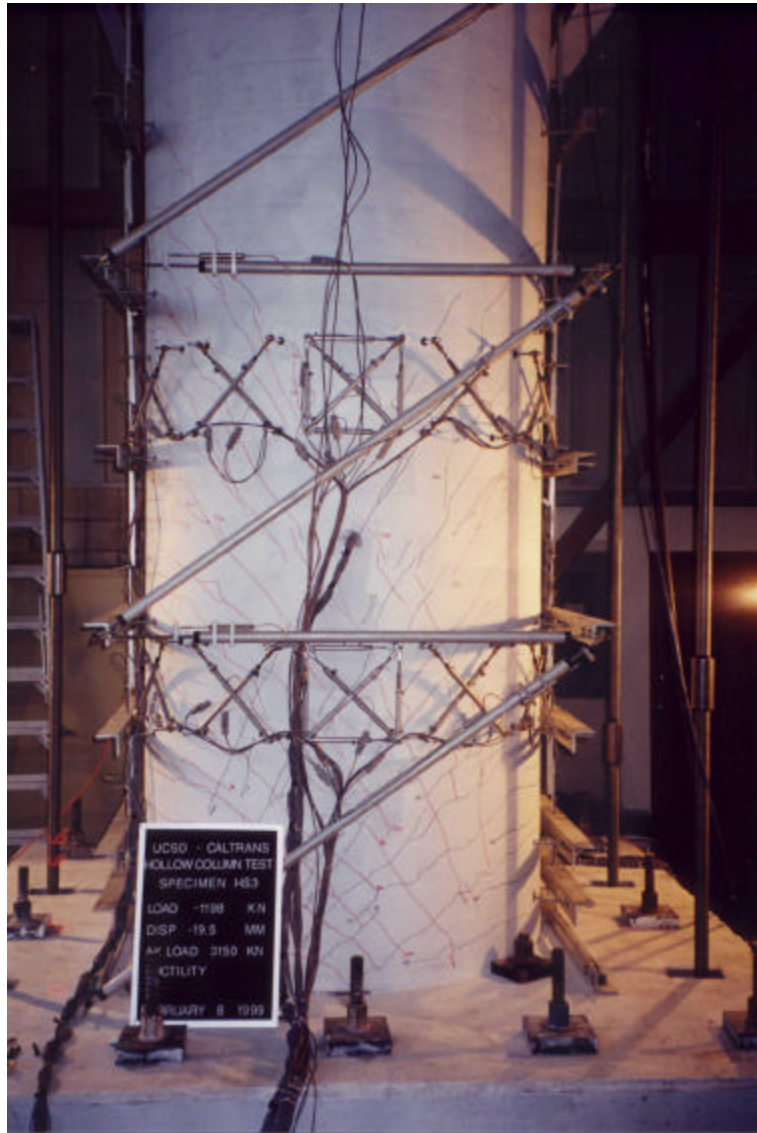
Figure 4.78 Unit HS3 Crack Pattern at 75% of First Yield (Side View)

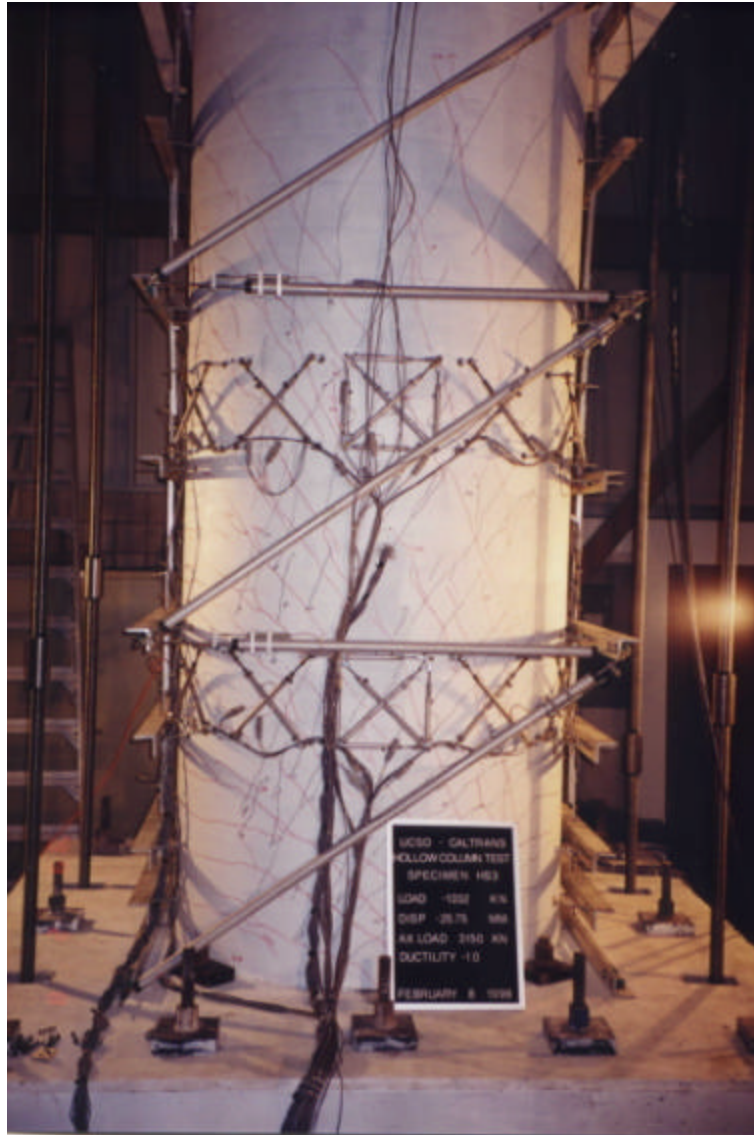
Figure 4.80 Unit HS3 Crack Pattern at Ductility 1 (Side View)

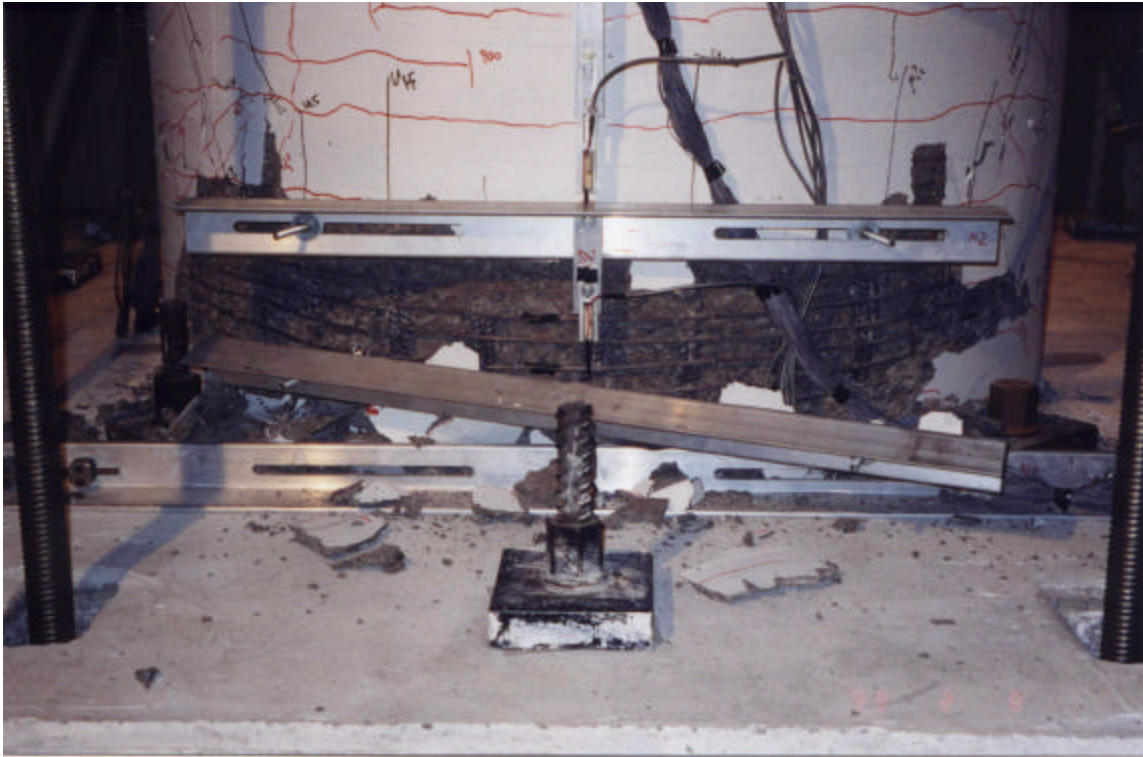
spalling in the inside face occurred at approximately 400mm from the base. A similar behavior was found in the pull direction at ductility 2.0, with a drop in strength of 60%. A similar pattern of concrete spalling and rebar buckling was observed. At this point, the axial load was removed and the test was terminated.

Figure 4.81 Unit HS3 Spiral Bar Fracture at Ductility 2

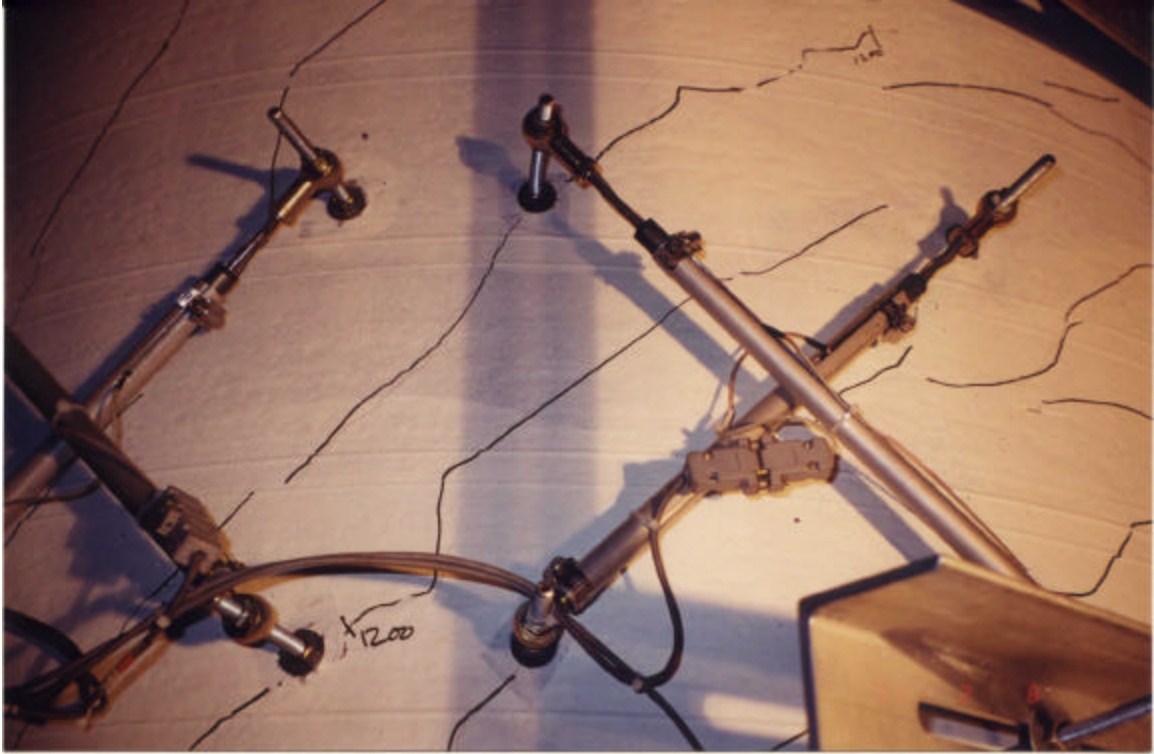
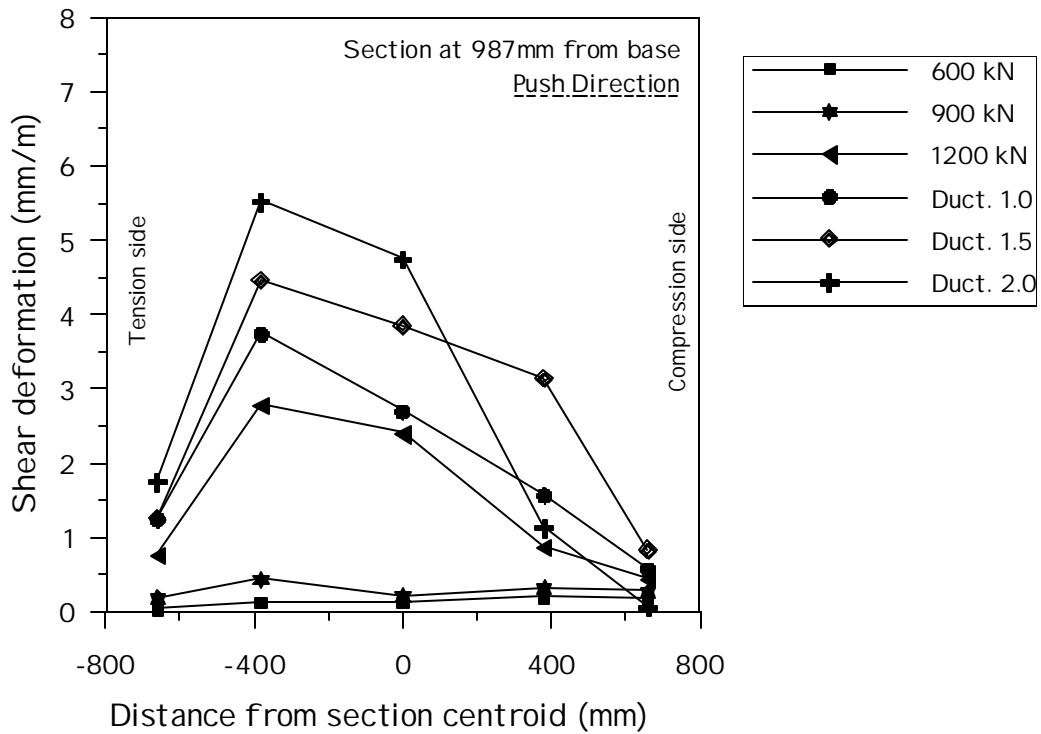
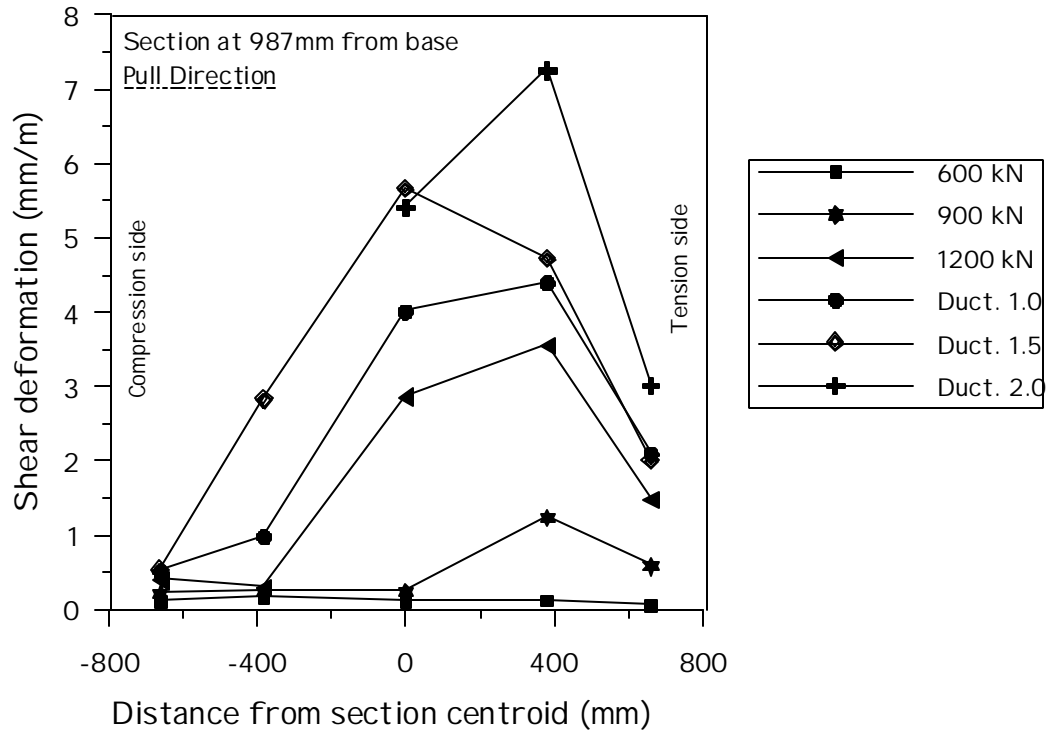
Figure 4.109 Crack Pattern in Small Instrumental Shear Panels
