Report No.
SSRP–06/11

THE ASSESSMENT OF ASPECTS RELATED TO DEFECT CRITICALITY IN CFRP STRENGTHENED CONCRETE FLEXURAL MEMBERS

Final Report Submitted to the California Department of Transportation Under Contract No. 59A0337.

May 2006

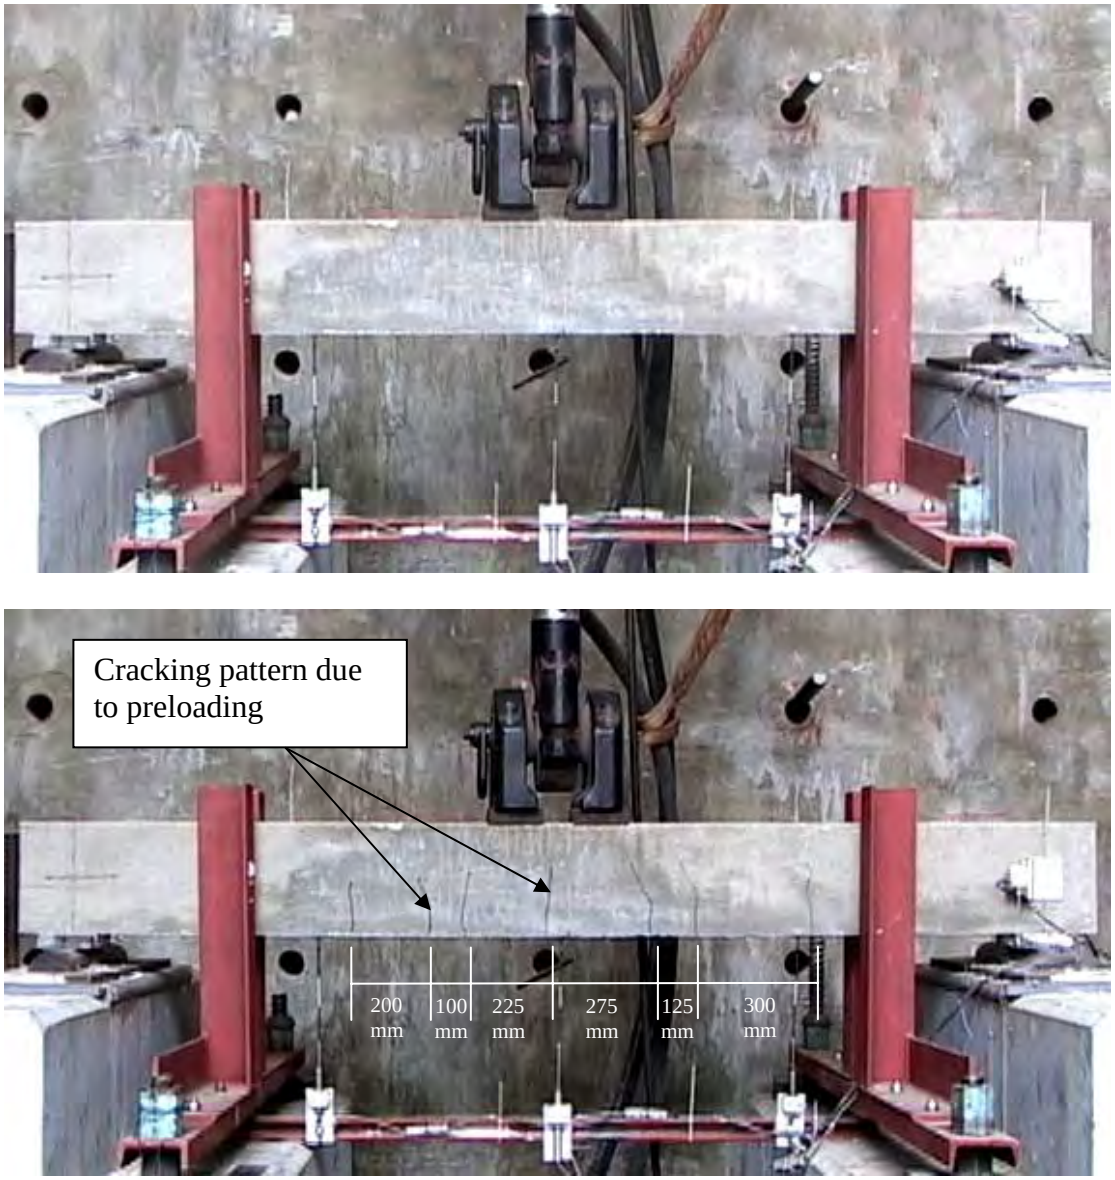
Figure 2-16: Picture before preloading and after preloading to 35.6kN.

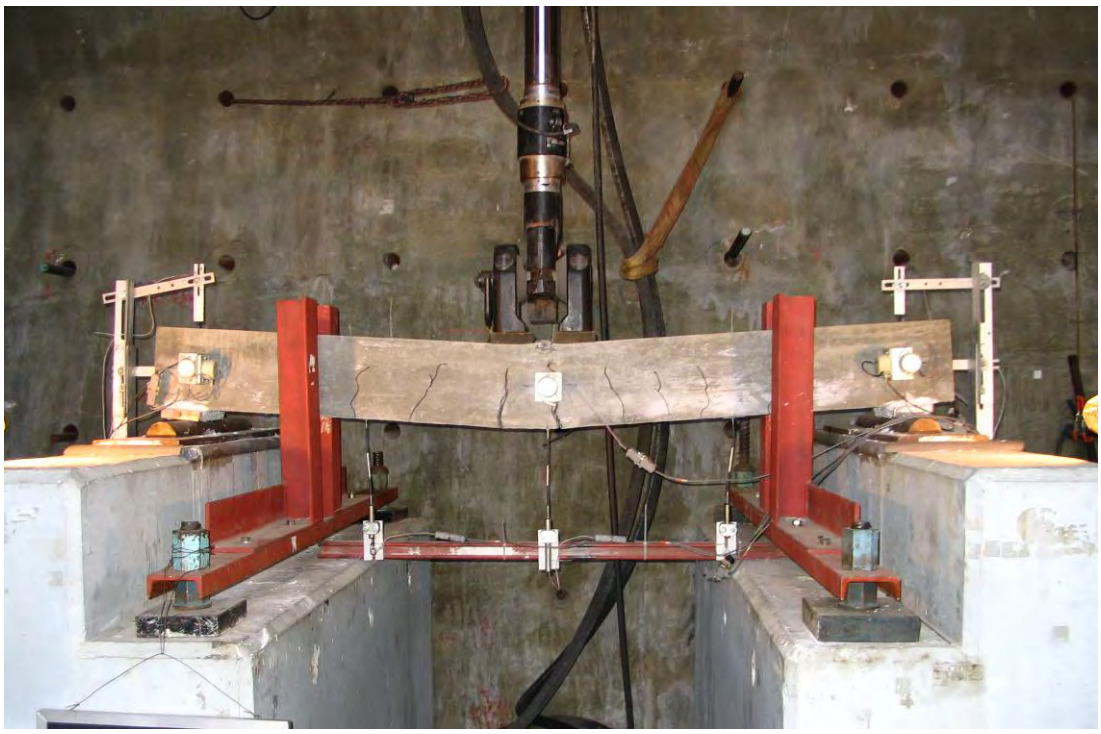
Figure 4-2: Typical failed unstrengthened control specimen.

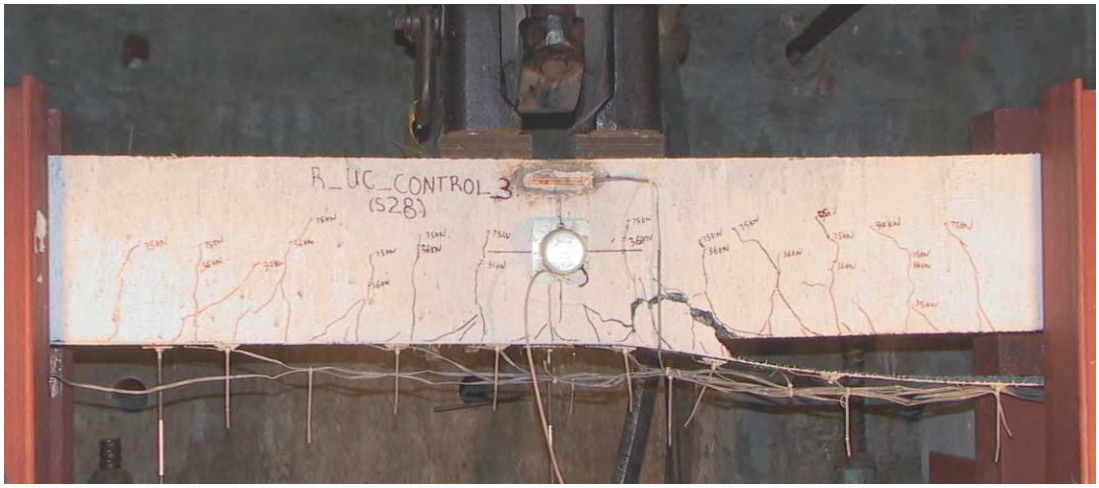
This subset of specimens consisted of four beams that had been strengthened with two layers of FRP material applied to the tension face of the beam (as described in Sections 2.5 and 2.9), but were not preloaded prior to the application of composite. Figure 4-3 is a picture of the crack pattern and debonding failure of a typical non-preloaded, strengthened beam. The non-preloaded, strengthened beam results in a relatively small, uniform crack spacing compared to the beams that are first preloaded before the application of FRP (as can be seen in Figure 4-3). A representative load-displacement curve can be seen in Figure 4-5. Figure 4-5 is a plot of typical control specimens of each of the three types described in this section. The specimens chosen in this plot and many of the plots in this section are representative specimens for a group of specimens, which will be explained further in the text for each section. Performance changes due to the application of FRP are easily noted in this figure where the non-precracked, strengthened beam reached an average ultimate load of 93.9kN compared to an average of 54.2kN ultimate load by the unstrengthened beam in conjunction with a greater initial stiffness. Figure 4-6 is a plot of the midspan steel

Figure 4-3: Crack pattern and debonding failure of a typical non-preloaded, strengthened beam.

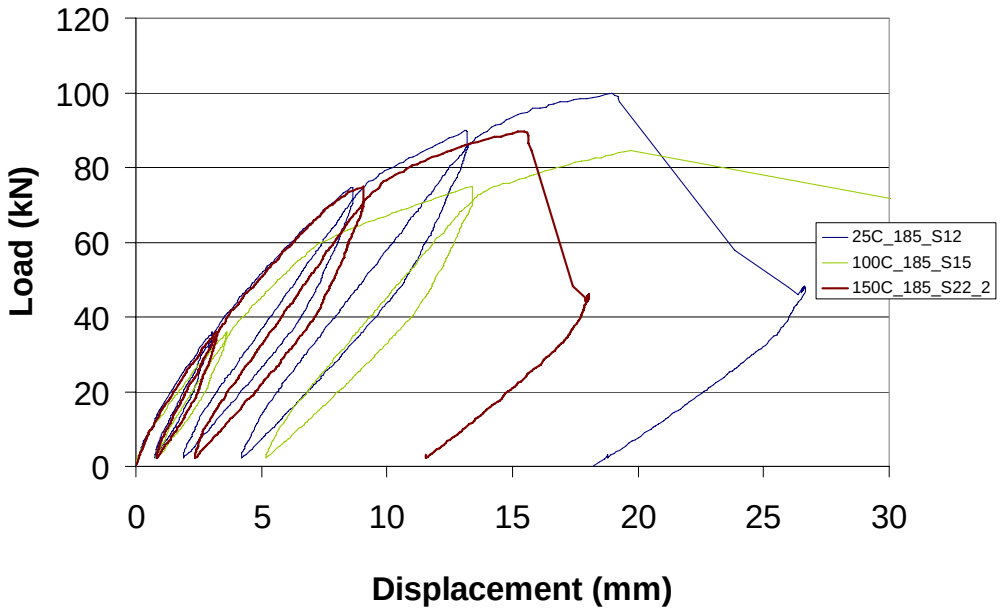
When considering the load vs. midspan displacement plots for this group of specimens, three different trends are evident: 1)beams that fail at a high load and a high displacement; 2) beams that fail at a relatively lower load and a lower displacement; and 3) those that fail at a low load, but a high displacement. Figure 4-12 is a plot containing a curve that represents each of these three behaviors. These three curves each represent a different failure mode observed during testing of this specimen set. These failure modes are “deep concrete, steel”, “thick concrete bondline”, and “FRP rupture”, respectively. The beam that represents the deep concrete, steel failure in figure 4-12 is specimen 12, the 25mm diameter disbond located 185mm from the midspan (25C_185_S12). The beams that fall in this category are specimen 59 (25mm), specimen 21 (50mm), specimen 12 (25mm), specimen 60 (50mm), specimen 5 (100mm), and specimen 17 (150mm). The low load and low displacement failure (thick concrete bondline failure) is represented by specimen 22 with a 150mm diameter disbond (150C_185_S22_2). The beams tested that fall in this category are specimen 16 (100mm) and specimen 22 (150mm). Only one specimen falls in the third category of failing at low load, but high displacement (due to FRP rupture): Specimen 15. This specimen behaved different from the others because it was inadvertently rehabilitated with only one layer of FRP, decreasing the structural stiffness, and changing the failure mode from debonding to FRP rupture. From the load displacement plots all of the beams from the first two sets had very similar initial stiffness of 9.00kN/mm.

Figure 4-12: Characteristic load vs. midspan displacement plots for circular disbonds with different failure modes.

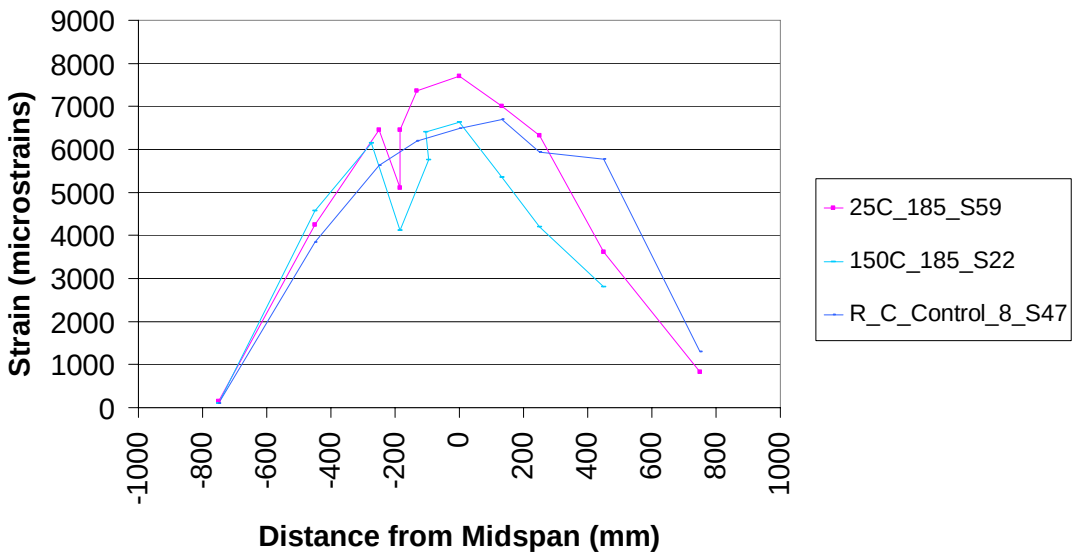
Figure 4-15 shows characteristic FRP strain profiles for the specimens with circular disbonds considered in this section compared to a typical control specimen. The location of the center of the defect is 185mm to the left of the midspan, as noted earlier. At this location, a drop in FRP strain is apparent because no shear stress can be transferred. Instead only tension is carried. However, slight increases in strain were noted at each edge of the disbond where the bond resumed. This stress concentration in conjunction with the diagonal cracking seems to play a large role in the mechanism initiating debonding. Specimens with larger disbonds tend to result in larger crack

Figure 4-15: Representative strain profiles for beams with circular disbonds.

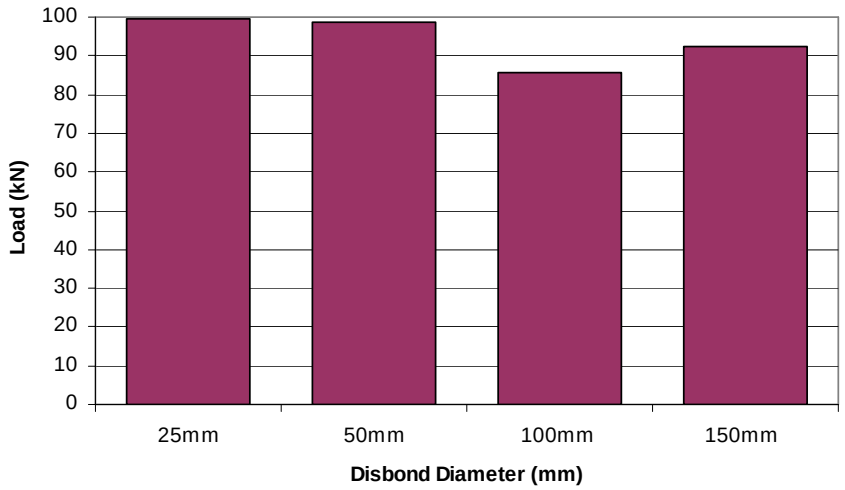
In order to effectively eliminate the influence of the various failure modes, behavior of specimens failing by the “deep concrete, steel” failure mode only are compared in Figures 4-18 to 4-21. The average maximum load for each disbond diamter of 25mm, 50mm, 100mm, and 150mm are 99.6kN, 98.7kN, 85.6kN, and 92.2kN microstrains respectively as shown in figure 4-18, indicating decrease in capacity as disbond diameter increases. The displacement at debonding follows a similar trend shown in figure 4-19 where midspan displacements of 17.9, 16.5, 14.2, and 15.3mm were measured. The average values of FRP strain at debonding for each specimen for the 25mm, 50mm, 100mm, and 150mm diameter disbonds are 7748, 6670, 6069, and 6082 microstrains respectively as shown in figure 4-20, indicating that the maximum FRP strains decrease as the disbond size increases. In the same order, average steel strains at yield are 2460, 2357, 2344, and 2389 microstrains, suggesting a decreasing trend as well. Excluding specimen 5, the average load at steel yield for this subset increased with disbond diameter giving values of 69.4kN, 72.3kN, and 82.6kN for 25mm, 50mm, and 150mm specimens respectively, suggesting that the large disbonds may be changing the load path such that the FRP is being activated earlier in the loading process due to the large cracks found near the disbond edges. Evidence supporting this suggestion can be seen in figure 4-21, noting the FRP stress concentrations found near the defect location at steel yielding load. Generally, there seems to be a trend of decreased beam performance with the increased diameter of circular disbonds, although these trends do not suggest a large or critical influence on

Figure 4-18: Maximum load vs. circular disbond diameter for "deep concrete, steel" failure mode.

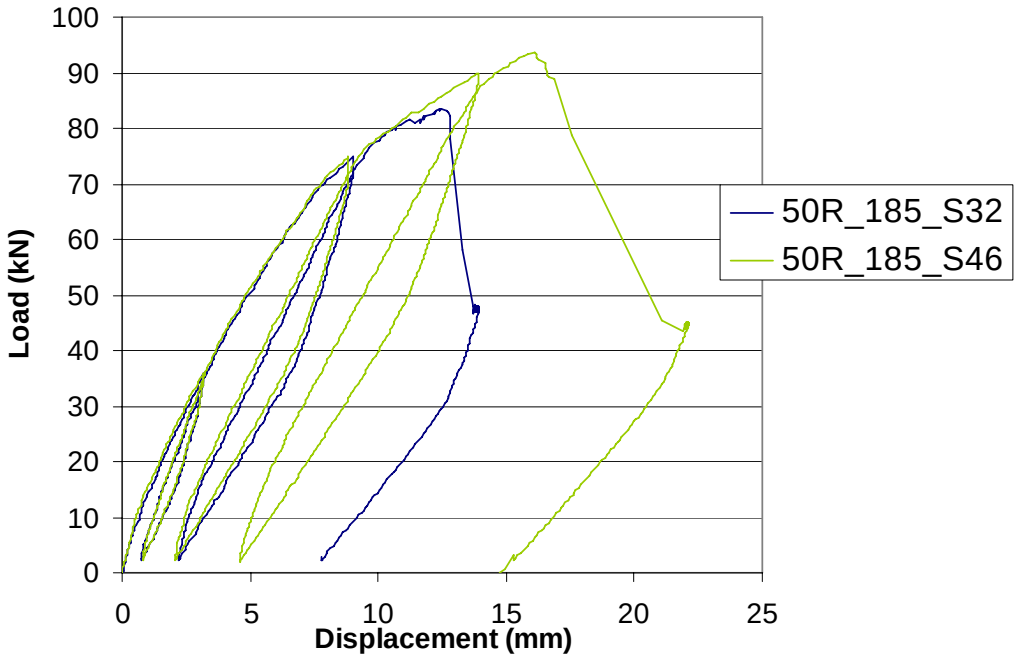
The load-displacement data for all of the specimens tested in this set is largely similar until the point at which debonding initiates. Figure 4-23 is a plot of two load vs. displacement curves that are representative of the common failures found in this set of beams. The specimens used as representative specimens in figure 4-23 are specimen 32 (full name: 50R_185_S32) and specimen 46 (full name: 50R_185_S46). From the figure it can be shown that until a load of 80kN is attained, the specimen stiffnesses are very similar. The point where the plots begin to diverge (approximately 80kN) is likely the point where local debonding began to occur and the specimen began losing

Figure 4-23: Characteristic load vs. displacement plots for rectangular disbond sets.

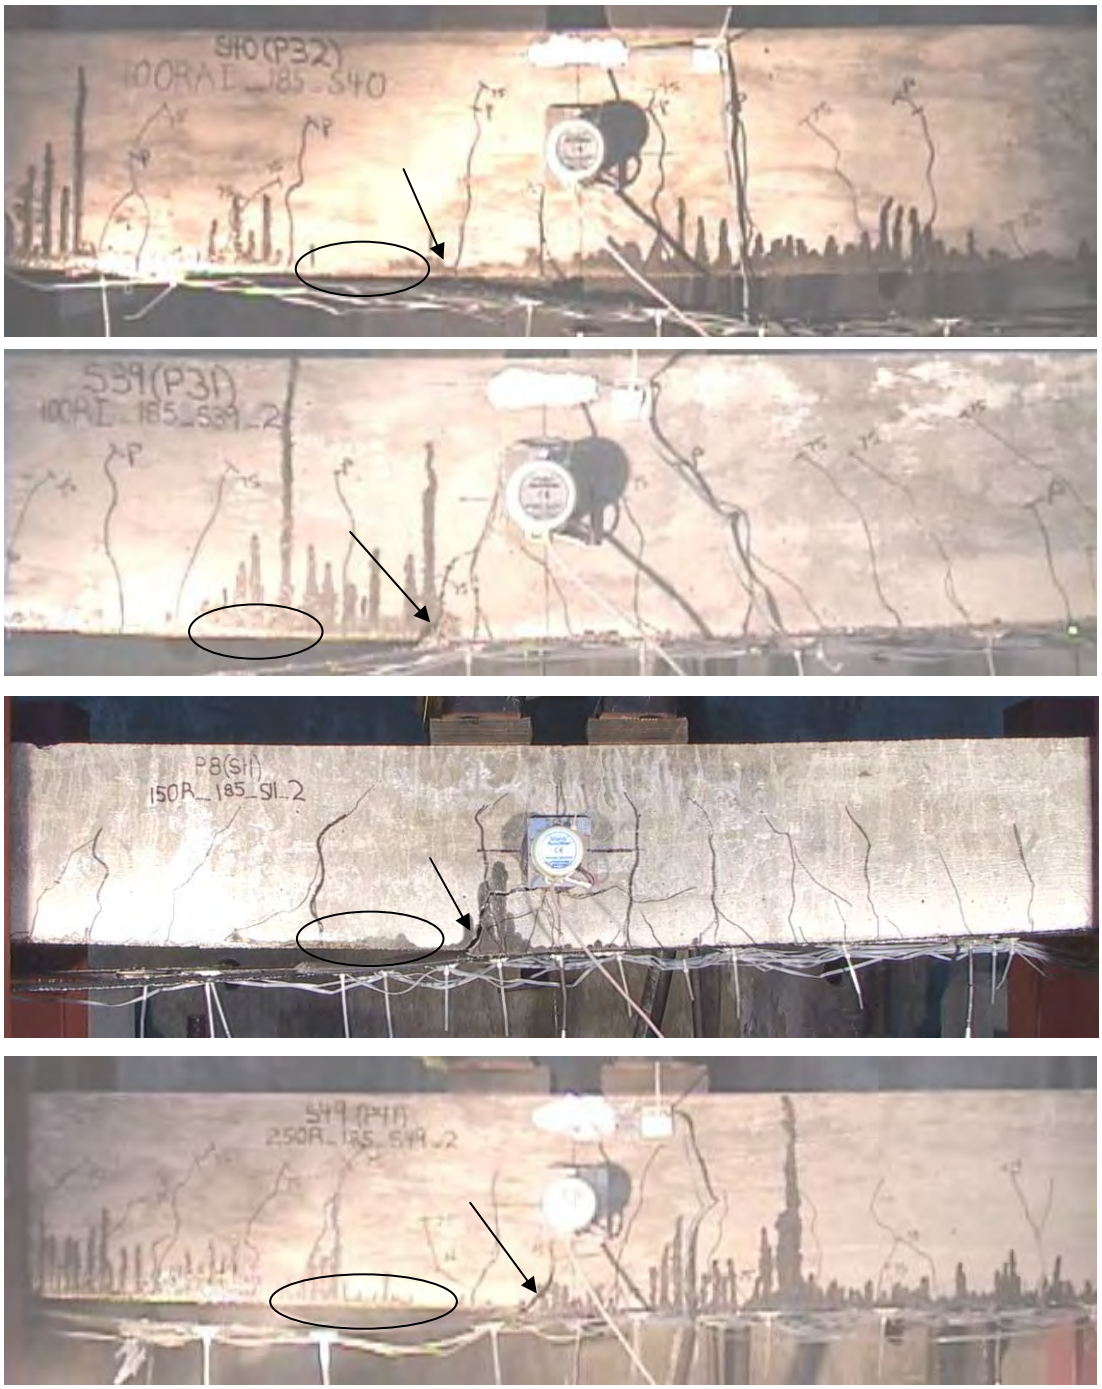
Figure 4-25: Typical cracking patterns for specimens with disbond defects. The circled regions represent the approximate locations of the disbond(s).

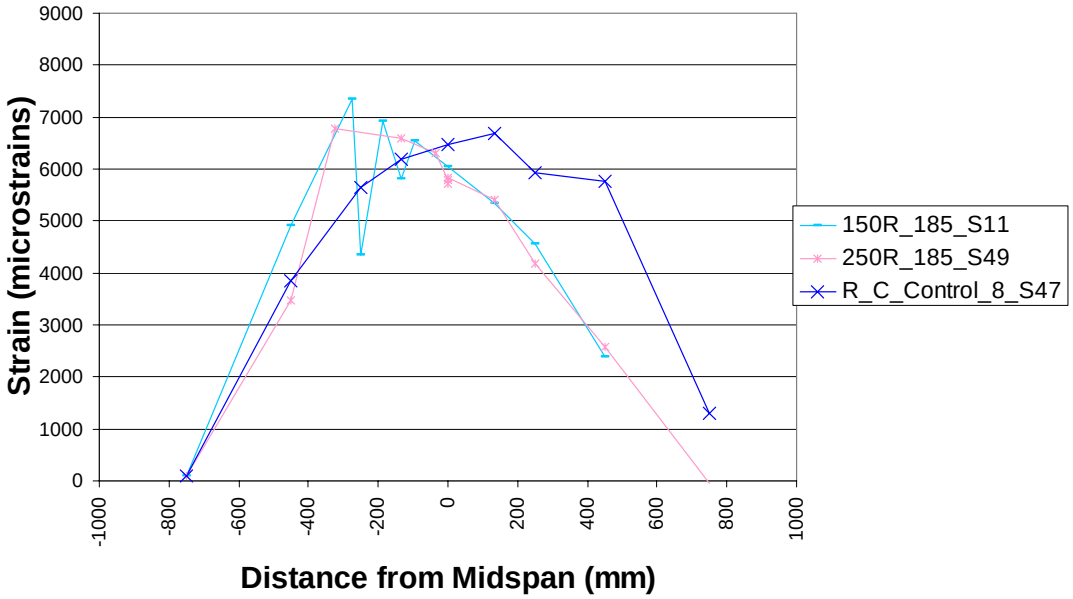
Figure 4-26 is a representative plot of strain profiles at ultimate load for typical specimens with rectangular disbonds compared to a typical control specimen. Specimens 11 and 49 were chosen here because they had large disbond sizes of 150mm and 250mm respectively. Specimens with large disbonds had particularly pronounced stress concentrations in the disbond region. The peak strains measured at ultimate load were located near the edges of the disbond as opposed to the control specimens which usually had peak strains near the midspan. Specimens with and without defects typically debonded at similar maximum strains, however the location of debonding was strongly influenced by the defect location.

Figure 4-26: Representative strain profiles for beams with rectangular disbonds.

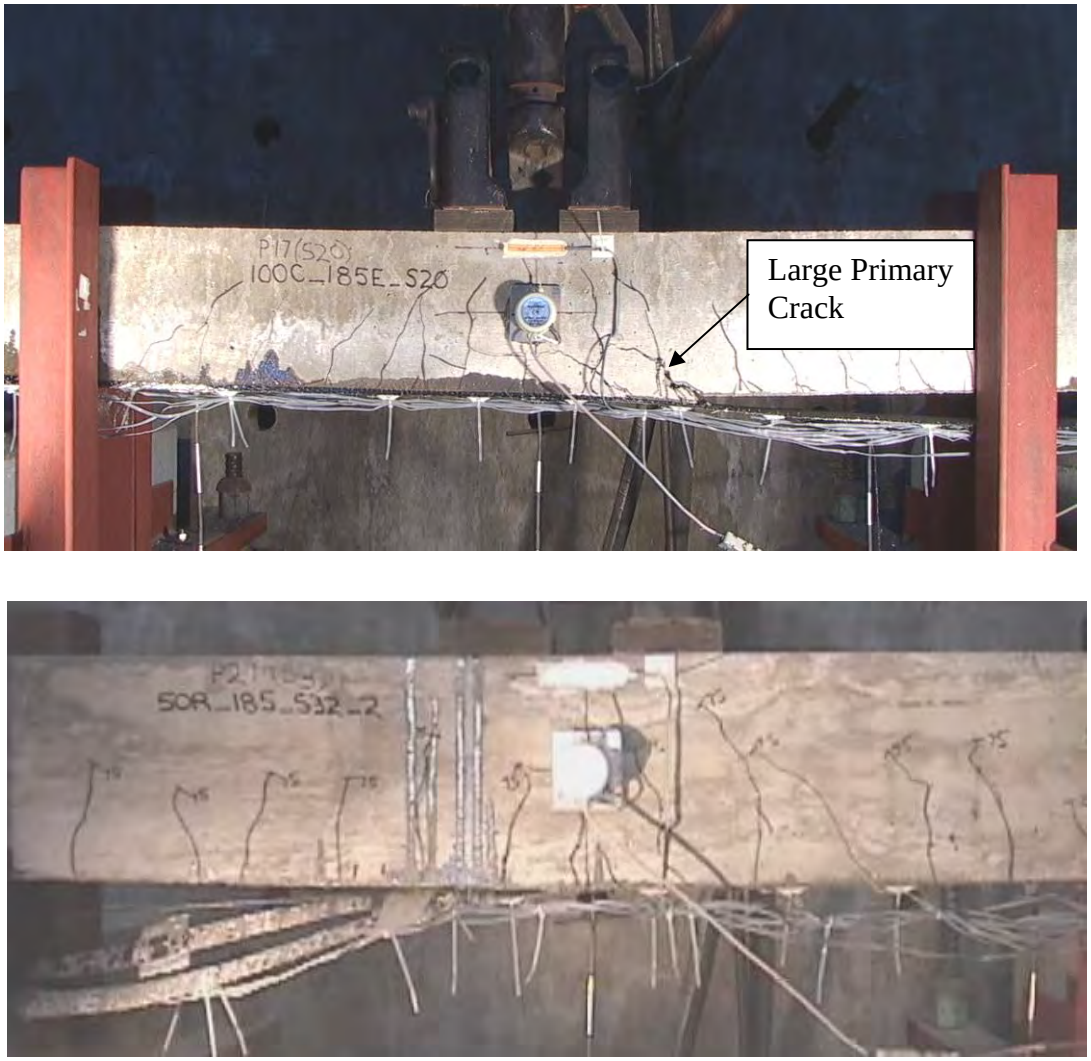
Figure 4-58: representative photos of large primary crack (top) and a multiple distributed cracks (bottom).

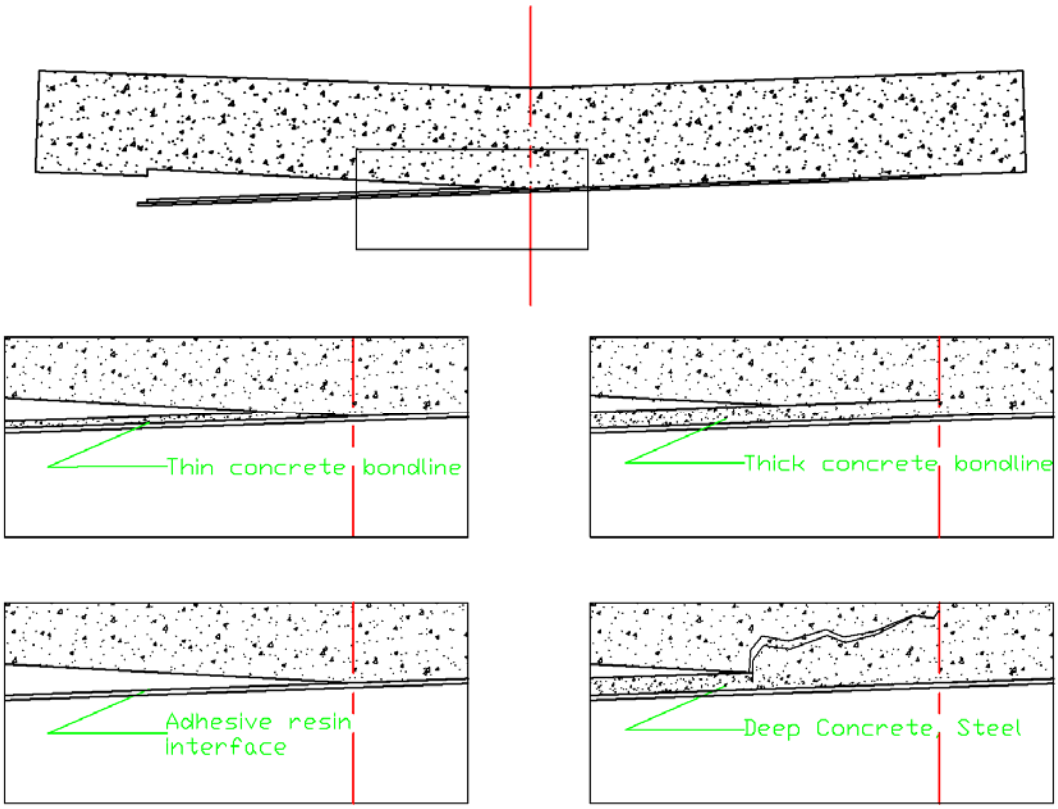
Figure 5-3: Four debonding failure modes that occurred.

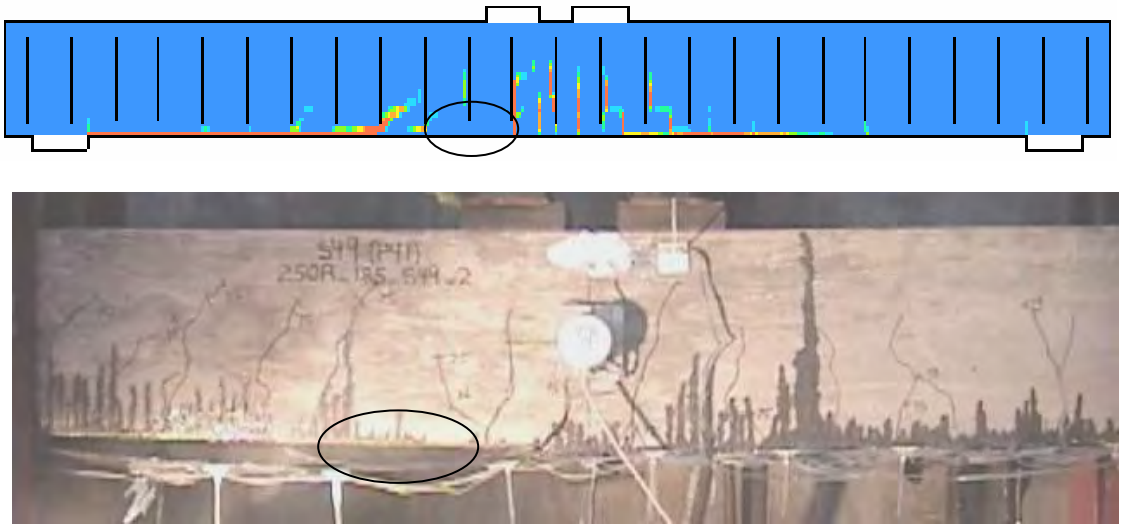
Figure 5-14: Comparison between FEA predicted cracking pattern of a beam and a failed specimen with a 250mm disbond located 185mm from the midspan.

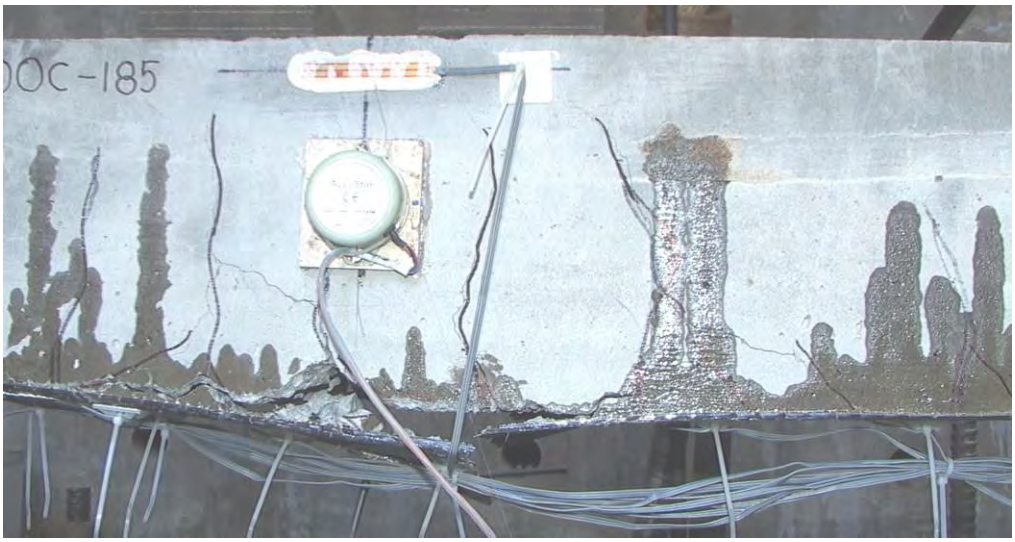
Figure A-4: Debonding through the “Resin Interface”

4. Debonding through the adhesive layer where very little concrete is left attached to the FRP. However, there may be large amounts of adhesive material still attached to the concrete surface. This failure is a result of poor bonding either by inadequate application of resin during rehabilitation or due to the concrete

strength being superior to the adhesive material. This failure generally resulted in the weakest specimens tested.

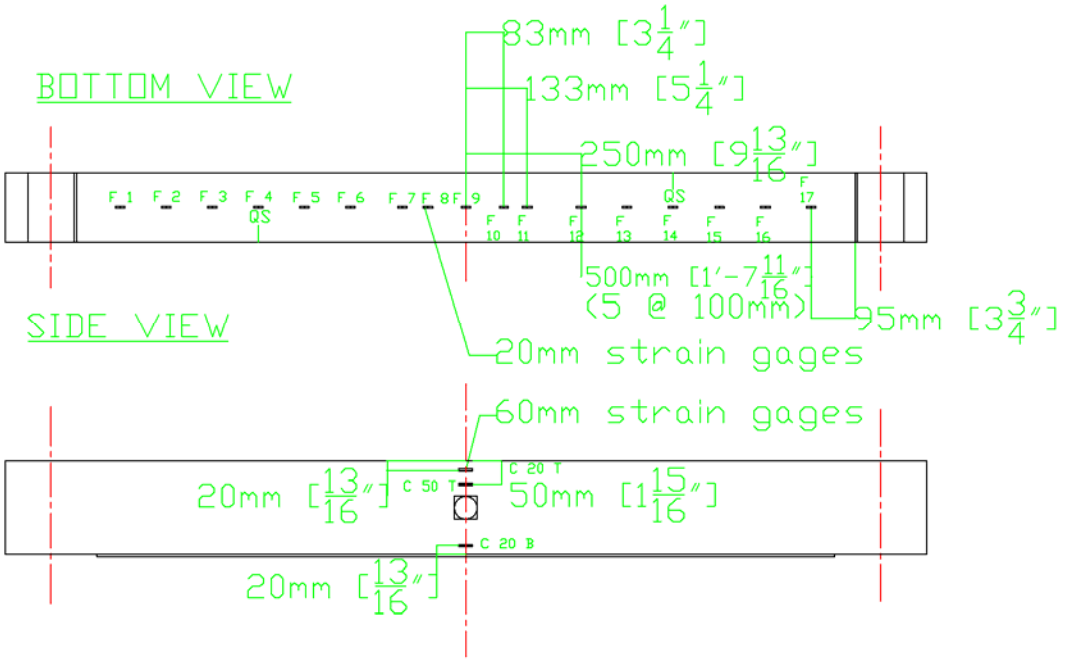
Specimen 7: Strengthened, preloaded control specimen tested 5/18/2005 (R_C_Control_1_S7)

Load (kN)	Crack Width (mm)	Notes
0.00	0.00	
36.25	< 0.10	Existing cracks dialated somewhat and many small new cracks occurred (near surface) in the high moment region at approximately 1cm spacing.
2.49		
74.86	0.1	Formation of Larger Cracks Propagating to the N/A between existing cracks. Cracks still held closed at the interface.
2.45		All cracks still reclosing.
89.99	Vert - 0.40 Shear - 0.90	Occurance of localized debonding approximately 7-10cm in length at a point of edge discontinuity due to a chip in the concrete.
2.45		Shear crack remained open. The vertical cracks closed somewhat, but remained slightly open.
96.97		Debonding occurred rapidly from a different point than it initiated from. It began in the max moment region about 1.5" into the concrete, remained deep in the concrete for about 7" then migrated to the shallow conrete along the interface.

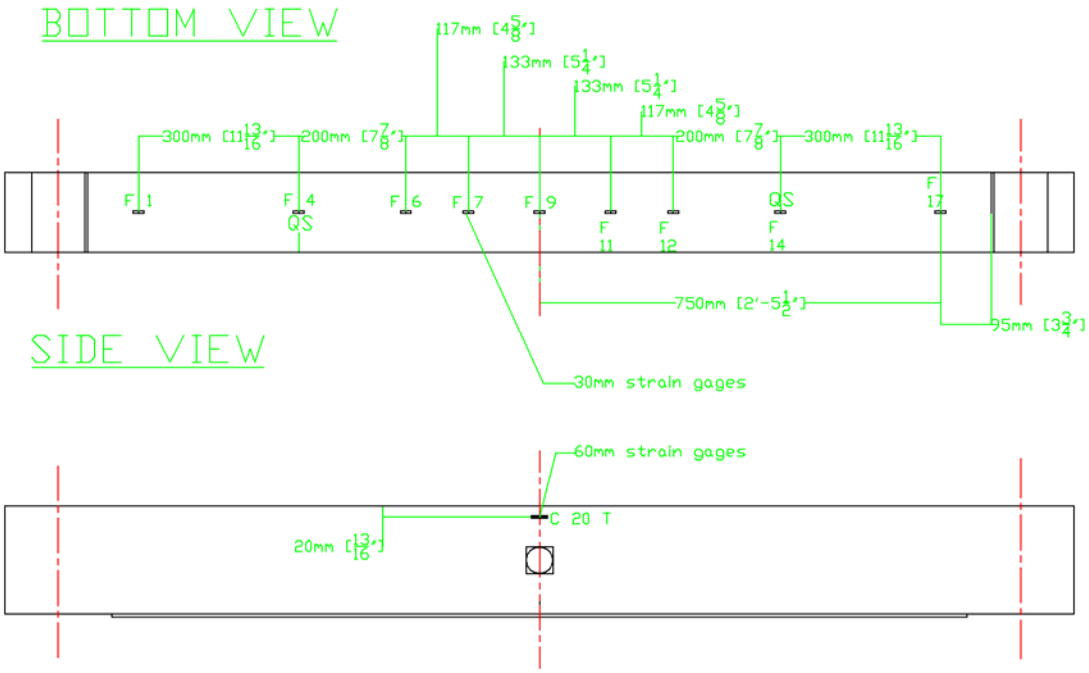
Specimen 9: Strengthened, preloaded control specimen tested 6/13/2005 (R_C_Control_2_S9)

Specimen 9 was another precracked, rehabilitated control specimen without any purposely inserted defects. Test 6 was ran monotonically to ensure the same behaviors are seen independent of whether the specimen is loaded monotonically or using a small number of cycles. Final debonding occurred from near the midspan, propagating to the left, as seen in the previous two tests.

Load (kN)	Crack Width (mm)	Notes
0.00	0	
36.00	< 0.1	Slight reopening of existing cracks lost c_20_t right away.
75.10	0.2	Many small cracks formed.
89.70		Cracking sound at approximately 87kN. Debonding.

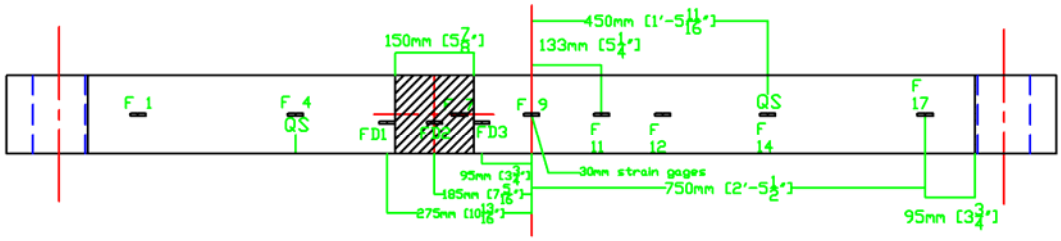
Specimen 14 was the first specimen tested in which a defect was manufactured into the rehabilitation process. The defect investigated was a rectangular disbond with a centroid located 185mm away from the midspan of the beam (see drawing). The disbond was created using three layers of thin Teflon sheets as discussed in section 2.4.1. The dimensions of the manufactured disbond were 150mm length by 150mm width (the full width of the beam). The beam was, precracked using the 35.6 kN preload level before the application of FRP. At the time of testing, the FRP had been applied for 6 days. The peak load held by this specimen was modest at 89.94 kN and corresponding midspan displacement of 12.72mm was much less than the control specimens. Final debonding occurred from approximately 125mm to the left of the

midspan, propagating to the left. The debonding mechanism was classified as a thick concrete bondline because the failure occurred by shearing a thick layer of concrete, but no large chunks of concrete were tore from the specimen (see picture). This failure mode was different from that of the control specimens that had been previously tested. This change in failure mode could have been caused by the presence of the disbond defect or by altered material properties because this specimen was rehabilitated on a different date. As usual, global debonding still occurred very rapidly, but was somewhat more gradual and less energetic than what was witnessed during testing of the control specimens.

Load (kN)	Crack Width (mm)	Notes
0.00	0	
36.10	< 0.1	Slight reopening of existing cracks.
2.50	<0.1	
75.00	0.4	No new crackin gin the unbonded region. However, very large crack openings near the edges of the unbonded region. An asymmetric crack pattern is forming.
2.50		
90.00		Debonding Initiated and occurred while stopped at 90kN load. Initiation of the debond was at the lateral edge of the defect. Debonding was gradual at first then violent at the end. Much less energetic than preavious tests, but unclear if it is a product of the actuator holding constant or the presence of the defect.

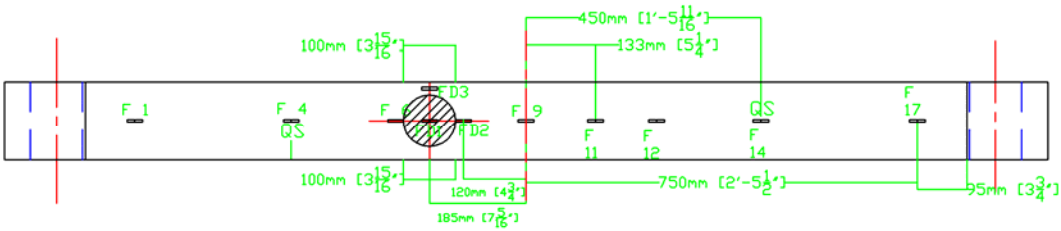
Load (kN)	Crack Width (mm)	Notes
0.00	0	
36.20	< 0.1	
2.50	<0.1	
75.10	0.4-0.5	Two large cracks formed near midspan with local debonding at the midspan and at the defect location, making it basically like the 100mm rectangular shaped defect.
2.50	0.1	
84.50	0.5	Debonding began to occur on both sides, but final failure was by FRP rupture. Upon inspection it appears only one layer of FRP was applied.

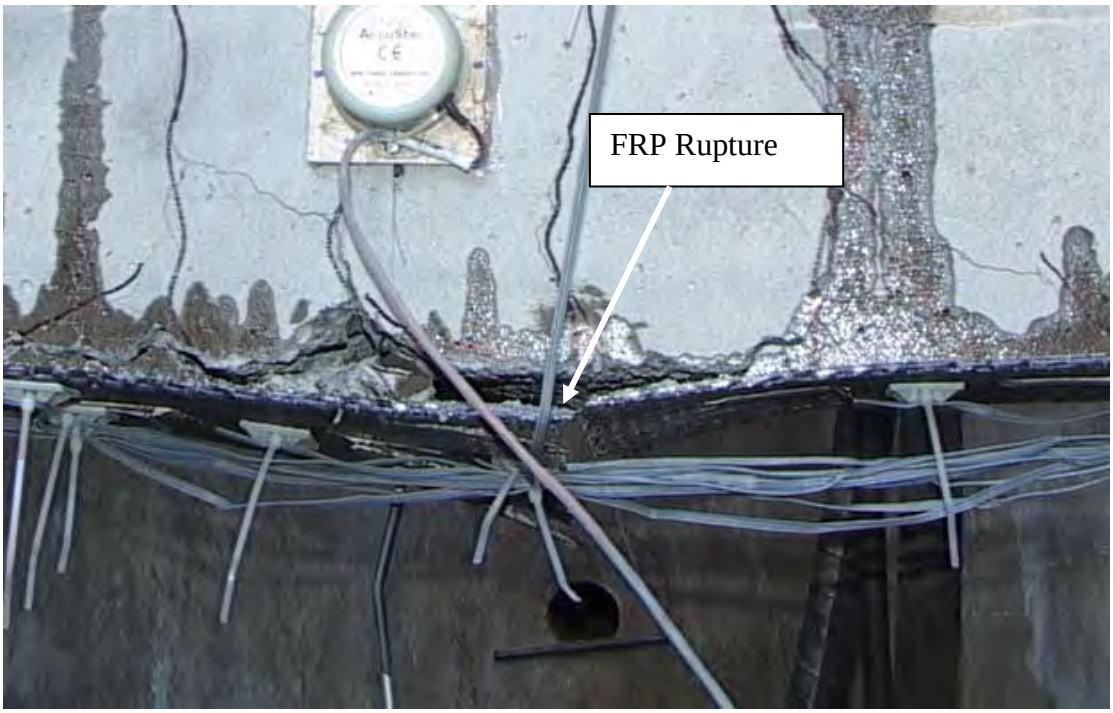
P12(S15) 100C-185

Specimen 15 contained a circular disbond defect with a centroid located 185mm away from the midspan of the beam. The size of the disbond was 100mm in diameter. Debonding began to occur on both sides of the midspan of the beam. However, final failure was by FRP rupture. This was not expected and upon inspection it was found that only one layer of fabric was placed on the specimen, rather than the two required for design. This is actually a defect that has great potential to occur in the field and is therefore still a useful test. Not only was the failure mode changed, but also the specimen failed at a low ultimate load compared to those that had been rehabilitated using two layers of FRP. This specimen was also very useful in the validation of the FEA model discussed in chapter 4.

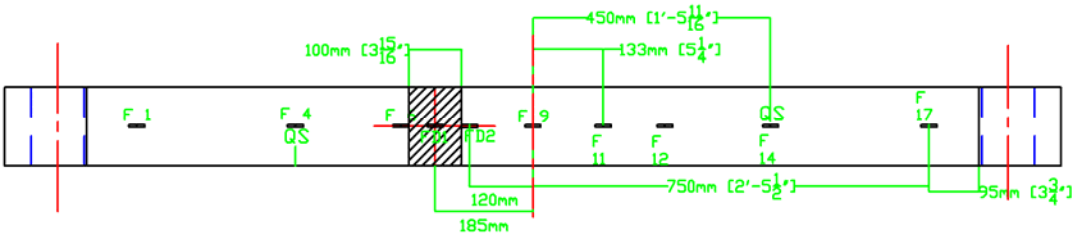
Load (kN)	Crack Width (mm)	Notes
0.00	0	
36.40	< 0.1	Typical crack reopening
2.50	<0.1	
74.90	0.1	Some local debonding near defect edges
2.50	<0.1	
90.00		Debonded while paused at 90kN

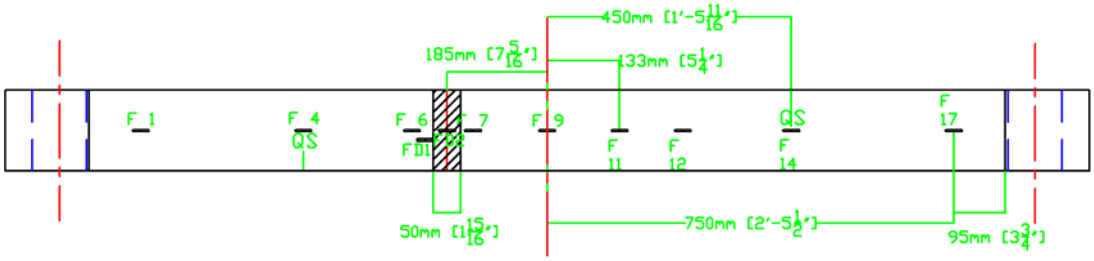
Load (kN)	Crack Width (mm)	Notes
0.00	0	
36.40	< 0.1	Typical crack reopening
2.50	<0.1	
75.00	0.2	Localized debonding occurring on each side of the defect (~40-50mm debond). Lost s_sg_m (midspan strain gage)
2.50	<0.1	
88.10		Debonded on the left side (defect side) from the defect location in the least energetic fashion seen yet.

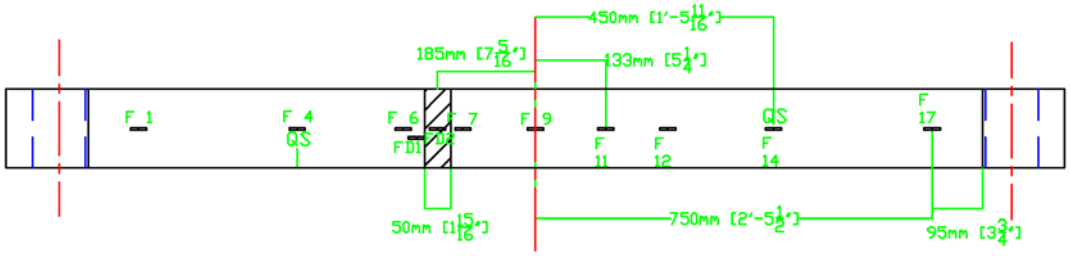
Load (kN)	Crack Width (mm)	Notes
0.00	0	
36.10	< 0.1	Typical crack reopening
2.50	<0.1	
75.00	<0.1	Crack opening is still quite small, but many sall cracks, no obvious local debonding yet.
2.50	<0.1	
90.00	0.2	Many cracks, some shear cracking. Some cracking heard. Maybe some local debonding.
2.50	0.1	Some small local debonding near the defect.
100.85

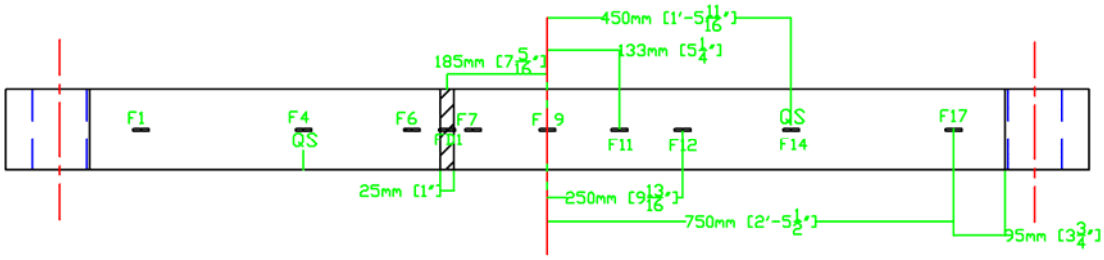
Load (kN)	Crack Width (mm)	Notes
0.00	0	
36.10	< 0.1	Typical crack reopening
2.50	<0.1	
75.10	0.1	Typical cracking
2.50	<0.1	
90.10	0.3	Approximately 50mm of local debonding in the constant moment region about 75mm to the left of the midspan. Cracking on each side of the defect
2.50		
96.90		Debonding from original point of observed local debonding

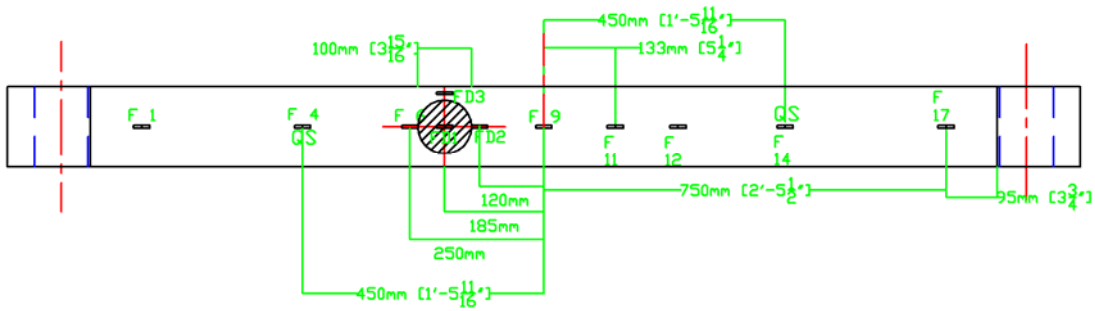
Specimen 5 contained a circular disbond defect with a centroid located 185mm away from the midspan of the beam. The size of the disbond was 100mm in diameter. This is the third beam tested with this defect configuration (denoted by the '3' in the last term in the specimen name). As often seen, failure occurred on the same side of the specimen as the disbond (the left side), debonding from near the midspan of the beam. Final debonding occurred at a low load relative to the control specimens of 85.6kN despite have a debonding failure mode of "deep concrete, steel", which is typically the strongest failure mode.

Load (kN)	Crack Width (mm)	Notes
0.00	<0.1	
36.10	<0.1	Typical crack reopening
2.40	<0.1	
75.30	0.3	Cracking heard at about 70kN. The largest crack is at the midspan.
2.50	<0.1	
85.80		Final debonding on the same side as the defect (the left side).

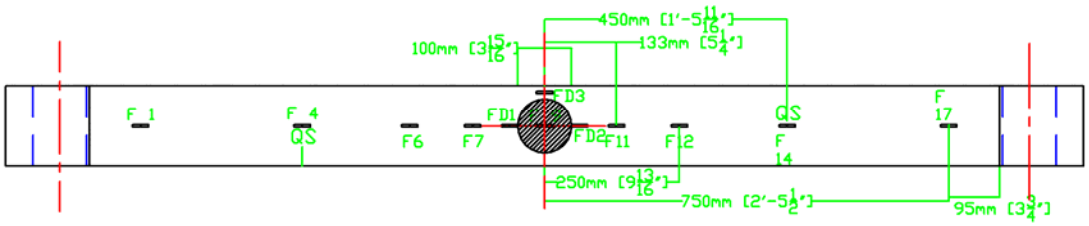
Specimen 23 contained a circular disbond defect with a centroidal location at the midspan of the beam. The size of the disbond was 100mm in diameter. Debonding occurred to the right propagating from the defect location at the midspan. Relatively low failure load of 86.7kN.

Load (kN)	Crack Width (mm)	Notes
0.00	<0.1	
36.10	<0.1	Small crack reopening.
2.50	<0.1	
75.30	0.2	Debonding through the width of the section at the defect location (the midspan), essentially making it a rectangular section. Many small cracks.
2.40	<0.1	
87.20		Weak specimen. Debonding occurred from the defect to the right side.

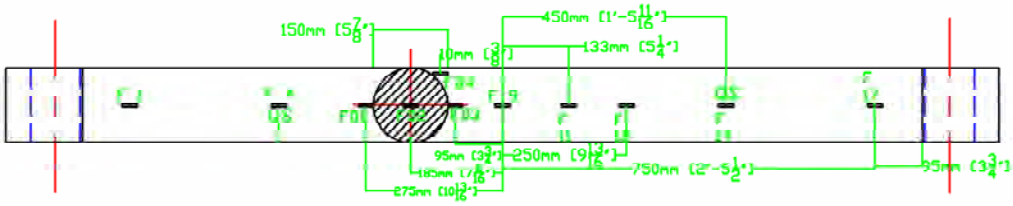
Specimen 22 contained a defect with a circular disbond with a centroid located 185mm away from the midspan of the beam (see drawing). The size of the disbond was 150mm in diameter. This is the largest size of circular shaped disbond that could be tested in this investigation because the defect diameter is equal to the full width of the beam. Specimen 22 is the second specimen tested with this defect configuration. The peak load held by this specimen was modest at 89.8kN and corresponding midspan displacement of 15.5mm was much less than the control specimens. Which is not surprising since the failure mode is debonding through a “thick concrete bondline”. Final debonding occurred from the defect location propagating to the left end of the beam.

Load (kN)	Crack Width (mm)	Notes
0.00	<0.1	
36.20	0.1	Typical crack reopening.
2.50	<0.1	
75.00	0.4	Debonding at the edges of the disbond causing it to become essentially a rectangular unbonded region. Debonding is several inches long at each corner. It appears to have been initiated by a large diagonal crack near the defect edge.
2.30		
90.00		Final debonding occurred almost immediately after 90kN load level was reached. Debonding occurred on the left side (side with the defect) of the structure, initiating at the defect location.

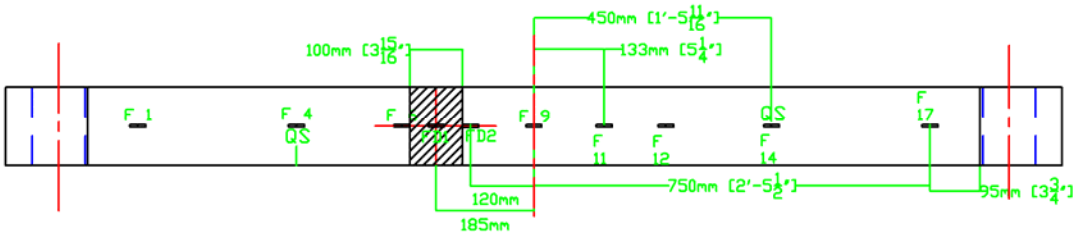
Specimen 31 was manufactured with a defect consisting of a rectangular disbond with a centroid located 185mm away from the midspan of the beam. The dimensions of the manufactured disbond were 100mm length by 150mm width (the full width of the beam). This specimen was the third manufactured with this defect configuration. The beam was, precracked using the 35.6 kN preload level before the application of FRP. Final debonding occurred from the location of a diagonal shear crack located under the left load point near the disbond. The failure load was very low due to debonding occurring through the adhesive resin interface.

Load (kN)	Crack Width (mm)	Notes
0.00	<0.1	
36.10	0.1	Specimen was loaded monotonically. Final debonding was relatively non-violent propagating from the defect to the left through a thin concrete layer.
0.00	<0.1	
75.20	0.4	Largest crack is just to the right (~25mm) of the defect. Local Debonding has occurred about 50mm to the left of the defect and 30mm to the right (began at 72kN).
0.00	<0.1	
80.30		Very low failure load. Much of the failure was in the adhesive layer.

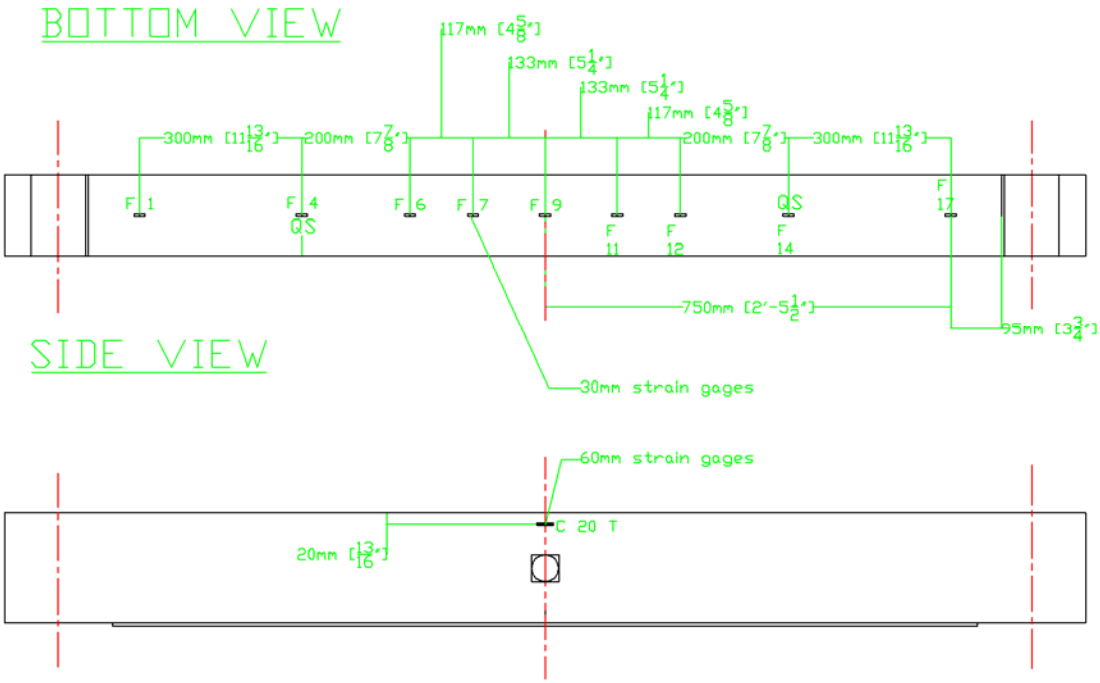
Specimen 36 was a control specimen with standard preloading as discussed in section 2.8, but without any purposely inserted defects. It is the control specimen that was created in conjunction with the defective beams for rehabilitation set five. The peak load held by this specimen was very low relative to the other control specimens at 80.28kN and corresponding midspan displacement of 12.8mm. Local debonding initiated during the 75kN load cycle at the location of a diagonal shear crack to the left of the midspan as can be seen in the photo. Final debonding occurred from this point and propagated to the left end of the FRP. left of the midspan, propagating to the right end of the FRP through the midspan. The debonding mechanism observed was failure through the resin interface, which is probably the main contributing factor for failure occurring at such low ultimate conditions. Yielding at the midspan of the longitudinal steel occurred at 67.2 kN in the beam at a steel strain of 2453 microstrains.

Load (kN)	Crack Width (mm)	Notes
0.00	<0.1	
36.50	< 0.1	Typical crack reopening
2.60	< 0.1	
75.00	0.3	A lot of noise heard during loading (cracking sound). A Large diagonal crack has occurred on the left side and local debonding has occurred at the diagonal crack propagating outward. Debonding is about 75mm long on the left side of the midspan and 25mm long on the on the right side.
2.00	0.1	
80.70		Debonding continued slowly until it was about 150mm in length, the macro debonding occurred on the left side of the midspan. Debonding occurred primarily through the adhesive.

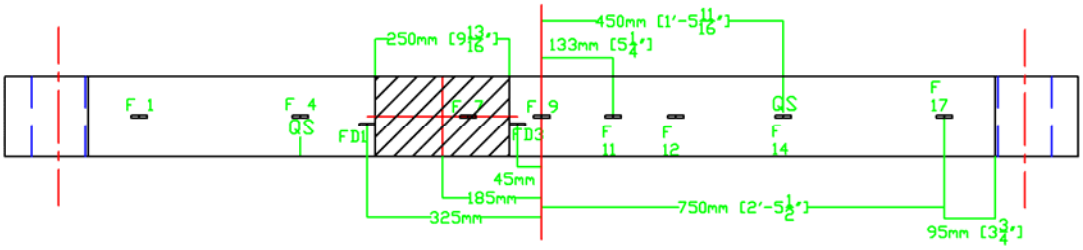
Specimen 35 was manufactured with a defect consisting of a rectangular disbond with a centroid located 185mm away from the midspan of the beam. The dimensions of the manufactured disbond were 250mm length by 150mm width (the full width of the beam). This specimen is the largest sized disbond that was investigated in the laboratory. The beam was, precracked using the 35.6 kN preload level before the application of FRP. Final debonding occurred from the midspan where a large crack was observed. The initial debonding propagated about 100mm until it reached another crack at which point debonding halted and the specimen reloaded some before final debonding occurred. This was the first test in which a crack was definitely observed to stop debonding until additional load was added. About 20% of the debonding was observed to propagate through the adhesive layer and the remainder through a thin concrete bondline, effectively mixing two of the debonding failure modes defined in appendix A.

Load (kN)	Crack Width (mm)	Notes
0.00	<0.1	
36.50	<0.1	Typical crack reopening.
2.50	<0.1	
75.50	0.5	A massive crack has opened near the right edge of the defect. A large diagonal crack has opened near the left side of the defect. F11 is reading quite high.
2.60	0.1	
88.70		Debonding initiated, propagated for ~100mm, then halted at a crack about 100mm outside the quarter span before continuing on after picking up some load again. First time macro-debonding has been halted. Approximately 20% of the debonding occurred in the adhesive layer.
