Report No.
SSRP–06/11

THE ASSESSMENT OF ASPECTS RELATED TO DEFECT CRITICALITY IN CFRP STRENGTHENED CONCRETE FLEXURAL MEMBERS

Final Report Submitted to the California Department of Transportation Under Contract No. 59A0337.

May 2006

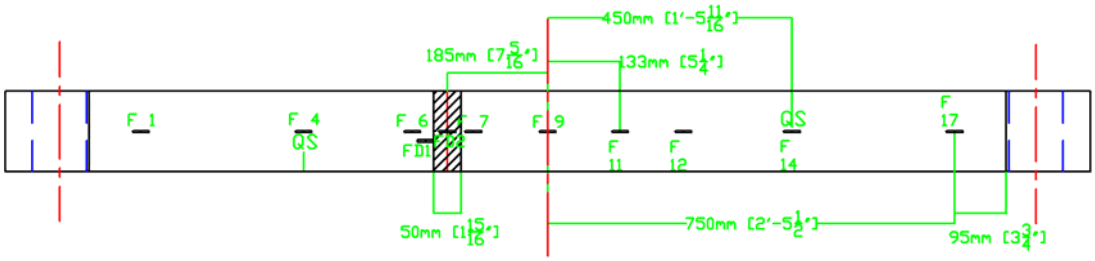
Specimen 32 was manufactured with a defect consisting of a rectangular disbond with a centroid located 185mm away from the midspan of the beam. The dimensions of the manufactured disbond were 50mm length by 150mm width. This specimen was the second manufactured with this defect configuration. The beam was, precracked using the 35.6 kN preload level before the application of FRP. Final debonding occurred from the location of the disbond. The failure load was very low due to much of the debonding occurring through the adhesive resin interface. Approximately 30% of the failure was observed to be a failure through the adhesive, suggesting that the bond strength and the concrete strength are similar.

Load (kN)	Crack Width (mm)	Notes
0.00	<0.1	
36.20	<0.1	Typical crack reopening
2.50	<0.1	
75.00	0.1	Some cracking noise heard over 70kN.
2.50	<0.1	Some long, narrow, local debonding away from the defect location.
84.20		Long, slow, gradual debonding. Local debonding occurred at about 150mm on both sides of the midspan. Also, extensive local debonding on the left side of the defect before macro-debonding. ~30% of failure was through the adhesive.

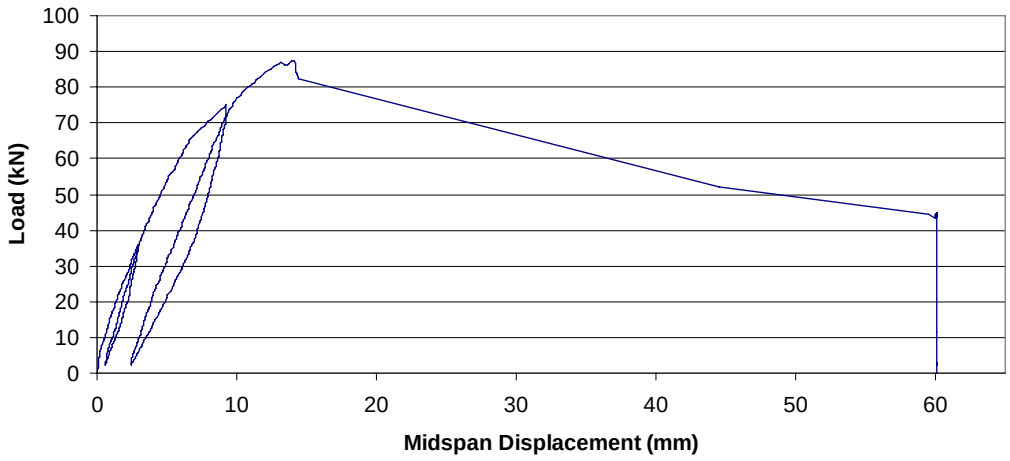
100RAI_185_S40

Specimen 40 was manufactured with a defect consisting of one rectangular disbond located between FRP layers (interlaminar) and one in the adhesive interface with a centroidal location 185mm away from the midspan of the beam. The dimensions of the manufactured disbond were 100mm length by 150mm width. This was the first specimen investigated with both interlaminar and adhesive interface disbonds. The beam was, precracked using the 35.6 kN preload level before the application of FRP. Debonding occurred to the right end of the FRP, initiating from the defect location and propagating through the midspan. There was also approximately 25mm to 35mm of local debonding to the left of the disbond. The debonding failure mode was through a thin concrete bondline, but a small amount of the failure surface (approximately 10%) was observed to have failed through the adhesive layer.

Load (kN)	Crack Width (mm)	Notes
0.00	<0.1	
36.10	<0.1	Typical reopening of cracks.
2.50	<0.1	
75.00	0.5	Extensive new cracking. Largest crack opening is located at the right edge of the defect. It is much larger than the others.
2.30	0.2	Crack width is <0.1mm at the FRP, but is ~0.2mm at the steel depth.
87.60		FRP strains are much higher on the side of the midspan with the defect. Final debonding occurred from the defect to the right (through the midspan). There was also about 25-35mm of debonding to the left of the defect. Failure was not bad, but some was in the interface.

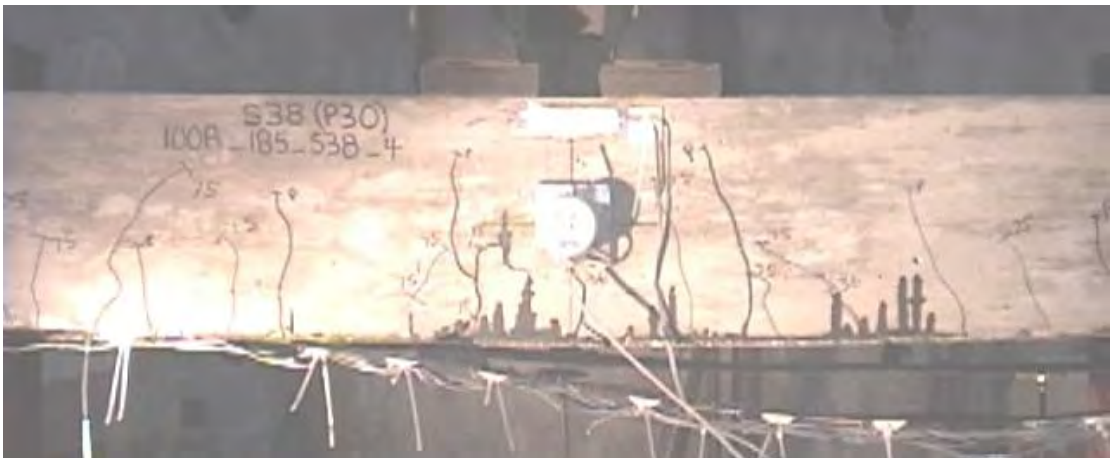
S38 (P30)
100R_185_S38_4

Specimen 38 was manufactured with a defect consisting of a rectangular disbond in the adhesive layer with a centroid located 185mm away from the midspan of the beam. The size of the manufactured disbond was 100mm in length by 150mm in width. This was the fourth specimen manufactured with this defect configuration. It was manufactured in order to compare it to other specimens in this rehabilitation set with interlaminar disbonds. Final debonding occurred from the defect, propagating to

the right through the midspan. The failure was poor occurring through the adhesive resin interface resulting in a fairly low ultimate load and displacement.

Load (kN)	Crack Width (mm)	Notes
0.00	<0.1	
36.10	<0.1	Typical crack reopening
2.30	<0.1	
75.30	0.5	Cracking sound at 47kN (very low load). Some local debonding on both sides of the defect. Largest crack opening is about 25mm to the right of the defect. Extensive cracking at the bondline near the midspan.
2.80	0.2	
87.00		Failure was again through the adhesive (primarily). Debonding propagated from the defect through the midspan to the right end of the FRP.

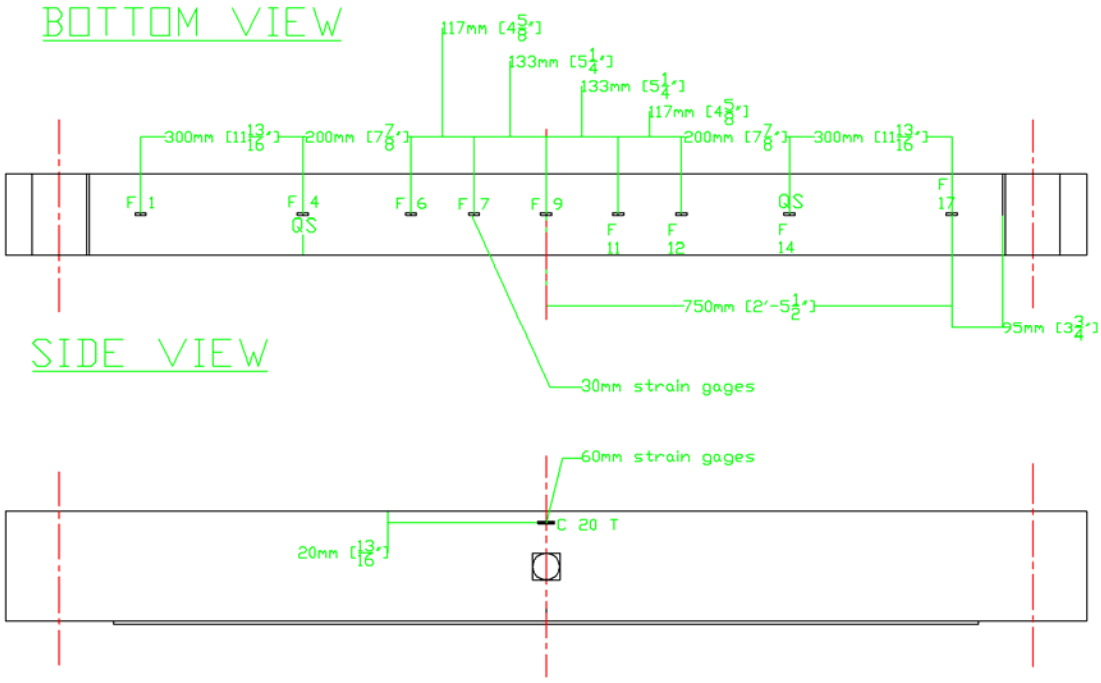
S42 (P34)
R_C_CONTROL_7

Specimen 42 was a control specimen with standard preloading as discussed in section 2.8, but without any purposely inserted defects. It is the control specimen that was created in conjunction with the defective beams for rehabilitation set six. The peak load held by this specimen was modest at 89.76kN and corresponding midspan displacement of 16.99mm. Local debonding initiated as the actuator approached the peak of the 90kN load cycle at the midspan location. Final debonding occurred when a 90kN load was approached on the 105kN load cycle. Debonding propagated to the left end of the beam. The debonding mechanism observed was failure through a thick concrete bondline with little failure through the resin interface.

Load (kN)	Crack Width (mm)	Notes
0.00	<0.1	
36.20	< 0.1	Typical crack reopening
2.60	< 0.1	
75.00	0.3	Typical cracking
2.50	0.1	
90.00		Debonding was once again somewhat gradual, but it was a good failure, primarily through the concrete.

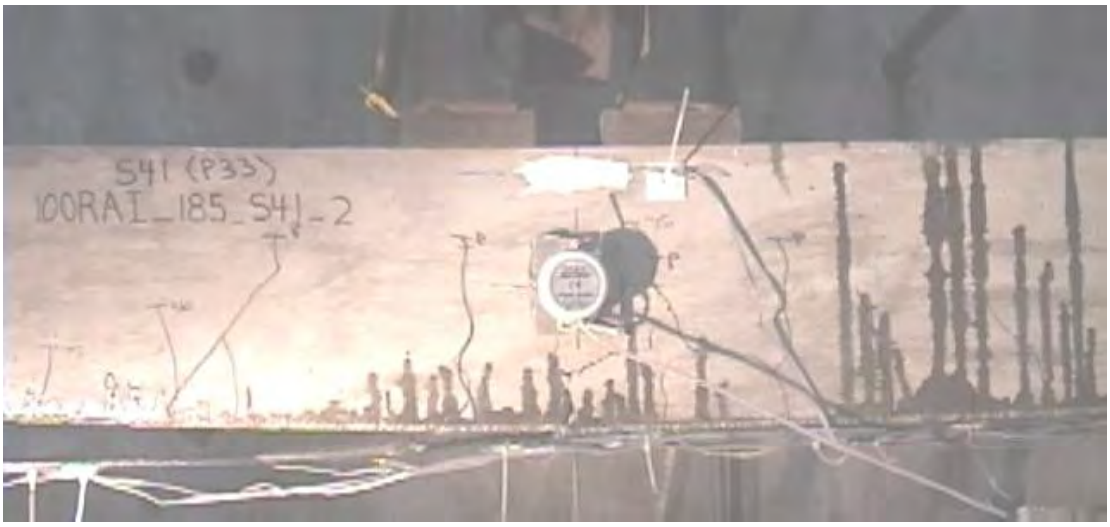
S41 (P33)
100RAI_185_S41-2

Specimen 41 was manufactured with a defect consisting of one rectangular disbond located between FRP layers (interlaminar) and one in the adhesive interface with a centroidal location 185mm away from the midspan of the beam. The dimensions of the manufactured disbond were 100mm length by 150mm width. This was the second beam tested with this defect configuration. The beam was, precracked using the 35.6 kN preload level before the application of FRP. Despite debonding through the adhesive resin interface, the specimen maximum load of 87.5kN was significantly greater than the previous two specimens (S44 and S45). Debonding propagated to the left initiating from the midspan.

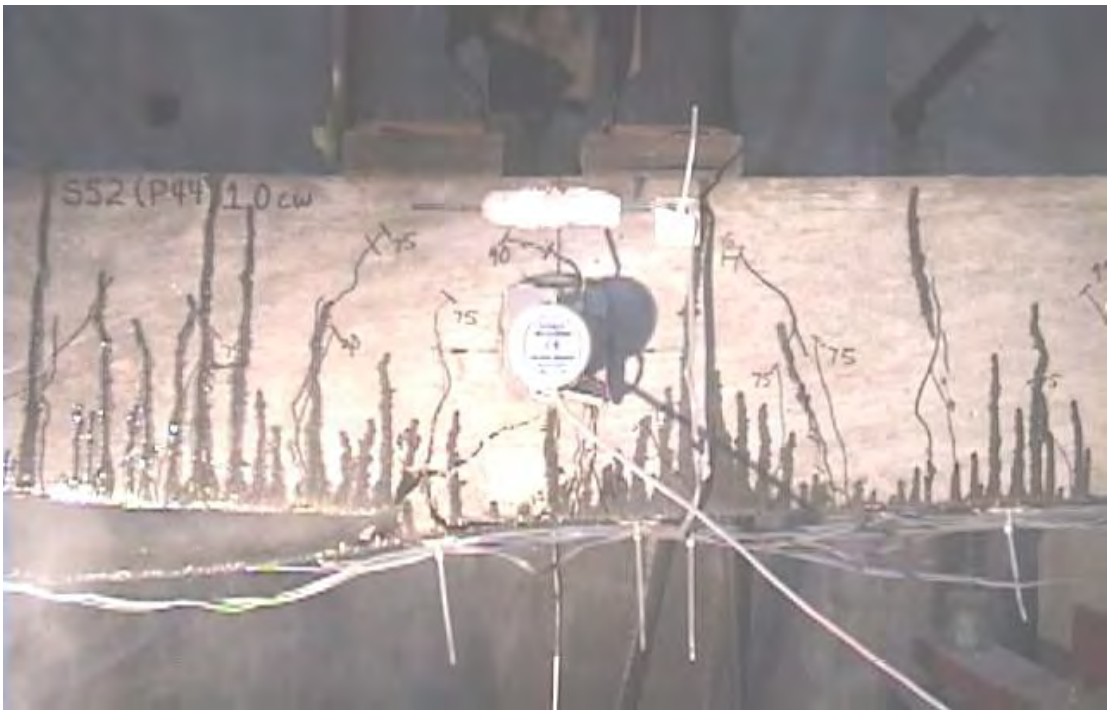
S52 (P44) 1.0 cw

This specimen was preloaded such that the residual crack width after the beam was unloaded was approximately 1.0mm. The midspan displacement necessary to yield this residual crack width was determined during preloading of specimen 48 where the beam was cycled to various preload displacements and then the cracks were measured after the load was released. The displacement necessary to achieve this residual crack width was also determined from FEA model. No unbonded regions were manufactured into this specimen. The large maximum crack width is the only defect. Final debonding occurred to the left initiating under the left load point with a “deep concrete, steel” failure mode, as can be seen in the photo below.

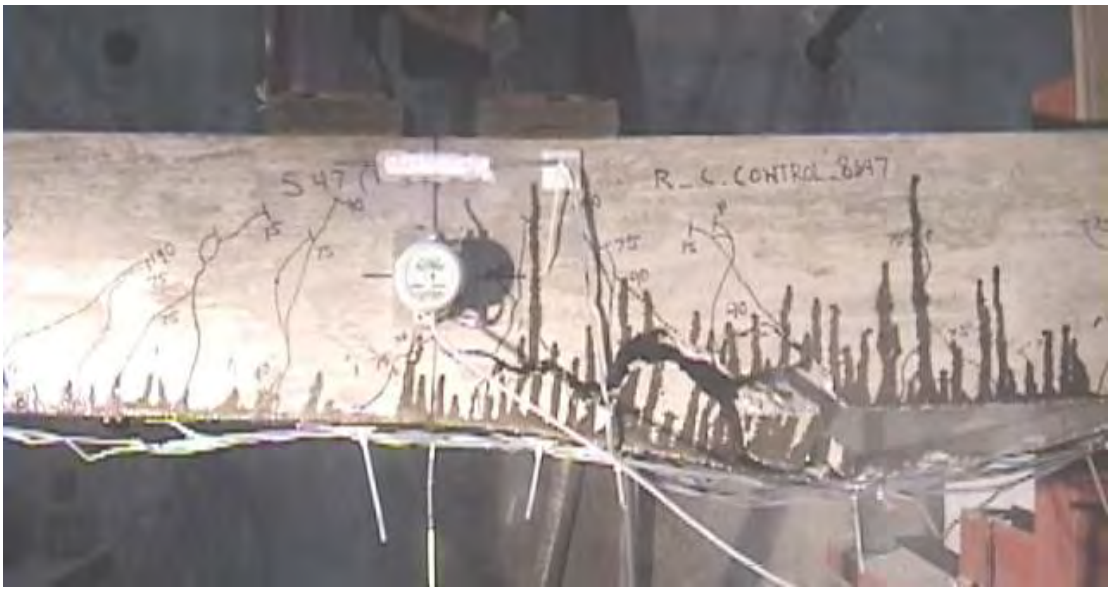
No steel strain gauge data was available during final testing due to damage during preloading. Specimen 48 was preloaded to the largest residual crack width investigated. This specimen was preloaded such that the residual crack width after the beam was unloaded was approximately 1.5mm. Like specimens 52, 51, and 50 tested previously, no unbonded regions were manufactured into this specimen. The relatively large maximum residual crack width is the only defect. Final debonding occurred to the left initiating a diagonal crack about 75mm to the left of the loading point. A “deep concrete, steel” failure mode was observed, as can be seen in the photo below. The peak load was 90.6kN at a midspan displacement of 16.05mm.

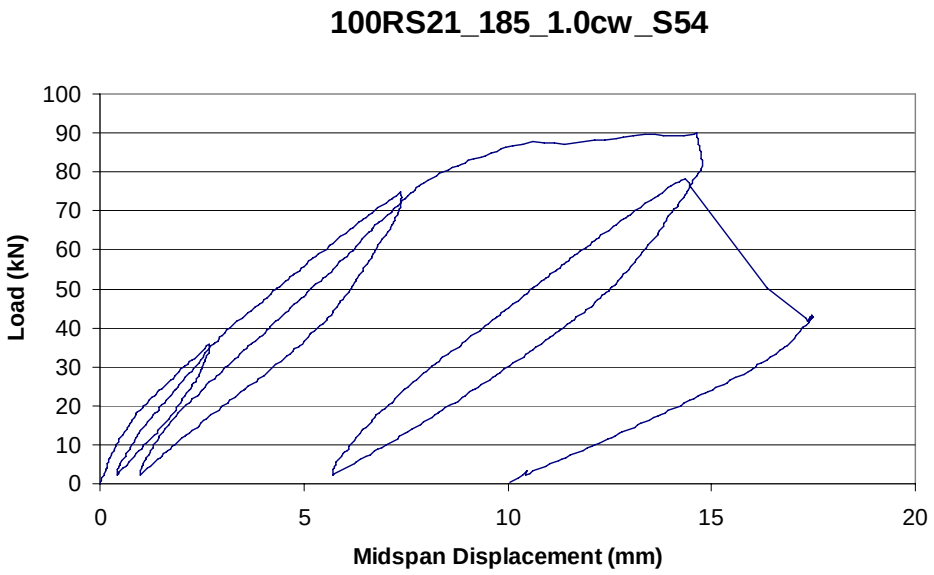
S54 (P46)
100RS_185_1.0cw_S54

Specimen 54 was preloaded such that a residual crack width of 1.0mm resulted (see section 2.8 for details). No steel strain data is available for final testing of this specimen due to the damage sustained to the strain gauges during preloading. This specimen consisted of a combination of three different defects in an effort to assess their cumulative effects: 1) excessive preload cracking to a 1.0mm residual maximum crack width; 2) a 100mm long by 150mm wide unbonded rectangular region in the adhesive interface located 185mm from the midspan; and 3) after initial curing the tension face was submerged in one inch of water for a period of twenty-one days. Given the large amount of damage that was manufactured into this beam, it performed quite well failing with a maximum load of 88.9kN at a midspan displacement of 14.6mm. The failure mode was debonding through a thick concrete bondline. Debonding occurred to the left propagating from near the right edge of the defect where a large crack opened prior to failure.

Load (kN)	Crack Width (mm)	Notes
0.00	1.0	The tension face of this specimen was submerged in ~25mm of water for 21 days.
36.10	1.1	
2.50	1	
75.20	1.2	Some new cracking. No obvious local debonding.
2.40	1	No new cracks at the defect location yet.
90.10	1.2	Massive local debonding from the defect to about 25mm to the left of the quarter span. Extensive concrete crushing at the midspan.
2.50	1.1	
		Global debonding occurred before the beam reached the 90kN load obtained in the previous load cycle. Final debonding was a good failure (~90% though the concrete).

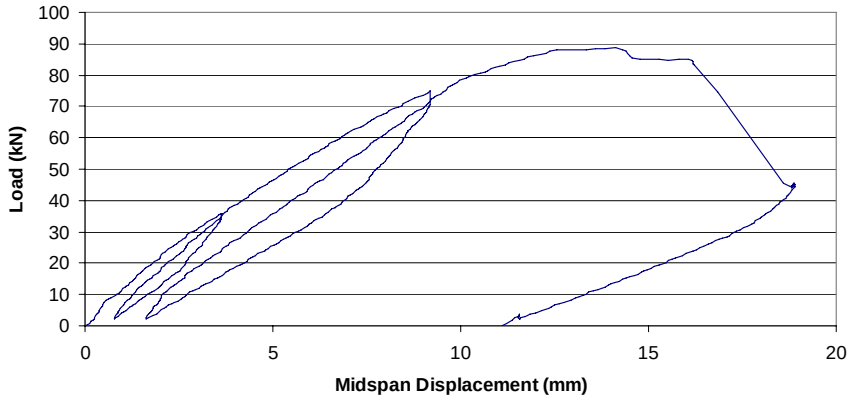
S57 (P49)
100R2-185.1.0cw_S57

Specimen 57 was preloaded such that a 1.0mm approximate residual crack width remained (see section 2.8 for details). This specimen consisted of two distinct defect types: 1) excessive preload cracking to 1.0mm; and 2) a 100mm by 150mm rectangular disbond in the adhesive interface located 185mm from the midspan in each direction (see drawing below). Debonding occurred to the left originating from the left side disbond. The failure was through a thin concrete bondline resulting in a typical specimen reaching a maximum load of 88.6kN at a typical midspan displacement of 14.1mm.

Load (kN)	Crack Width (mm)	Notes
0.00	0.8	
36.10	0.8	
2.40	0.8	
75.10	0.9	Some new cracking. No obvious local debonding
2.50	0.8	
88.80	0.5	Very gradual debonding propagating from the left defect in the left direction. Debonded through a thin concrete layer, but not through the adhesive. FRP ruptured, but I think it happened on the recoil as the composite snapped off due to global debonding.
2.50		
95.50		Final debonding appeared to propagate from the midspan (defect location) outward in each direction. Final failure was debonding on the right side of the beam.

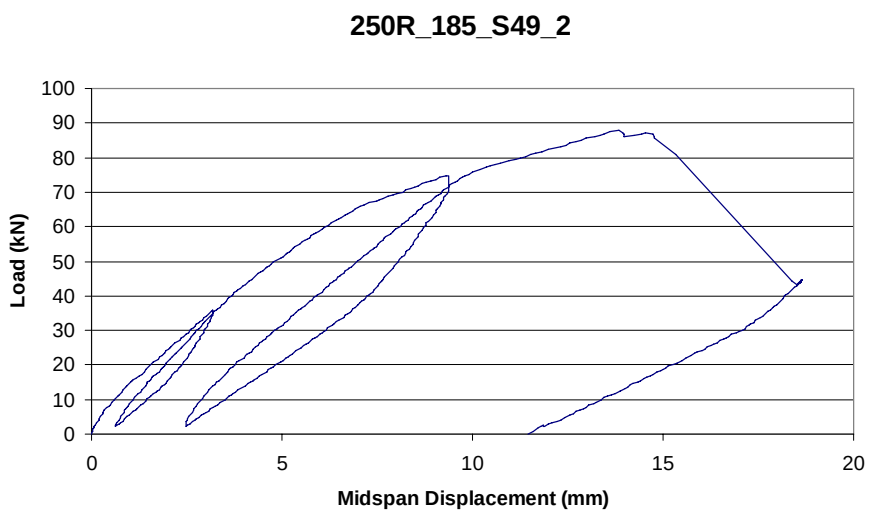
Specimen 49 was manufactured with a defect consisting of a rectangular disbond with a centroidal location 185mm away from the midspan of the beam. The dimensions of the manufactured disbond were 250mm length by 150mm width (the full width of the beam). This specimen is the largest sized disbond that was investigated in the laboratory. Specimen 49 is the second specimen tested with this defect configuration. The beam was, precracked using the 35.6 kN preload level before the application of FRP. Final debonding occurred from the defect where a large diagonal crack was observed. The specimen failed at 87.8kN and at a midspan deflection of 13.9mm by the thin concrete bondline debonding failure mode.

Load (kN)	Crack Width (mm)	Notes
0.00	<0.1	
36.10	<0.1	Typical crack reopening.
2.50	<0.1	
75.50	0.5	Largest crack is at the defect location.
2.60	0.15	
88.00		Debonding to the left from the defect location. Failed by shearing a thin concrete layer.
