Damage to Grier St. POC [Br. #53-1158]
Post-Earthquake Investigation Team Report

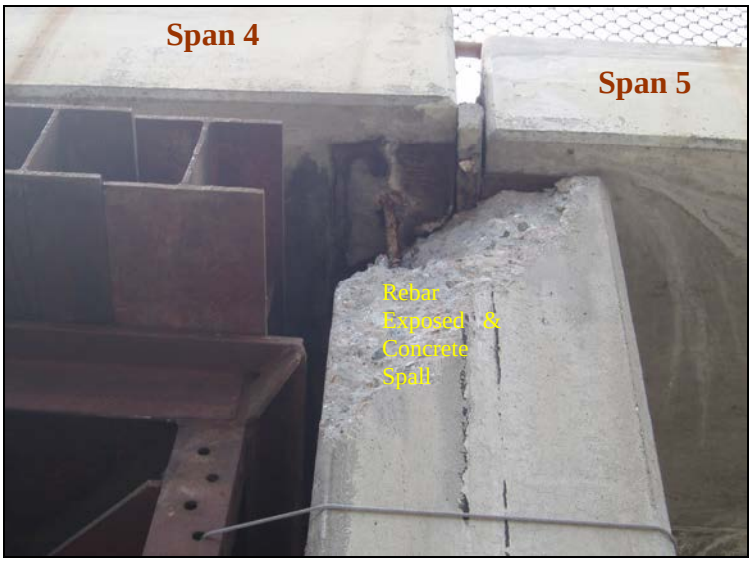
Concrete spalled at both ends of the top of Pier 5 supporting the Span 4 slab, exposing one dowel at each side. The two exterior dowels at each end of the are bent and the Span 4 slab exhibited a permanent transverse displacement of about 3 to 4 inches (toward the Southeast direction), as shown in Figure 5.

The exposed spalled area of concrete at the Northwest end of the Pier 5 seat exhibits rusty yellow stains (Figure 6). The exposed stains indicate that the area was cracked prior to the Chino Hills Earthquake. In addition, rust was observed on the two exterior dowels, which are now bent. The previous concrete cracking at the top edges of the Pier 5 may be related to the truck over-height hits on the Span 4 slab.

Figure 5 Concrete spalls at the southwest corner of Pier 5; note the evidence of corrosion on the dowel connecting the superstructure voided slab to the pier

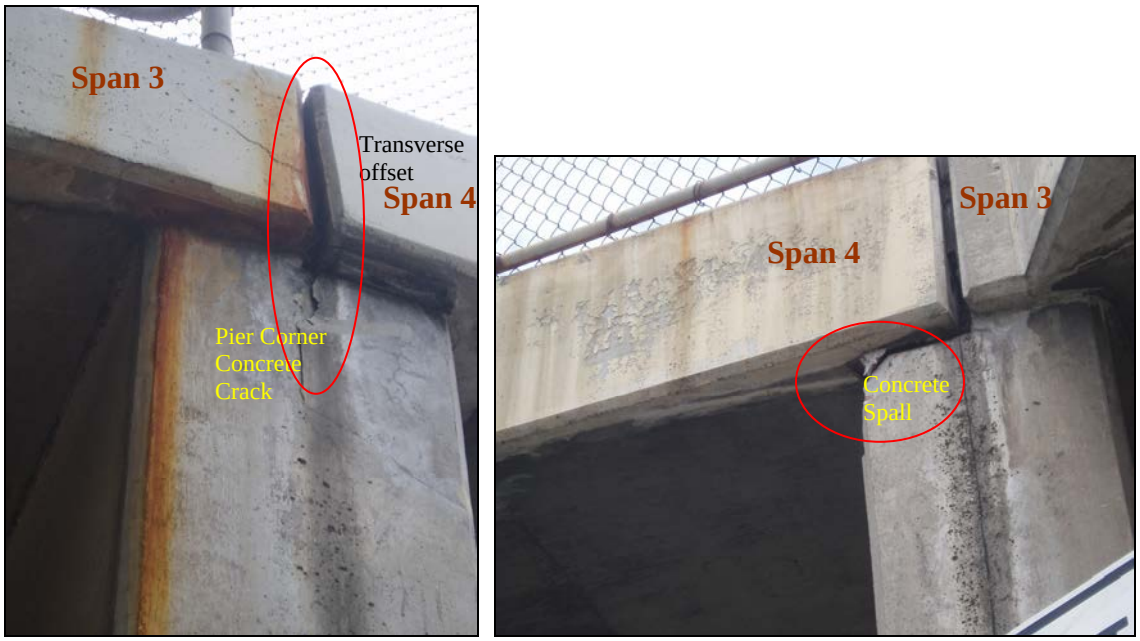
Concrete spalls and cracks were observed at the top the piers supporting the Span 4 slab. Small pieces of concrete (triangular shapes) had fallen off and cracks were visible at the exterior face of Pier 4. Similar to Pier 5, the slab in Span 4 had a permanent offset, displacing transversely (toward the Southeast direction) at Pier 4.

The ground motion pushed the Span 4 slab transversely, bent the dowels, and induced transverse displacement on Span 4 (Figure 7). The major observed failures were bending of the dowel bars connecting the super structure slab with the pier, and concrete cracking and spalling at the corners of the piers supporting Span 4.

Figure 7 Concrete cracking and spalling at Pier 4 under Span 4.
