Post Earthquake Investigation Team Report for the August 24, 2014 South Napa Earthquake

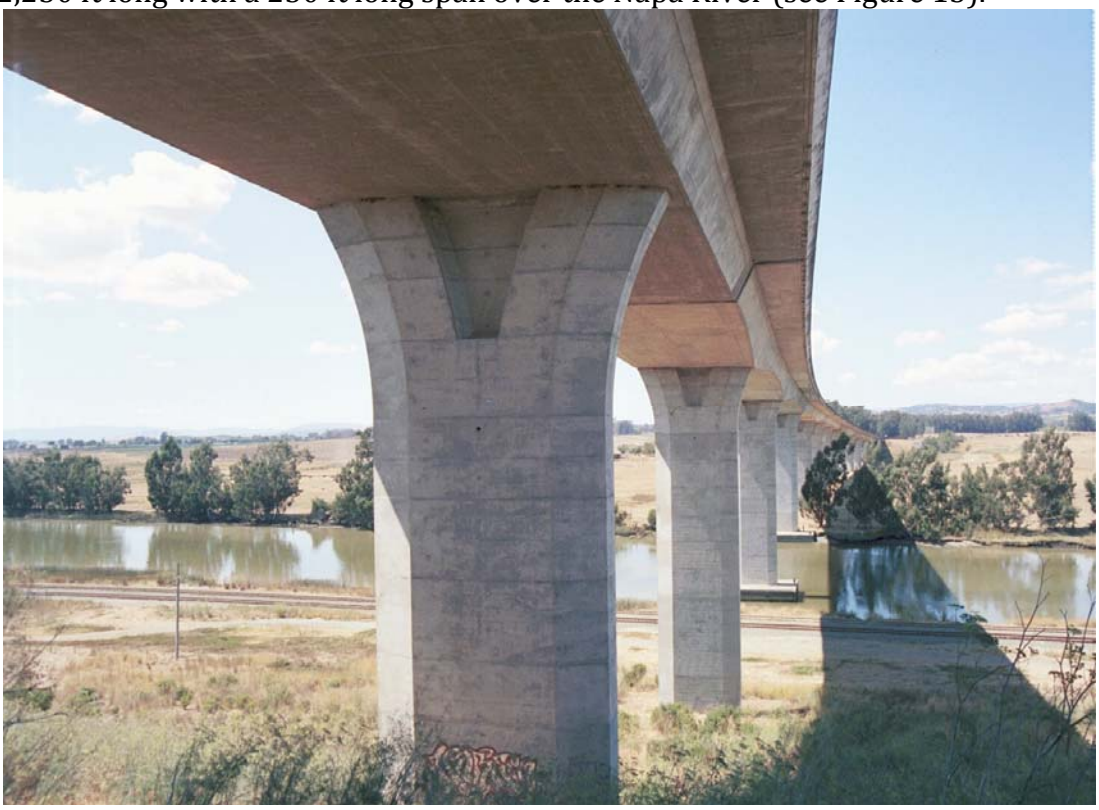
Figure 13. Napa River Bridge and Overhead.

This is a 13 span prestressed concrete continuous box girder bridge on single column bents that was built in 1977. It's 2,230 ft long with a 250 ft long span over the Napa River (see Figure 13).
