ATTACHMENT 1

Pile Design Data Form

Anomaly Overview

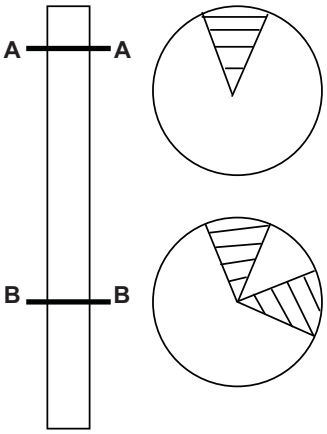
___**A-A**__
Elev.: -32ft to -34ft
Up to 14% Affected

__**B-B**__
Elev.: -65 ft to -67ft
Up to 28% Affected

Section A-A : Maximum Demand of Pile
Shear: 813 kips Moment: 21500 k-ft
Pile is structurally ☐ Acceptable ■ Unacceptable
Section B-B : Maximum Demand of Pile
Shear: 913 kips Moment: 13700 k-ft
Pile is structurally ■ Acceptable ☐ Unacceptable
