A Report of Coring Program for Checking Thicknesses of Cement Treated Bases and Asphalt Concrete Pavement Placed During 1959 Construction Season

Ernest Zube

State of California
Department of Public Works
Division of Highways
Materials and Research Department

June 14, 1960

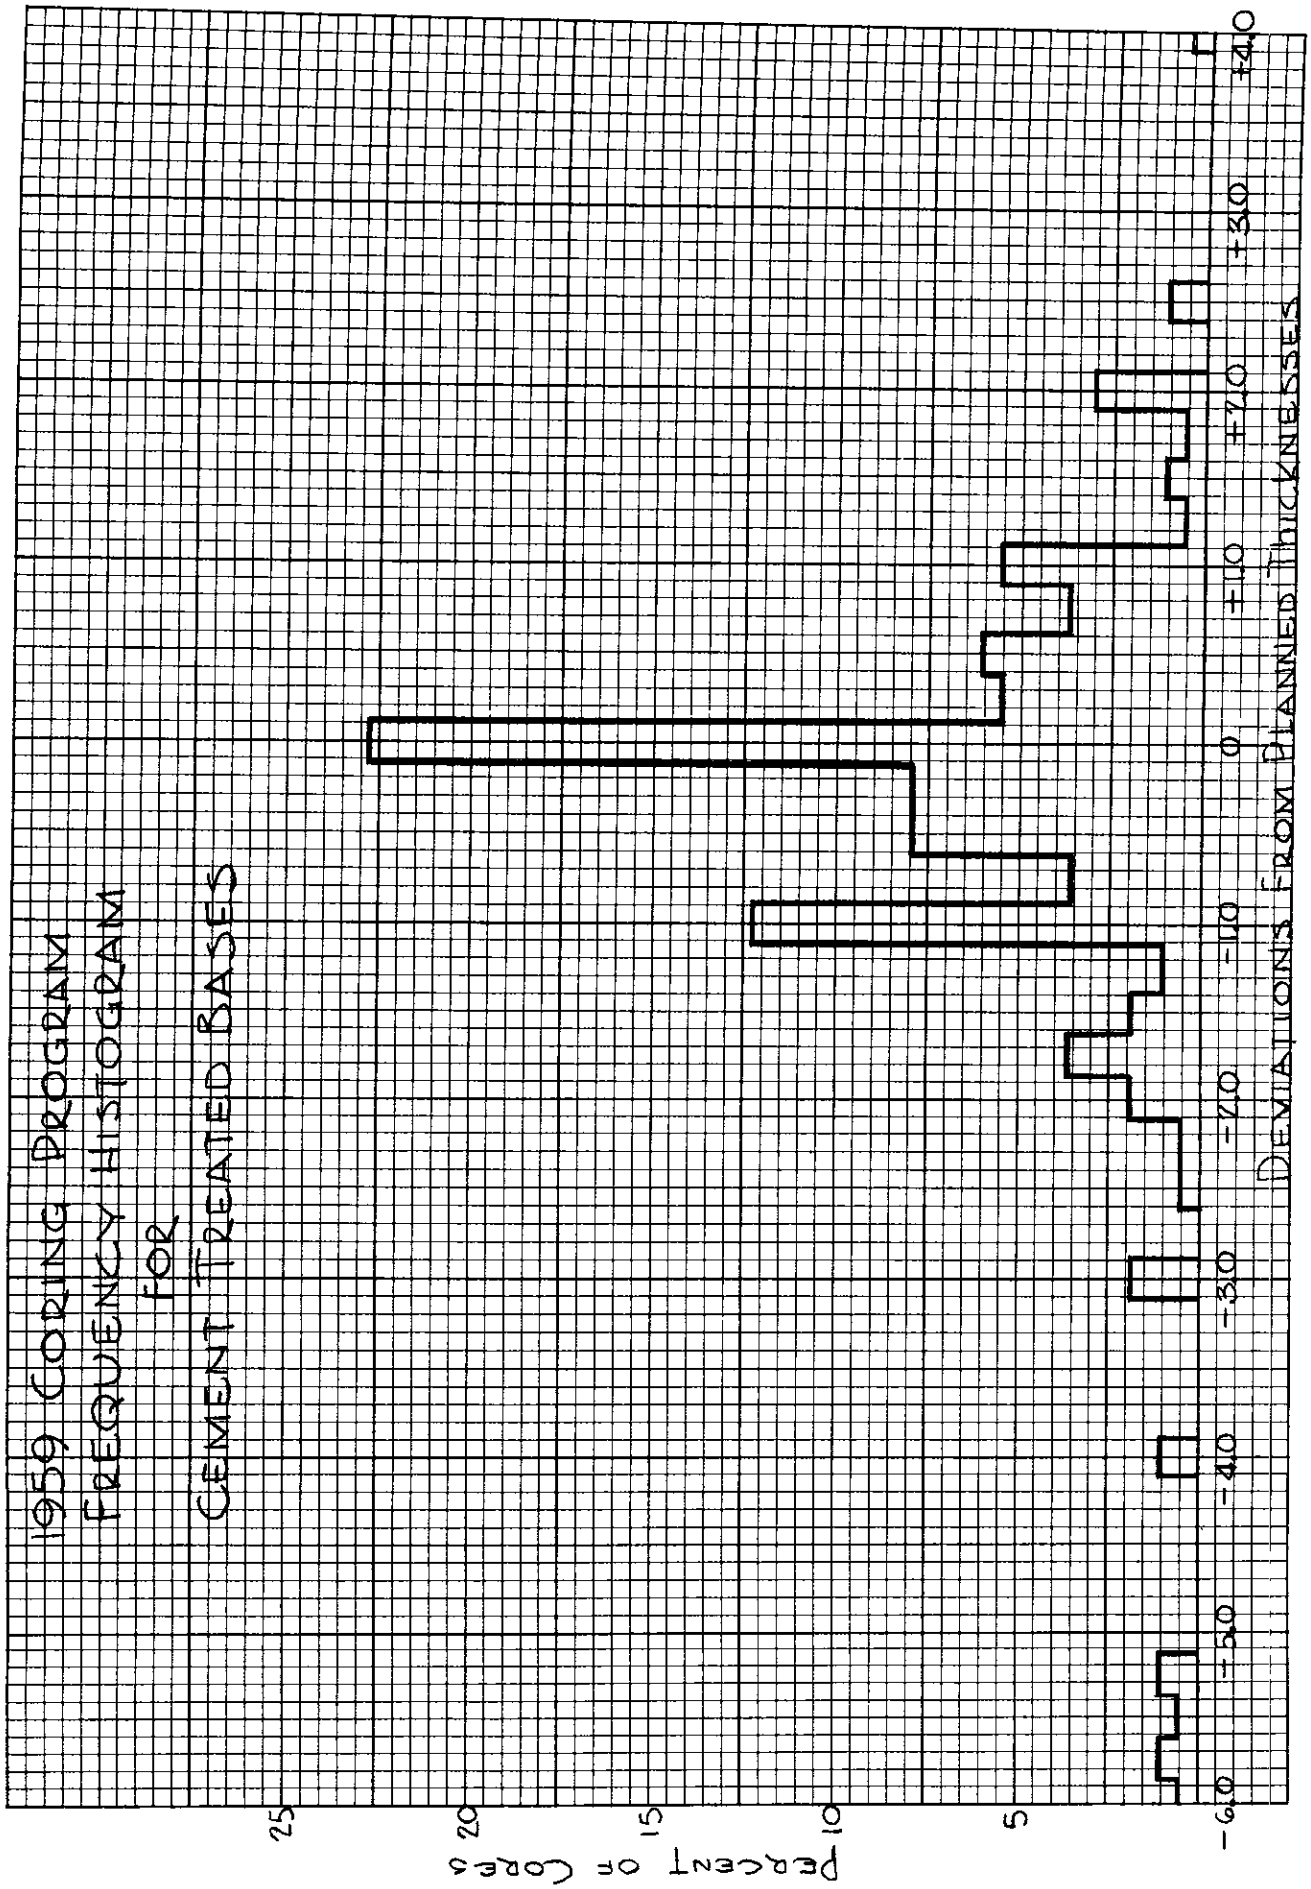
Figure 4

According to Figures 4 and 5, of the 162 cores drilled in cement treated bases, 23% were exactly the specified thickness, 50% of the cores fell within the thickness tolerance of + 0.05' (+0.6") permitted by the 1960 Standard Specifications, 33% showed thickness deficiency over 0.05' and 17% showed excessive thicknesses. The largest deficiency was 6" and the largest excess was 4".
