EXPERIMENTAL SAND DRAIN FILL AT NAPA RIVER

By
William G. Weber Jr.
Senior Materials & Research Engineer

Presented at
45 th Annual Highway Research Board Meeting
Washington D.C.
January 17 to 21, 1966

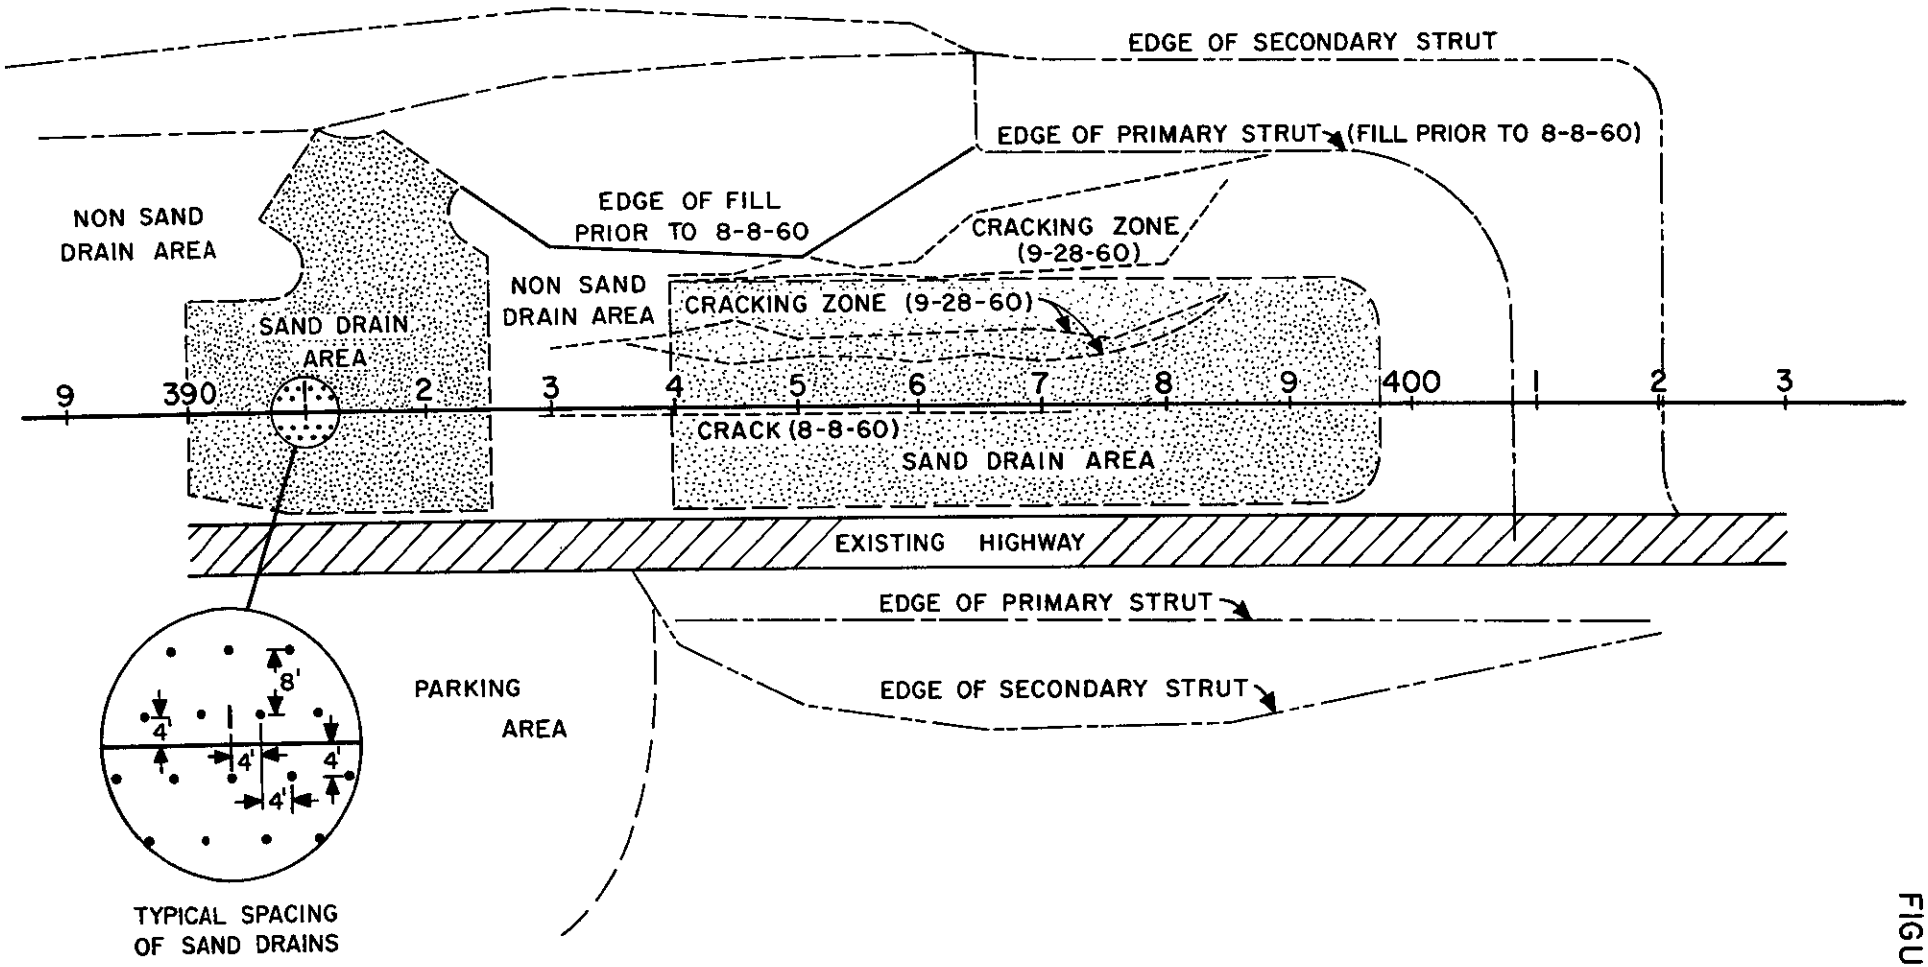
FIGURE 1

On September 27, 1960, a major movement occurred on the left side as shown in Figure Nos. 1 and 4. The piezometers at the toe of the main fill had been indicating a slow steady rise in excess hydrostatic pressure prior to the failure. The heave stakes had indicated a small steady outward movement, and the slope indicators showed that a minor flow of the soft bay mud was occurring at about elevation -10 feet. This movement occurred very rapidly with about a 4-foot drop in the left side of the fill.

PLAN OF TEST SITE

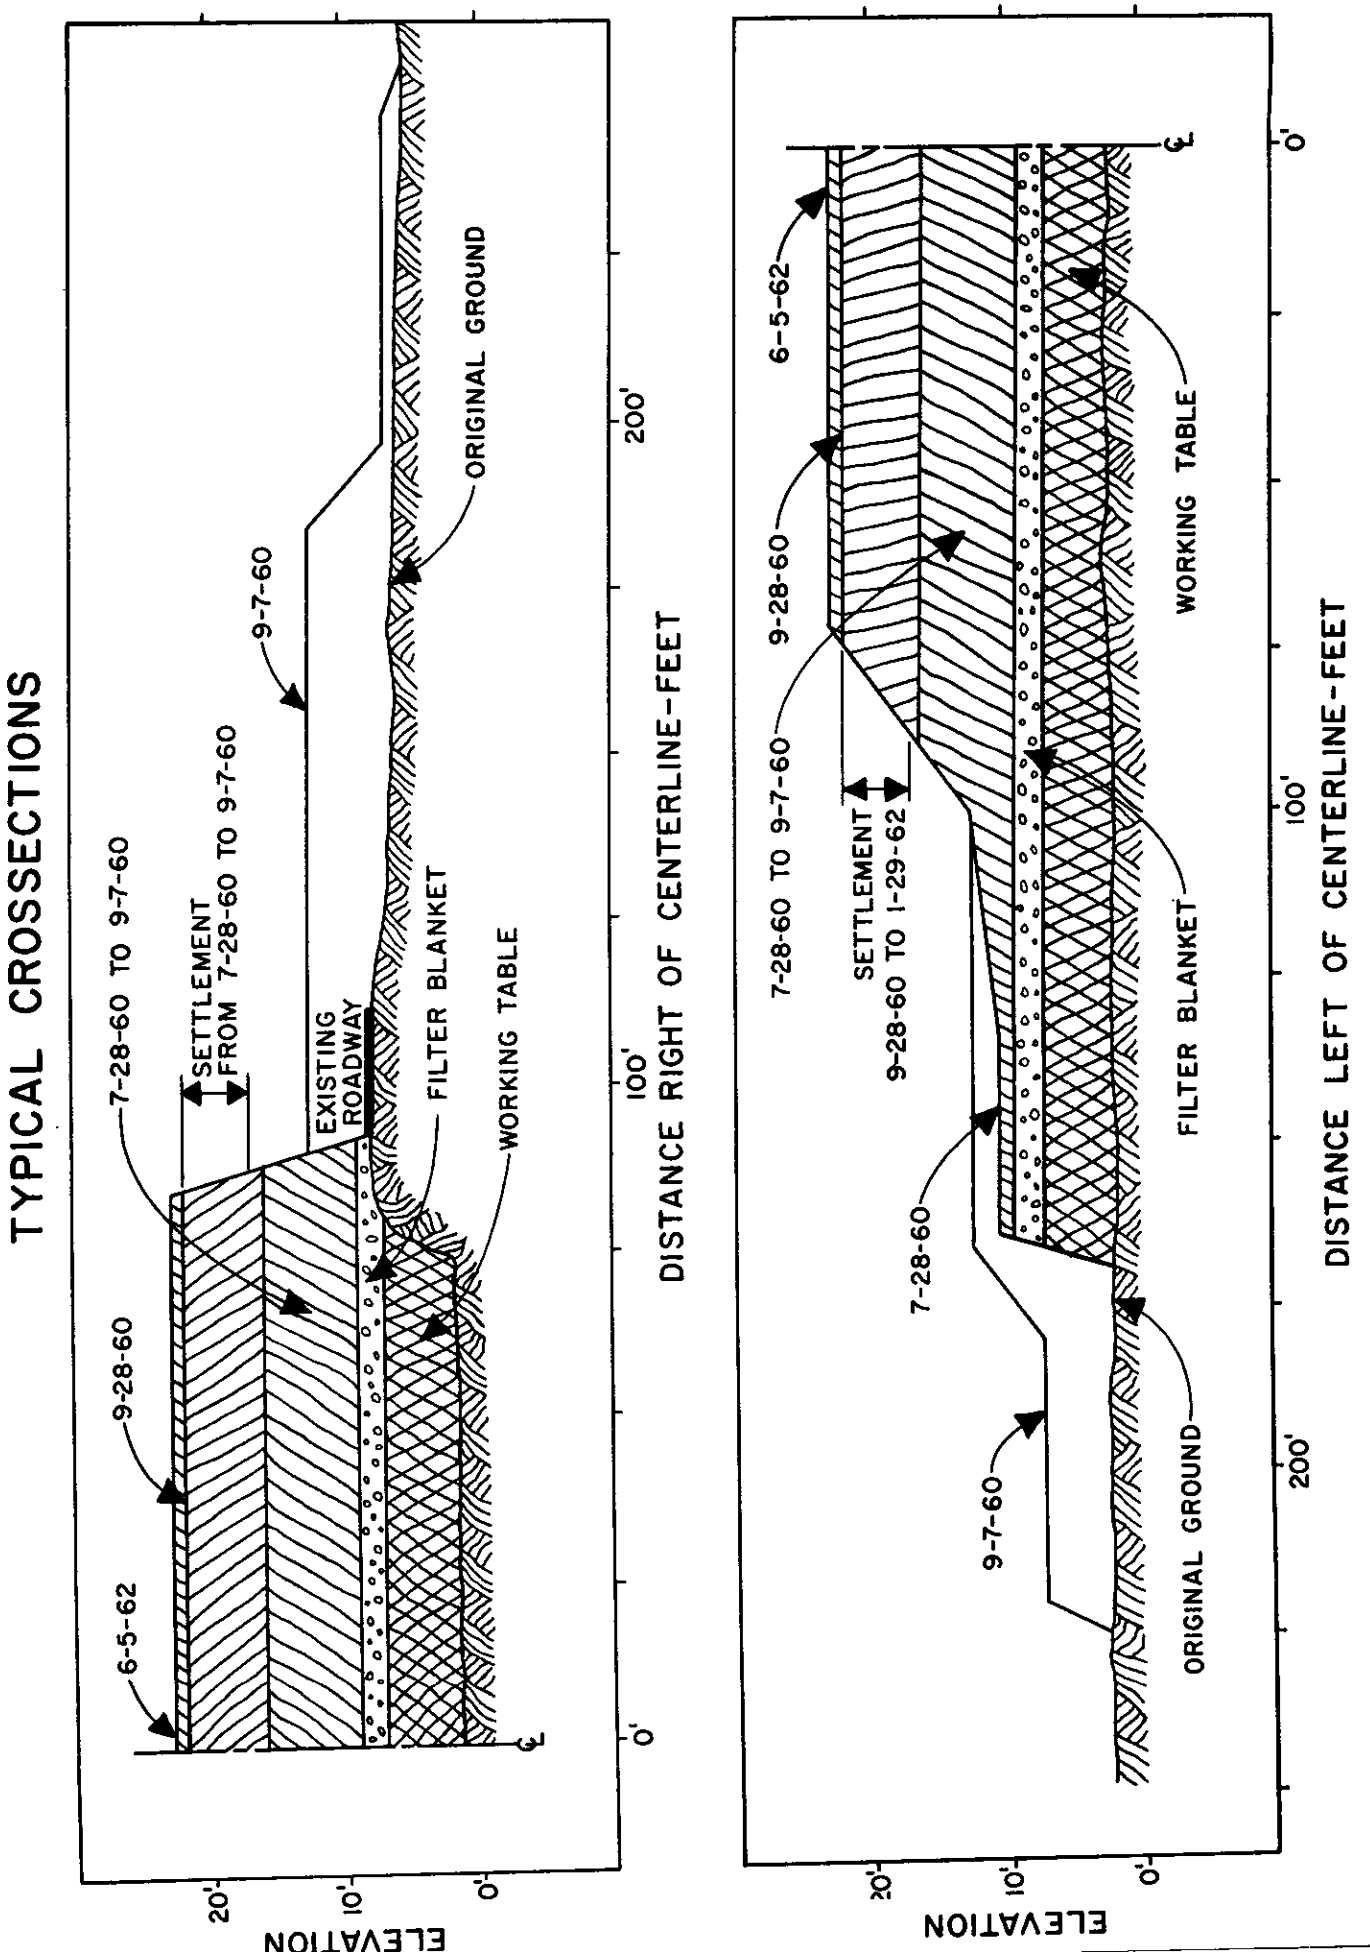
FIGURE 2

of the fill was then started at a rate of one and one-half feet per week. After the main fill reached a height of about 17 feet cracks appeared, with the right side tending to move excessively (see Figure No. 2).

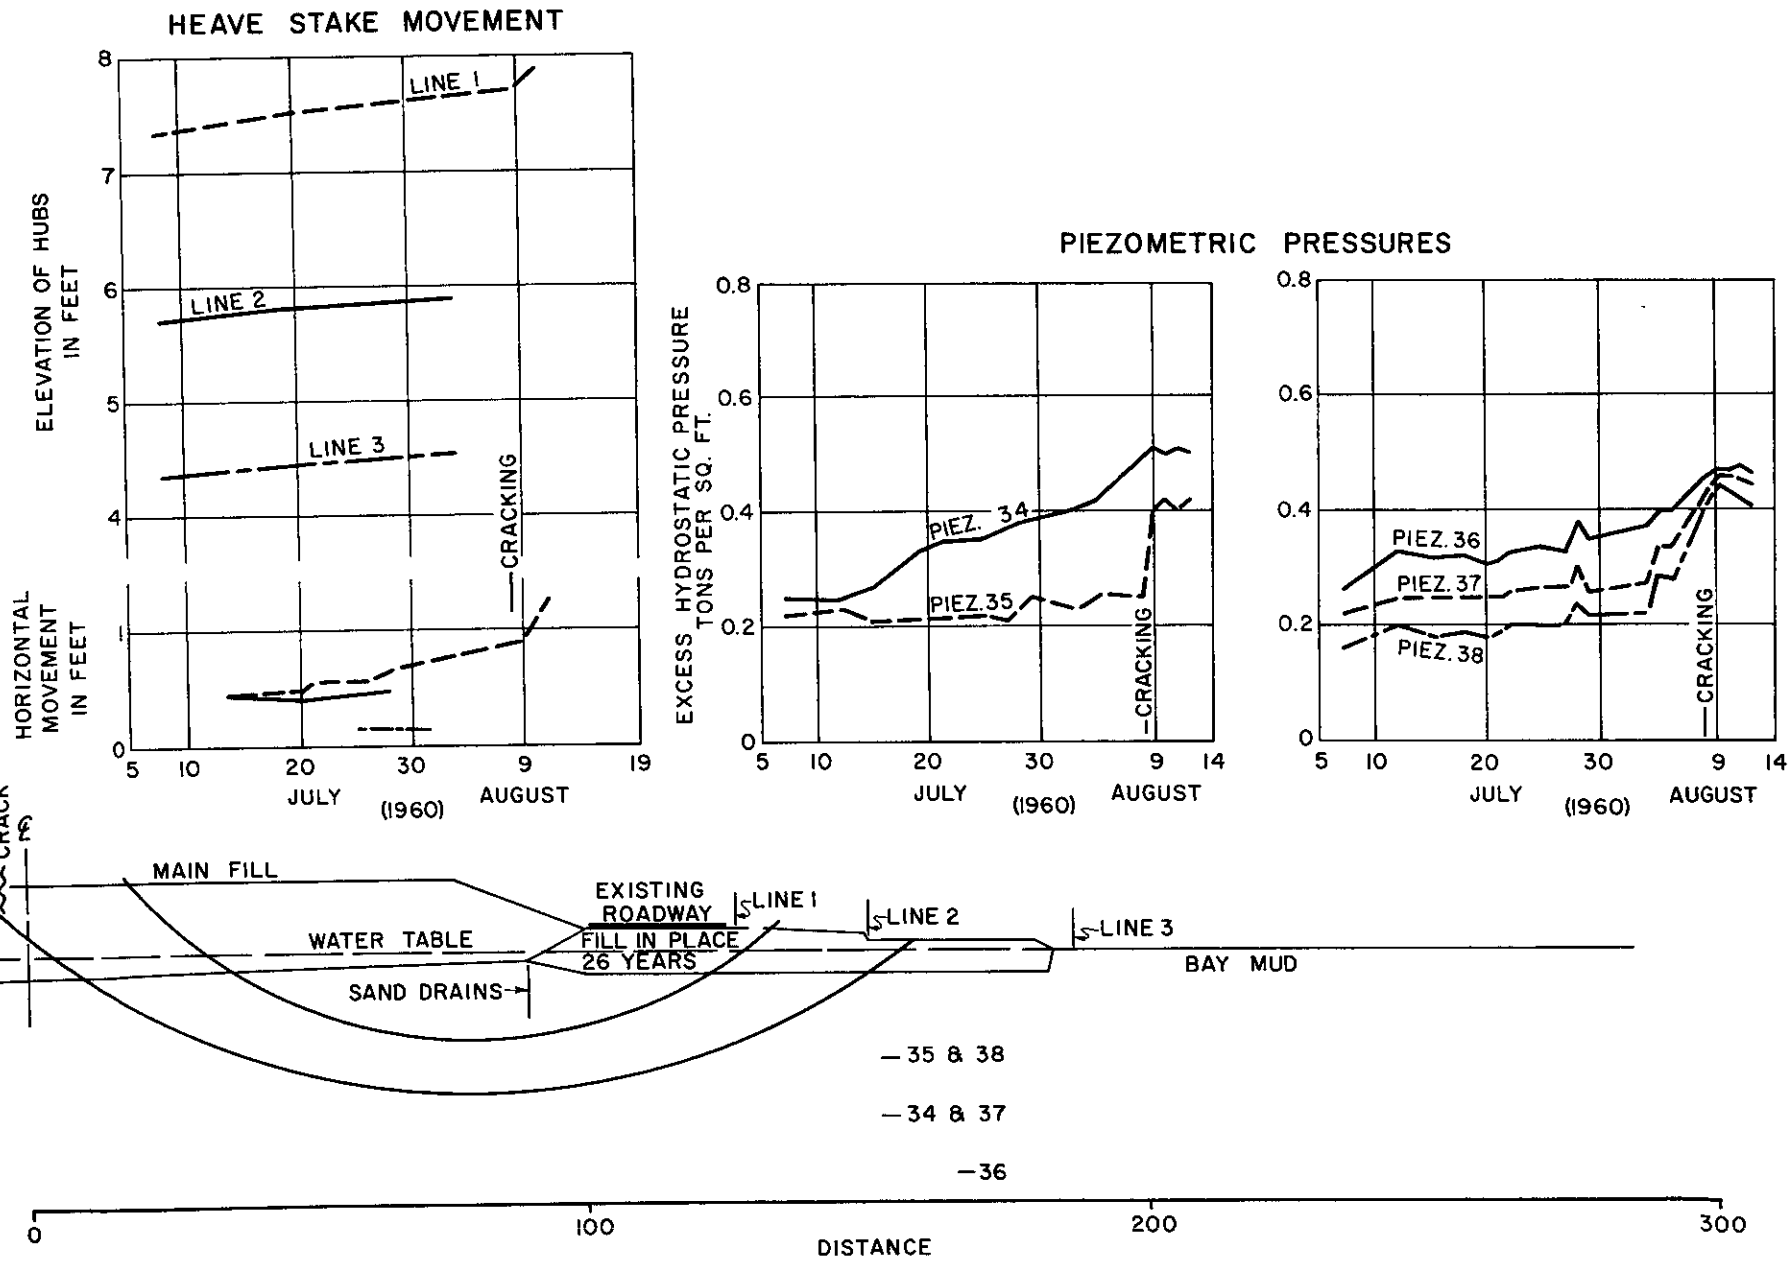
FIGURE 3

A cross-section of the fill is shown in Figure No. 3 along with the minimum failure arc. Stability analysis indicated that no significant increase in strength of the underlying foundation soil had occurred. Two minimum failure arcs with factors of safety just below unity were located and indicated that heave of the roadway or existing fill was occurring. This was in agreement with the observations that no visible movement of the mud surface to the right of the existing fill occurred, and that the roadway fill was rising.

The heave stake lines were installed on the berms. The failure to the right side produced a heave of the existing roadway and are shown in Figure No. 3. The rate of movement increased at the time of failure, and gave some notice that movement was occurring.

MOVEMENT ON RIGHT SIDE

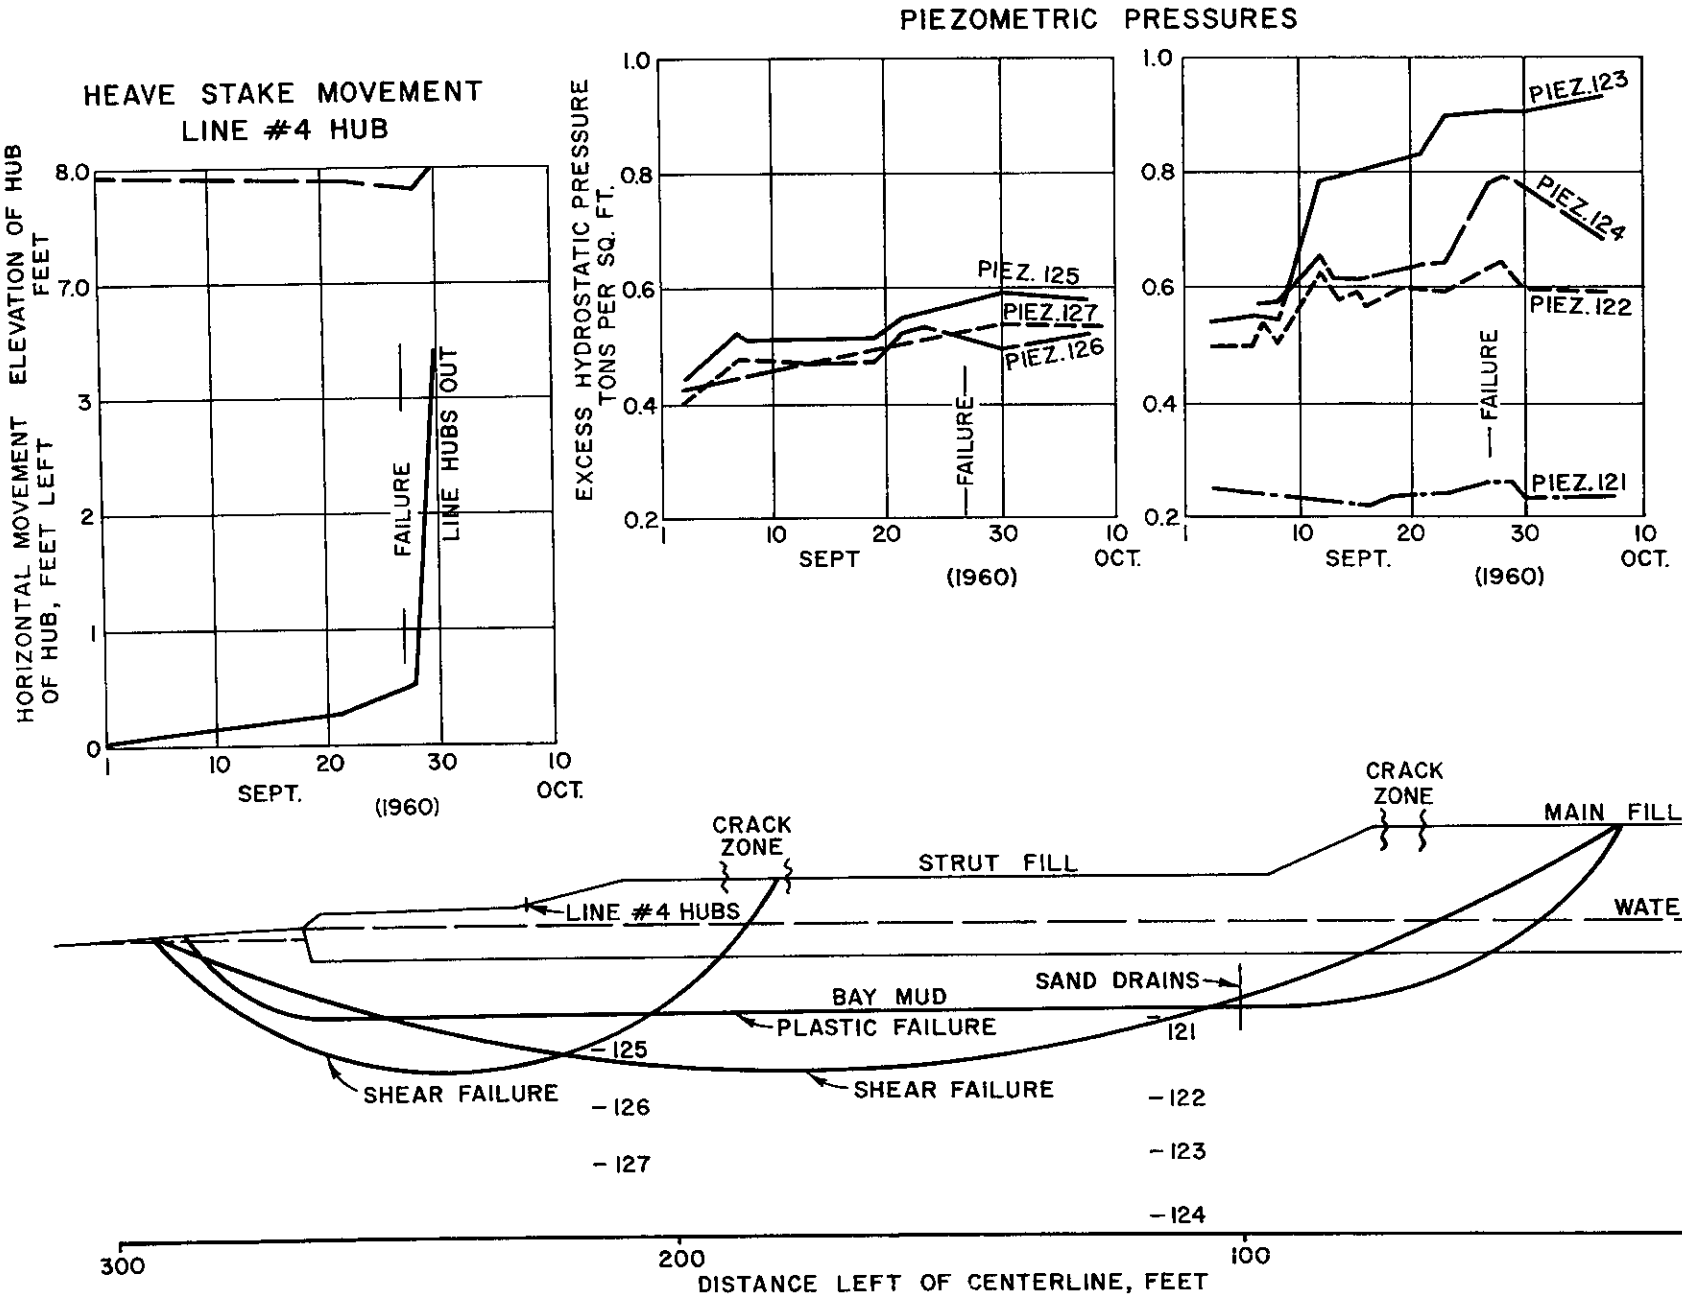
FIGURE 4

The stability analysis of this movement are shown in Figure No. 4. The shear circle analysis indicated a factor of safety of unity existed. Using the stability analysis for plastic type movements developed from analysis of the failures at Candlestick Cove[3], the results indicated a factor of safety of 0.7. The rapid development of a large mud wave and the general appearance of the area indicated that this plastic type of failure had occurred. There was no indication that a significant increase in strength of the soft foundation soil had occurred.

This shallow shear failure through the upper portions of the soft foundation soil was not expected. It had been expected that the upper portions of the soft foundation soil would consolidate rapidly, increasing the shearing strength of the soil immediately

below the berm. This would have resulted in a deeper failure surface with an increased length of the failure plane and in a higher strength soil. This failure surface in the upper portion of the soft foundation soil indicated very wide berms would be required to increase the length of the failure surface so that a stable fill could be constructed. This wide berm would have been uneconomical to construct. An alternative to such a wide berm would be the stabilization of the foundation soil under the berm by means of sand drains.

FAILURE ON LEFT SIDE

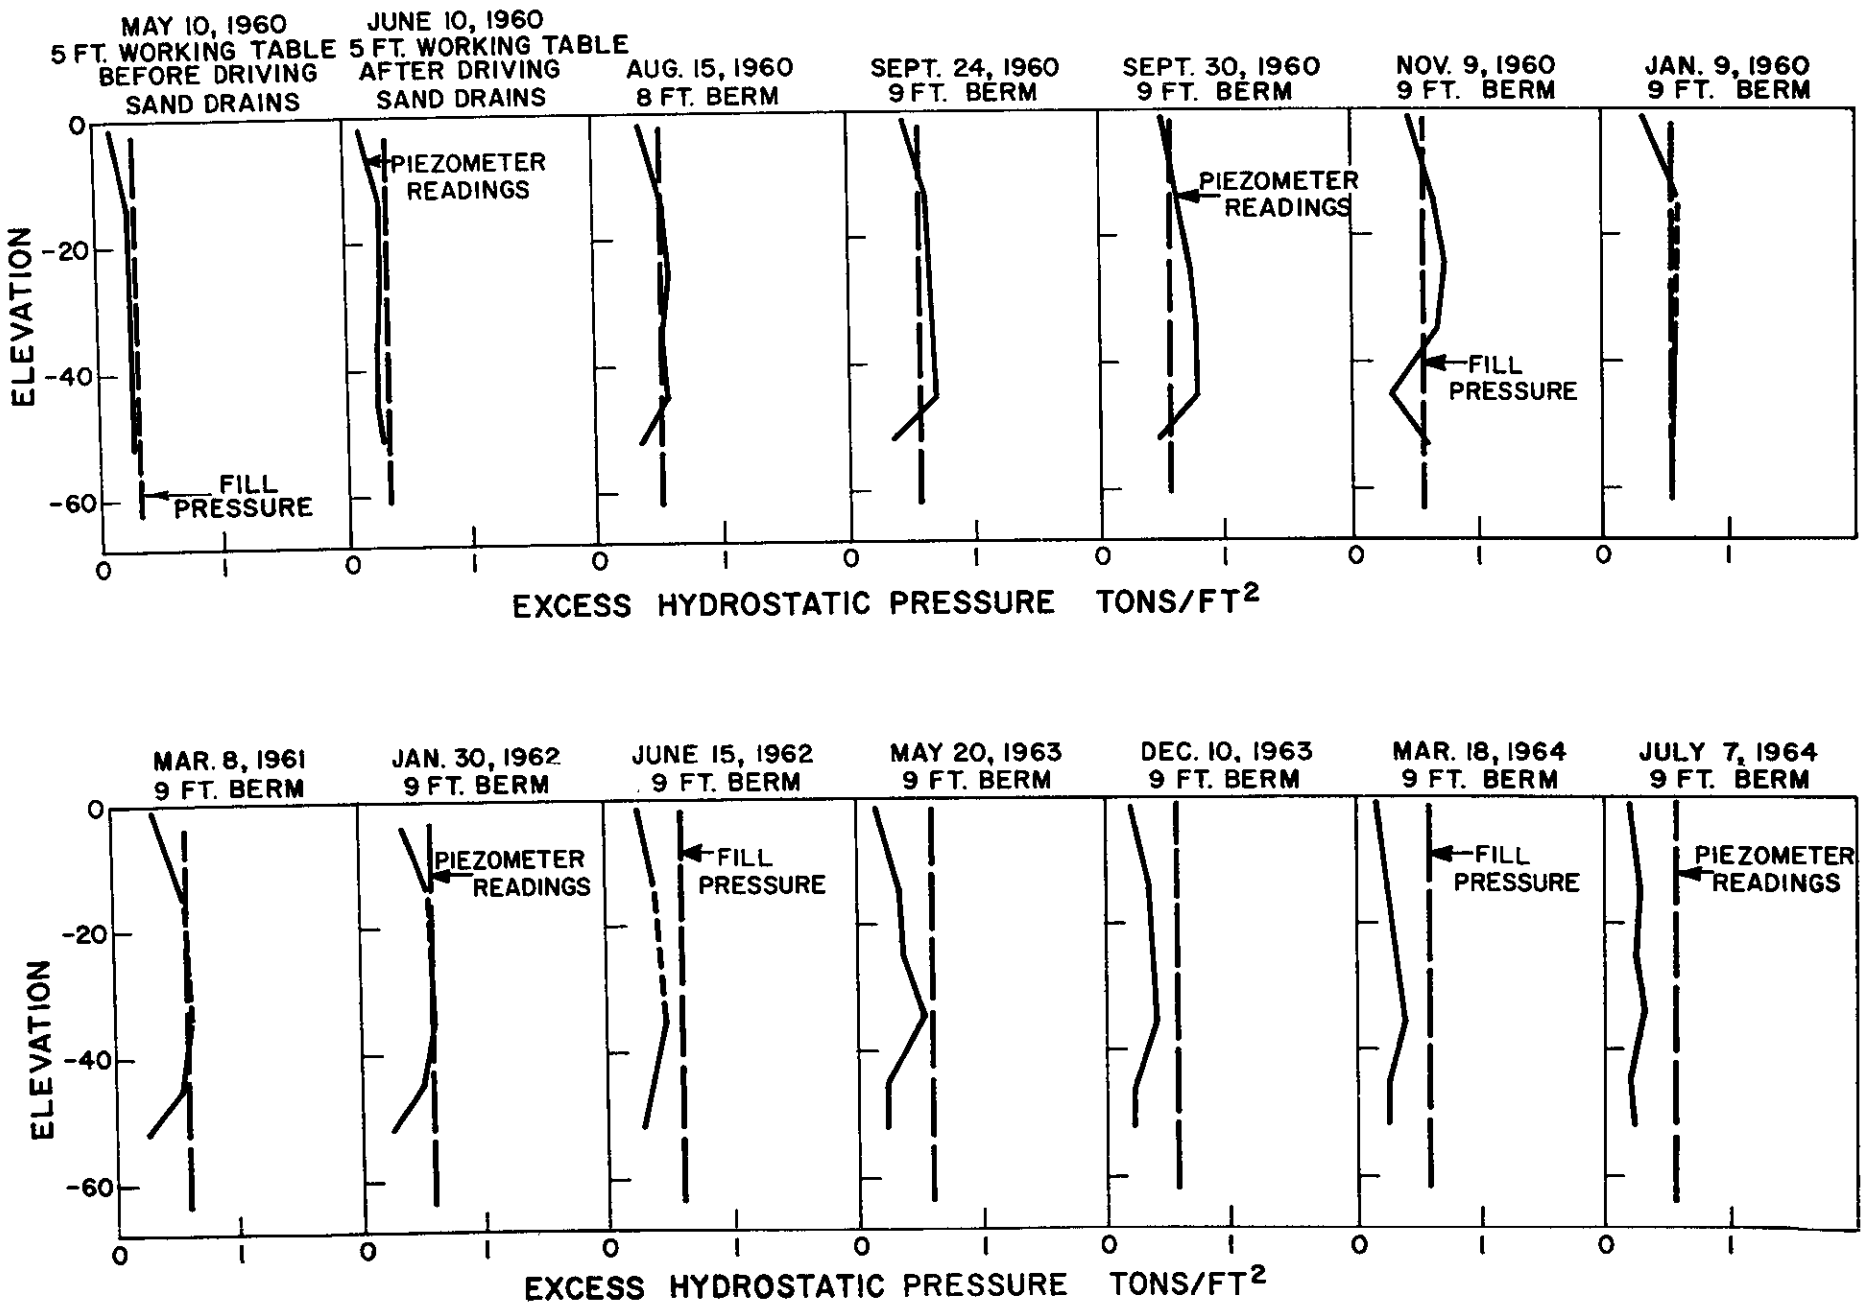
FIGURE 11

In Figure No. 11 this same data has been plotted with excess hydrostatic pressure as a function of depth at given times. The data indicates that at the time of the failure on the left side no significant consolidation of the foundation soil had occurred, which would indicate no increase in strength occurred at that time under the berms. The piezometers near the top and bottom of the layer started indicating a decrease in excess hydrostatic pressure by 1961, indicating that drainage had been occurring. By 1962 a significant decrease in excess hydrostatic pressure in the center of the layer was recorded. At the present time the excess hydrostatic pressure is decreasing as was indicated by the Terzaghi theory of consolidation. The piezometer near the bottom of the layer indicates that the sandy clay and/or peat layer is providing drainage for the soft clay layer. The above data is similar to the data at four other locations in nonsand drain areas and is in agreement with the settlement data at these locations.

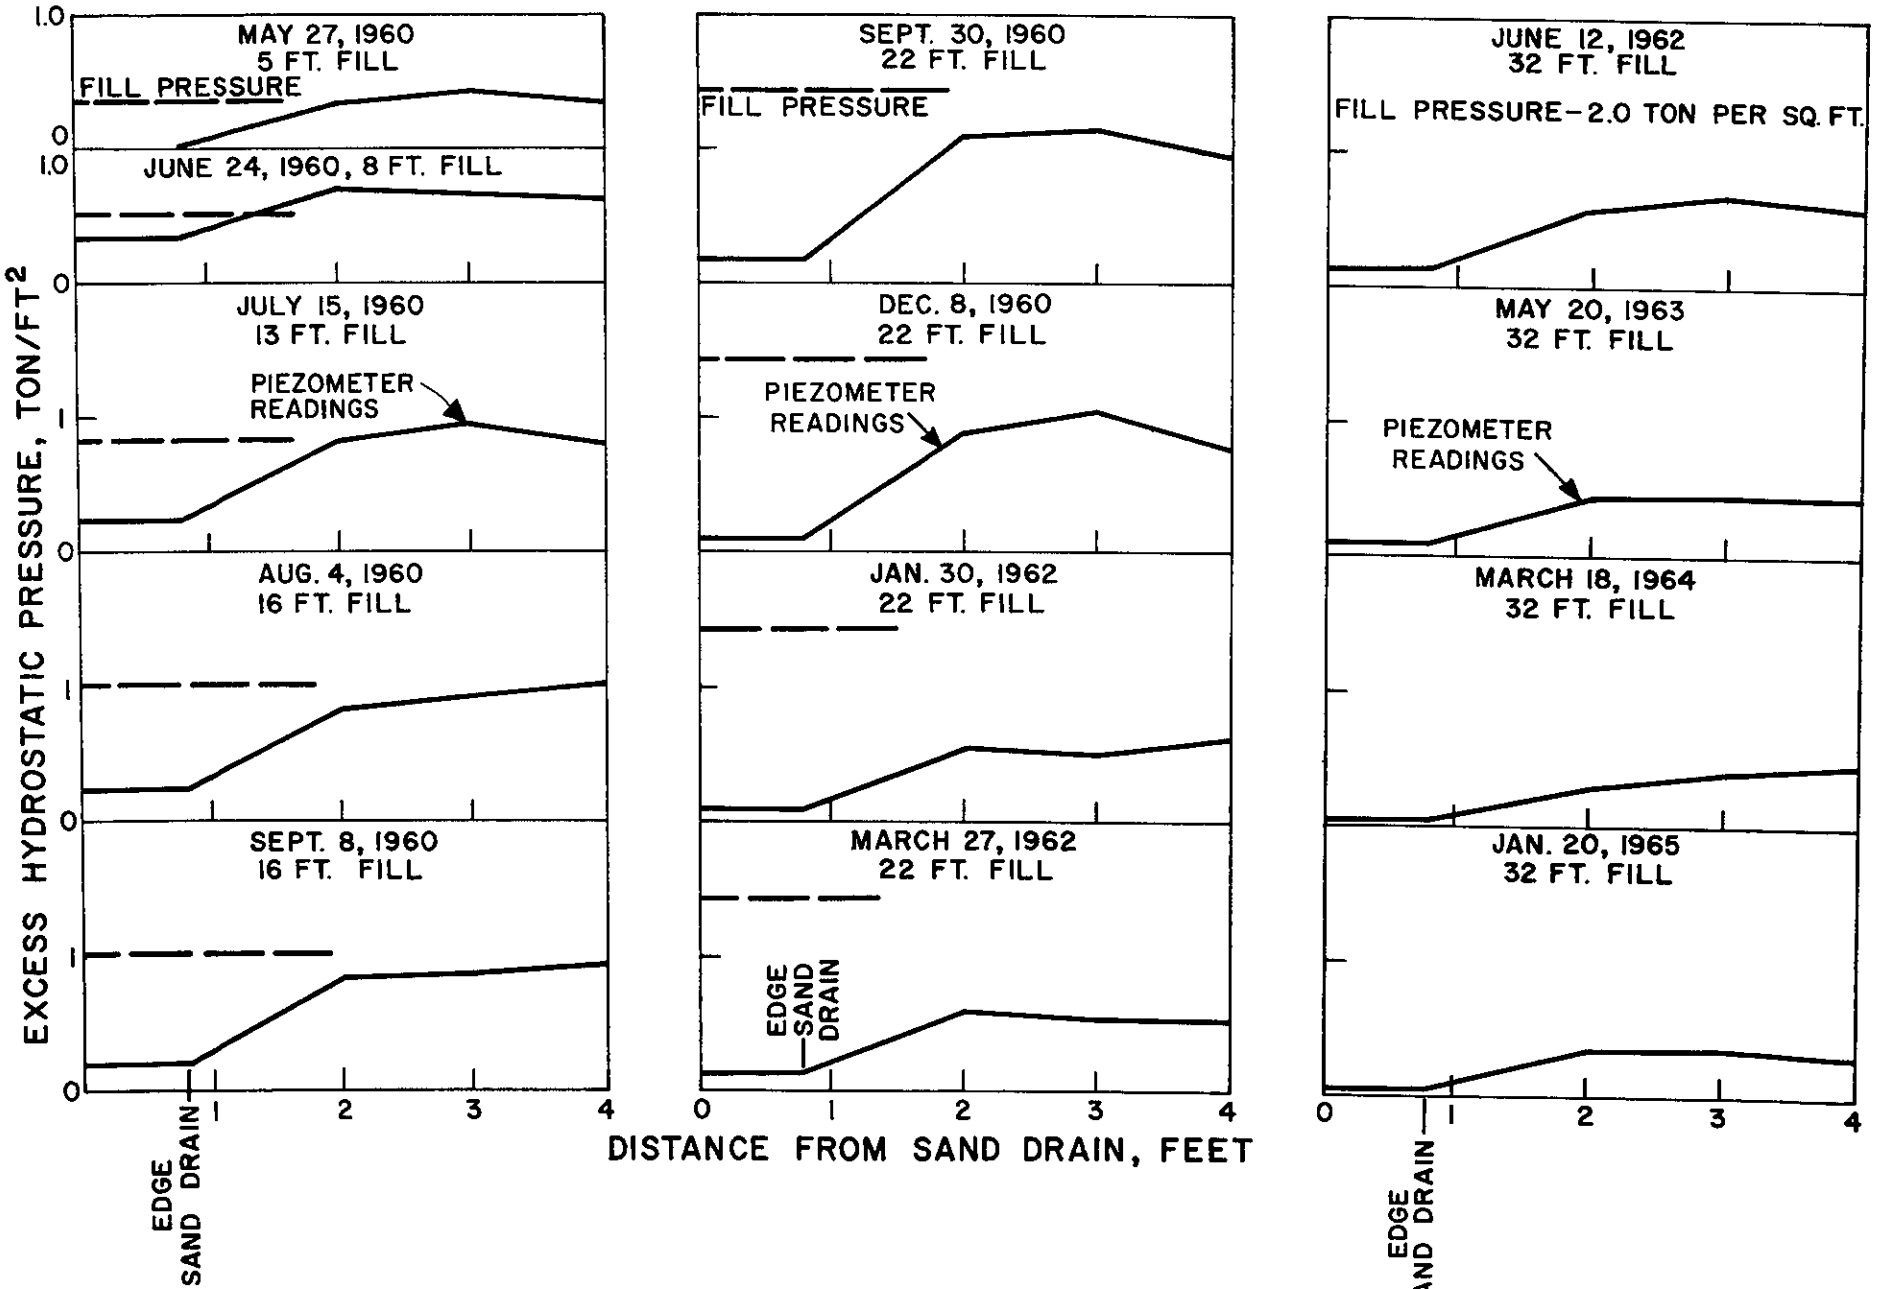
FIGURE 15

excess hydrostatic pressure variation with time. The pressures in the native soil were constant with distance from the sand drain. The excess hydrostatic pressures as a function of the distance from the sand drain at any given time are shown in Figure No. 15. The data indicate that the expected hyperbolic pressure distribution did not develop, even after a period of several years. This condition existed at all three test locations. The blockage of drainage at the peripheral smear zone appears to be the reason for this condition. As a routine operation, the permeability test was performed on each piezometer after it was installed[9]. A review of these data indicated that the permeability indicated by the piezometers one foot from the sand drain was 1/5 to 1/10 the permeability two to three feet from the sand drain. It would thus appear that the smear zone extends outward from the sand drain one to two feet. The permeability two to three feet from the sand drain was slightly lower than the permeabilities indicated by other piezometers prior to the driving of the sand drains. No data was obtained at the same piezometer location before and after driving sand drains. However, the data is fairly consistent at the three test locations.

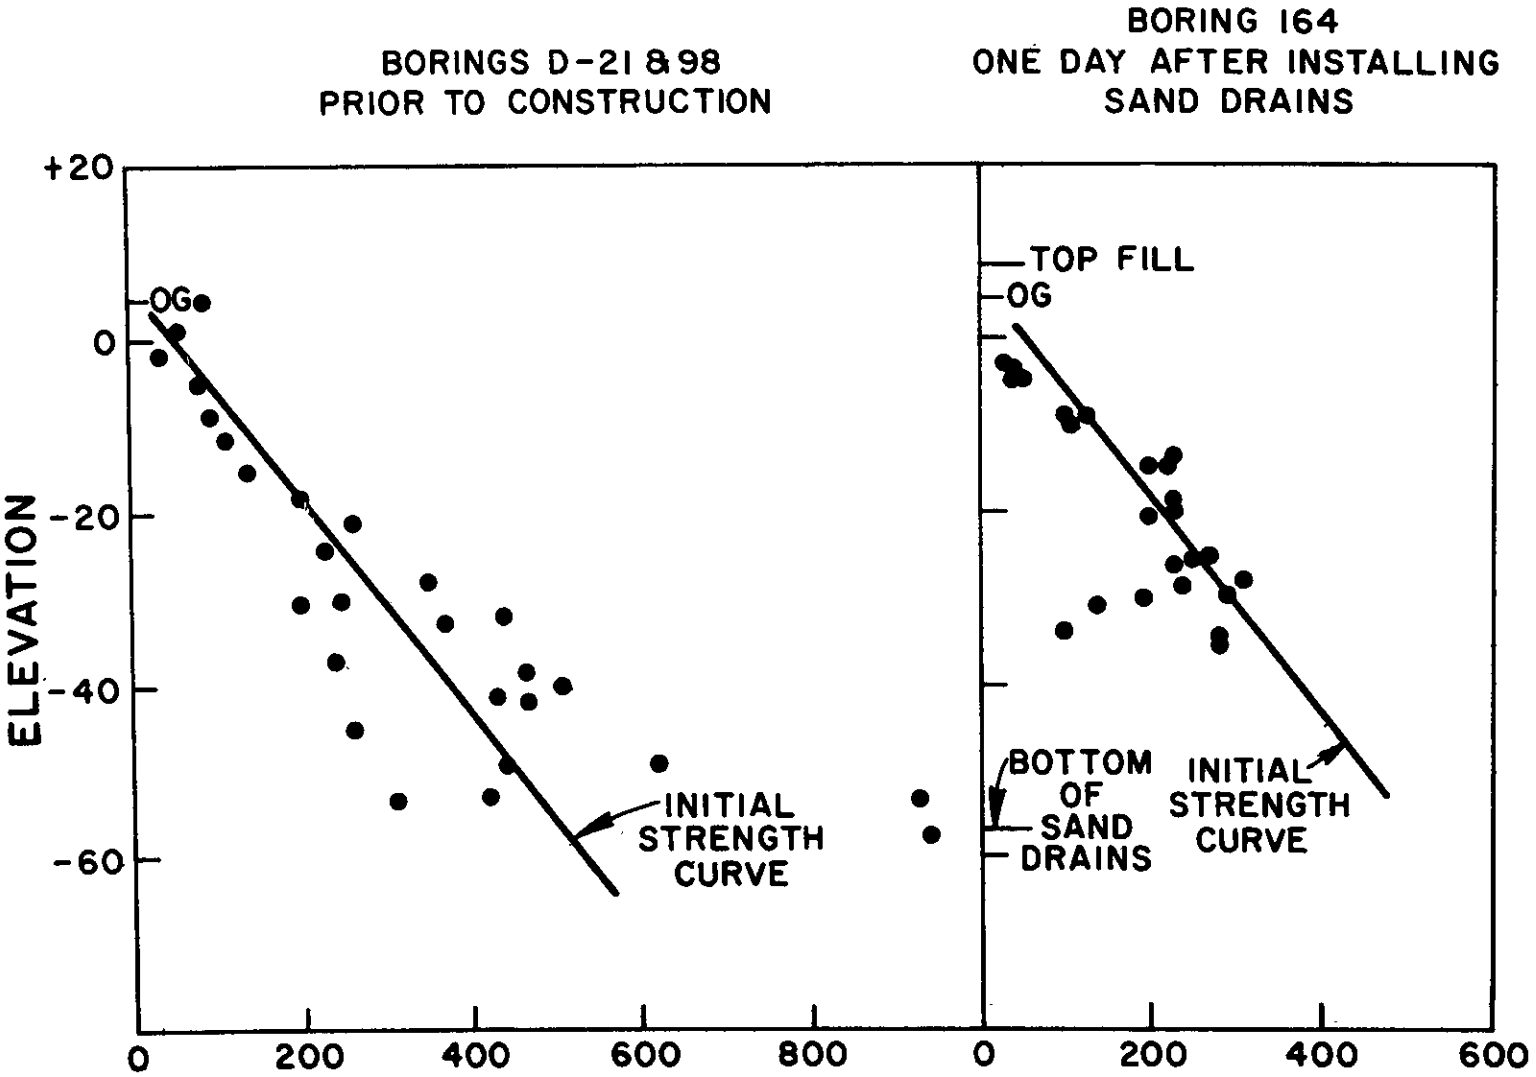
FIGURE 16

To determine the effect of the driving of the sand drains upon the strength of the foundation soil three borings were made one day after the sand drains in three different areas were driven. A typical set of data is shown in Figure No. 16. The borings that were made after the sand drains were driven were an equal distance from four sand drains. The data indicates that no significant change in shearing strength of the foundation soil occurred when the sand drains were driven.

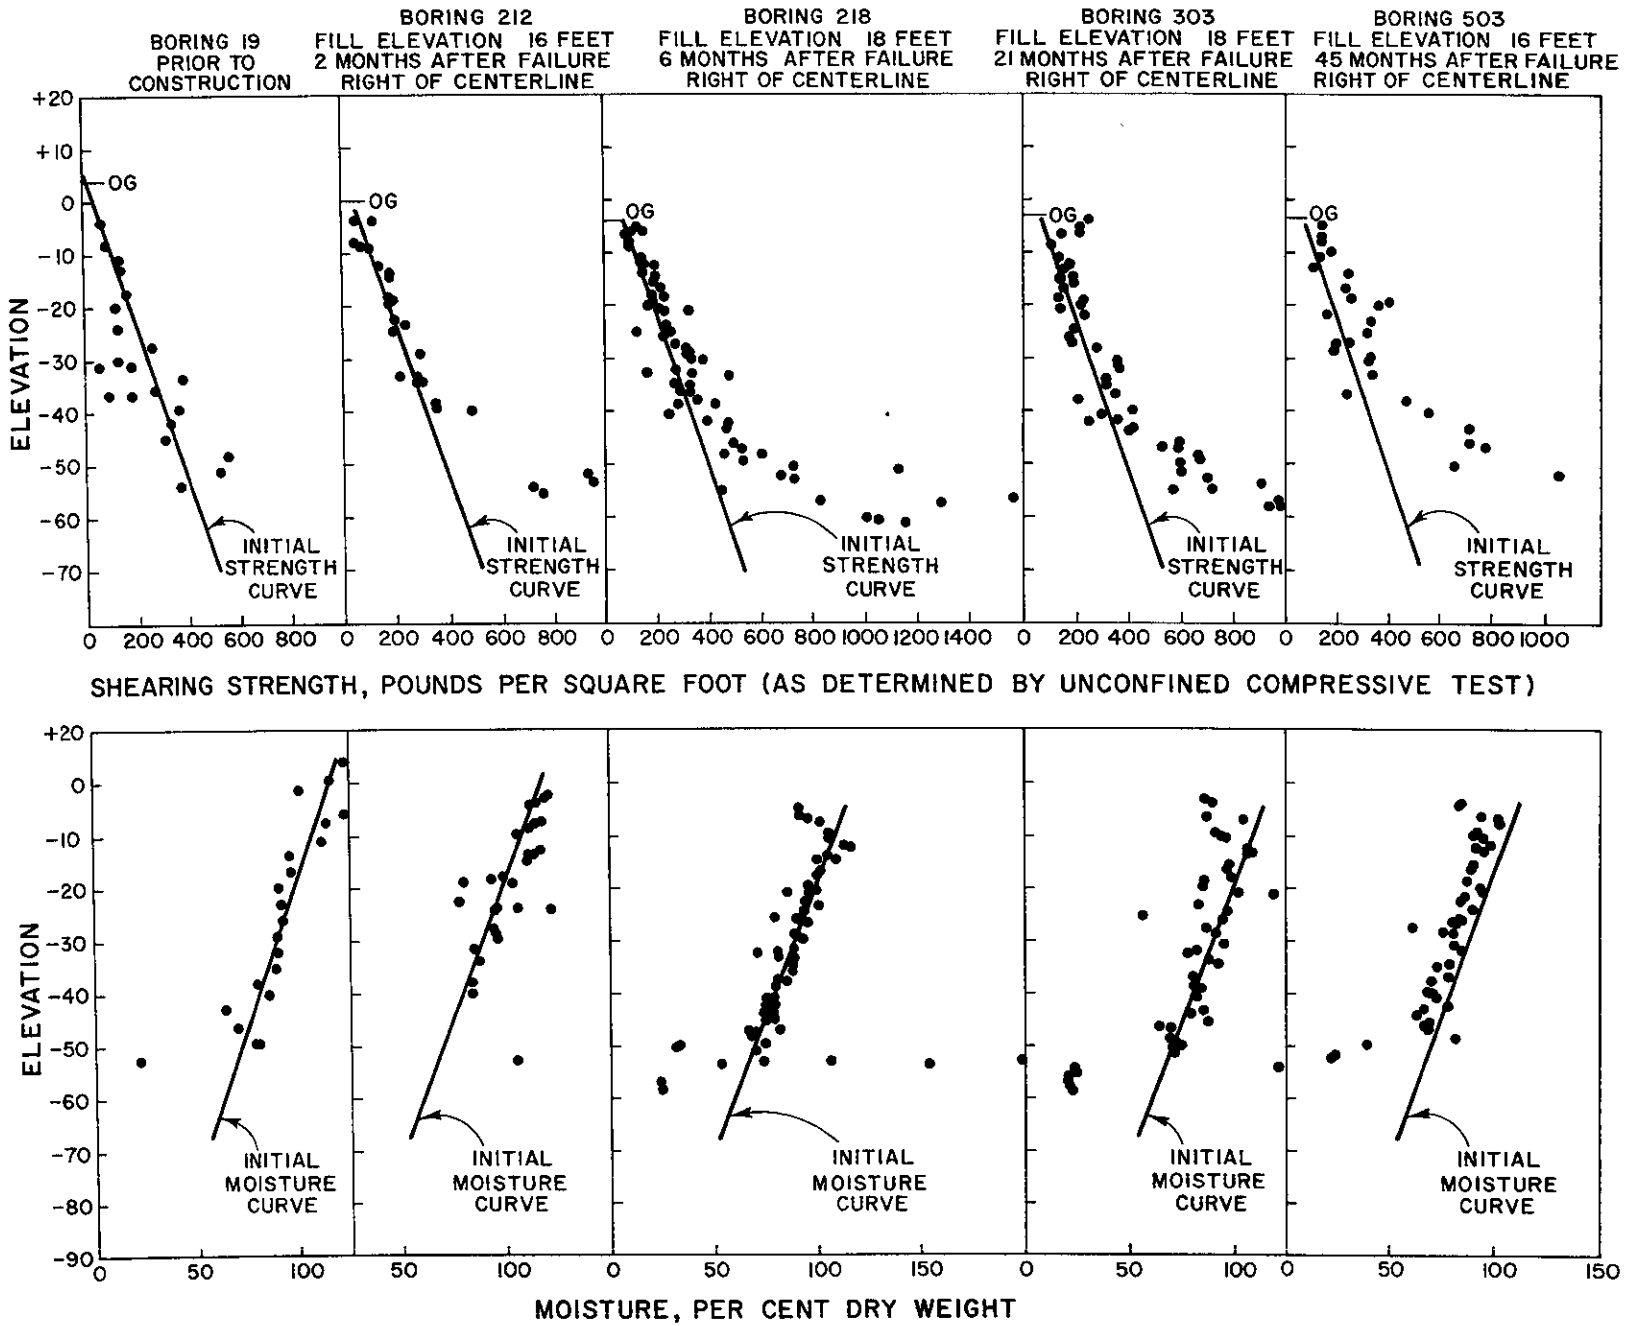
FIGURE 17

The moisture content of the soft silty clay in the nonsand drain areas showed a minor decrease four years after construction. See Figure No. 17. Two years after completion of the fill the moisture decrease was about 3 percent and after four years was about 10 percent.

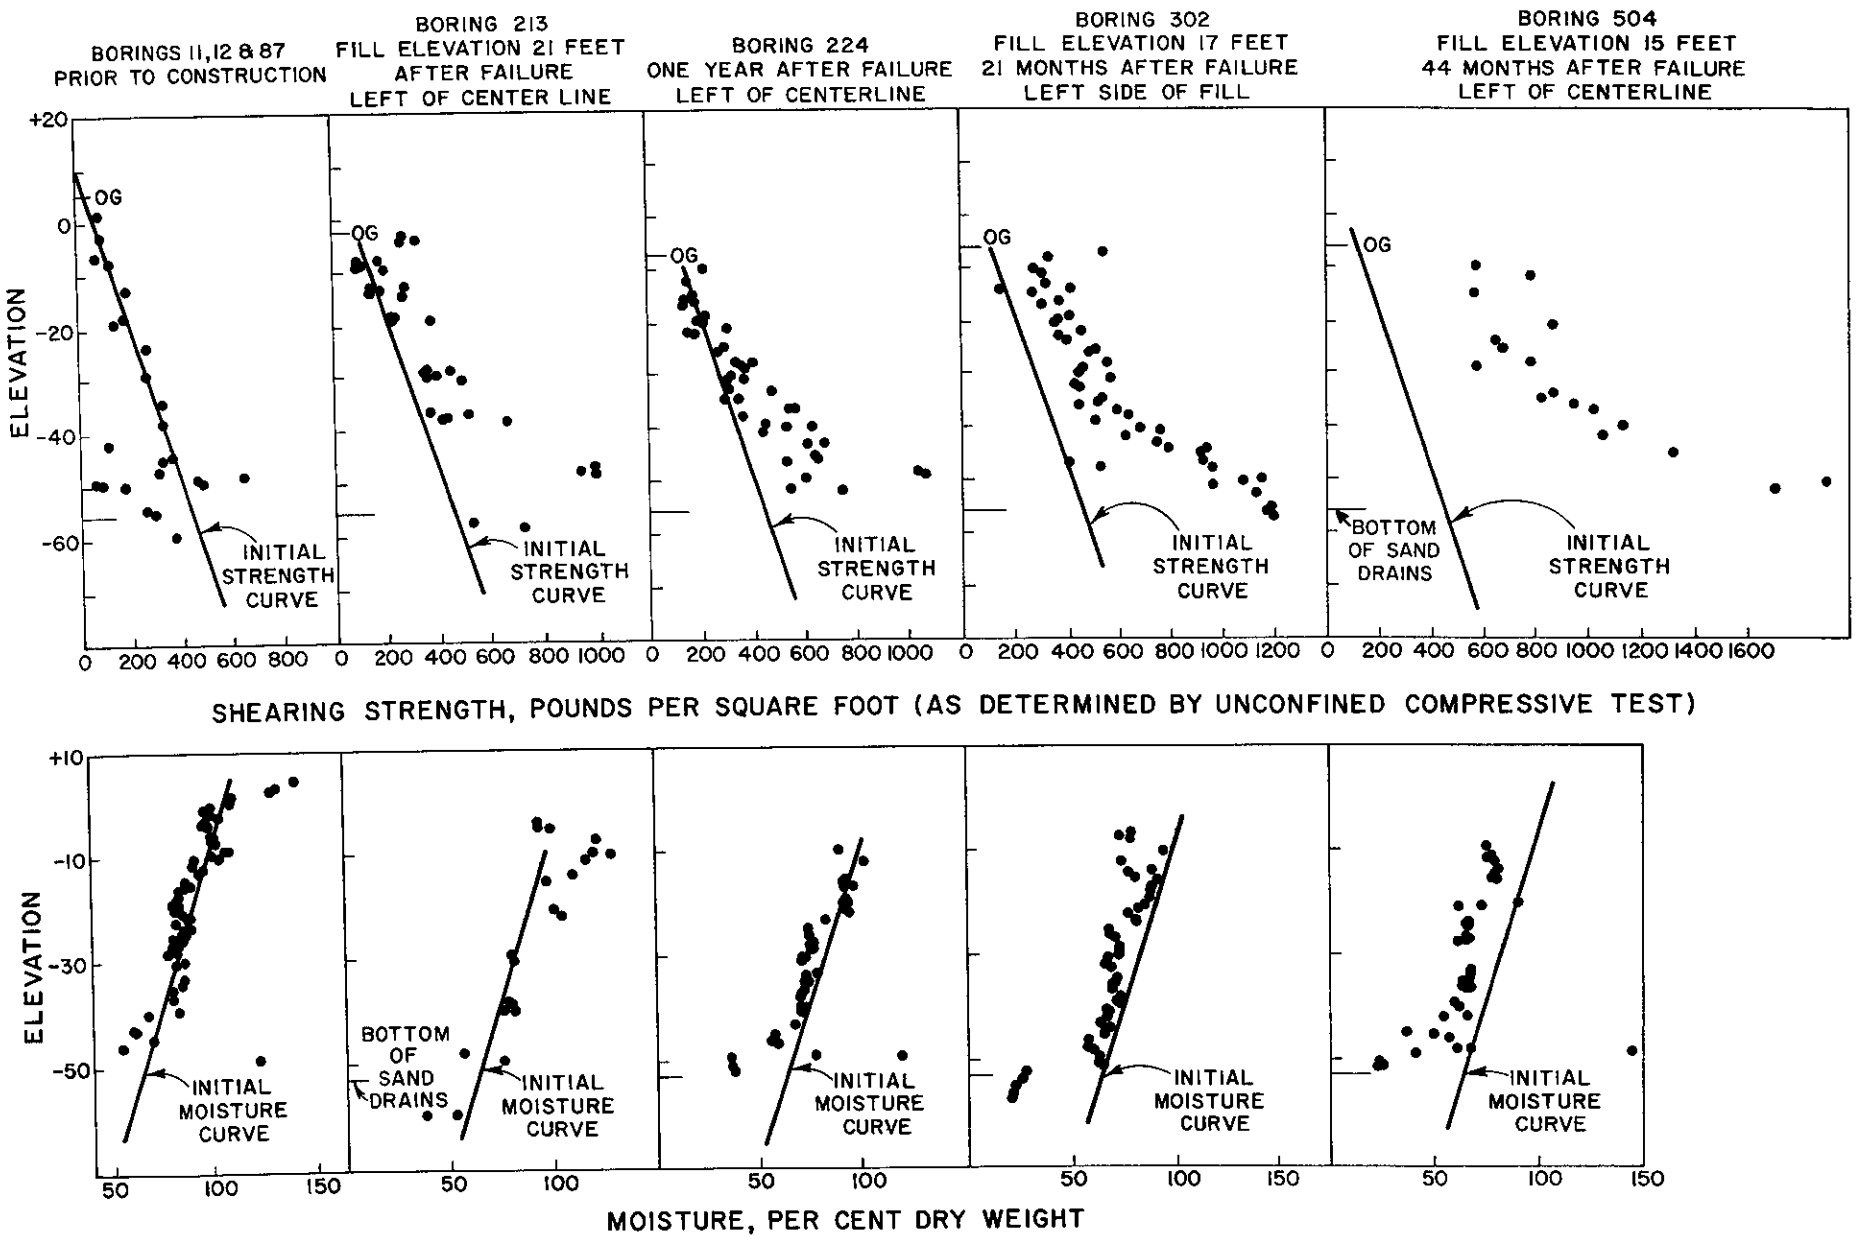
FIGURE 18

A set of representative data at one of the test locations is shown in Figure No. 18. This test area is near the settlements shown in Figure No. 8. All borings in the sand drain area were made equal distance from four sand drains. At the time of failure on the left side there was about a 25 percent increase in shearing strength of the foundation soil in the sand drain area. About two years after the completion of the fill the shearing strength of the foundation soils had increased by 50 to 100 percent, increasing about 200 pounds per square foot at all depths. Four years after completion of the fill the strength of the foundation soil had increased to 600 to 1,000 pounds per square foot which is about what the ultimate shearing strength was estimated to be under the loading of 24 feet of fill.

The shearing strength of the soft foundation soil did not increase as rapidly as was estimated prior to construction. It was estimated that the upper 20 feet of the foundation soil would increase about 50 to 75 pounds per square foot in the nonsand drain area during the loading of the fill. It was estimated that the foundation soil in the sand drain area would increase in shearing strength about 100 pounds per square foot during loading. Neither of these strength increases occurred. This lack of strength increase resulted in the failure of the fill.

The moisture content of the soft foundation soil as determined from the samples from borings in the sand drain areas did not show a decrease during construction. See Figure No. 18. Two years after construction the moisture content had decreased 15 percent and after four years had decreased 20 to 25 percent.
