EXPERIMENTAL SAND DRAIN FILL AT NAPA RIVER

By
William G. Weber Jr.
Senior Materials & Research Engineer

Presented at
45 th Annual Highway Research Board Meeting
Washington D.C.
January 17 to 21, 1966

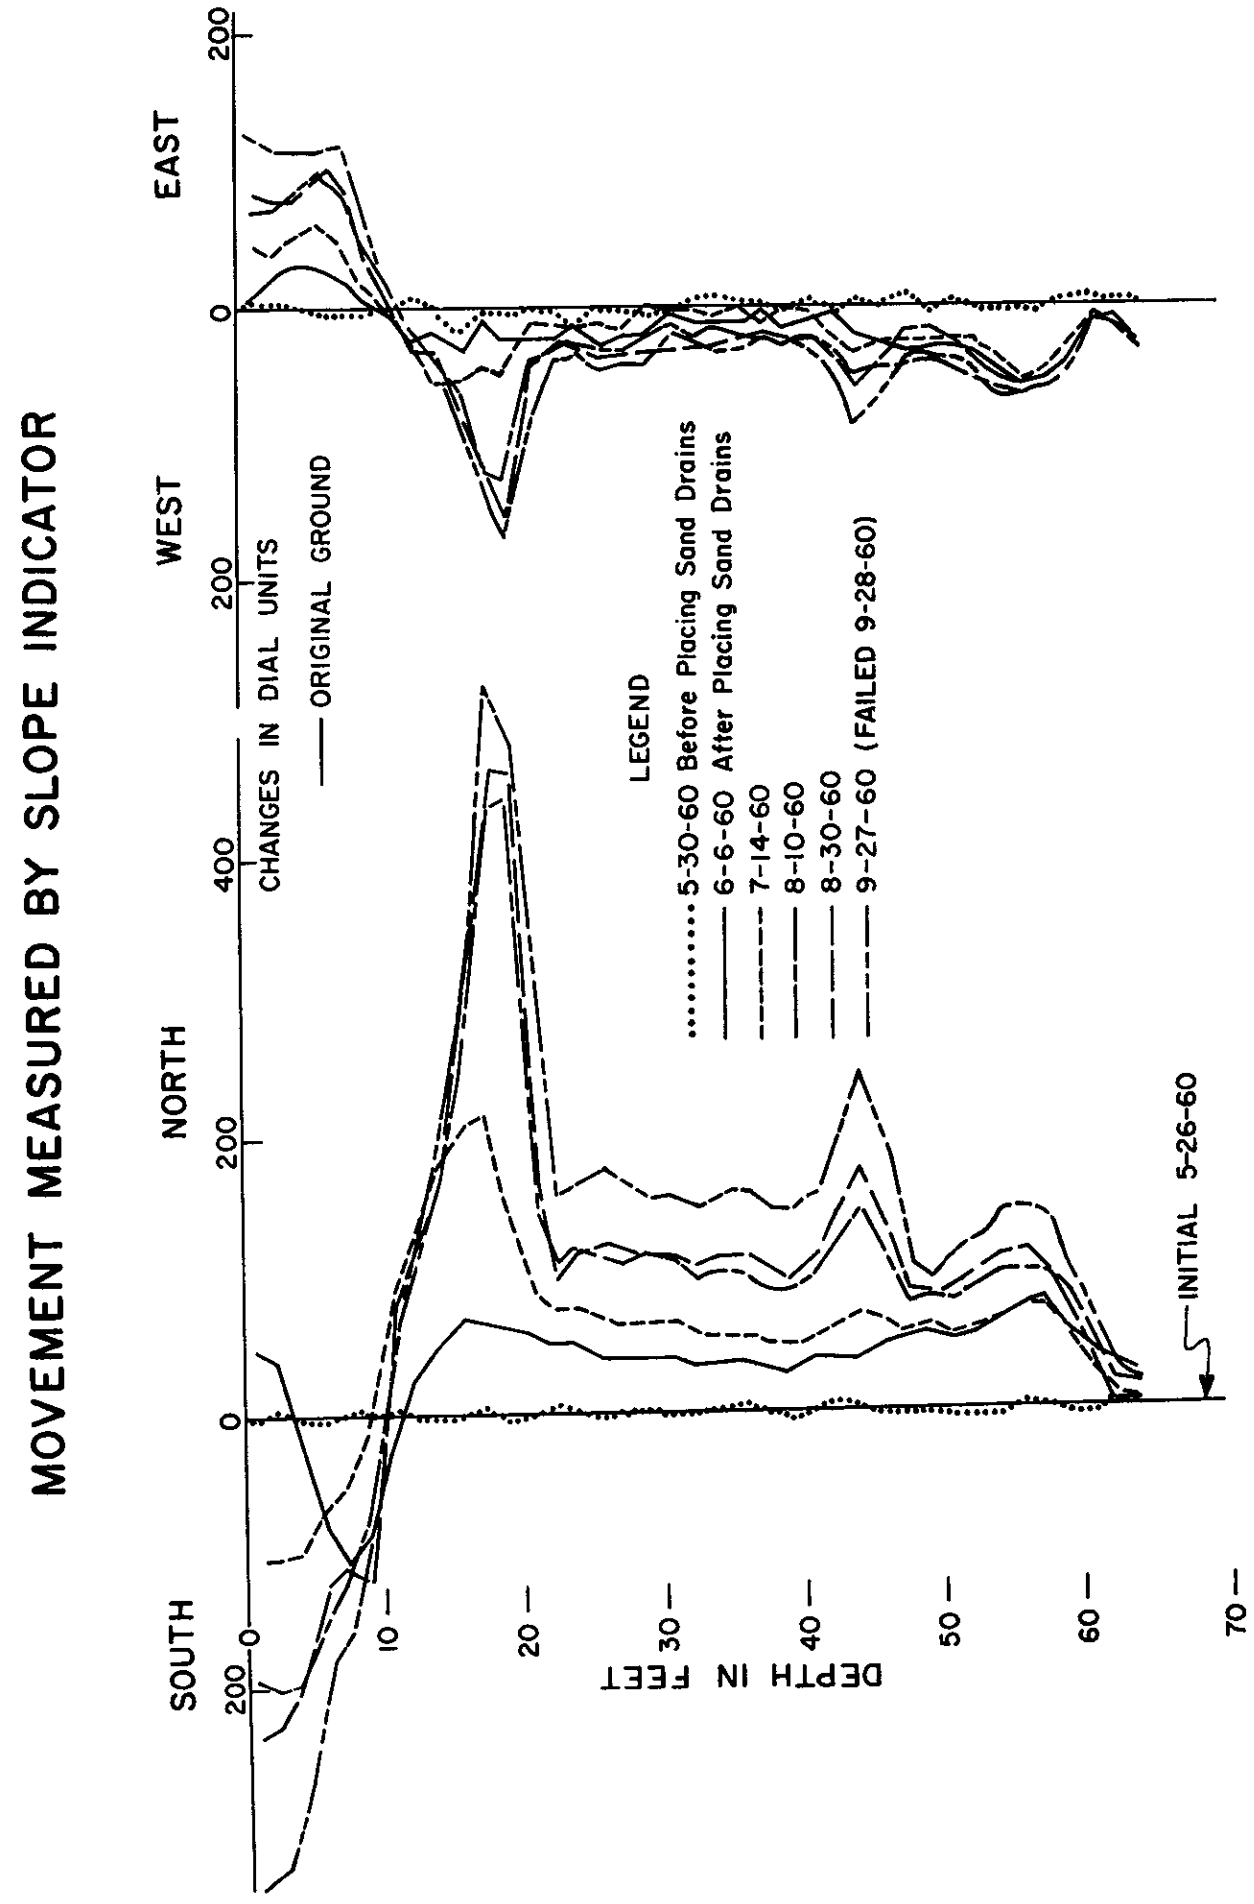
FIGURE 20

The slope indicators were installed when the working table was completed. Two slope indicators were installed ten to fifteen feet from the edge of the future sand drain area. The lateral movement of the foundation soil caused by the driving of the sand drains is shown in Figure No. 20. The soft foundation soil was moved laterally during the contractor's opera-

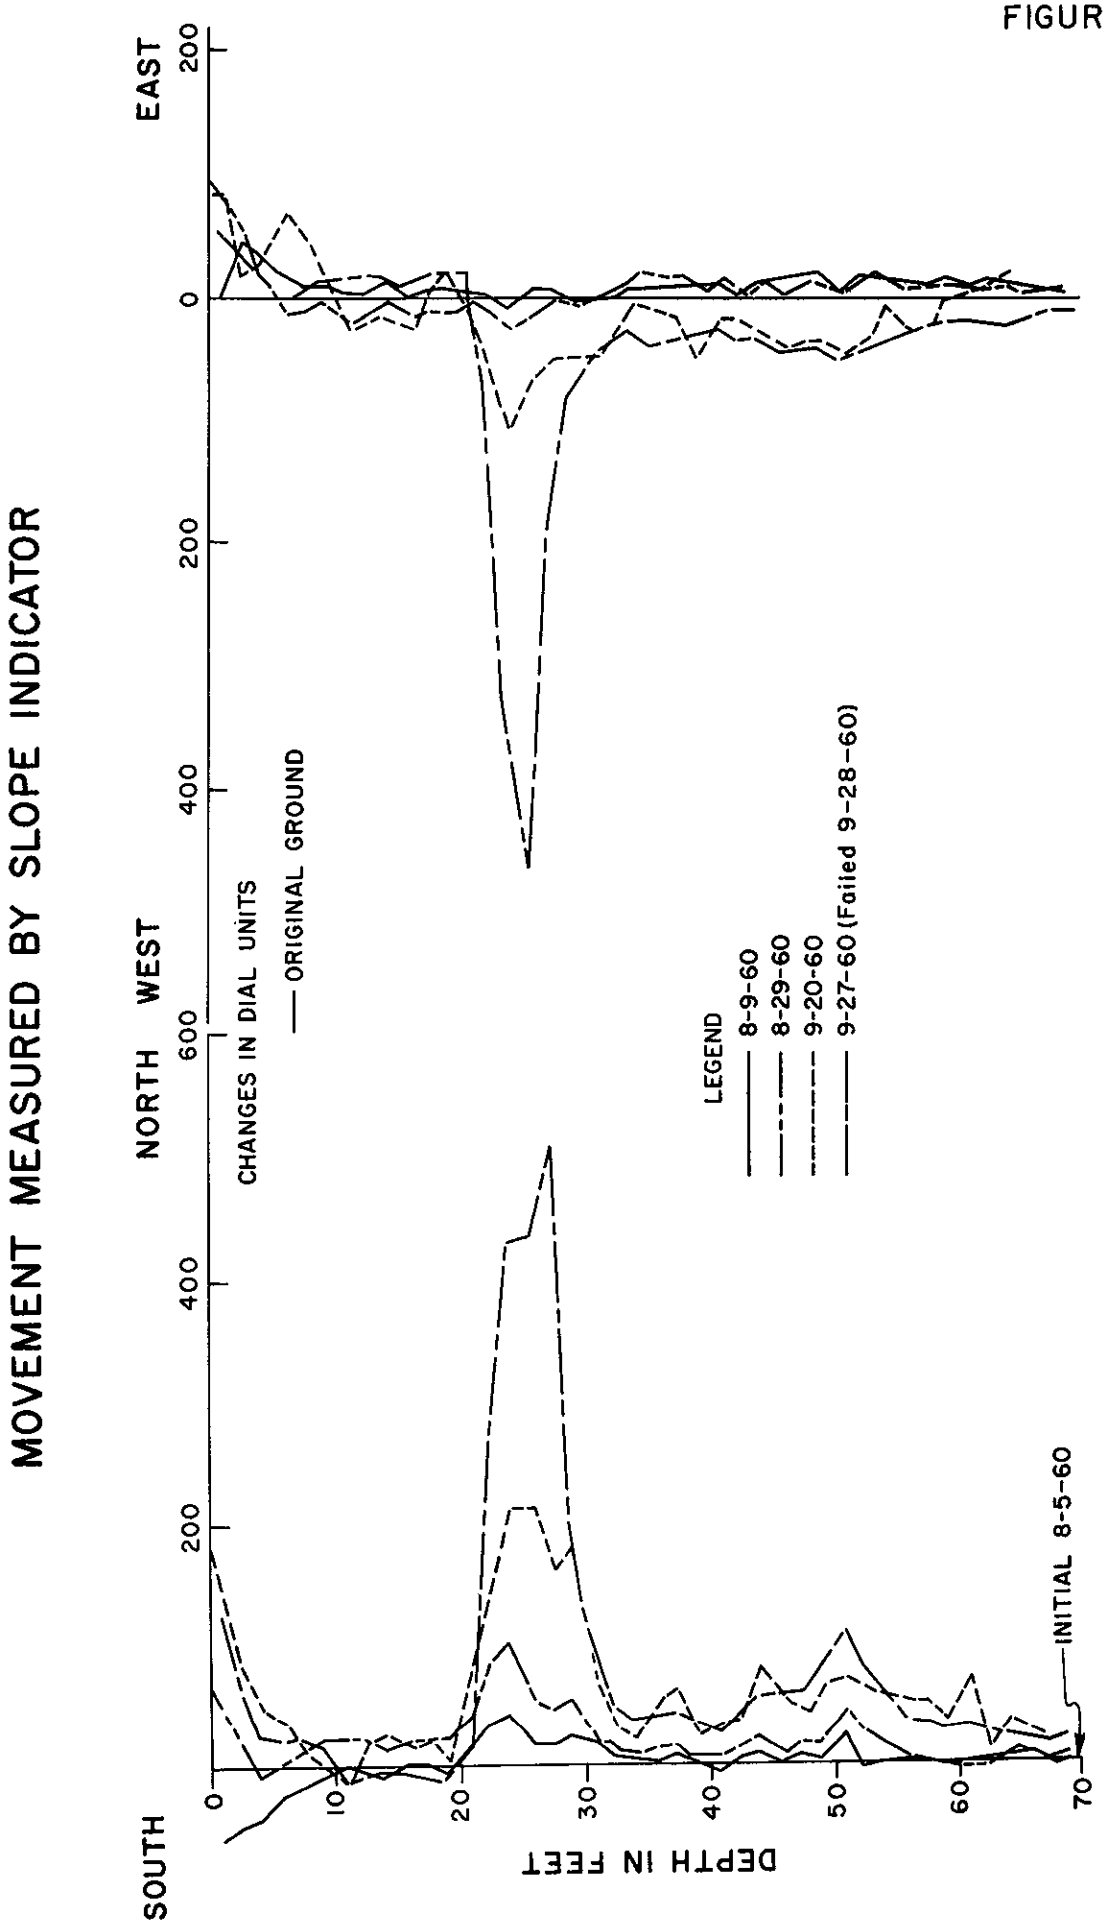
FIGURE 21

The data obtained from a slope indicator to the left of the fill in the area that failed is shown in Figure No. 21. This installation was destroyed during construction and reinstalled after the berms were widened on the left. As loading of the main fill was resumed, after the failure on the right, a minor movement was noted at a depth of 25 feet below the top of the tubing. On the morning of September 27th this installation was read. When the data was reduced and plotted on the norming of the 28th, after the failure, it was found that the slope indicator had indicated a major movement occurred at a depth of 25 feet. This indicates how the time delay is critical in stability problems. On September 28, 1960, it was found that the tubing had failed at a depth of about 20 feet.

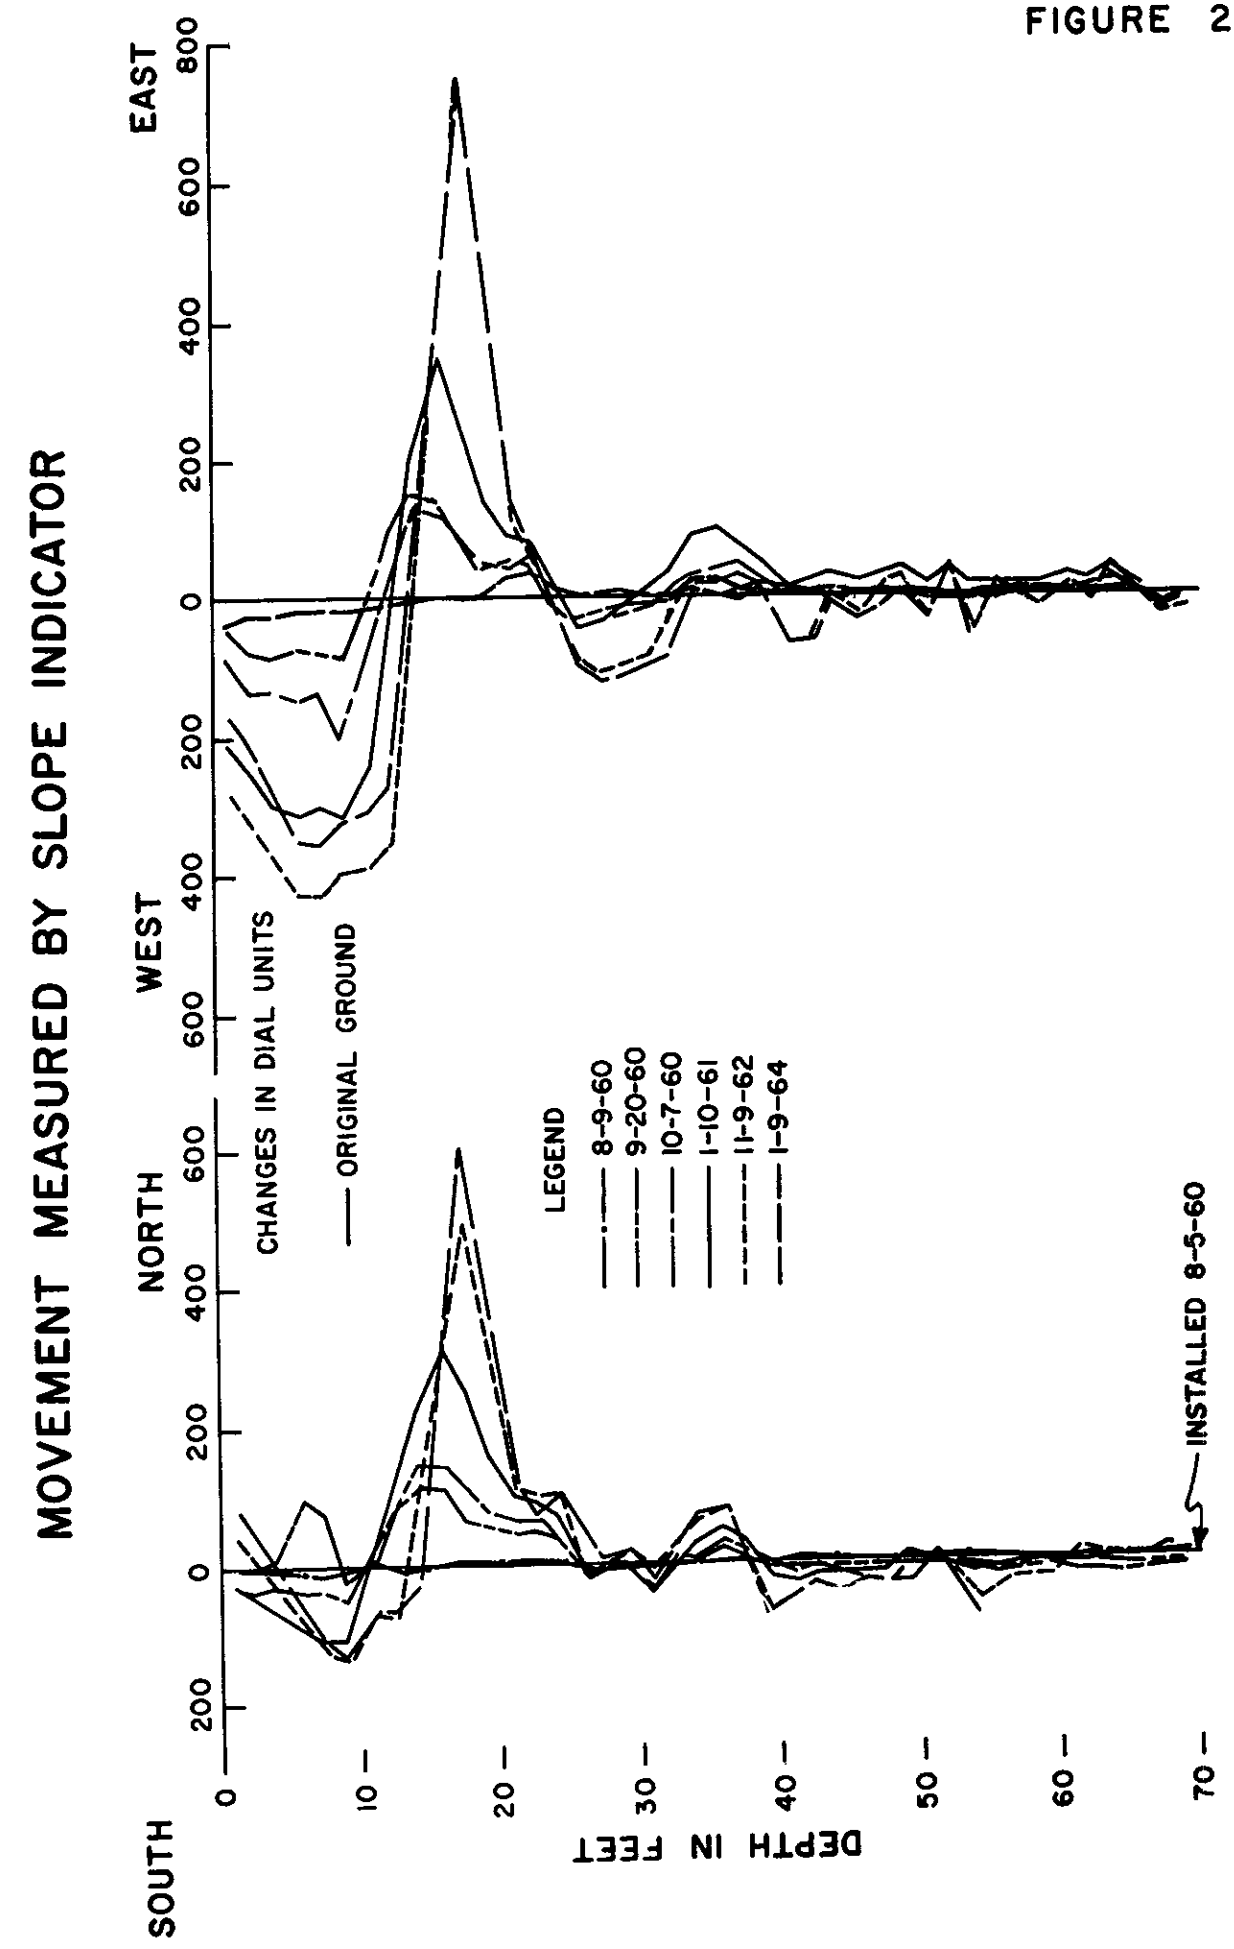
FIGURE 22

A series of long-term readings are shown in Figure No. 22 from an installation to the right side. During the loading of the main fill prior to September 27, 1960, a minor movement occurred at a depth of 15 feet. This movement has continued to 1965 at a fairly uniform rate and is now at the limit of the slope indicator scale. This indicates a movement of the foundation soil is occurring which has not been recorded by the heave stakes. This is evidently a plastic type flow that is slowly occurring. This condition has been noted on several other slope indicators that have long-time readings. However, no cracking or mud waves have been observed.
