A Preliminary Investigation To Determine The Safety And Economic Benefits Of Water-Filled Tube Barriers

A PRELIMINARY INVESTIGATION TO DETERMINE THE SAFETY AND ECONOMIC BENEFITS OF WATER-FILLED TUBE BARRIERS

HOUSE RESOLUTION NO. 203

MARCH 1969

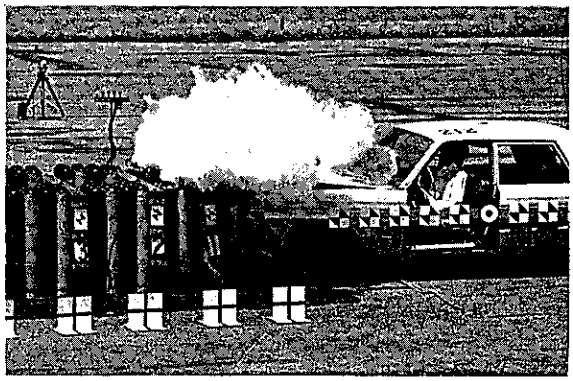
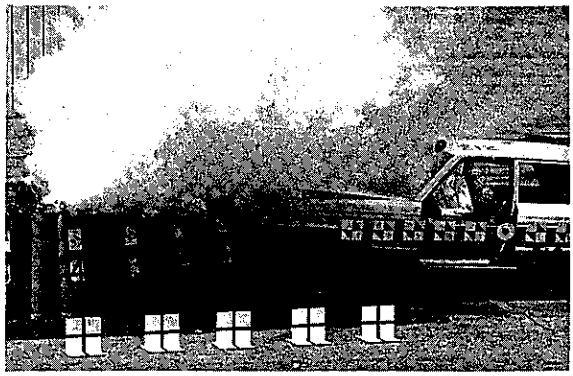
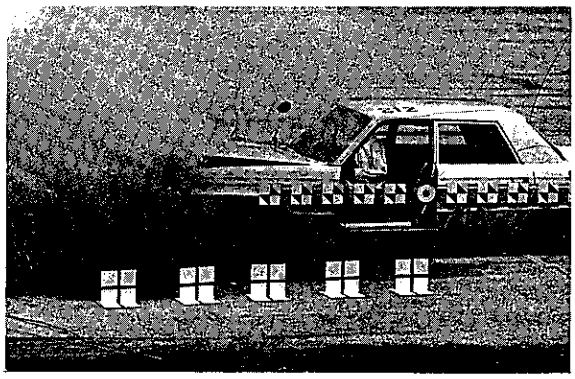
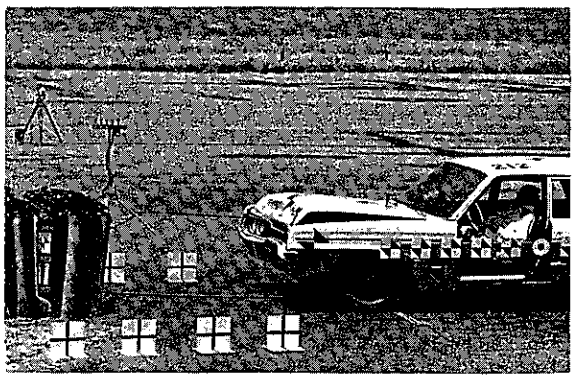
Deceleration was not as smooth as that experienced during the 15 mph test. The maximum vehicular penetration into the barrier was 8'-4". The post-impact position of the leading edge of the barrier was 6'-6" behind its original, pre-impact location. The front of the test vehicle rose 9" during the collision.

Test No.	212
Date	6-27-68
Vehicle	1966 Dodge
Vehicle Weight (W/Dummy & Instrumentation)	4680 Lbs.
Impact Speed	33.3 mph
Impact Angle	Head-on
Dummy Restraint	None

Barrier Depth	15'-0"
No. of Water Tubes	167
Vehicle Peak Deceleration	18 G's
Vehicle Average Deceleration (Highest 40 Ms)	10 G's
Permanent Displacement of Barrier Nose	6'-6"
Maximum Vehicular Penetration	8'-4"
Maximum Vehicular Rise	9"

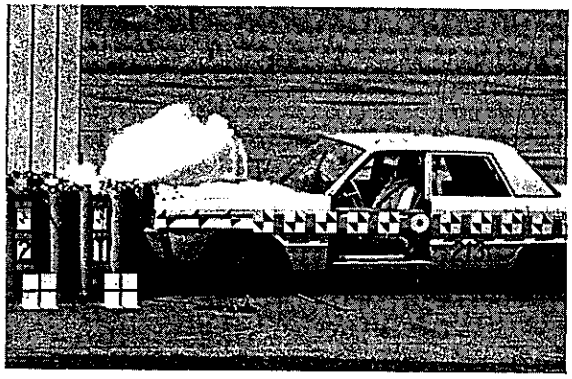
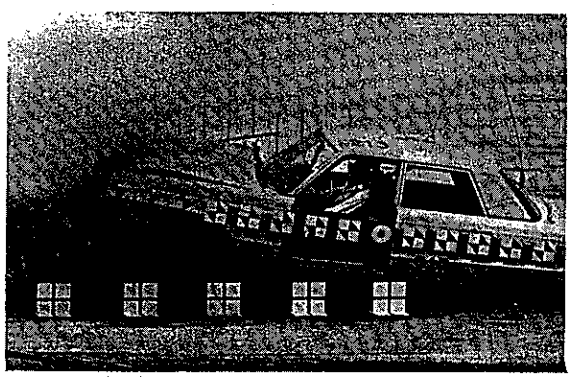
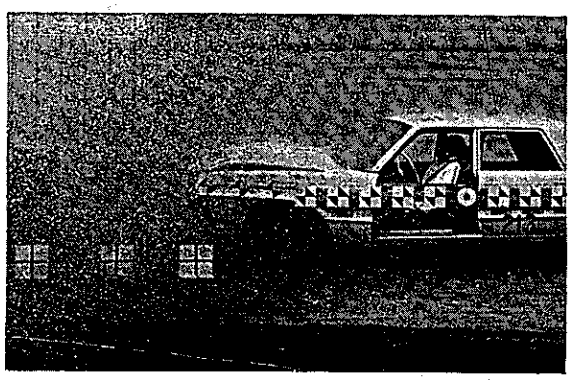
TEST 213

Deceleration was more severe than that observed during the 30 mph test (212). The maximum vehicular penetration into the barrier was 12'-5". The post-impact position of the leading edge of the barrier was 6'-2" behind its original pre-impact location. The vehicle rose 11 inches and rode up on the barrier nose. This vehicular rise accounts for the large difference between total vehicular penetration and barrier displacement.

Test No.	213
Date	8-8-68
Vehicle	1966 Dodge
Vehicle Weight (W/Dummy & Instrumentation)	4600 Lbs.
Impact Speed	48.2 mph
Impact Angle	Head-on
Dummy Restraint	Lap Belt & Single Shoulder Harness

Barrier Depth	16'-5"
No. of Water Tubes	165
Vehicle Peak Deceleration	15 G's
Vehicle Average Deceleration (Highest 40 Ms)	11 G's
Permanent Displacement of Barrier Nose	6'-2"
Maximum Vehicular Penetration	12'-5"
Maximum Vehicular Rise	11"

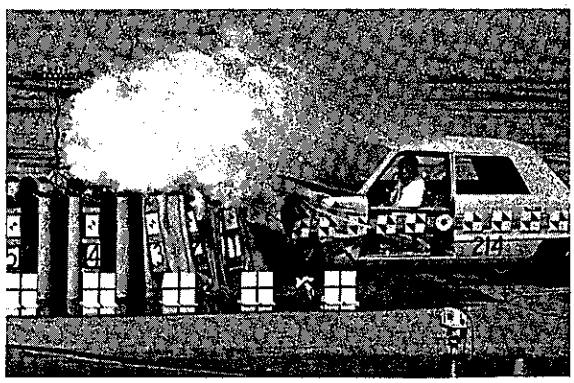
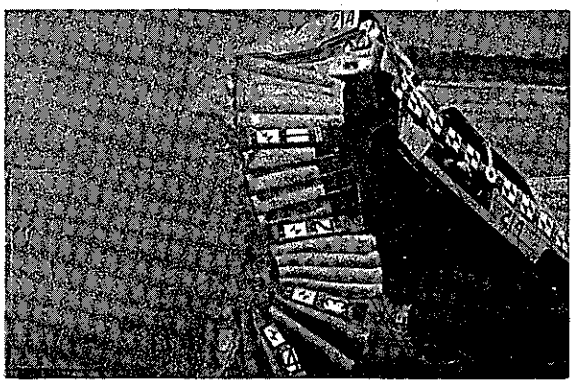
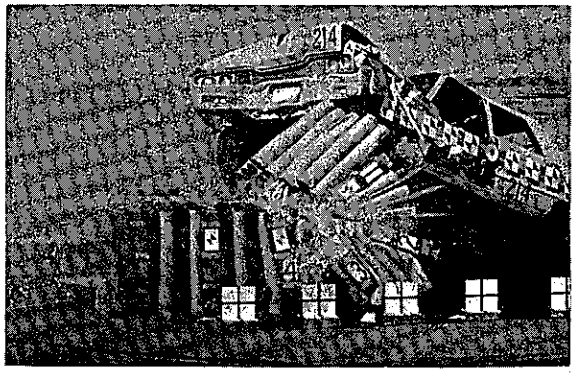
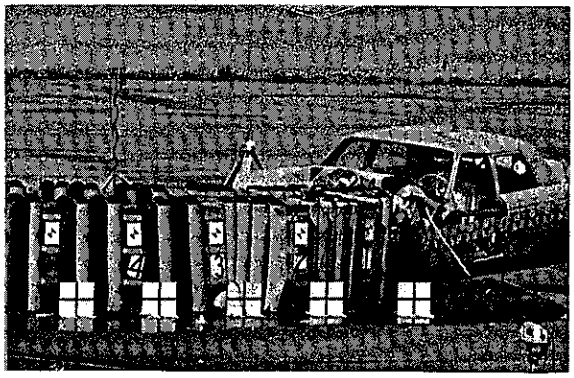
Deceleration was fairly smooth until the barrier "bottomed out". The vehicle then twisted longitudinally and the front end rose more than 6 ft. as the nose of the barrier was doubled back on the body of the barrier. Much of the vehicular rise took place after the cable that provided vertical and lateral restraint for the barrier came loose at the front anchor. The maximum vehicular penetration was 13'-8". The post-impact position of the leading edge of the barrier was only 3'-2" behind its original, pre-impact location. The displacement of the barrier, up and back as the vehicular rise took place, accounts for the large difference between the vehicular penetration and the displacement of the barrier nose.

Test No.	214
Date	9-25-68
Vehicle	1966 Dodge
Vehicle Weight (W/Dummy & Instrumentation)	4600 Lbs.
Impact Speed	59.8 mph
Impact Angle	Head-on
Dummy Restraint	Lap Belt & Single Shoulder Harness

Barrier Depth	16'-2"
No. of Water Tubes	150
Vehicle Peak Deceleration	15 G's
Vehicle Average Deceleration (Highest 40 Ms)	10 G's
Permanent Displacement of Barrier Nose	3'-2"
Maximum Vehicular Penetration	13'-8"
Maximum Vehicular Rise	6'-2"

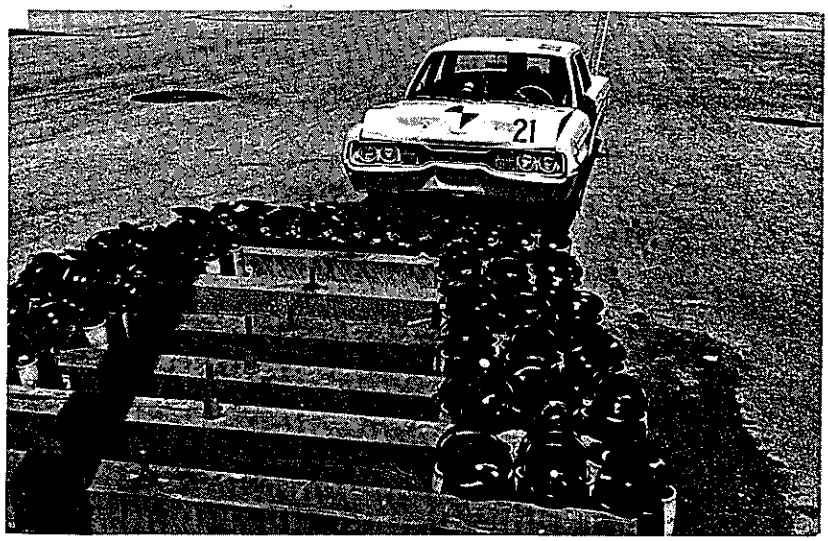
NO. 212

Although the damage sustained by the barrier was considered minor, the vehicular damage was moderate (see Exhibit 6). The unrestrained dummy, located in the driver's seat of the vehicle, struck the steering wheel with sufficient force to impart a permanent deformation of 2-1/4" thereto (see Exhibit 7).

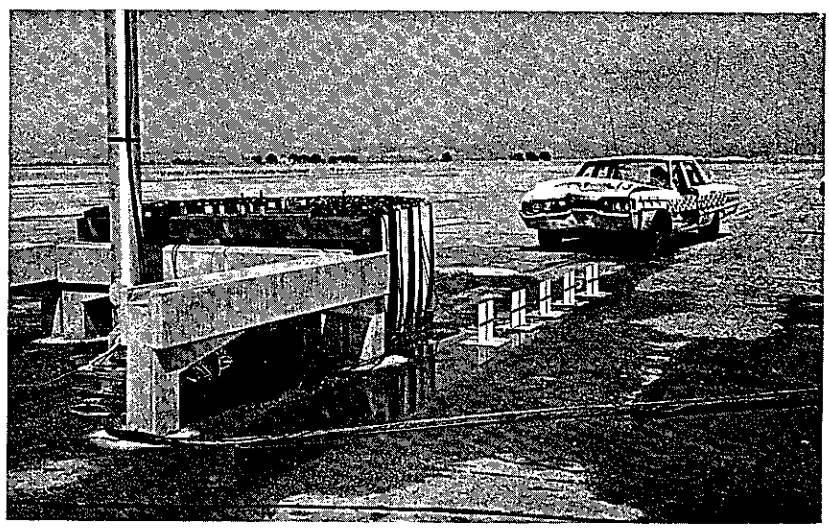
NO. 213

Minor barrier damage was again sustained. Vehicular damage, however, was considered severe (see Exhibit 6). The dummy, restrained for this test with both a lap belt and a single diagonal shoulder harness, again struck the steering wheel and imparted a permanent deformation of 2-1/2" thereto (see Exhibit 7).

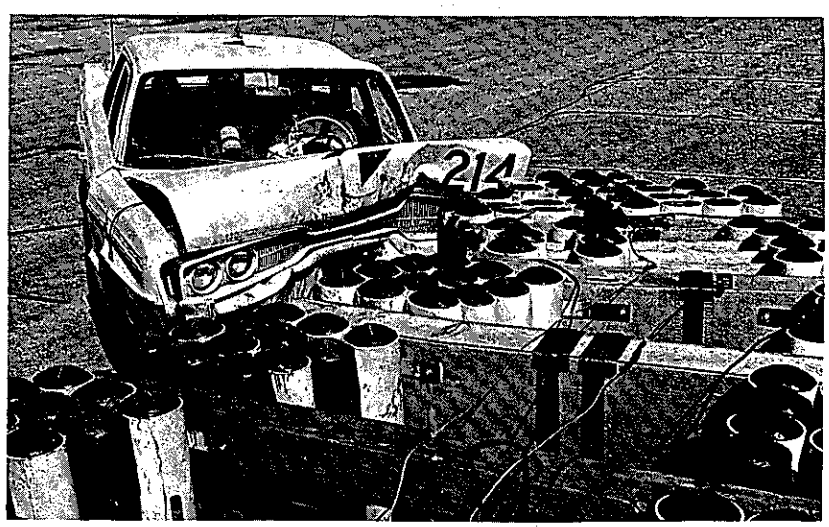
NO. 214

The barrier damage sustained for this test was moderate, but the vehicular damage was very severe (see Exhibit 6). The dummy, again restrained with both a lap belt and a single diagonal shoulder harness, impacted the steering wheel with sufficient force to impact a permanent deformation of 3-3/4" to it (see Exhibit 7).

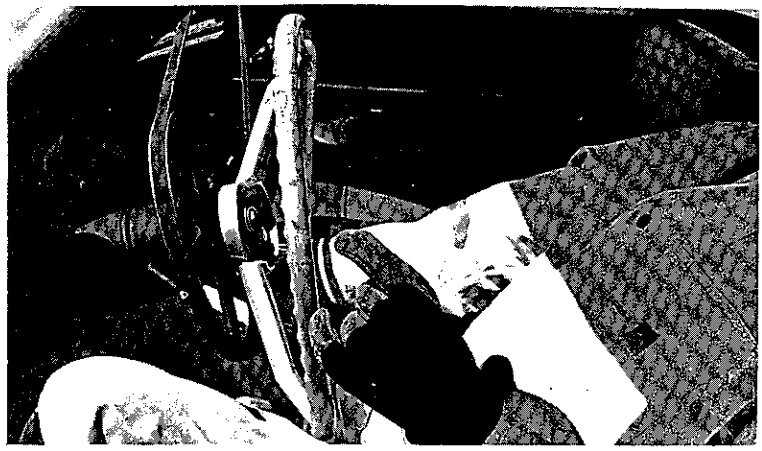
No. 212
2-1/4" Permanent Deformation

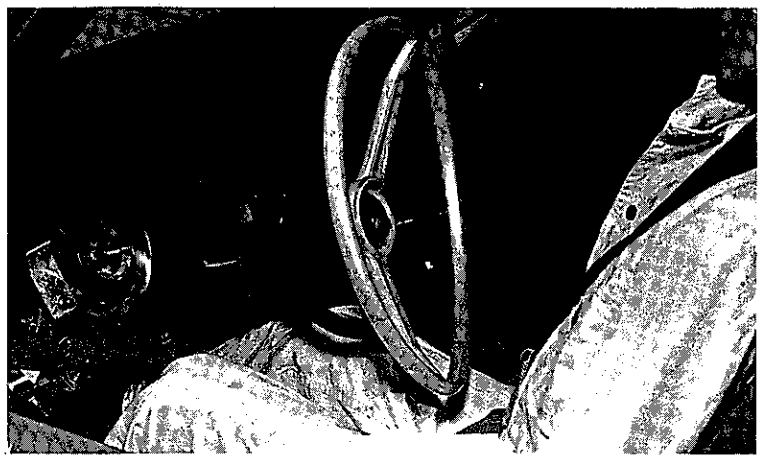
No. 213
2-1/2" Permanent Deformation
