4. TITLE AND SUBTITLE
Dynamic Tests Of Energy Absorbing Barrier Employing Sand-Filled Frangible Plastic Barrels

DYNAMIC TESTS OF AN ENERGY ABSORBING BARRIER EMPLOYING SAND-FILLED FRANGIBLE PLASTIC BARRELS SERIES XXIV

71-21

July 1971

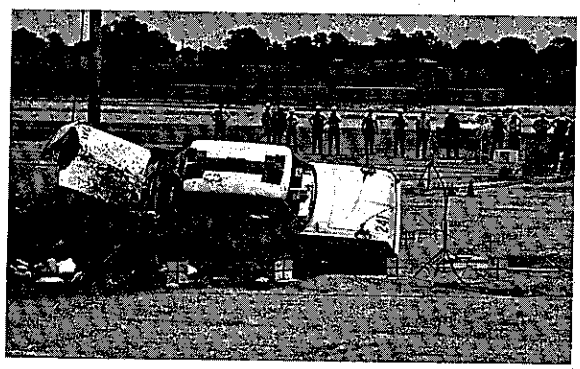
FIGURE 7

See Plate 3, page 16, for a summary of the test results. The vehicle, traveling 58 mph, impacted the barrier head-on about one foot to the left of the nose and plowed through the entire barrier (Figures 5 and 6). About 3-4 feet in front of the bridge railing, it ramped up on barrier debris and came to rest on the bridge rail just in front of the camera tower, 24' behind the nose of the barrier. As it ramped up, it tilted sharply in a counterclockwise direction, since the left front wheel was off the bridge rail, and almost turned over (Figure 7) before returning to its final position. The left rear fender was flush with the ground when the vehicle came to rest.

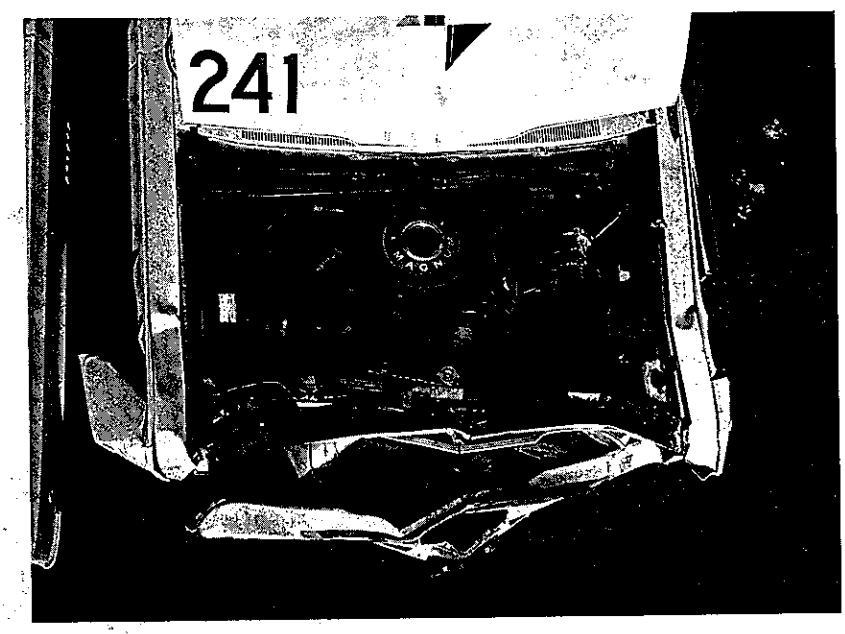
FIGURE 8

Damage was confined mainly to the front end. Maximum significant crush at the center of the vehicle forestructure was 1'-8". The crush was fairly uniform across the front of the vehicle but slightly less on the left side (see Figure 8 and Exhibit 3). The lower frame member, bumper, and front fenders were all severely buckled and the radiator was shoved back against the engine. On the passenger side, the front windshield was cracked where the sun visor came down and was struck by the dummy's head. No crimp in the roof over the doorpost was observed. The doorpost on the driver's side was torn loose from its roof connection and displaced back ½". Immediately after impact, the hood flew open. However, it sustained no damage, mainly because the level of the hood was higher than the 2'-6" high barrels at the nose of the barrier.

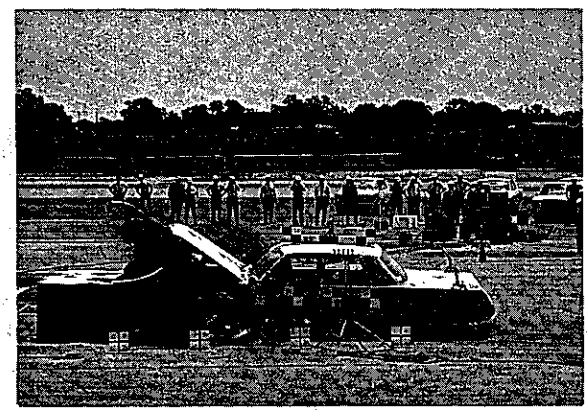
Plate 3

Impact + 0.027 Sec.

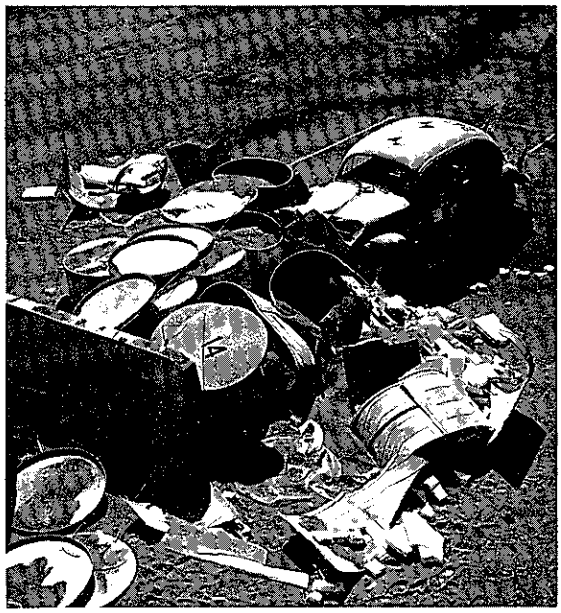
FIGURE 11

See Plate 5, page 22, for a summary of the test results. The VW hit the barrier nose head-on about 9" to the left of the barrier center line at an impact velocity of 59 mph. The vehicle came to rest 19' beyond the nose of the barrier with all its wheels on the ground (Figures 11 and 12). During impact there was a 1'-4" rise at the rear of the vehicle (measured at a target on the right rear fender).

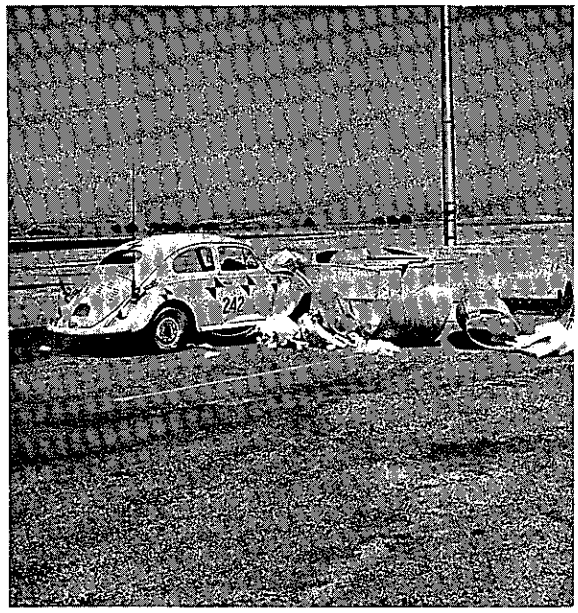
FIGURE 12

The front trunk lid remained closed and was moderately buckled, as were the front fenders. Maximum crush at the forestructure was

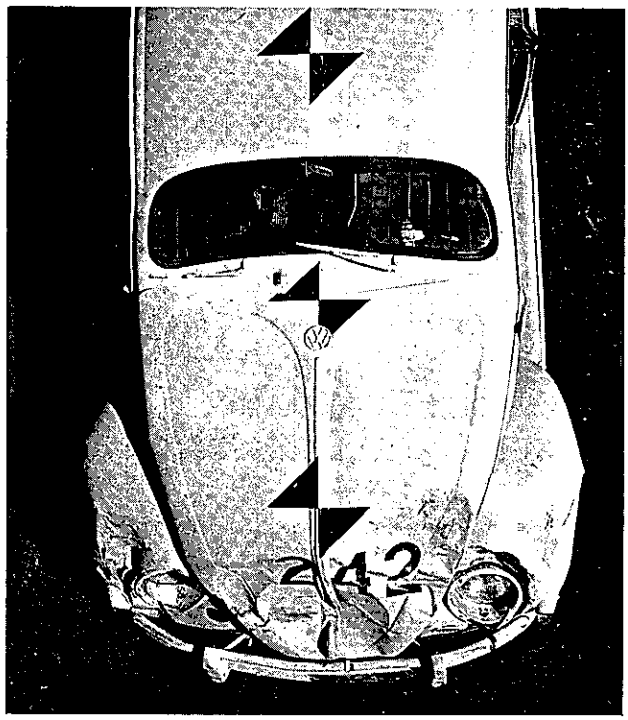
FIGURE 13

only 8" (see Exhibit 3 and Figure 13). The entire windshield popped out due to the impact from the dummy's head.

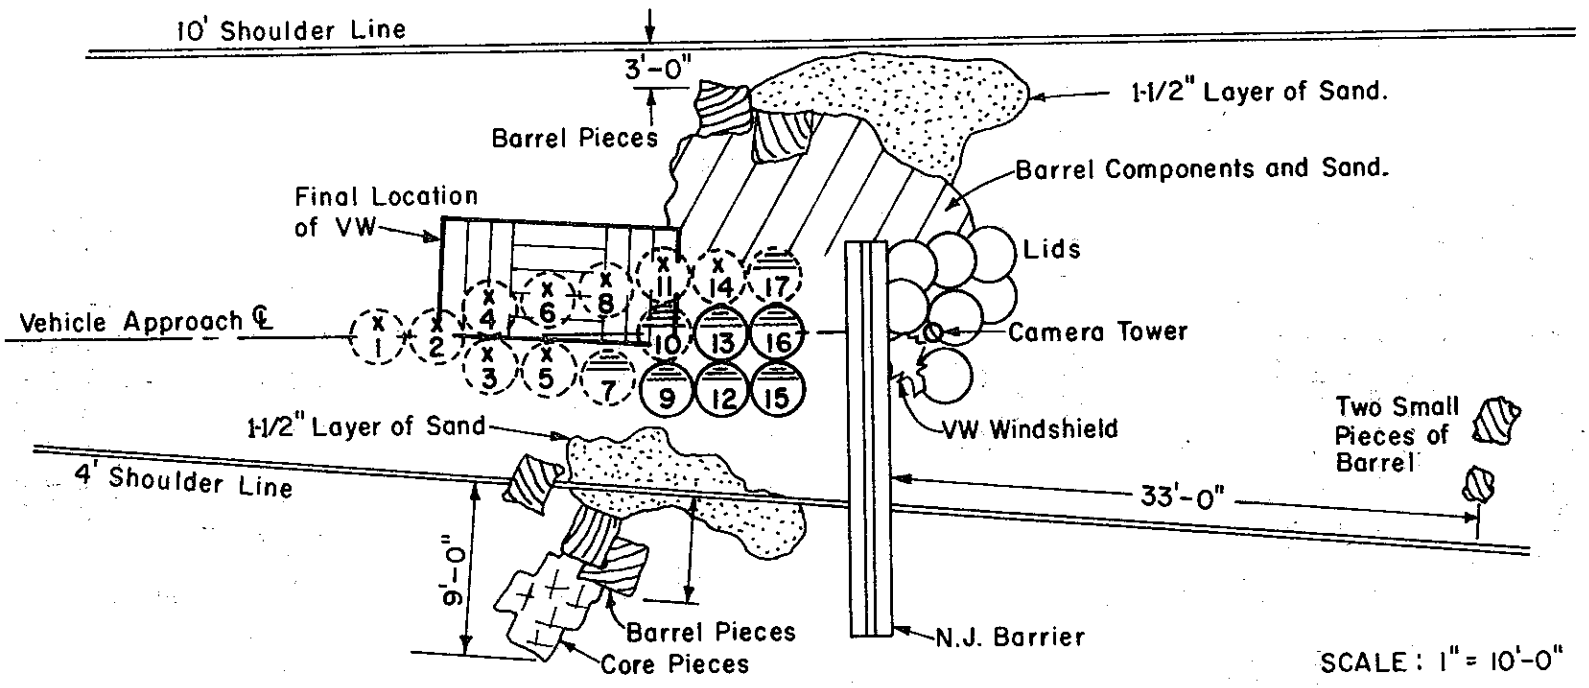
1. Barrels 9, 12, 13, 15, & 16 were all intact with lids on; two were slightly compressed. No. 16 was 9" from N.J. Barrier.
2. Barrels with an (X) were broken and thrown out of position.
3. All lids remained tied together.
4. Small number of core pieces under car.
5. All 4 wheels of VW on ground.
6. Barrels 7 & 10 were compressed but unbroken, lids were off.
7. Barrel 17 was compressed, unbroken, lid off, leaning against N.J. Barrier.

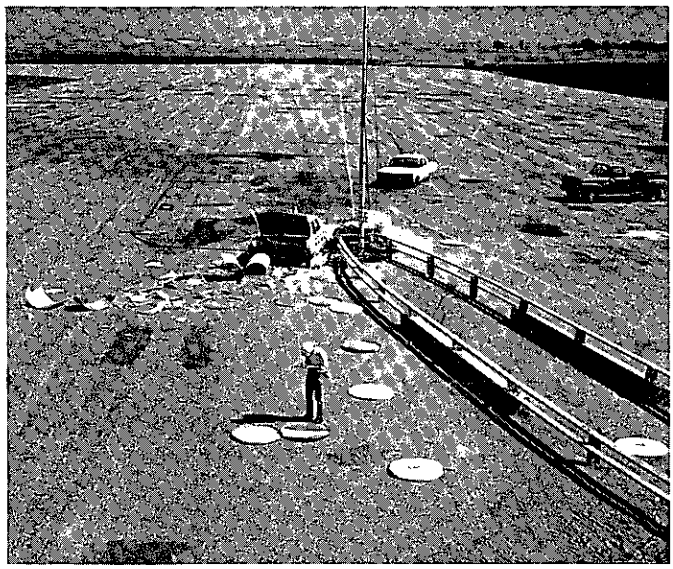
FIGURE 17

with the rear of the vehicle even with the last row of barrels in the barrier. It came to rest with all wheels on the ground on a thin layer of sand (Figures 17 and 18).

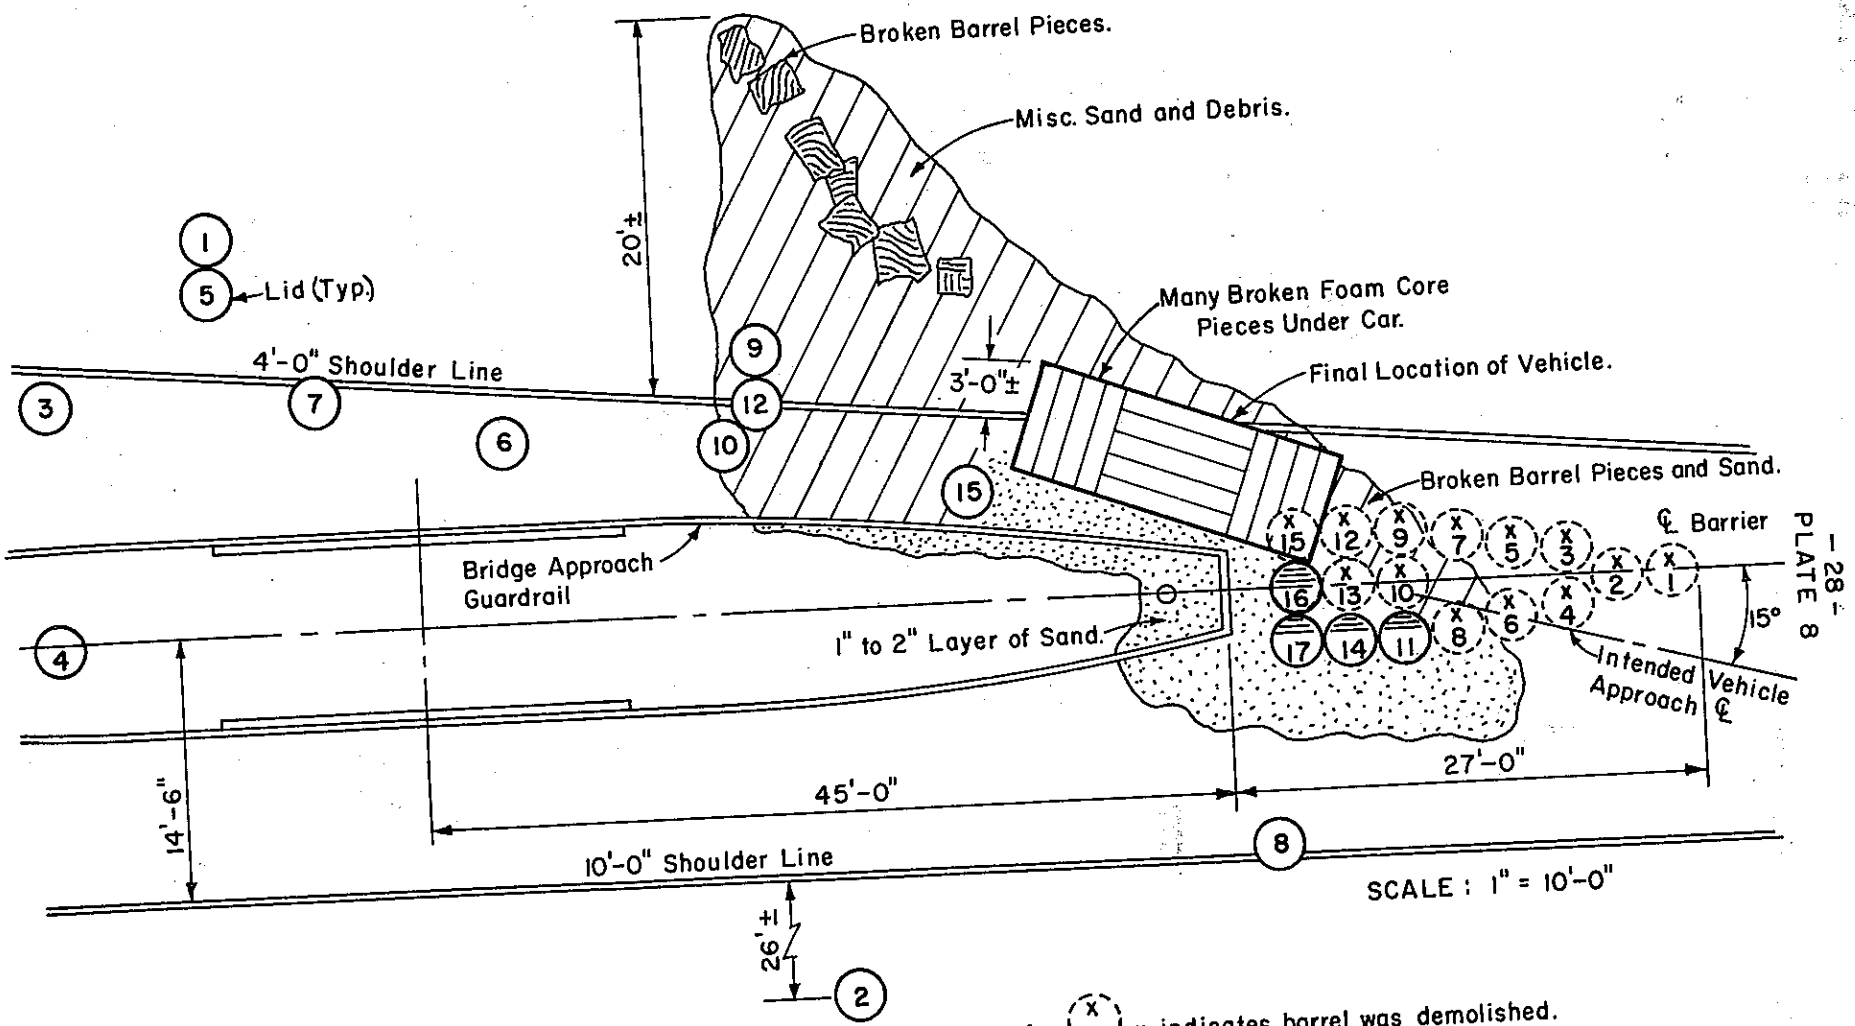
1. Many small, broken foam core pieces blown in all directions by wind.
2. Barrels 11, 14, 16 & 17 still upright, but squashed out of shape with lids still on.
3. Vehicle struck barrier 1 foot to right of intended vehicle approach centerline.
4. (X) x indicates barrel was demolished.
5. Shoulder width measured at last row of barrels.

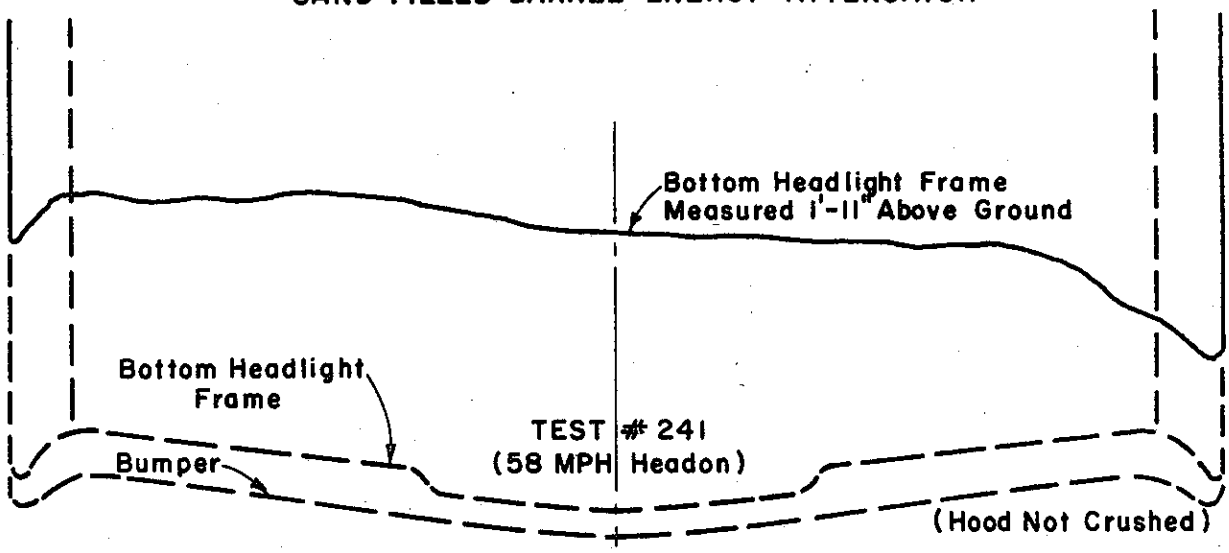
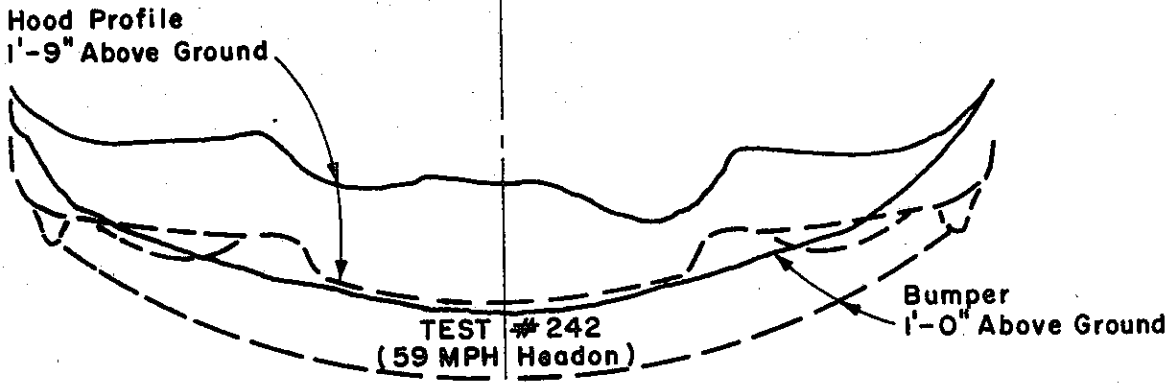
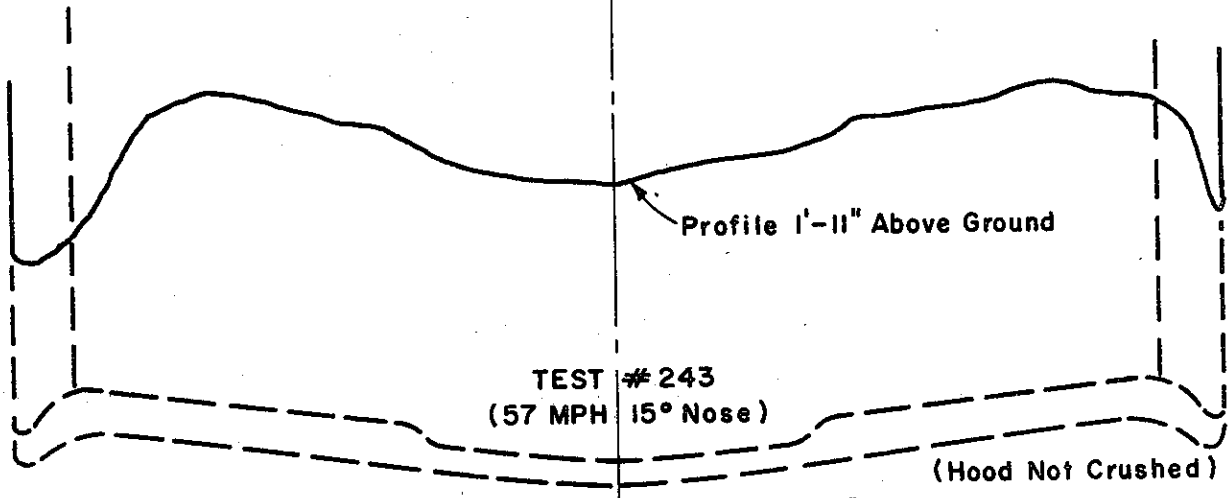
VEHICULAR CRUSH

Dashed lines show precrash profiles.
