4. TITLE AND SUBTITLE
Dynamic Tests Of The Modified California Type 20 Bridge Barrier Rail

DYNAMIC TESTS OF THE MODIFIED CALIFORNIA TYPE 20 BRIDGE BARRIER RAIL

CA-HY-MR-6589-1-72-30

Prepared in Cooperation with the U.S. Department of Transportation, Federal Highway Administration December, 1972

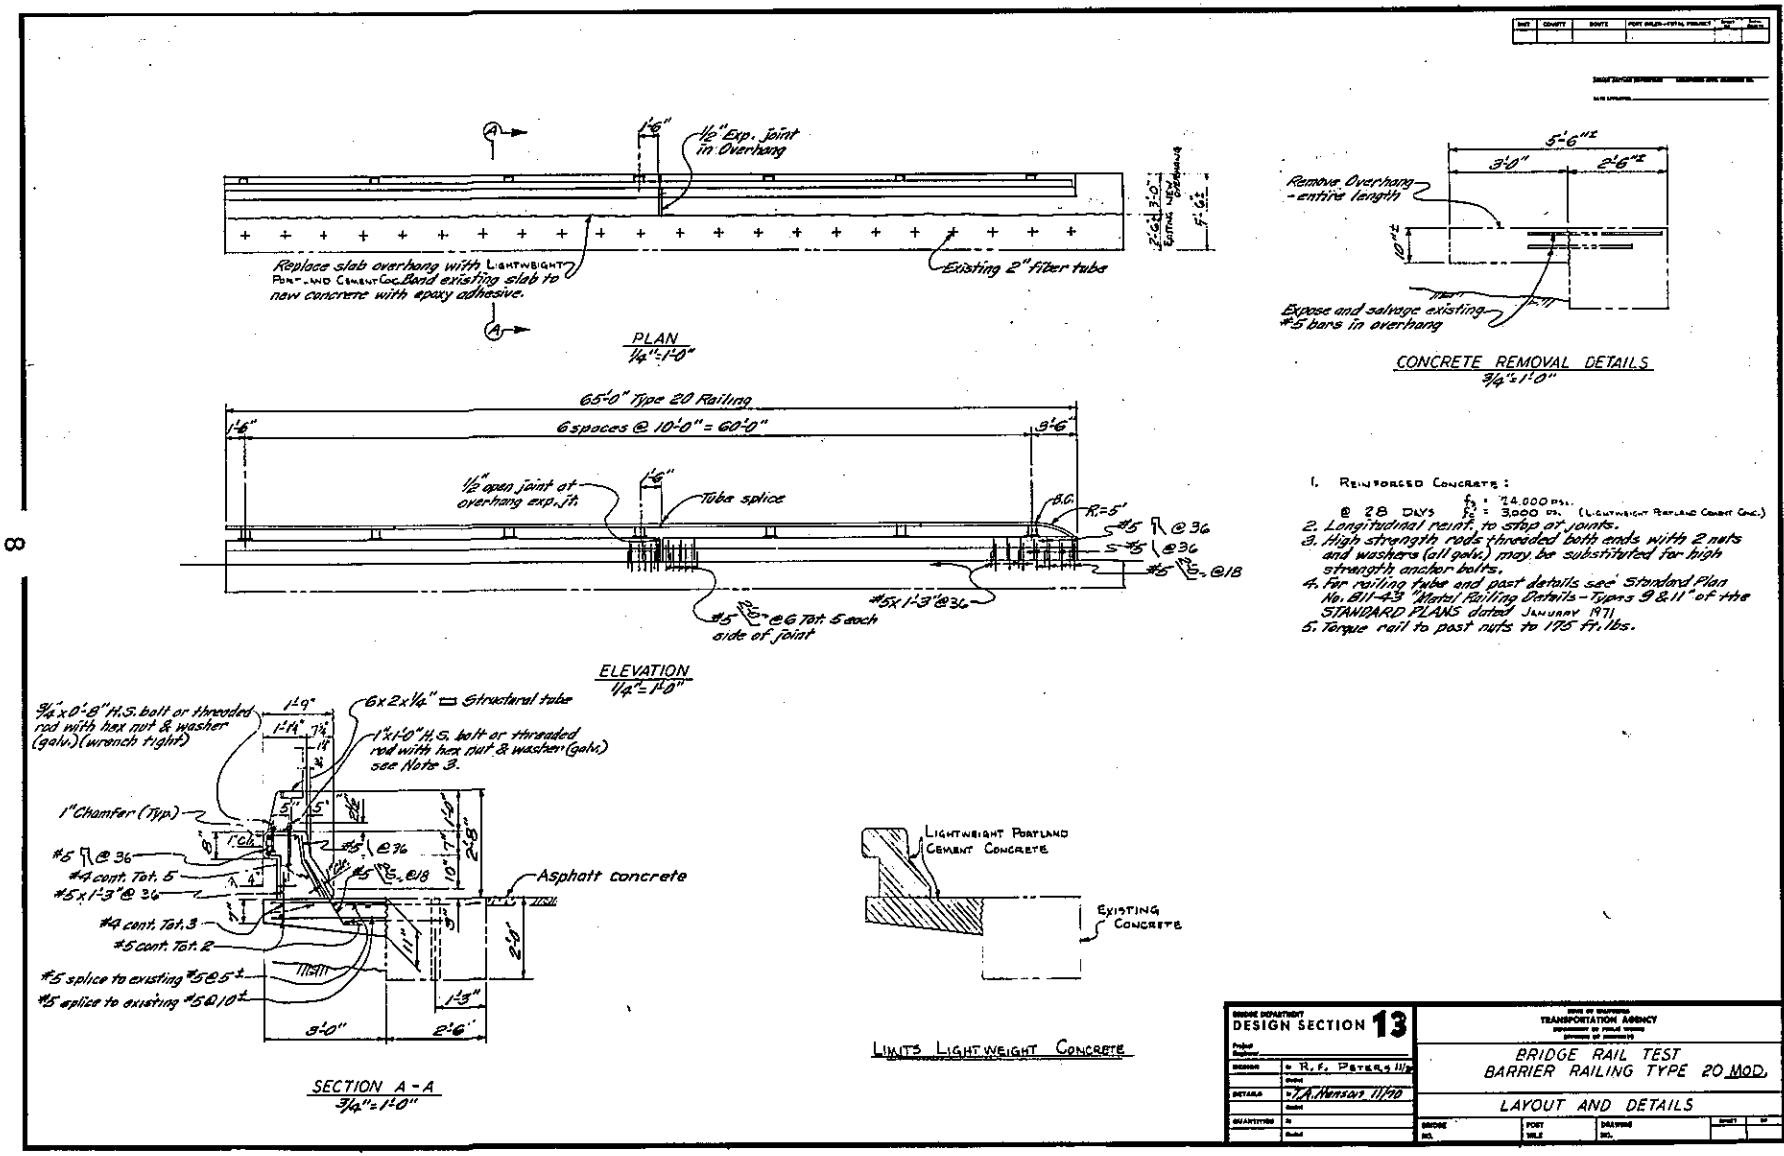
FIGURE 4

The total barrier height was 32 inches from the bridge deck to the top of the steel rail member. The deck and parapet reinforcing, as well as other details of the Modified Type 20 Bridge Barrier Rail, are shown on Figure 4. This system was designed in accordance with the requirements of the "Standard Specifications for Highway Bridges" adopted by the American Association of State Highway Officials in 1969.

DETAILS OF MODIFIED TYPE 20 BRIDGE BARRIER RAIL
(Reduced plan - not to scale)

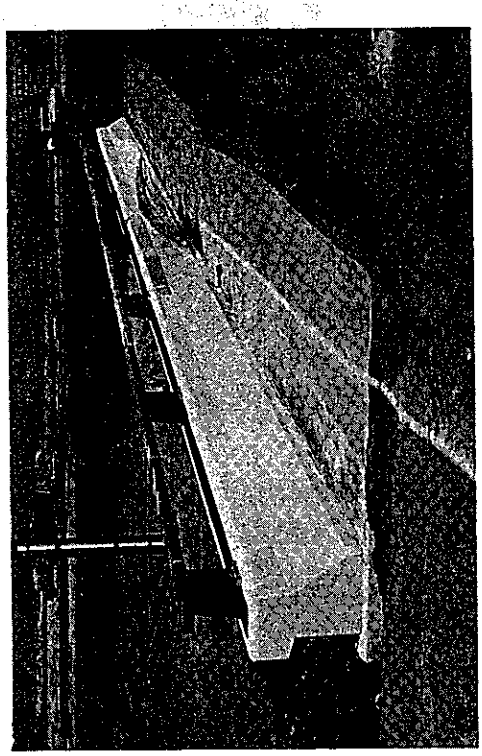
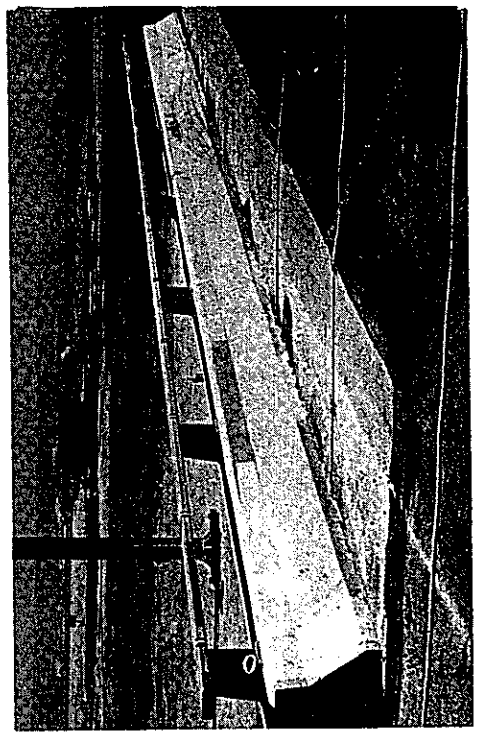
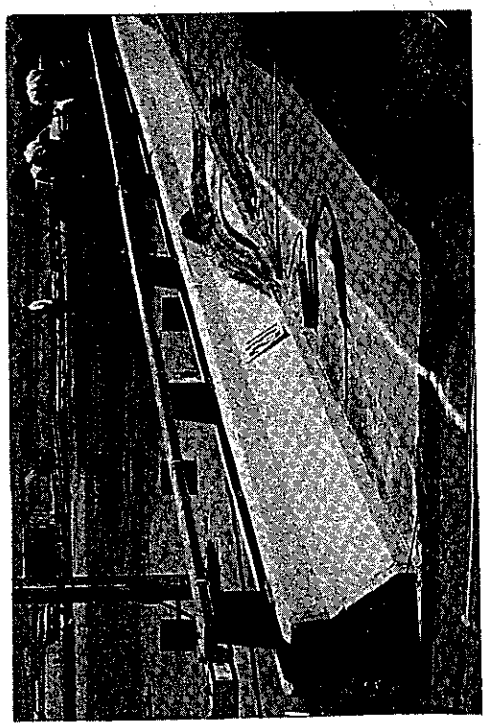
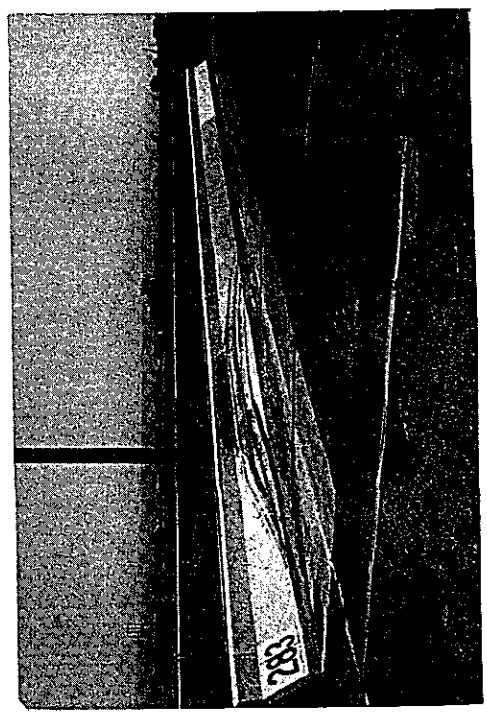
FIGURE 5

The vehicle in each of the four tests was effectively retained and redirected without any significant damage to the bridge rail (Figure 5).

COMPARISON OF BARRIER DAMAGE FOR TESTS 281-284

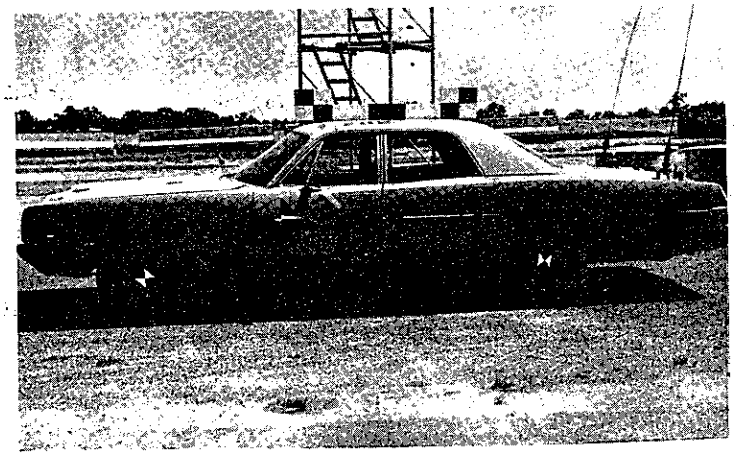
Vehicular damage, which was considered minor, increased only slightly relative to the increase in impact velocity (Figure 6). The same test vehicle was reused for all four 5° tests with only cosmetic sheet metal and paint repairs required between tests and for a subsequent larger angle test.

Vehicle sheet metal contact with the barrier was at the left front fender where the steel railing creased the sheet metal to a depth of 0.2 ft. There was also minor sheet metal deformation and paint abrasion along the left side and at the left rear fender. There was no apparent damage to the vehicle suspension or steering system from the four impacts.

COMPARISON OF VEHICULAR DAMAGE FOR TESTS 281-284

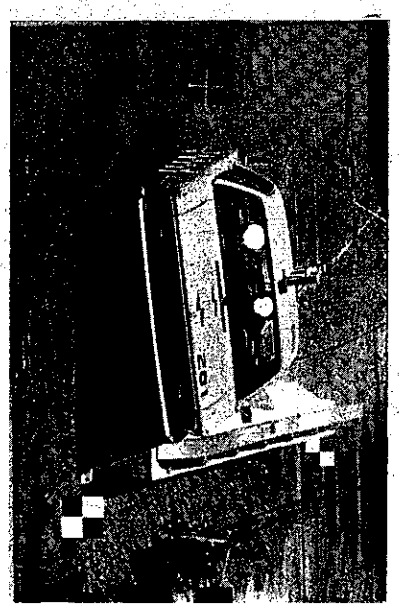
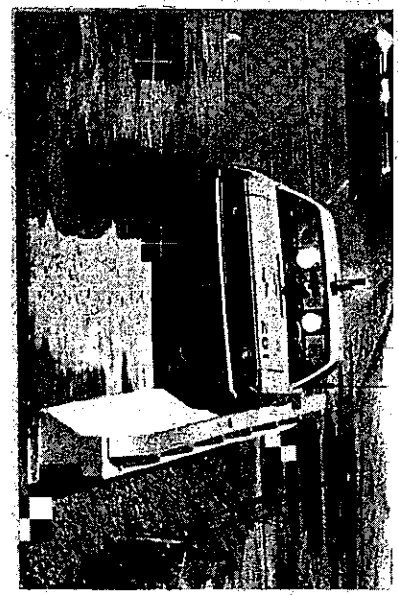
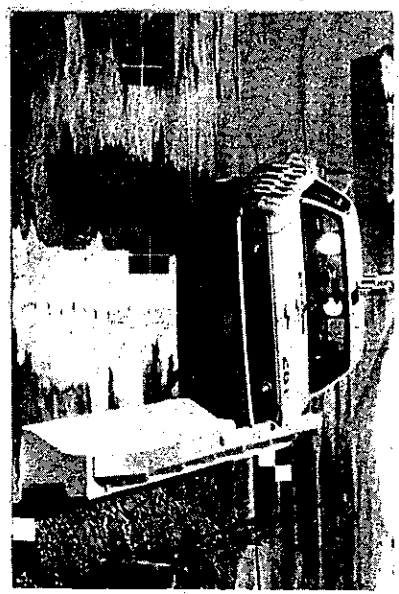
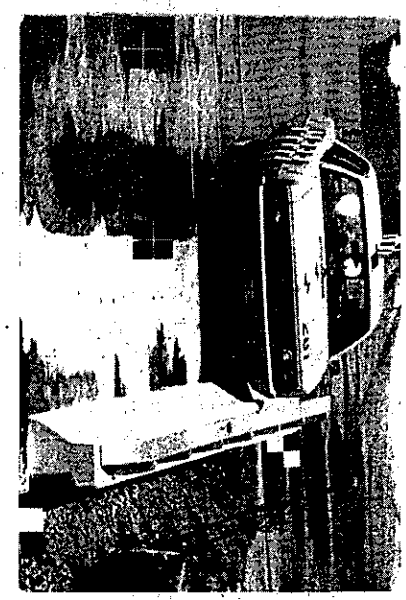
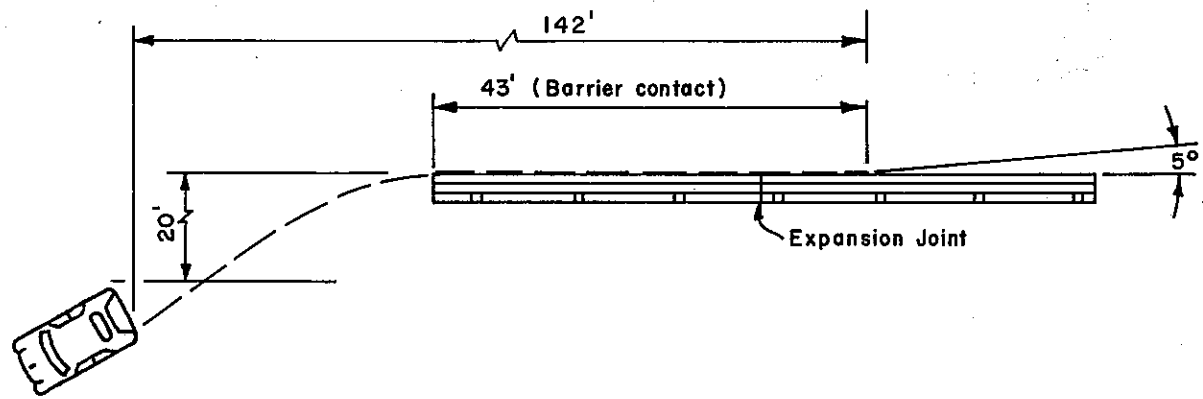
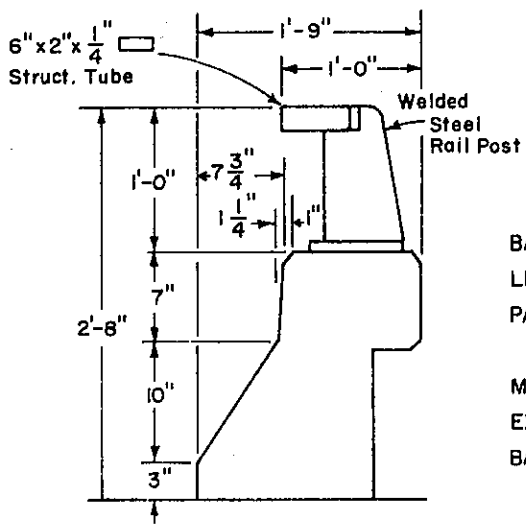
TEST NO.	281
DATE	7/14/71
VEHICLE	1969 Dodge Sedan
SPEED	47 mph
IMPACT ANGLE	5°
VEHICLE WEIGHT (Incl./dummys & instrumentation	4895 Lbs
DUMMY RESTRAINT	Lap Belt

BARRIER TESTED		Modified Type 20 Bridge Rail
LENGTH OF INSTALLATION		65' ±
PASSENGER COMPARTMENT DECEL. (Highest 50ms average)	Long.	1.4
	Lat.	1.7
MAXIMUM VEHICLE RISE		0.5'
EXIT ANGLE		0°
BARRIER DAMAGE		Negligible

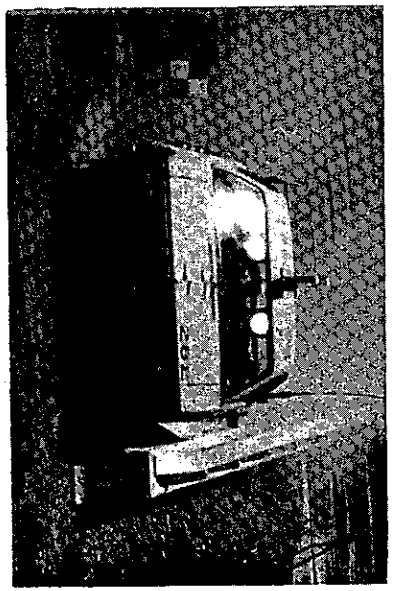
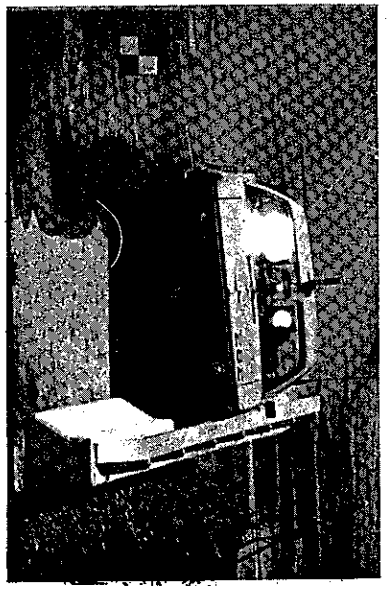
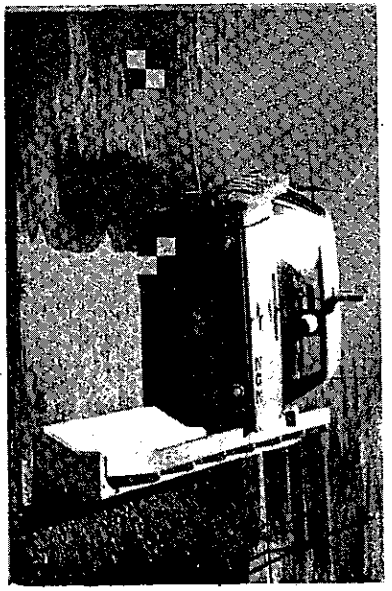
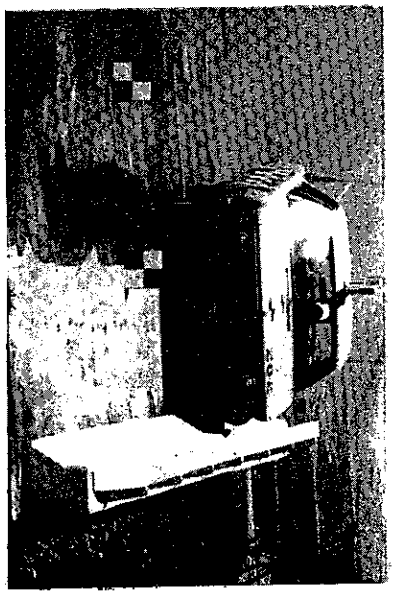
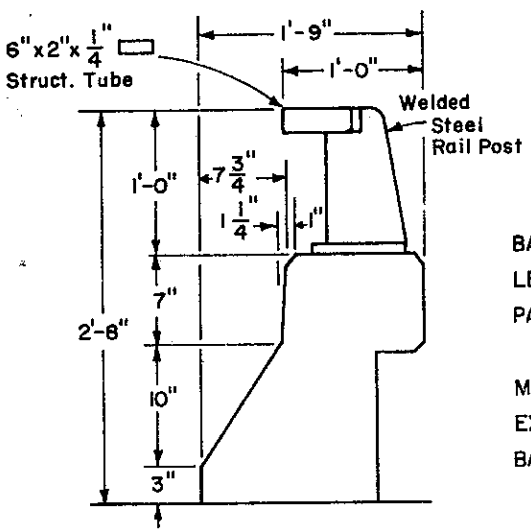
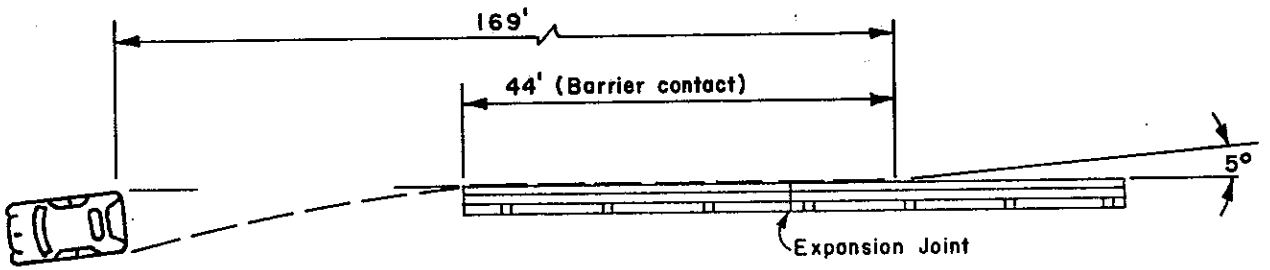
TEST NO.	282
DATE	7/14/71
VEHICLE	1969 Dodge Sedan
SPEED	54 mph
IMPACT ANGLE	5°
VEHICLE WEIGHT (Incl./dummys & instrumentation	4895 Lbs
DUMMY RESTRAINT	Lap Belt

BARRIER TESTED		Modified Type 20 Bridge Rail
LENGTH OF INSTALLATION		65' ±
PASSENGER COMPARTMENT DECEL. (Highest 50ms average)	Long.	0.3
	Lat.	1.2
MAXIMUM VEHICLE RISE		0.5'
EXIT ANGLE		0°
BARRIER DAMAGE		Negligible

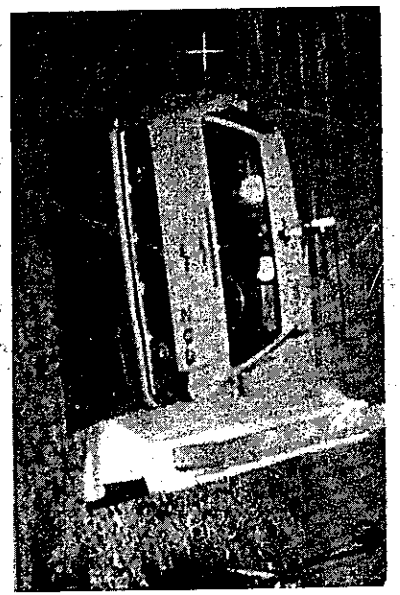
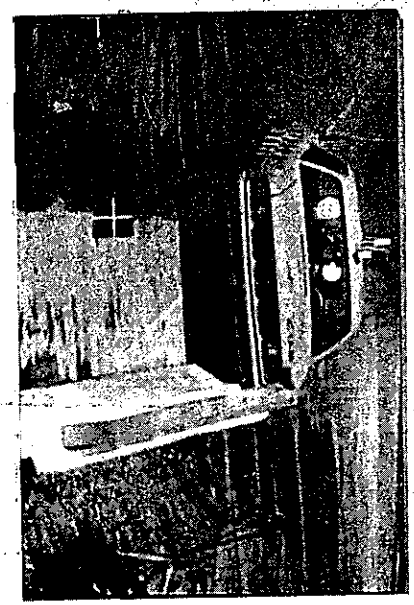
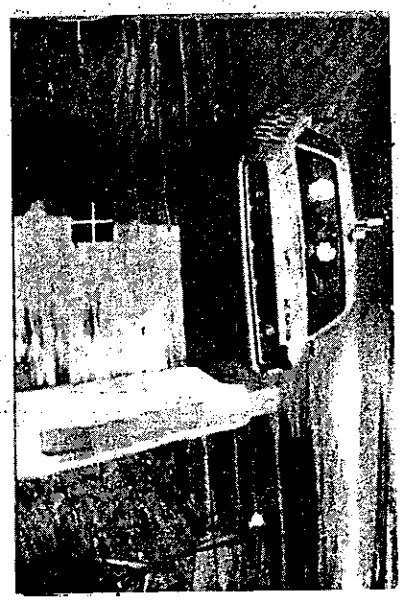
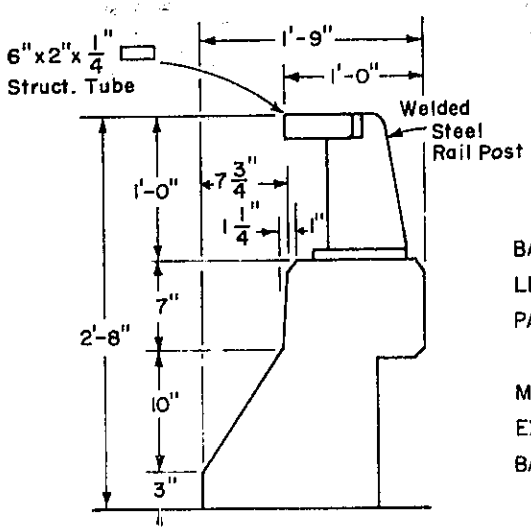
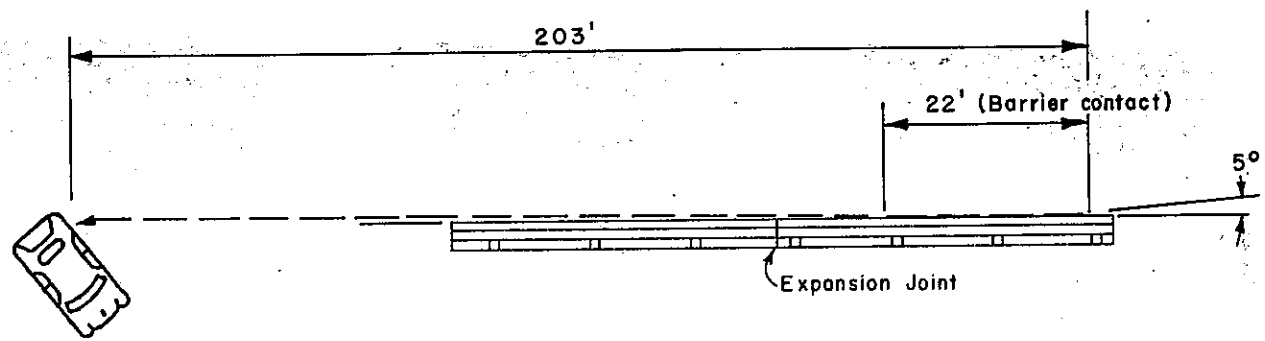
TEST NO.	283
DATE	7/21/71
VEHICLE	1969 Dodge Sedan
SPEED	57 mph
IMPACT ANGLE	5°
VEHICLE WEIGHT (Incl./dummys & instrumentation	4895 Lbs
DUMMY RESTRAINT	Lap Belt

BARRIER TESTED	Modified Type 20 Bridge Rail	
LENGTH OF INSTALLATION	65' ±	
PASSENGER COMPARTMENT DECEL. (Highest 50ms average)	Long.	1.5
	Lat.	2.6
MAXIMUM VEHICLE RISE	0.6'	
EXIT ANGLE	1°	
BARRIER DAMAGE	Negligible

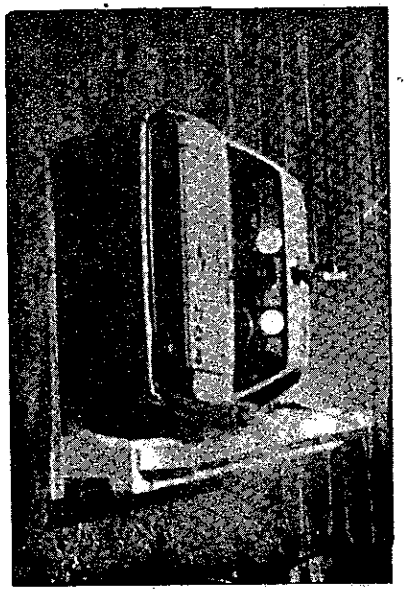
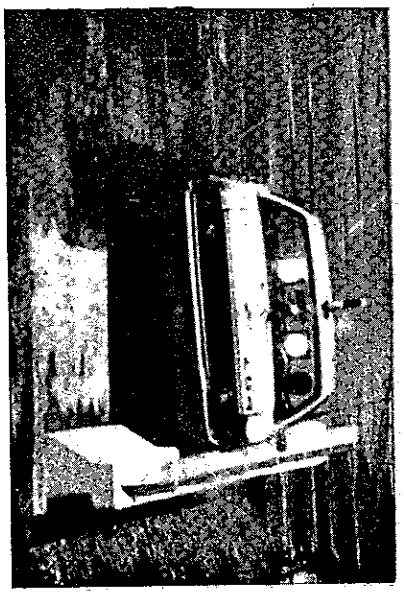
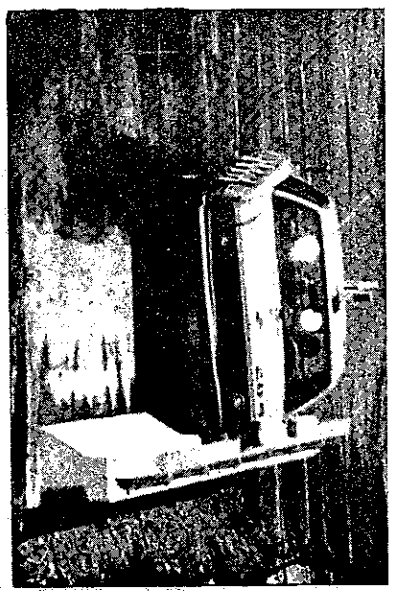
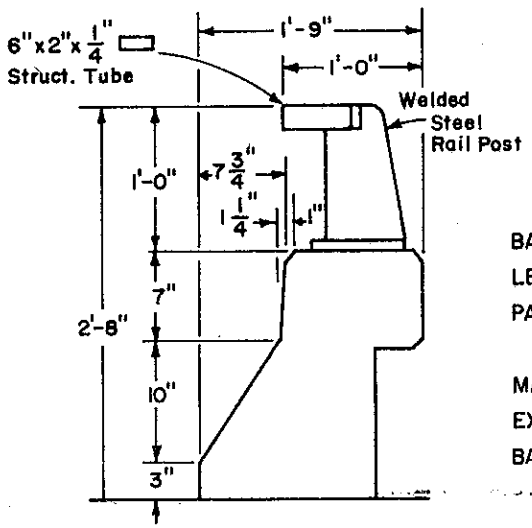
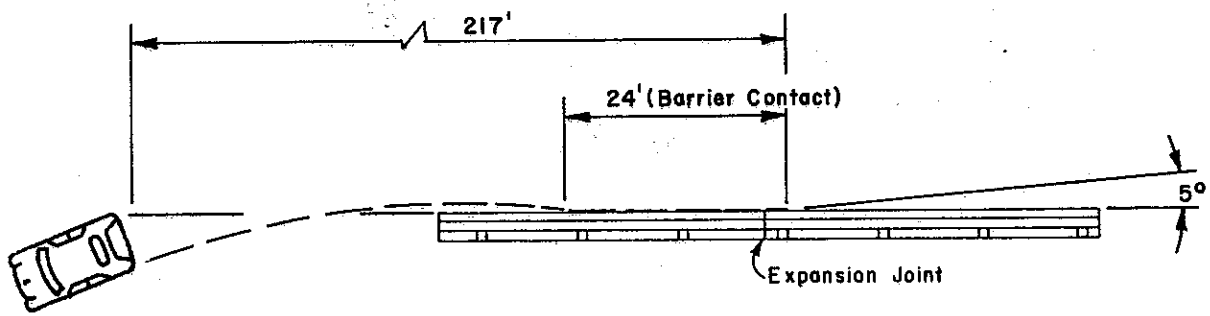
TEST NO.	284
DATE	7/21/71
VEHICLE	1969 Dodge Sedan
SPEED	62 mph
IMPACT ANGLE	5°
VEHICLE WEIGHT (Incl./dummys & instrumentation	4895 Lbs
DUMMY RESTRAINT	Lap Belt

BARRIER TESTED		Modified Type 20 Bridge Rail
LENGTH OF INSTALLATION		65' ±
PASSENGER COMPARTMENT DECEL. (Highest 50ms average)	Long.	1.6
	Lat.	3.5
MAXIMUM VEHICLE RISE		0.6'
EXIT ANGLE		1°
BARRIER DAMAGE		Negligible

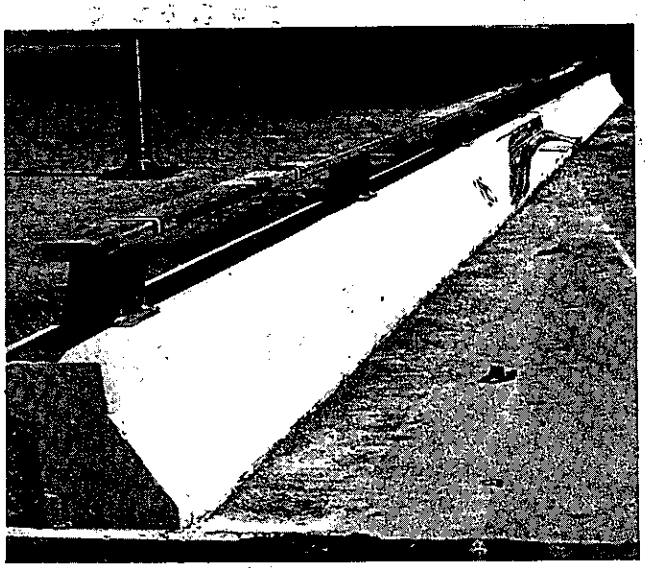
FIGURE 11 - BARRIER DAMAGE
TEST 285

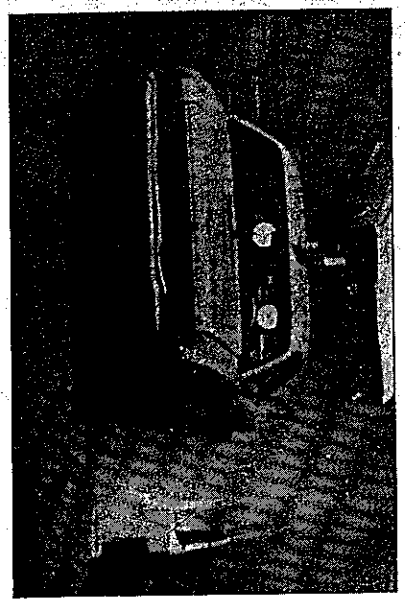
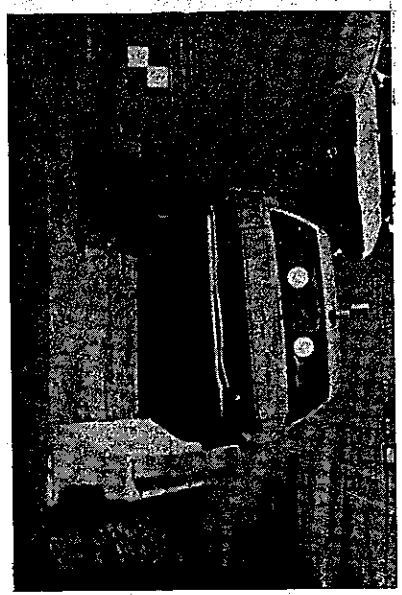
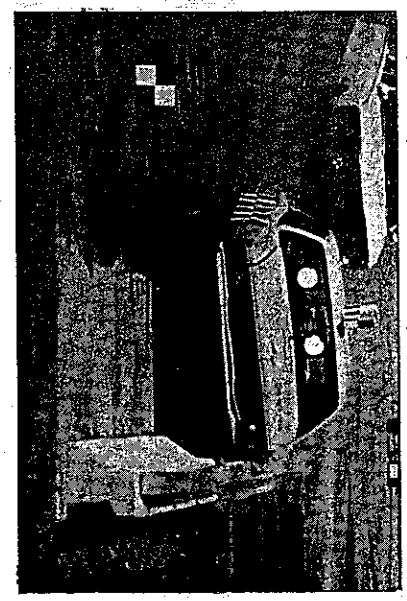
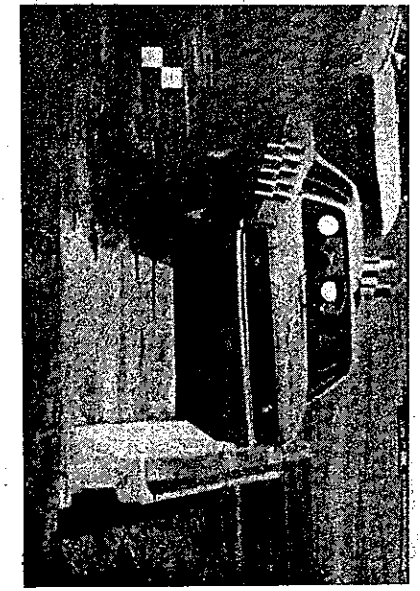
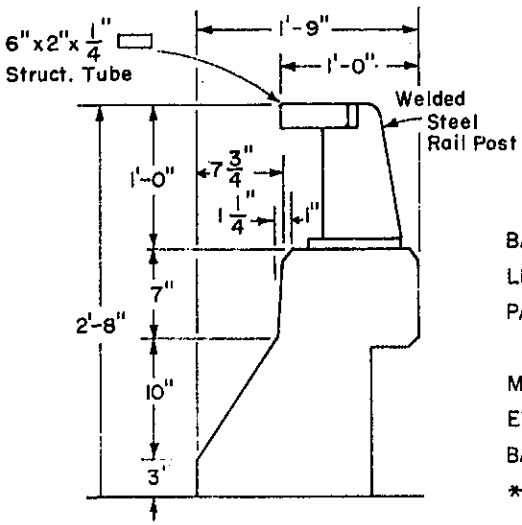
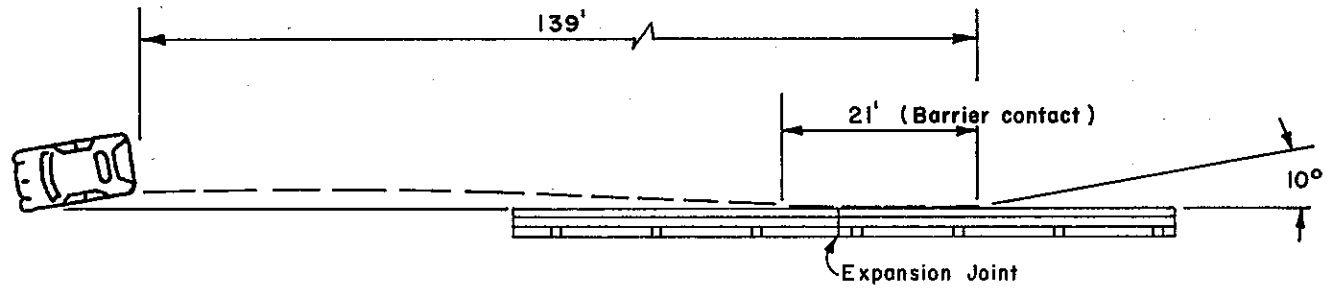
BARRIER TESTED	Modified Type 20 Bridge Rail
LENGTH OF INSTALLATION	65' ±
PASSENGER COMPARTMENT DECEL. (Highest 50ms average) Long.	*
PASSENGER COMPARTMENT DECEL. (Highest 50ms average) Lat.	*
MAXIMUM VEHICLE RISE	0.7'
EXIT ANGLE	2°
BARRIER DAMAGE	Negligible

* ERRONEOUS DATA

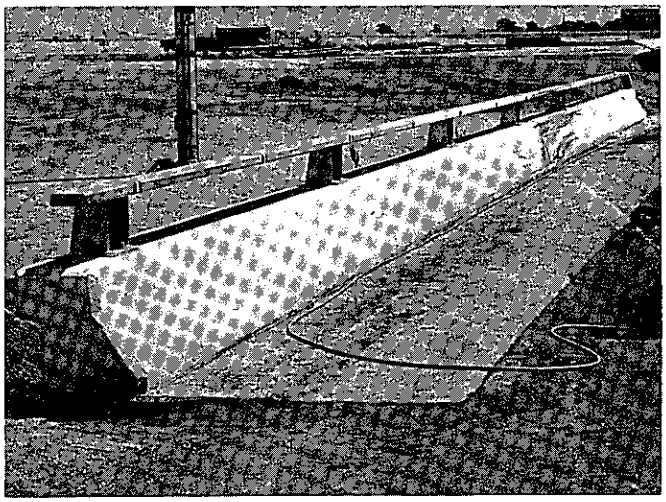
The bridge rail effectively retained and redirected the vehicle without sustaining any damage (Figure 14). Vehicle damage was relatively severe (Figure 15).

FIGURE 14 - BARRIER DAMAGE
TEST 286

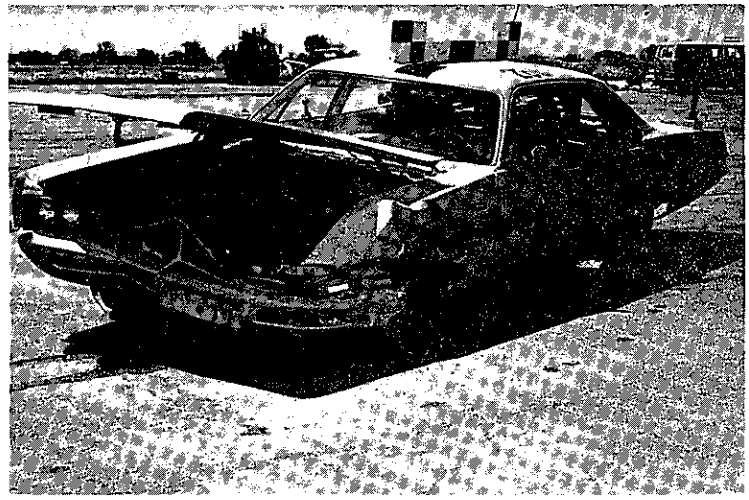
FIGURE 15 - VEHICLE DAMAGE
TEST 286

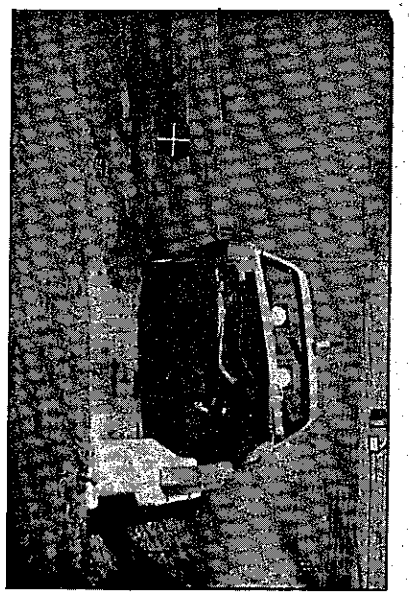
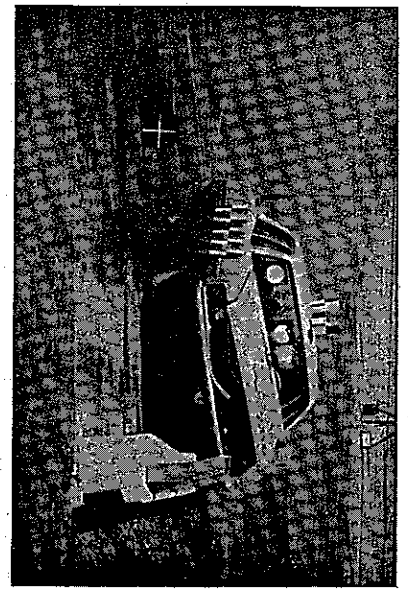
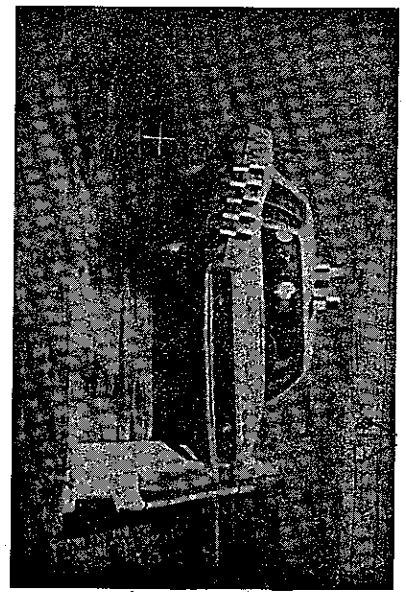
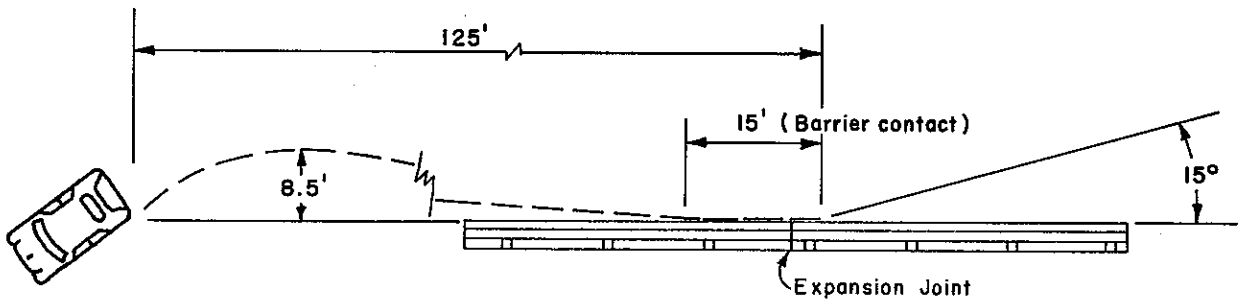
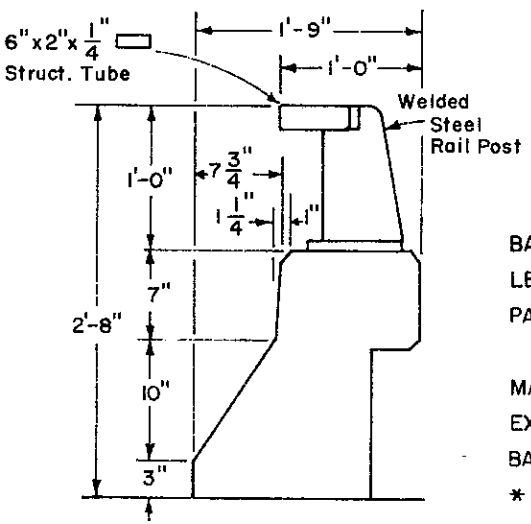
BARRIER TESTED	Modified Type 20 Bridge Rail	
LENGTH OF INSTALLATION	65' ±	
PASSENGER COMPARTMENT DECEL. (Highest 50ms average)	Long.	*
	Lat.	*
MAXIMUM VEHICLE RISE	1.2'	
EXIT ANGLE	2°	
BARRIER DAMAGE	Negligible

* ERRONEOUS DATA

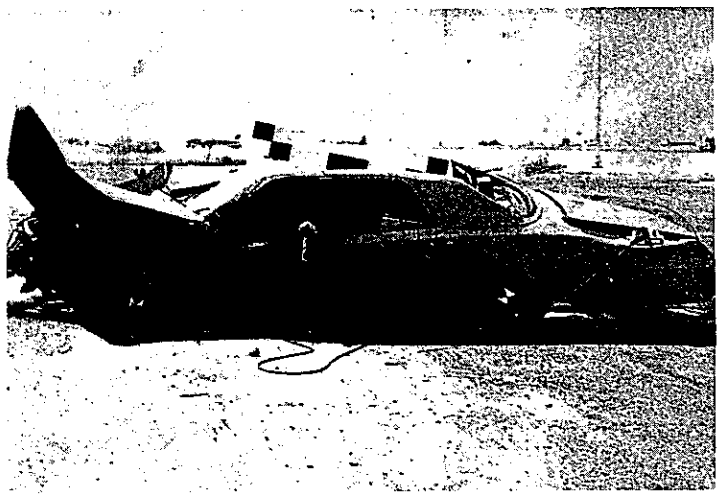
The bridge rail did not retain the vehicle in this test. The barrier was heavily damaged and the vehicle was totally destroyed (Figures 17 and 18).

FIGURE 18 - VEHICLE DAMAGE
TEST 287

The vehicle was totally destroyed with both sides, top, front, and rear heavily damaged. The barrier was likewise extensively damaged. Post Nos. 5 and 6 were deformed with post No. 5 displaced 100 ft. downstream and 45 ft. behind the barrier. Three rail sections were bent with the rail stud bolts broken off two of these sections. The terminal rail section was displaced 65 ft. downstream and 60 ft. behind the barrier. There was considerable concrete spalling of the upper parapet at post Nos. 4, 5, and 6. The post anchor bolts at post No. 4 were pulled free of the parapet. At post No. 5 the anchor bolts were pulled out of the parapet and displaced downstream with the post. Post Nos. 6 and 7 were still secured to the parapet. Many of the details and results of Test 287 are summarized in Figure 19.

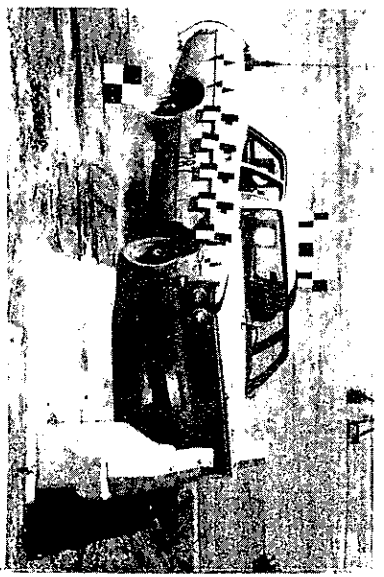
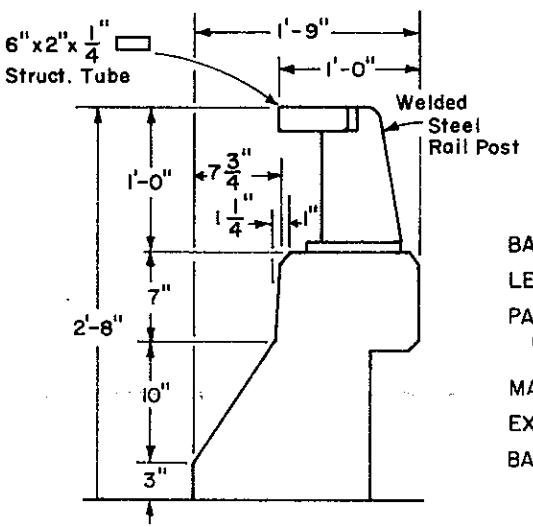
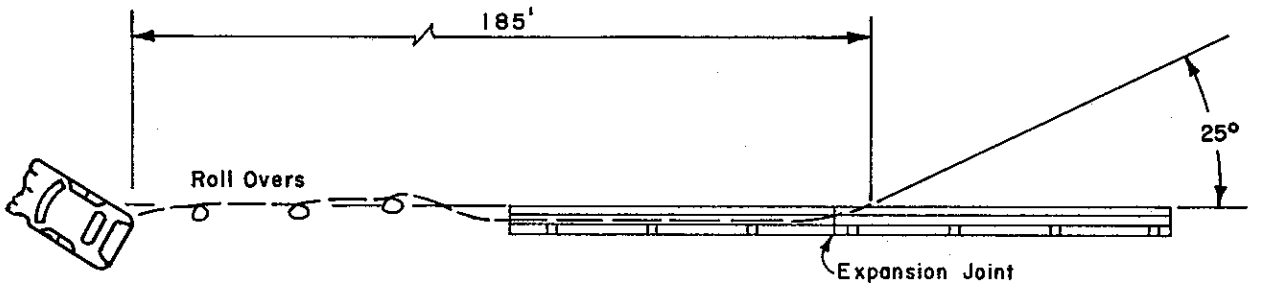
BARRIER TESTED	Modified Type 20 Bridge Rail	
LENGTH OF INSTALLATION	65' ±	
PASSENGER COMPARTMENT DECEL. (Highest 50ms average)	Long.	7.8
	Lat.	14.6
MAXIMUM VEHICLE RISE	Barrier Failure	
EXIT ANGLE	Barrier Failure	
BARRIER DAMAGE	Barrier Failure

TEST NO.	287
DATE	8/26/71
VEHICLE	1969 Dodge Sedan
SPEED	72 mph
IMPACT ANGLE	25°
VEHICLE WEIGHT (Incl./dummys & instrumentation)	4895 Lbs
DUMMY RESTRAINT	Lap Belt

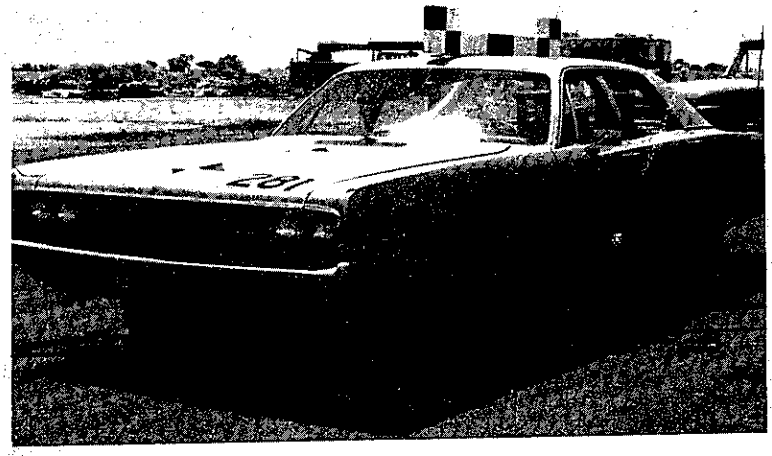
In the first four tests of this series (Test Nos. 281 - 284) the vehicle damage, although minor, was more than that sustained in similar tests of the standard Type 20 design (Test Nos. 231-232) (Figures 20 and 21).

FIGURE 20 - VEHICLE DAMAGE
TEST 281 WITH MODIFIED
TYPE 20 BARRIER

This increased damage, consisting essentially of sheet metal deformation, was attributed primarily to the 7 inch lower parapet/railing of the modified design. (Figure 22, Modified Type 20 design - Figure 23, standard Type 20 design).

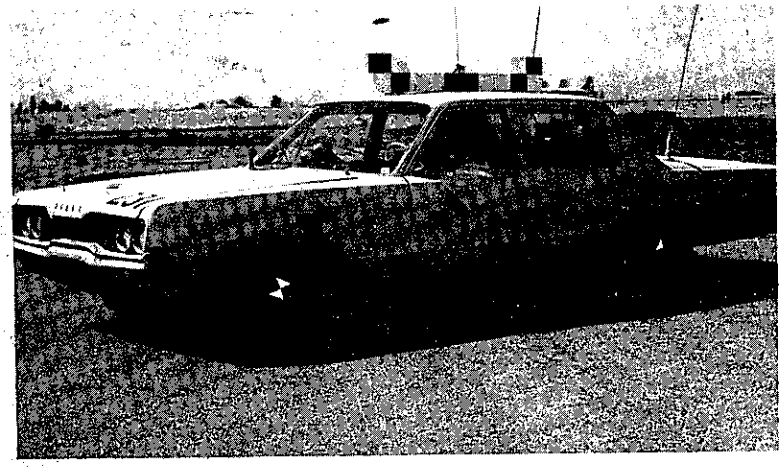
FIGURE 21 - VEHICLE DAMAGE
TEST 231 WITH STANDARD
TYPE 20 BARRIER

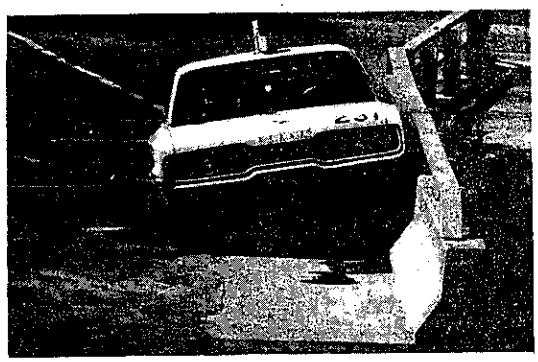
The 0.6 ft. average vehicle rise for the four low angle tests on the Modified Type 20 design was considerably less than the 1.3 ft. rise observed in the similar low angle tests on the Standard Type 20 design (Figures 26 and 27).

FIGURE 27 - VEHICULAR RISE ON STANDARD TYPE 20 BARRIER TEST 231

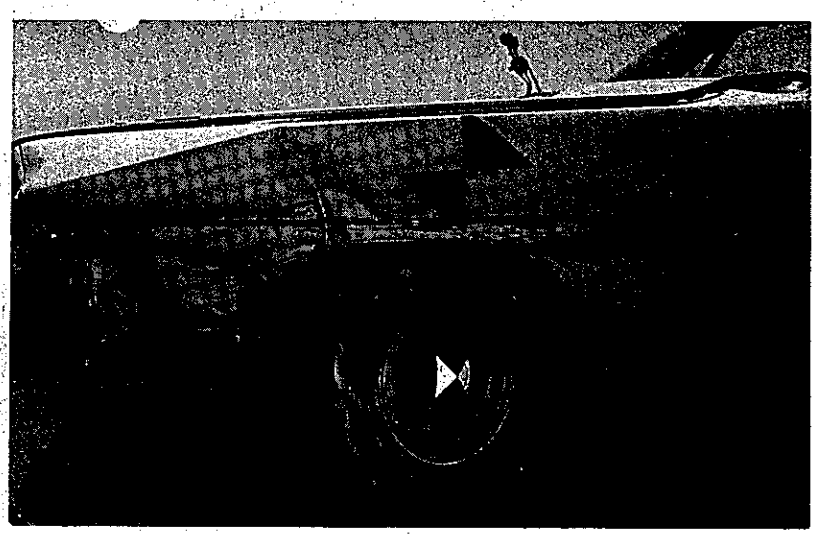
This lack of significant vehicular rise in the tests of the Modified Type 20 design is attributed to the indentation of the steel railing into the vehicle fender sheet metal which restricted the upward movement of the vehicle body. The vertical impact force was thus dissipated through greater compression of the vehicle suspension components and resistance of the barrier elements. In all tests conducted on "safety shape" parapets when impact angles were 10° or less the vehicle suspension and steering systems were not damaged and the vehicle was still operable (Figure 28). If a vertical concrete parapet had been used, it is quite likely that considerably more vehicle damage would have been sustained, and possibly the vehicle might have been rendered uncontrollable.

FIGURE 28 - VEHICLE DAMAGE
MODIFIED TYPE 20 BARRIER
TEST 285 (10° ANGLE)

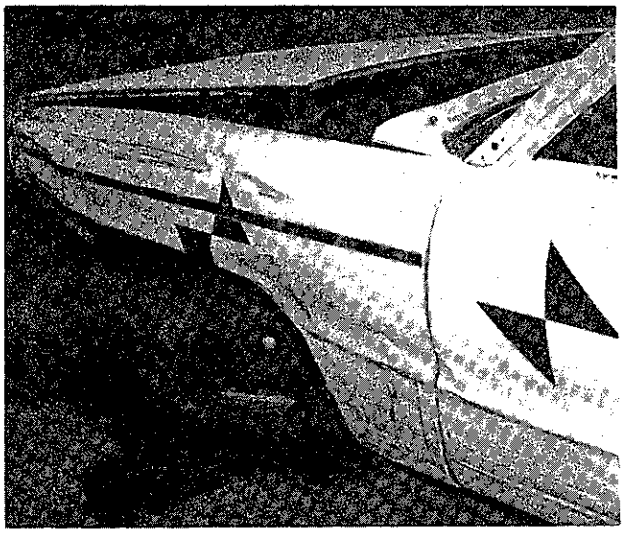
However, at the wider 15° impact angle the effectiveness of the sloping "safety shape" parapet diminishes with regard to vehicle damage, and the results are comparable between the Modified Type 20 design (Test 286 - 15° - Figure 29), the standard Type 20 design (Test 233 - 15° - Figure 30), and to some extent a vertical

FIGURE 29 - VEHICLE DAMAGE FROM MODIFIED TYPE 20 BARRIER TEST 286 (15°)

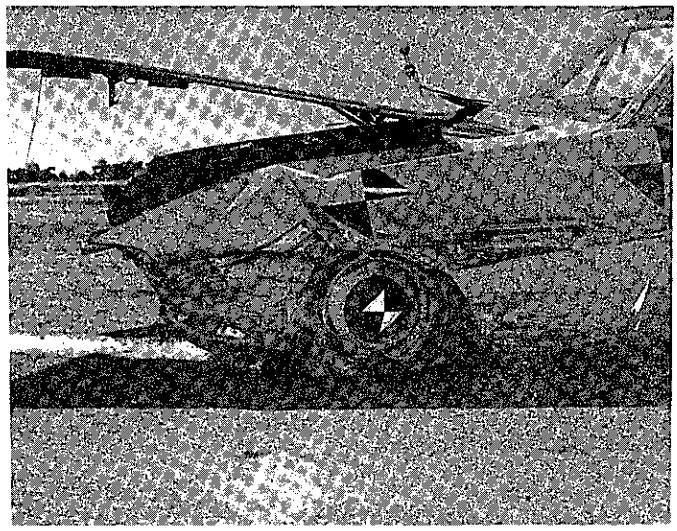
FIGURE 30 - VEHICLE DAMAGE FROM STANDARD TYPE 20 BARRIER TEST 233 (15°)

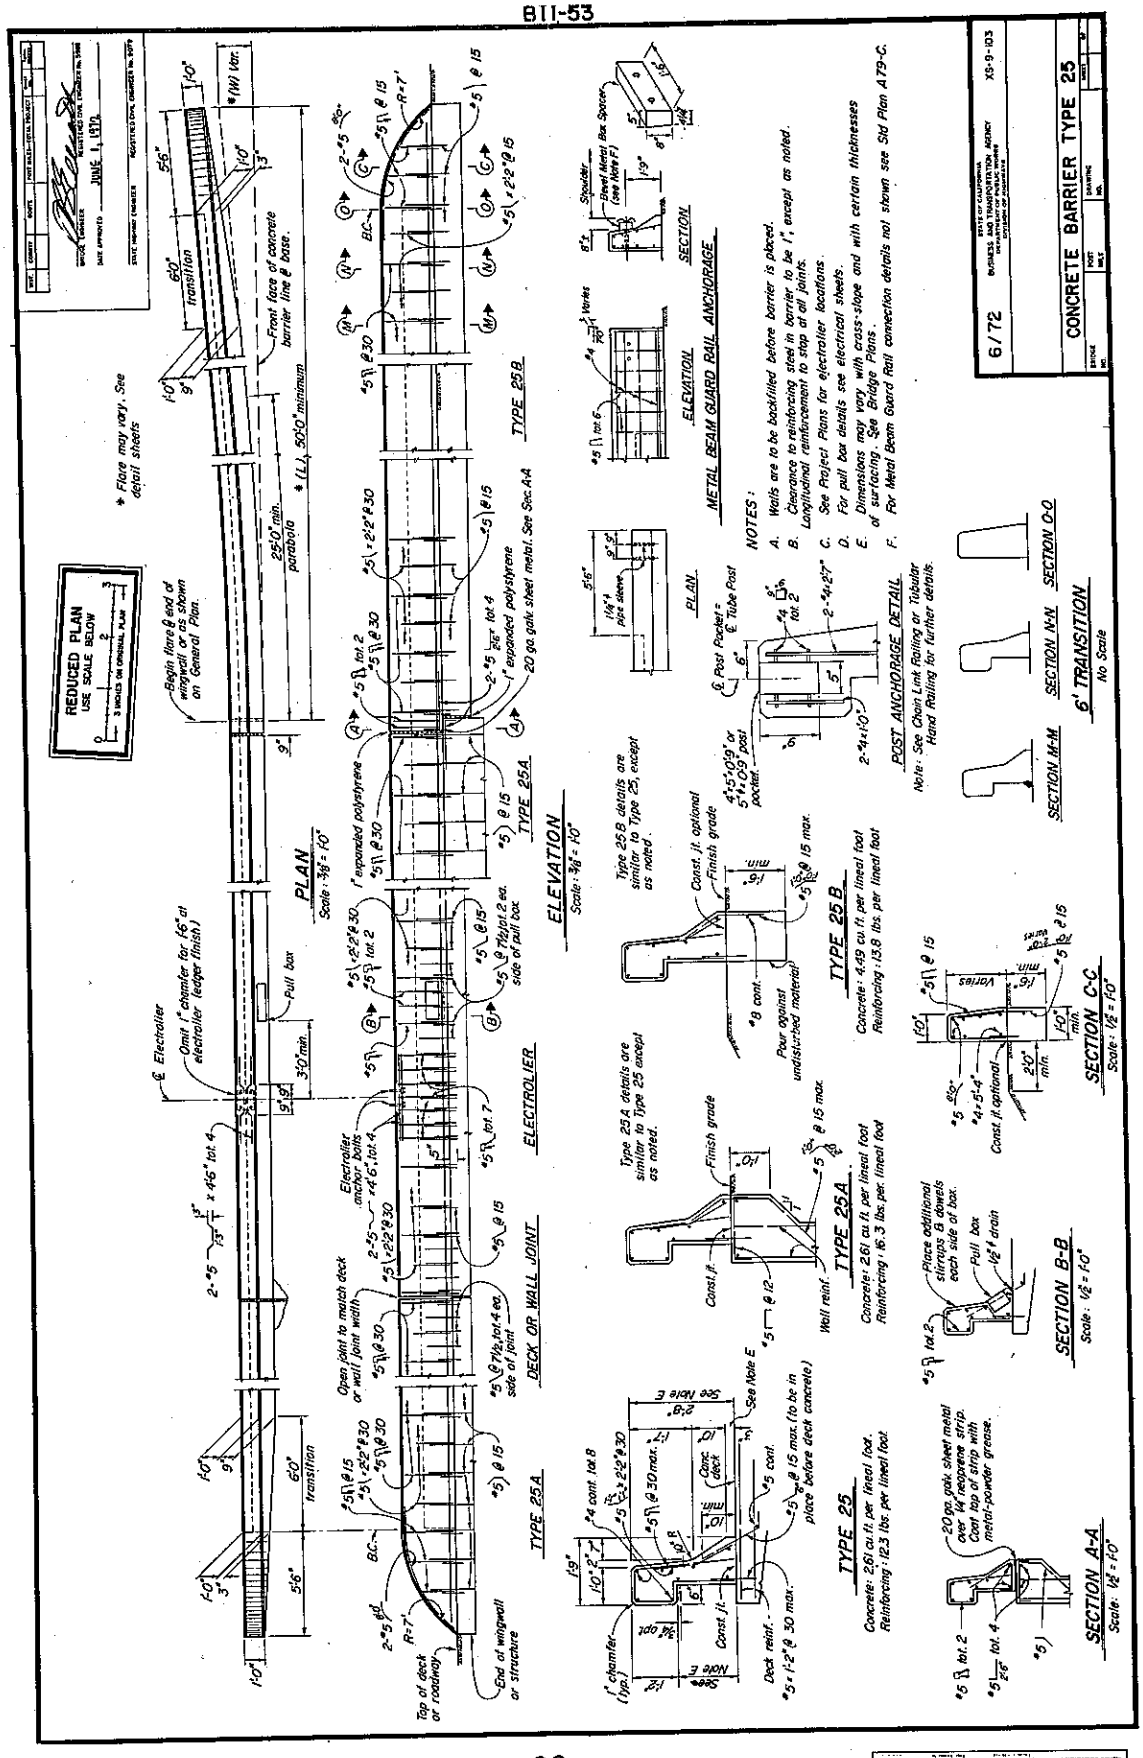
FIGURE 32

After reviewing all crash tests on the modified and standard Type 20 Bridge Rail, the Bridge Department made the decision to adopt an all concrete bridge rail called "Concrete Barrier - Type 25. Details for this design, which will be included in the 1973 Standard Plans, are shown on Figure 32. The concrete parapet height for the standard Type 20 Bridge Rail had been set at 27 inches to be compatible with existing standard approach guardrail design heights. The Type 25 design, however, with a concrete parapet height of 32 inches includes an all concrete approach barrier which is a continuation of the main bridge barrier. The Type 25 design was selected in preference to the Type 20

DETAILS OF CONCRETE BARRIER TYPE 25
(Reduced plan - not to scale)
