4. TITLE AND SUBTITLE
Dynamic Tests Of The Modified California Type 20 Bridge Barrier Rail

DYNAMIC TESTS OF THE MODIFIED CALIFORNIA TYPE 20 BRIDGE BARRIER RAIL

CA-HY-MR-6589-1-72-30

Prepared in Cooperation with the U.S. Department of Transportation, Federal Highway Administration December, 1972

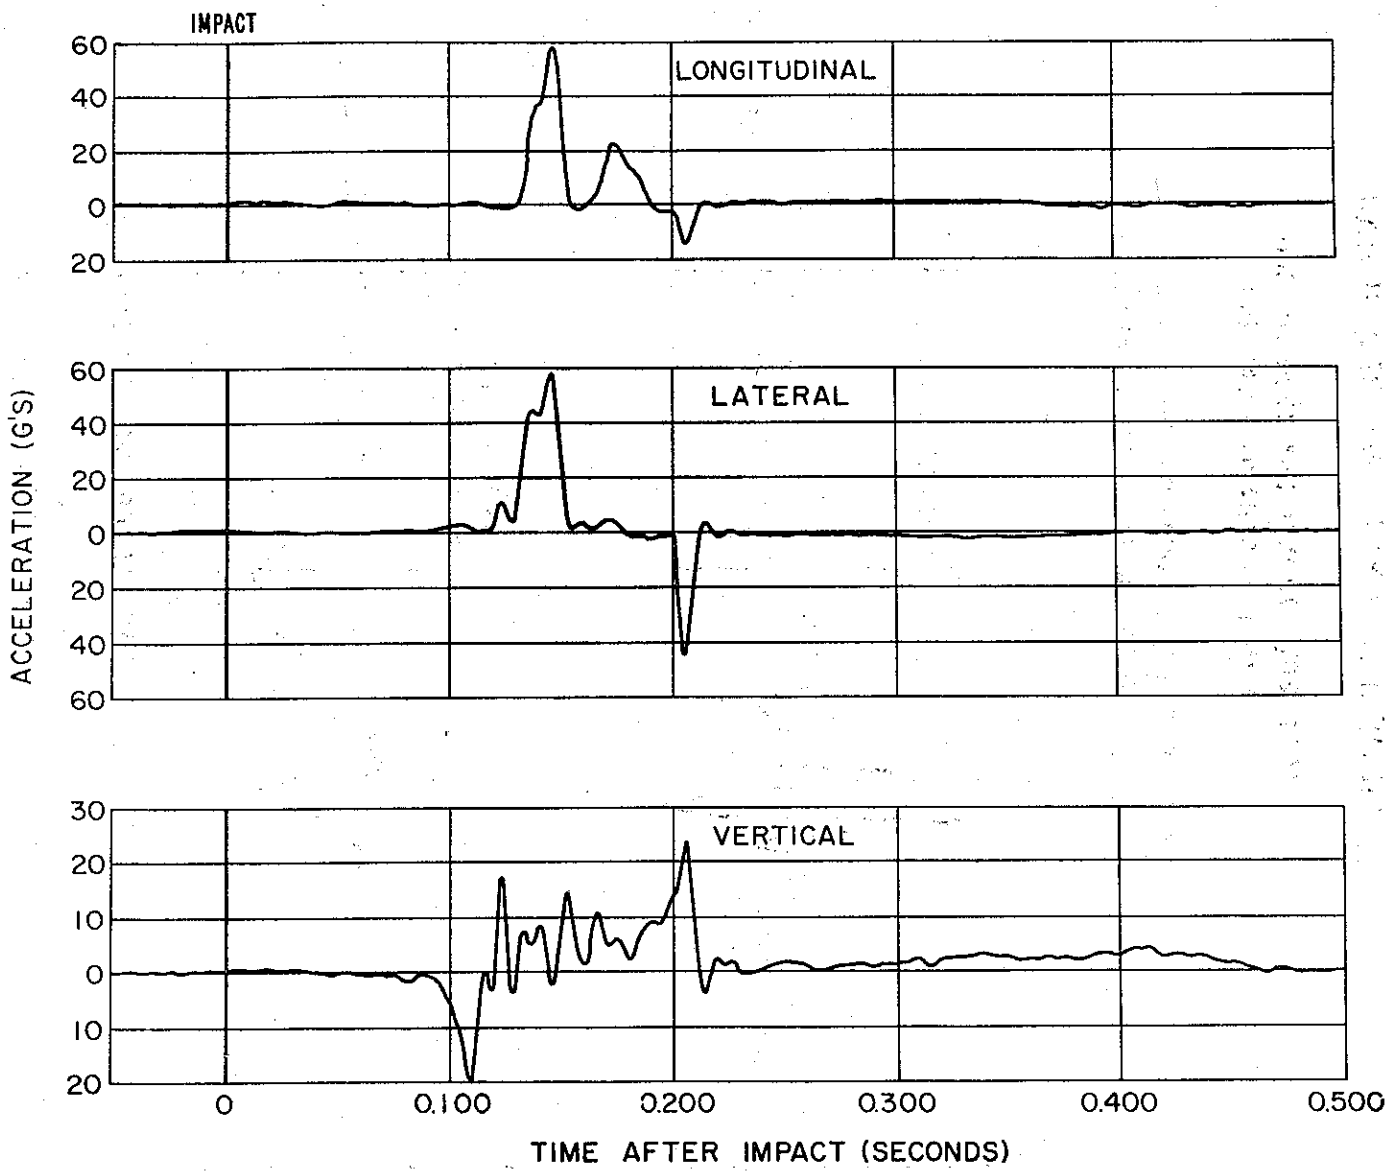
FIGURE 7-A
ACCELEROMETER RECORDS - DUMMYS HEAD
TEST 287

TEST 287 72 MPH, 25°, 4830 LB. DODGE
DUMMY RESTRAINT-LAP BELT

ACCELEROMETER LOCATION-DUMMYS HEAD
DATA FILTERED AT 100 HERTZ

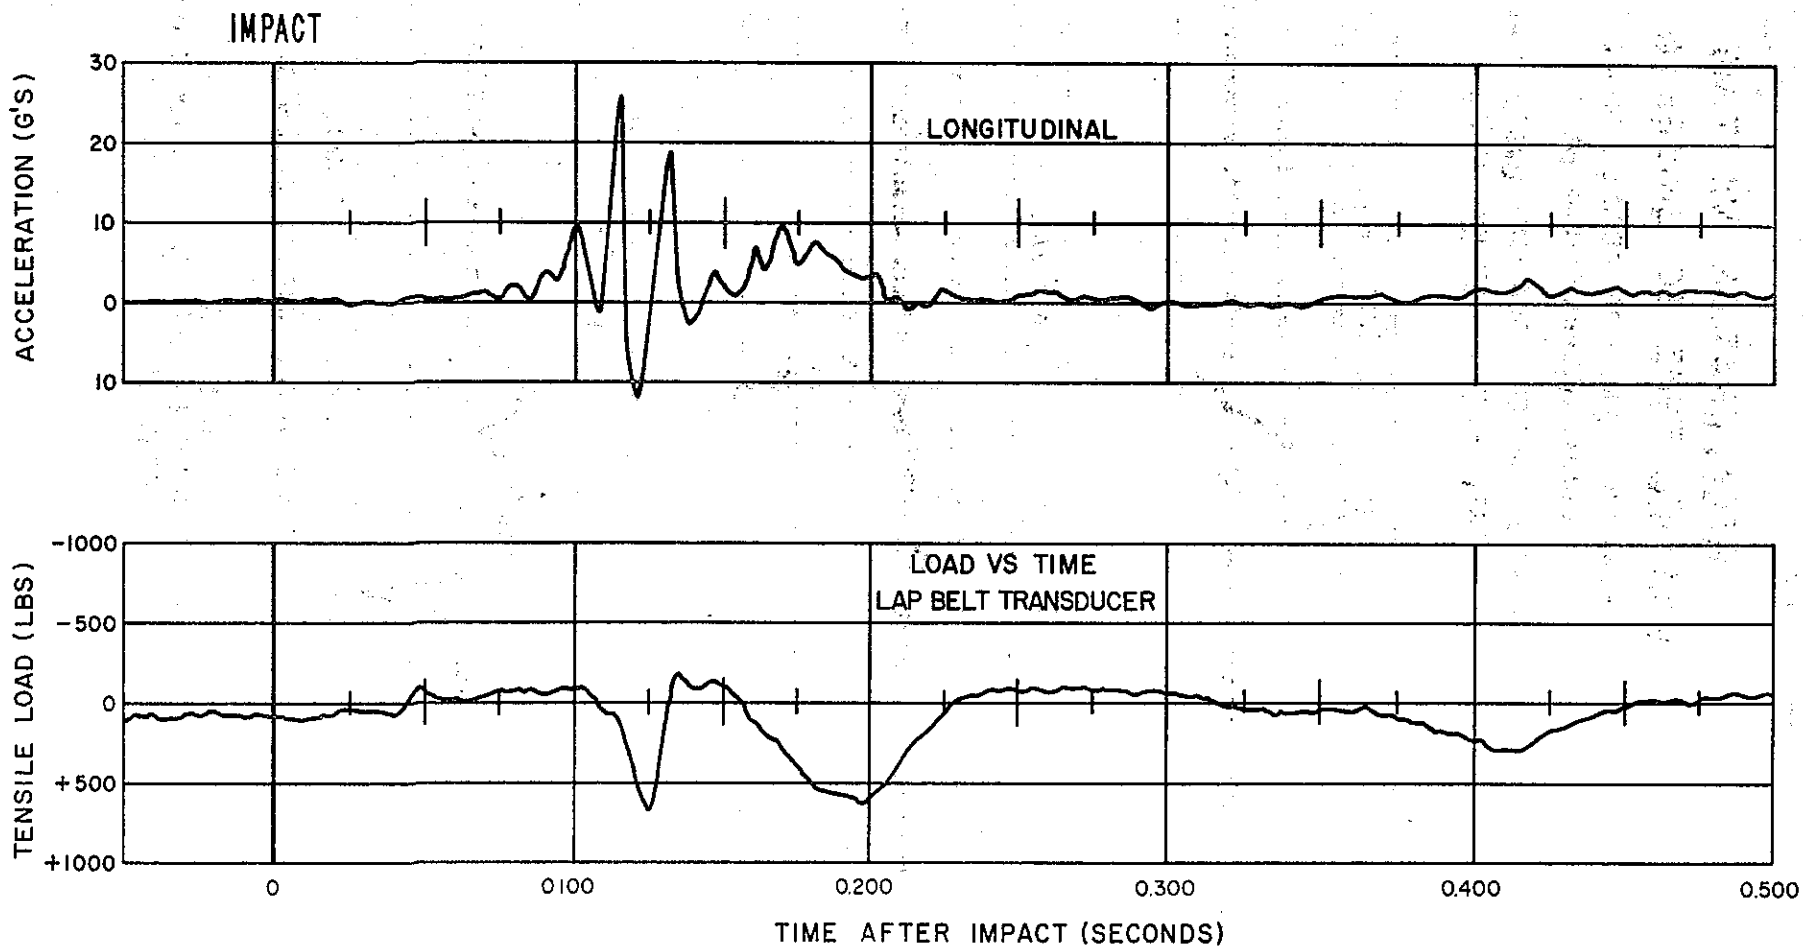
FIGURE 8-A
ACCELEROMETER RECORDS- DUMMYS CHEST
TEST 287

TEST 287 72 MPH, 25°, 4830 LB. DODGE
DUMMY RESTRAINT - LAP BELT

ACCELEROMETER LOCATION- DUMMYS CHEST
DATA FILTERED AT 100 HERTZ

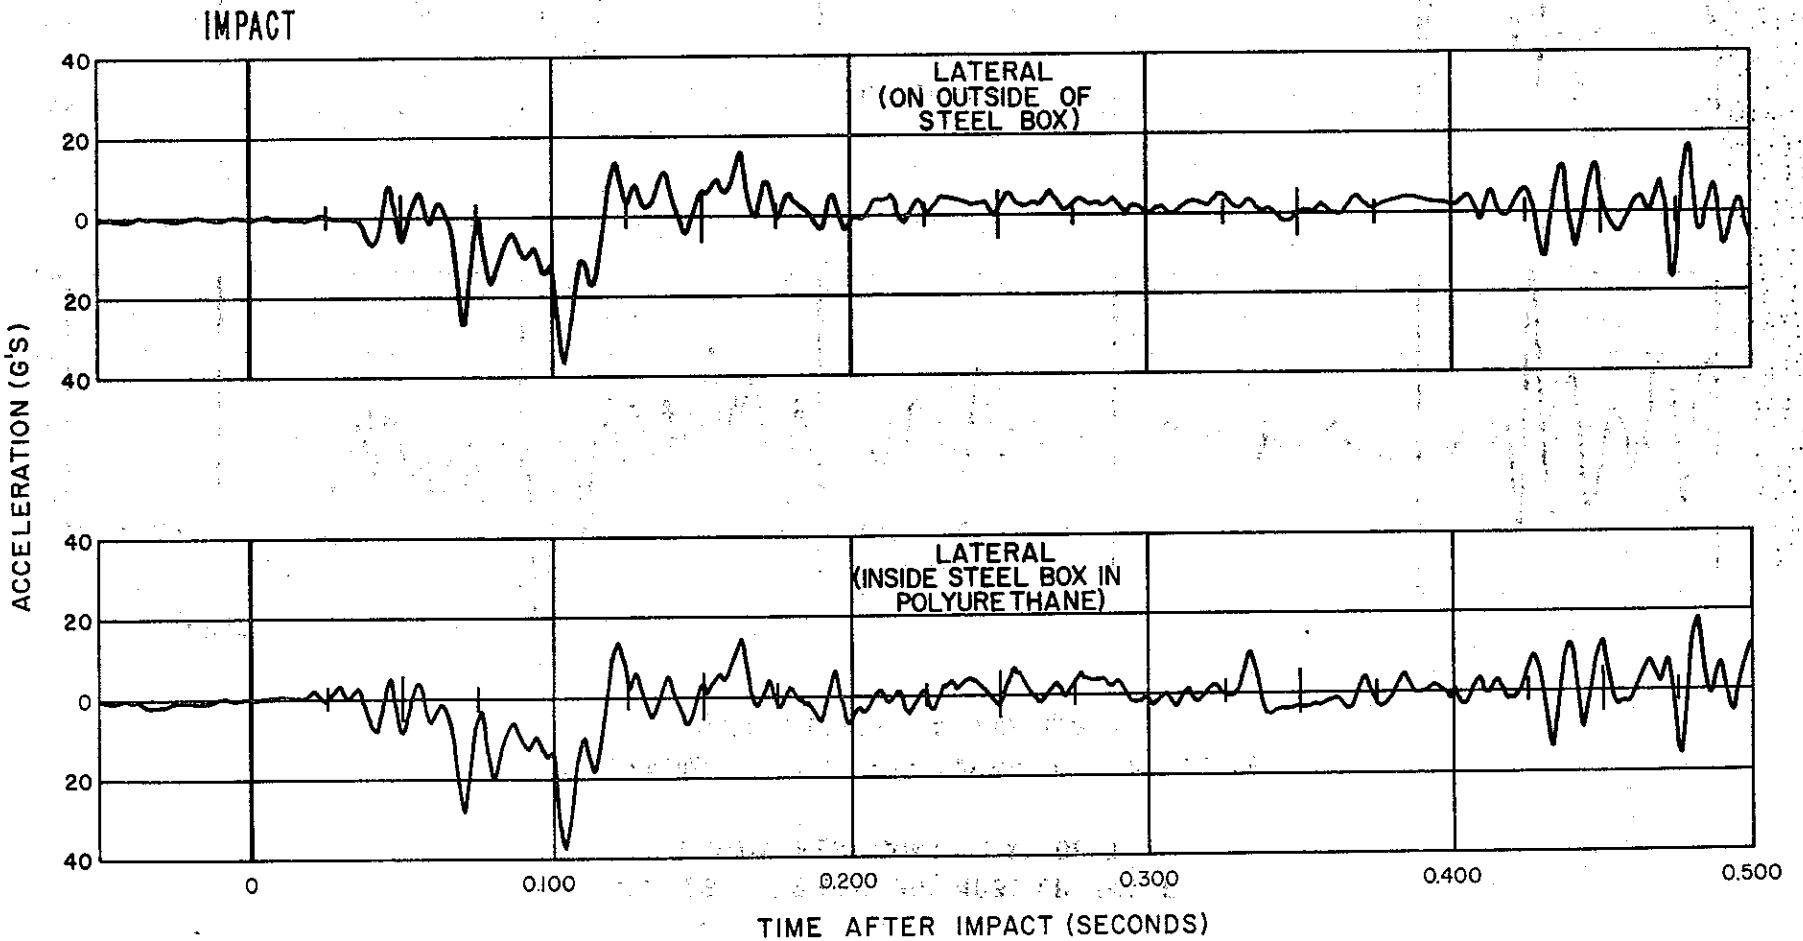
FIGURE 9-A
ACCELEROMETER RECORDS - VEHICLE FLOOR
TEST 287

TEST 287 72 MPH, 25°, 4830 LB. DODGE
DUMMY RESTRAINT - LAP BELT

ACCELEROMETER LOCATION- VEHICLE FLOOR
DATA FILTERED AT 100 HERTZ

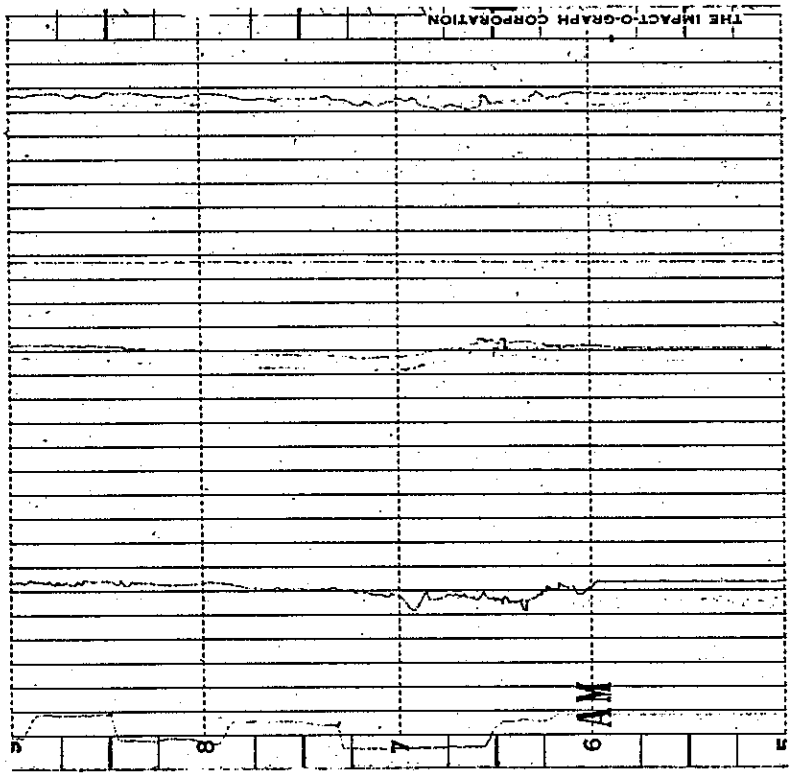
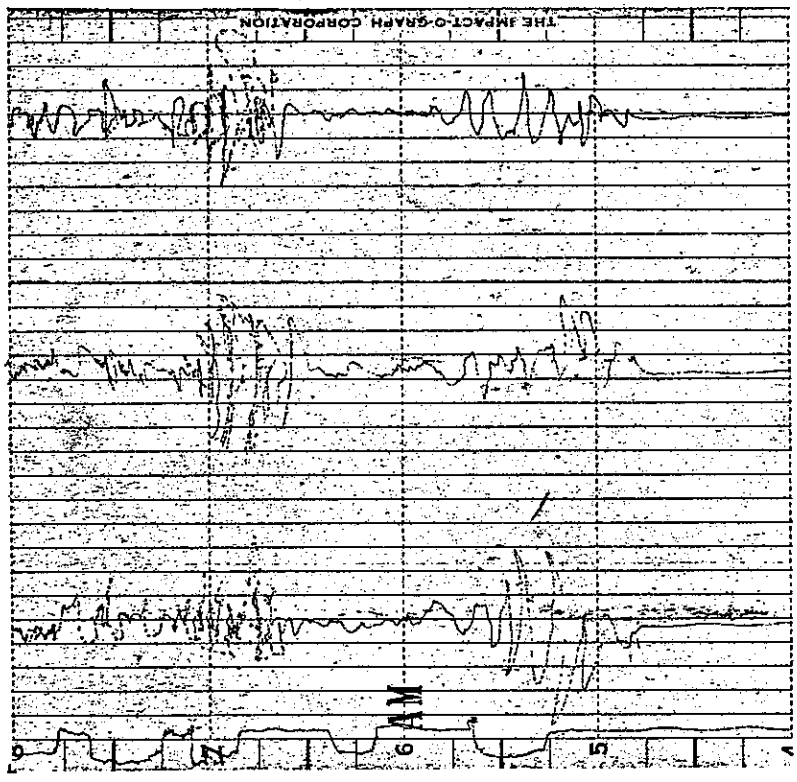
FIGURE 13-A
VEHICLE IMPACTOGRAPH DATA
TESTS 286-287

As mentioned elsewhere in this report, these Impactograph values are not "G" forces, but rather, traces of the relative severity of impact as measured on the test vehicle. The records are reproduced in the Appendix, Section V.E, Figures 11-A through 13-A. The Impactograph values indicate that at impact angles less than 15°, the severity of impact in this test series increased only slightly in the lateral direction relative to the impact velocity with no appreciable difference noted in the longitudinal and vertical recordings. Overall impact severity with this barrier design appears to be more a function of the angle of impact, as illustrated by the substantially higher values obtained in Tests 286 (15°) and 287 (25°), rather than a function of impact speed (Tests 281 - 284).

TEST 286
65 MPH
15 DEGREES

TEST 287
72 MPH
25 DEGREES
