4. TITLE AND SUBTITLE
Bridge Deck Restoration - Methods And Procedures, Part I: Repairs

BRIDGE DECK RESTORATION METHODS AND PROCEDURES

REPAIRS

Interim Report

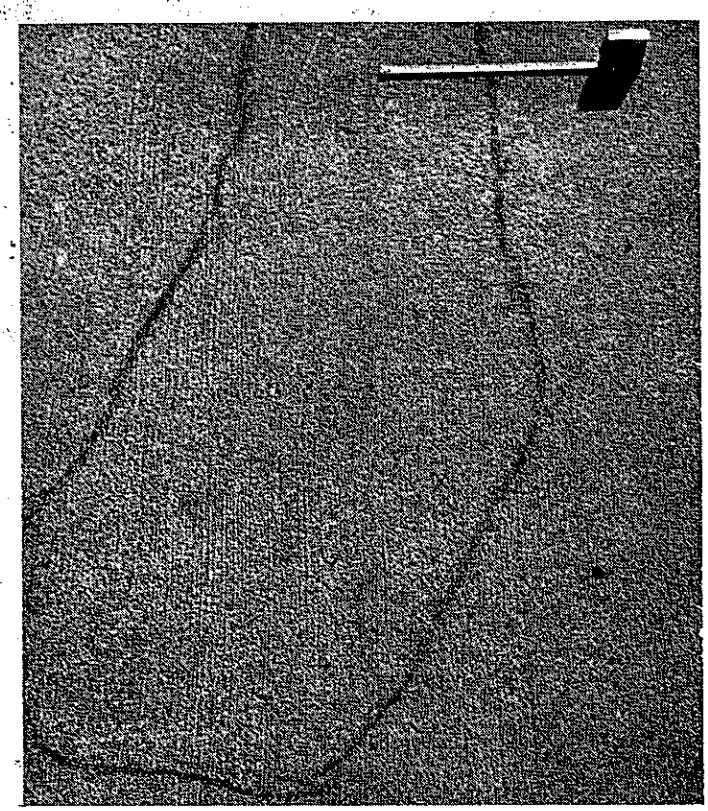
Figure 5

Most decks needing restoration have begun to pothole due to fractured concrete raveling out under traffic. It is not unusual however to find large areas of undersurface fracture without any evidence of this incipient pothole on the surface, as is shown in Figure 5. Some type of sounding device, such as a hammer, rod, or chain, is needed to locate these fractured areas so as to repair them. By pounding the surface with the device, or by dragging the device over the surface, and observing the sound, a fractured area is easily discerned by the low pitched "hollow" sound which results when the operation is directly over it.

Outline of Undersurface Fractured Area

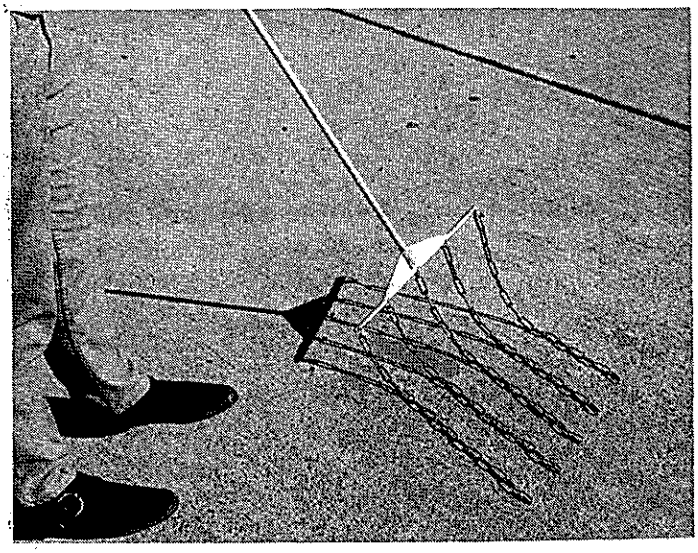
The broom shaped chain drag shown in Figure 6 has proven to be a very effective sounding device. Its greatest

Chain Drag for Detecting Undersurface Fractures

attribute is that large areas can be rapidly covered with a sweeping motion. As an added feature, this device will detect undersurface fractures which cannot be detected by striking the surface with a hammer or rod.

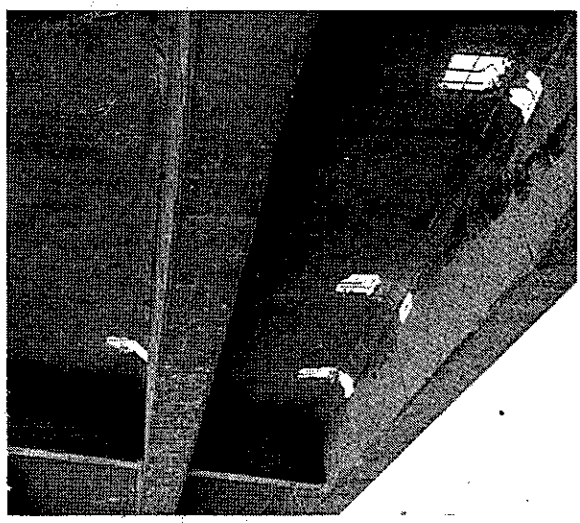
Figure 7

There is a wide variation in the skill of jackhammer operators found on restoration projects. This has been demonstrated on several occasions when holes were punched through the deck at the start of a contract with virtually none towards the end after the operators became more experienced with the work. See Figure 7. The quantity of

Holes Jackhammered Through the Deck

The size of jackhammer to be used in removing fractured concrete during restoration is to some extent dependent upon the skill of the operator. Experience has shown however that the maximum size should be no more than 65 pounds for the initial breakout, regardless of the operator's skill. For less skilled operators the maximum should be 30 pounds. Final clean up of small areas which were fractured by the larger jackhammers should be removed with a small air powered chipping gun. See Figure 8. Or if preferred, the final

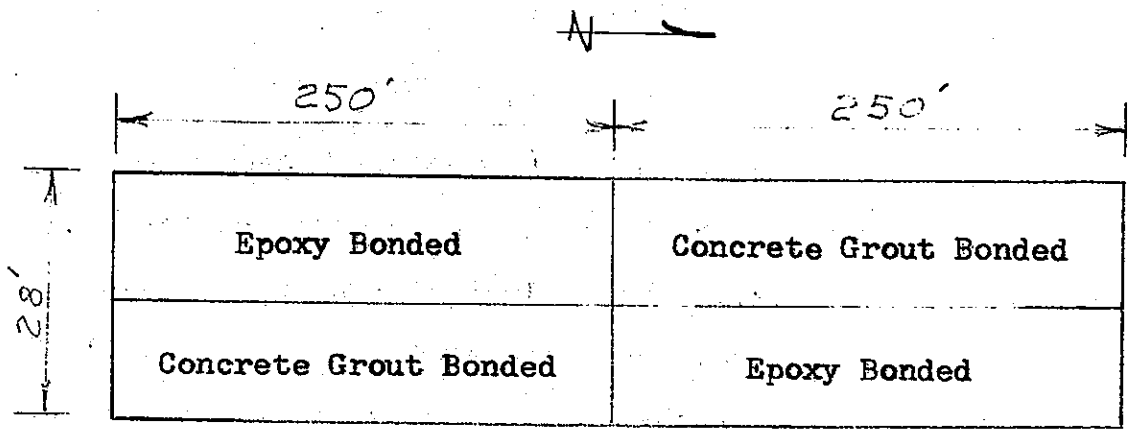
Figure 10

For the purpose of verifying the theoretical concepts under field conditions, a 500-foot long bridge was patched with both cement grout and epoxy bonding agent. The two materials were used in opposite quadrants as shown in Figure 10. The

Layout of Bonding Materials
Used on Kings River Bridge

and undersurface fractures than have the areas where epoxy bonding was used.

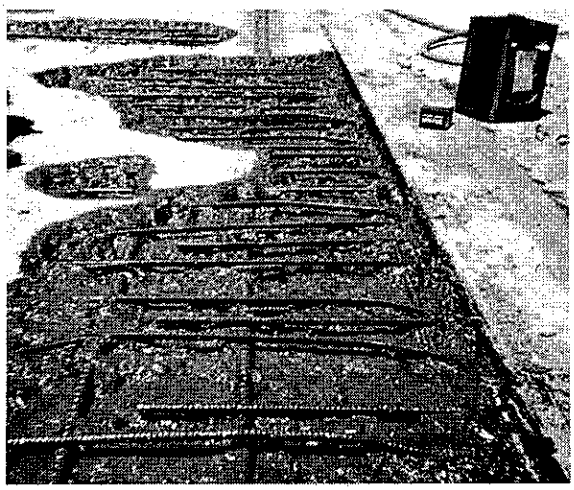
Figure 11

The use of epoxy bonding material in California has not precluded steel in the patched area from participating in the galvanic corrosion process. The magnitude of active corrosion in patched areas of deck restoration has not been determined, hence it is not known if the few cases where corrosion has been found are unique or typical conditions. Since under lab conditions the epoxy used appears to be a good electrical insulator, it is conceivable that during field application the epoxy at times has been either improperly mixed or improperly placed. More work directed towards investigating this phenomena is planned. In the meantime California will continue to use only epoxy as a bonding agent in restoration work. See Figure 11.

Epoxy Bonding Material
Applied to Area to be Patched
