**1. REPORT No.**
CA-DOT-TL-3324-1-76-14

**4. TITLE AND SUBTITLE**
A Review Of The Performance Of Lime Treated Roadways In California

**5. REPORT DATE**
April 1976

**9. PERFORMING ORGANIZATION NAME AND ADDRESS**
Office of Transportation Laboratory
California Department of Transportation
Sacramento, California 95819

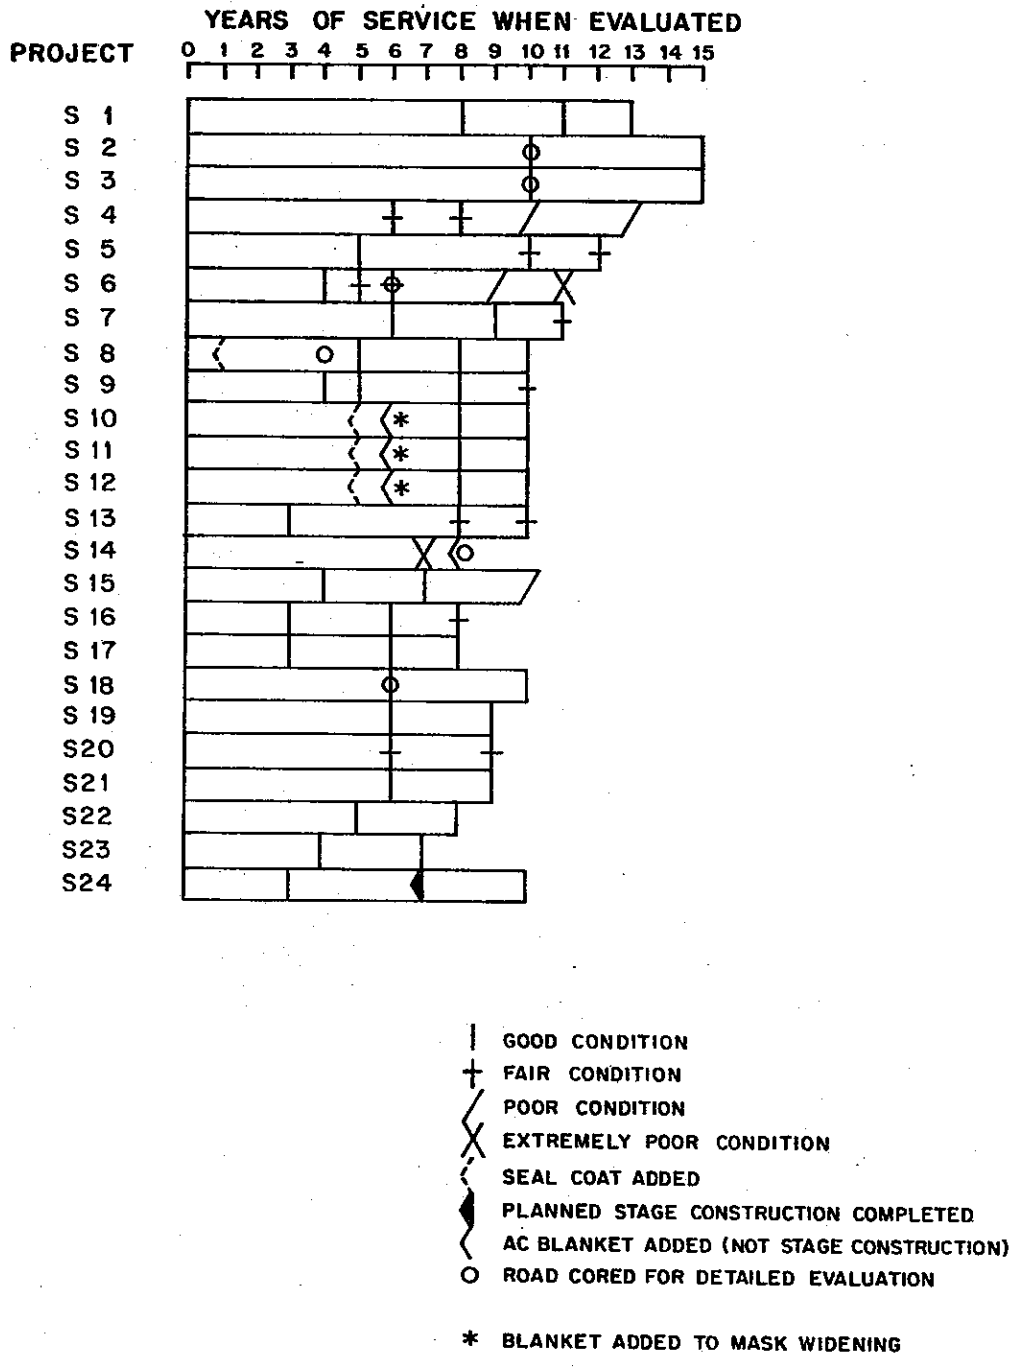
Figure 1

of service. Included in this condition survey is a list of the types of distress or cracking observed and an assigned condition rating. The surface conditions after various lengths of time in service are presented in Figure 1. The length of service time prior to resurfacing, reconstruction, or coring in conjunction with this study are also shown.

## PERFORMANCE EVALUATION OF ROADWAYS INCORPORATING LIME TREATED MATERIALS AS A SUBBASE

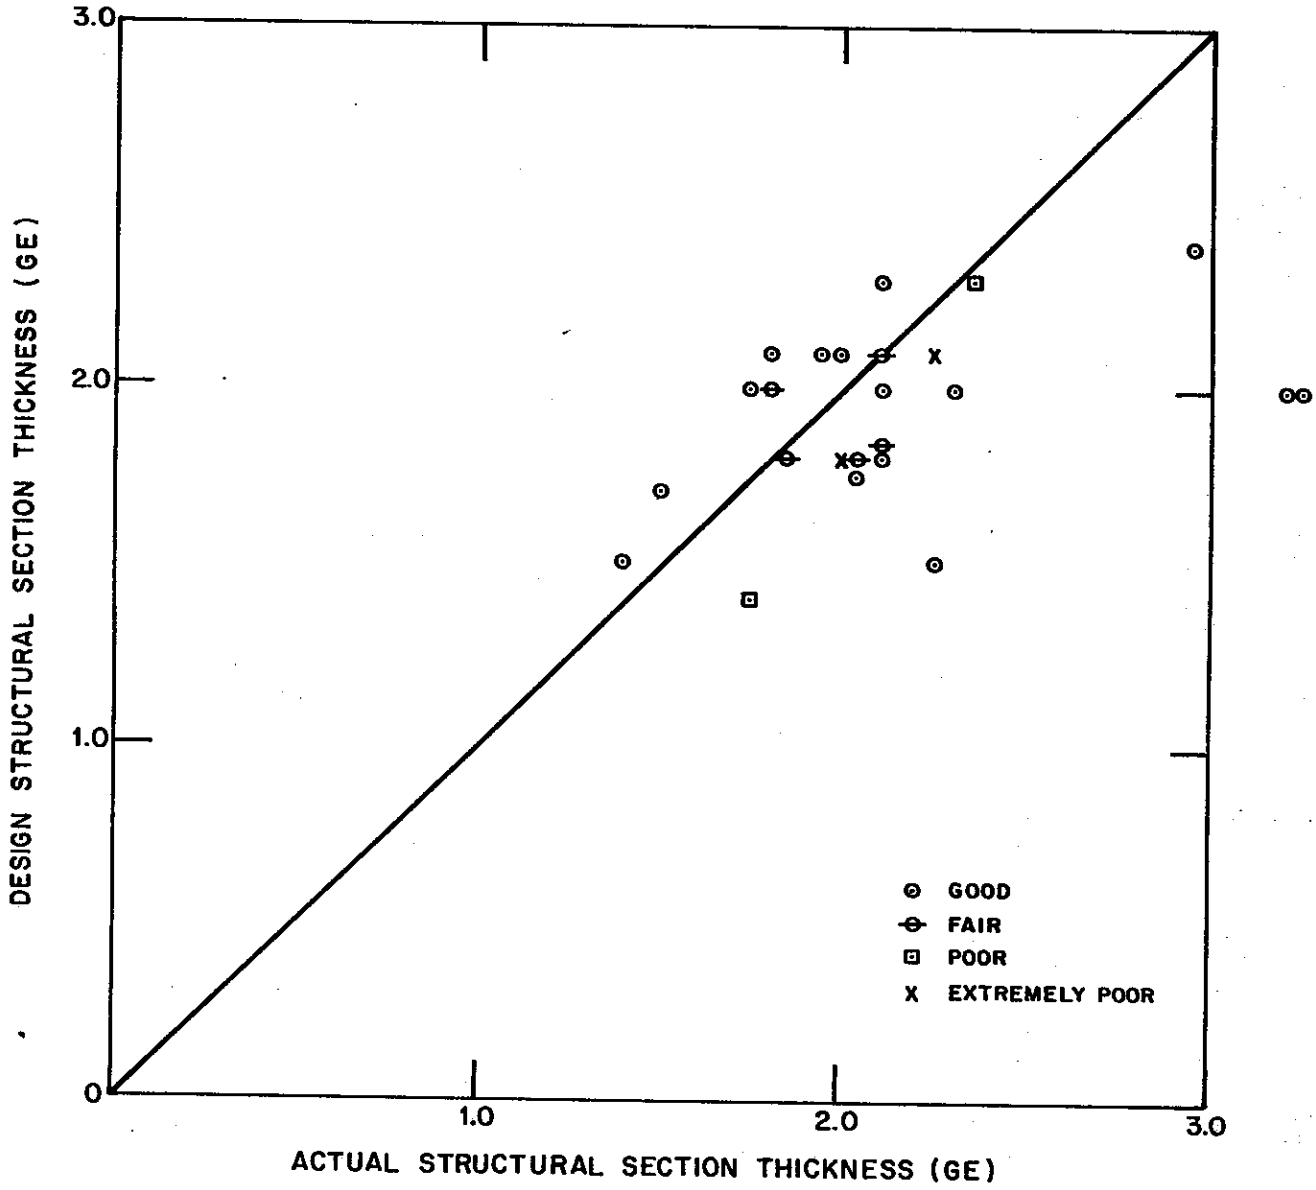
A review of the structural section data in Table 1 indicates that the actual gravel equivalent thicknesses of the 24 different roads varied from 0.3 foot less than required by the current design procedure to as much as 1.2 feet more than required. A comparison of the current design thicknesses with the actual as-built thicknesses in Figure 2 fails to show a definite correlation between the structural section and the performance rating. Each of the four roads constructed with 0.5 ft. or more thickness than required was in good condition but all of the roads which were rated as being in poor or extremely poor condition were also constructed with an "adequate" design thickness or better. Only one of the nine roads constructed with less than "adequate" total thickness was judged to be in fair condition while all of the remainder were in good condition.

## DEVIATION FROM STRUCTURAL SECTION DESIGN THICKNESS AND THE EFFECT ON PAVEMENT PERFORMANCE (LIME TREATED SUBBASE)

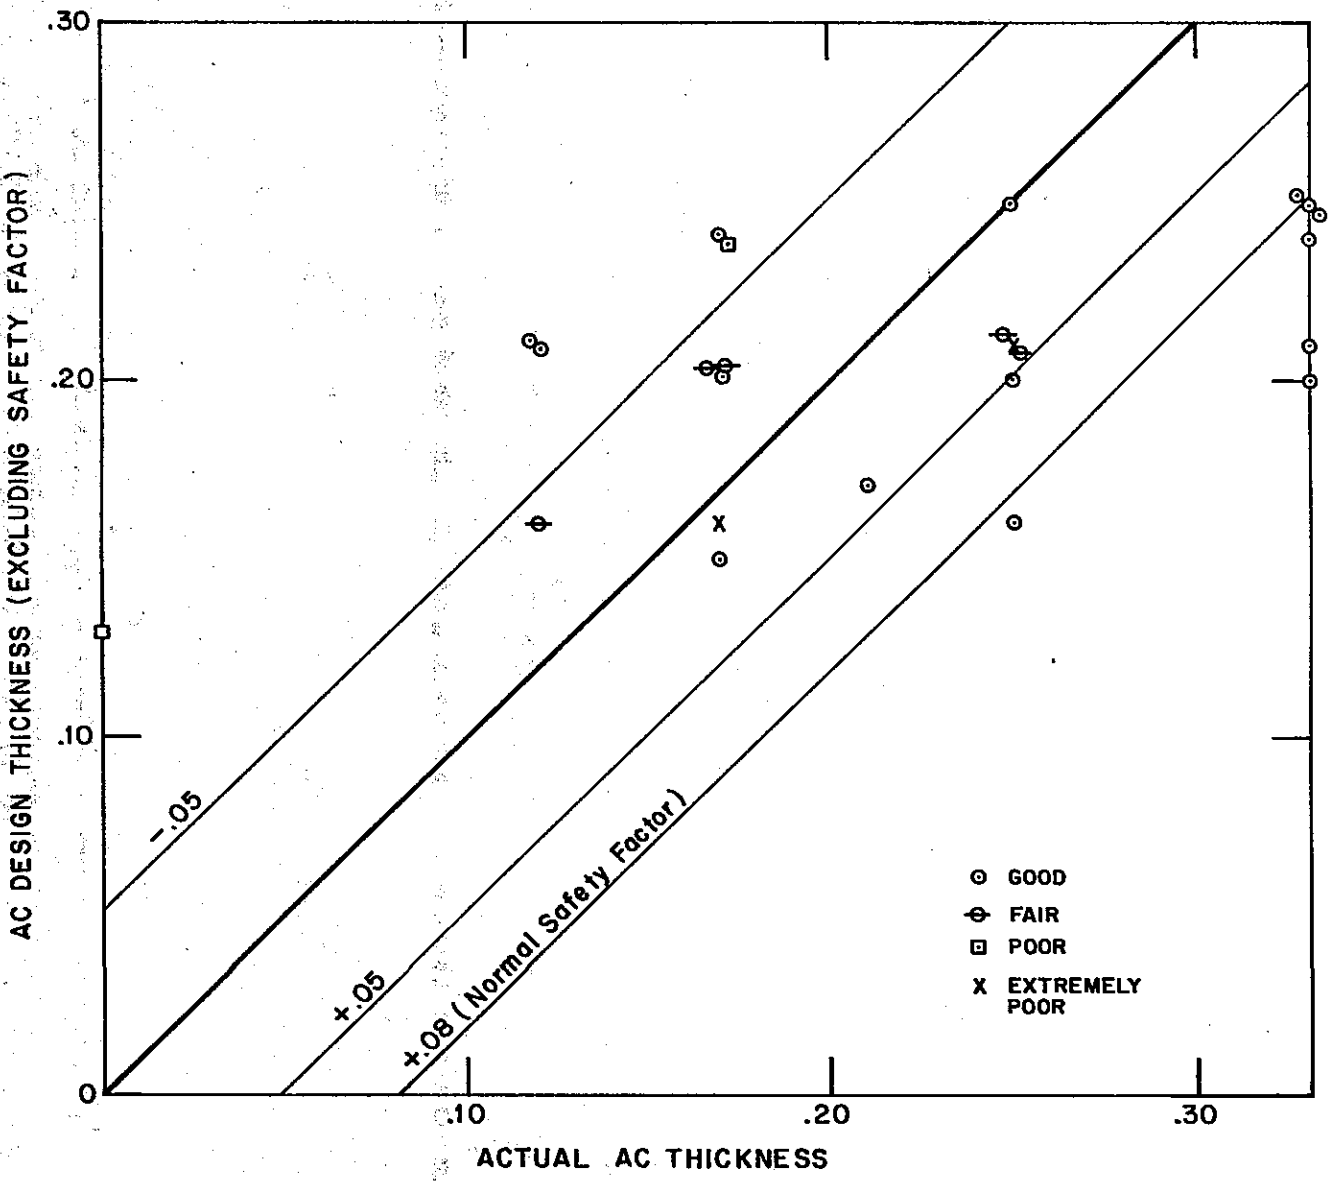
A comparison of the current thickness design requirements and as-built thicknesses of the asphalt concrete in Figure 3 shows that the performance of this group of roads is influenced to some degree by the adequacy of the surfacing. All of the roads which included the additional asphalt concrete required by the design procedure as a safety factor were in good condition. Eighty two percent of the roads which were constructed within $\pm$ .05 ft. of the "design" asphalt concrete thickness were in fair to good condition while 60% of the roads which were deficient in asphalt concrete thickness by more than .05 foot were in fair to good condition.

## DEVIATION FROM ASPHALT SURFACING DESIGN THICKNESS AND THE EFFECT ON PAVEMENT PERFORMANCE (LIME TREATED SUBBASE)

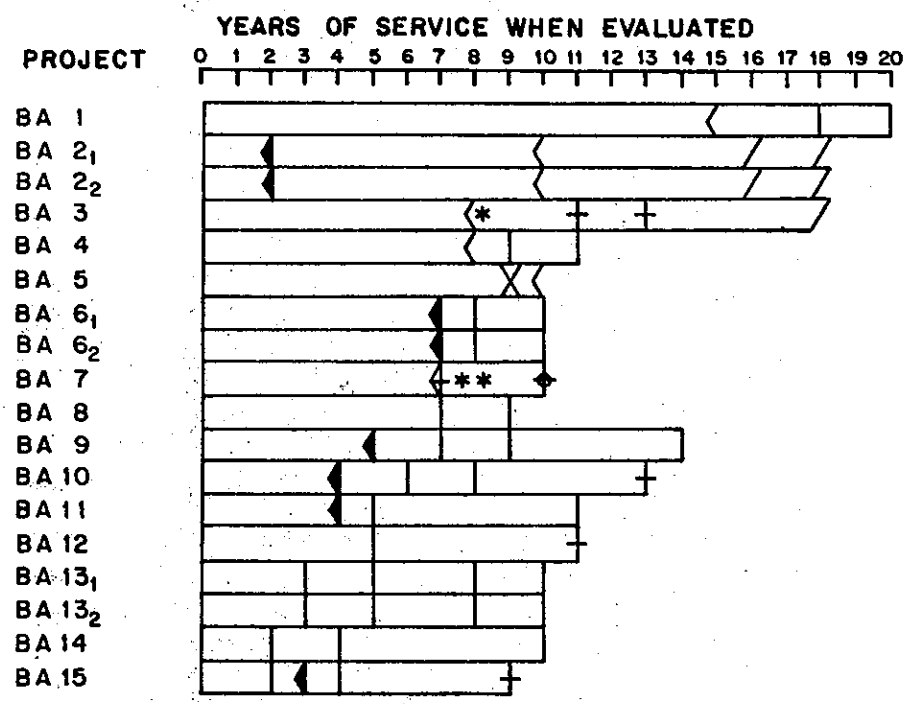
Figure 4

The design data and structural section thicknesses for the eighteen roads constructed with lime treated aggregate as a base are tabulated in Table 3. A summary of the lime treated material used on each project and an evaluation of the actual or projected surface condition of the roadway after 10 years of service are listed in Table 4. The surface conditions after various lengths of time in service are presented in Figure 4. The length of service time prior to resurfacing, reconstruction, or coring in conjunction with this study are also shown in Figure 4.

## PERFORMANCE EVALUATION OF ROADWAYS INCORPORATING LIME TREATED AGGREGATES AS A BASE

* .08 blanket just meets design
** Measurements at the time the road was cored indicated that several blankets have been added (.5-.6 measured)

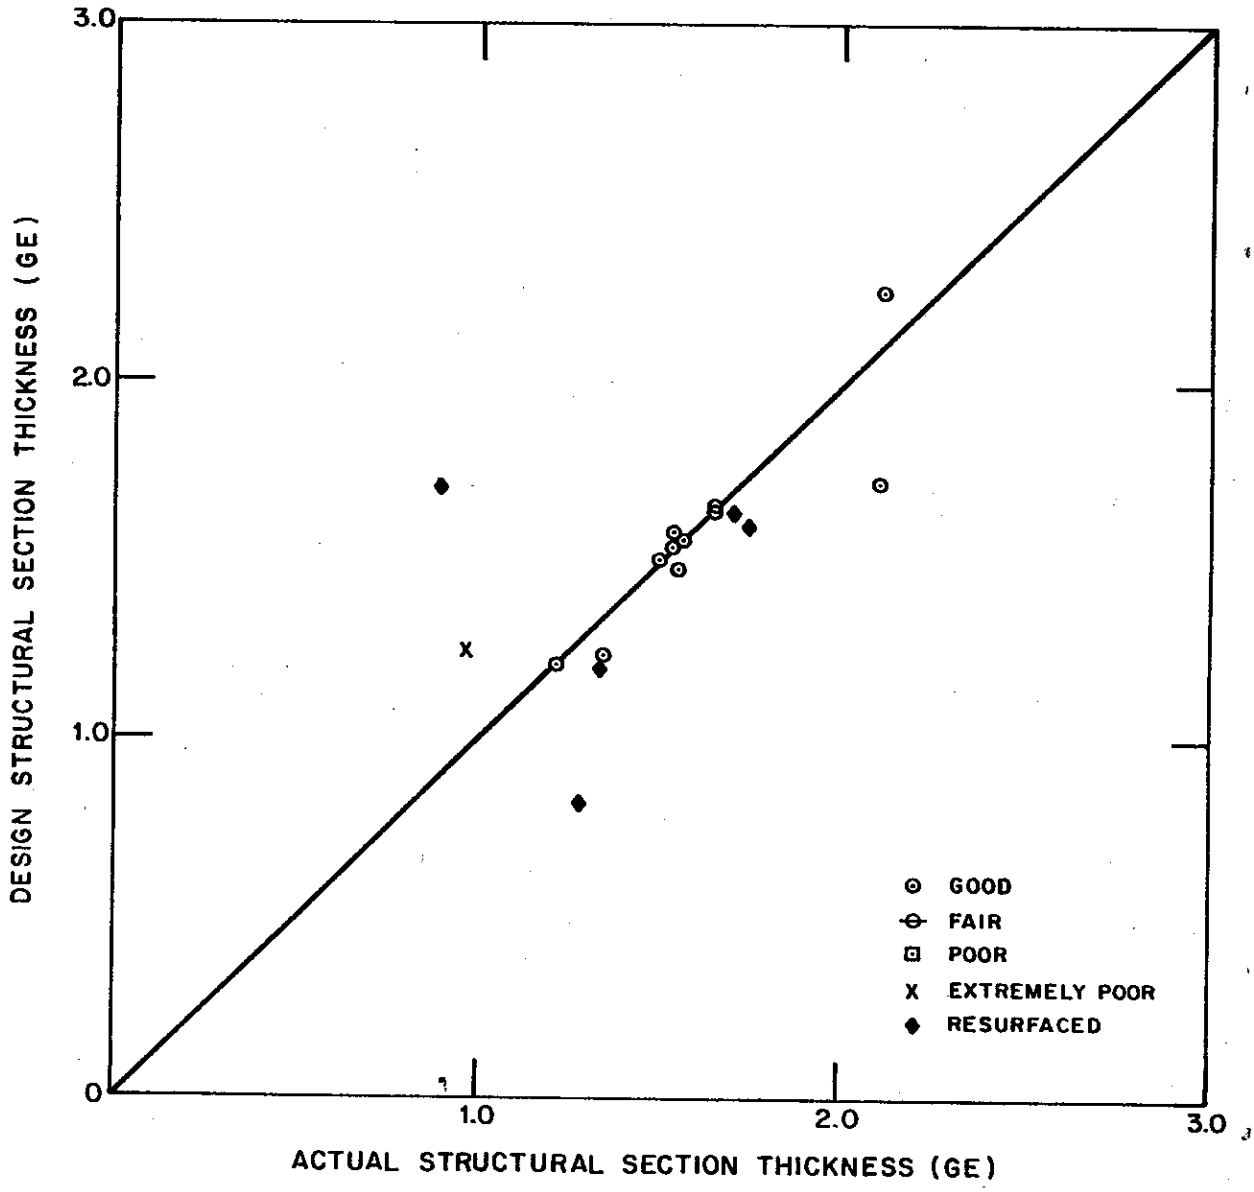
Figure 5

## DEVIATION FROM STRUCTURAL SECTION DESIGN THICKNESS AND THE EFFECT ON PAVEMENT PERFORMANCE (LIME TREATED AGGREGATE BASE)

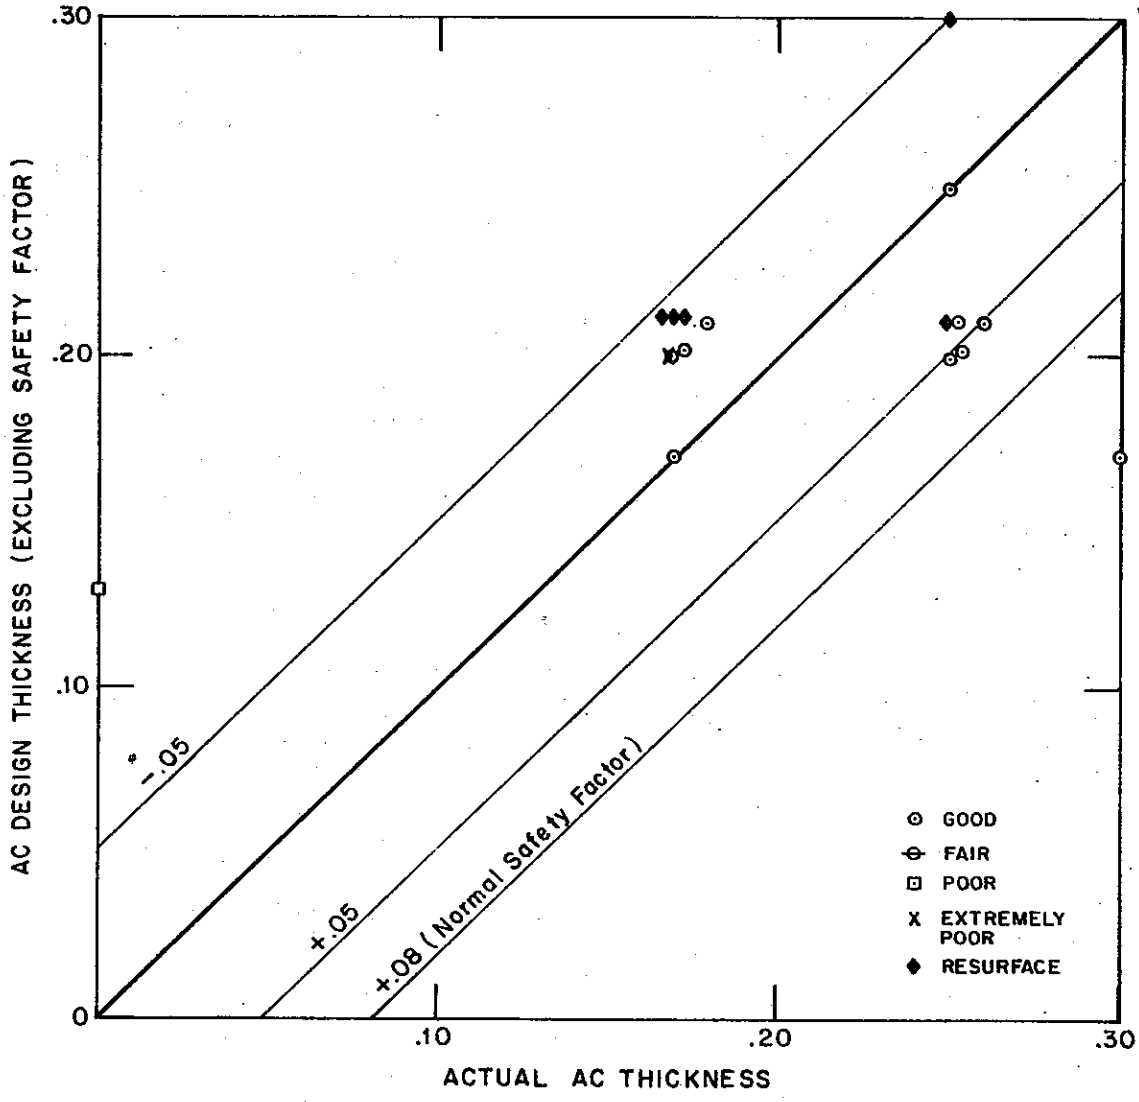
Figure 6

A comparison of the design asphalt concrete thicknesses with the as-built thicknesses is presented in Figure 6. Approximately one half of the projects were constructed with less than the minimum thickness of asphalt concrete indicated by the design formula. The road which was judged to be in extremely poor condition after nine years and one of the two roads which were resurfaced because of surfacing distress were deficient in asphalt concrete thickness. All of the roads except one were deficient in asphalt concrete thickness, by at least a small margin, when the safety factor requirement is considered.

## DEVIATION FROM ASPHALT SURFACING DESIGN THICKNESS AND THE EFFECT ON PAVEMENT PERFORMANCE (LIME TREATED AGGREGATE BASE)

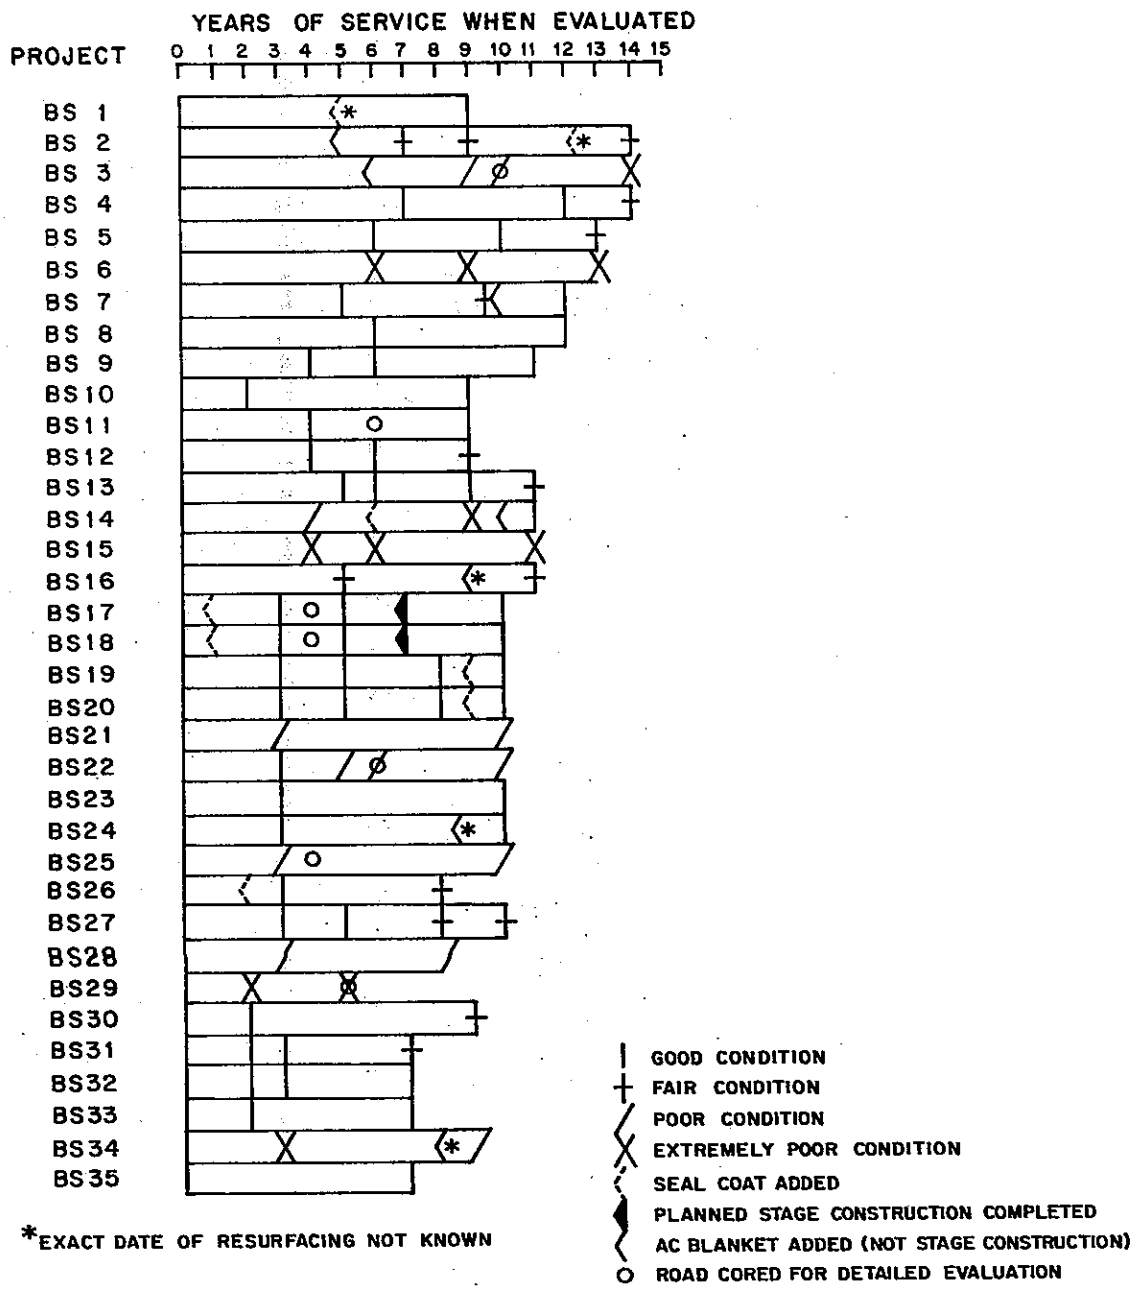
Figure 7

The design data and structural section thicknesses for this group of roads are tabulated in Table 5. A summary of the lime treated material used on each project and an evaluation of the actual or projected surface condition of the roadway after 10 years of service are listed in Table 6. The surface conditions after various lengths of time in service, along with the length of service time prior to resurfacing, reconstruction, or coring are presented in Figure 7.

## PERFORMANCE EVALUATION OF ROADWAYS INCORPORATING LIME TREATED SOILS AS A BASE

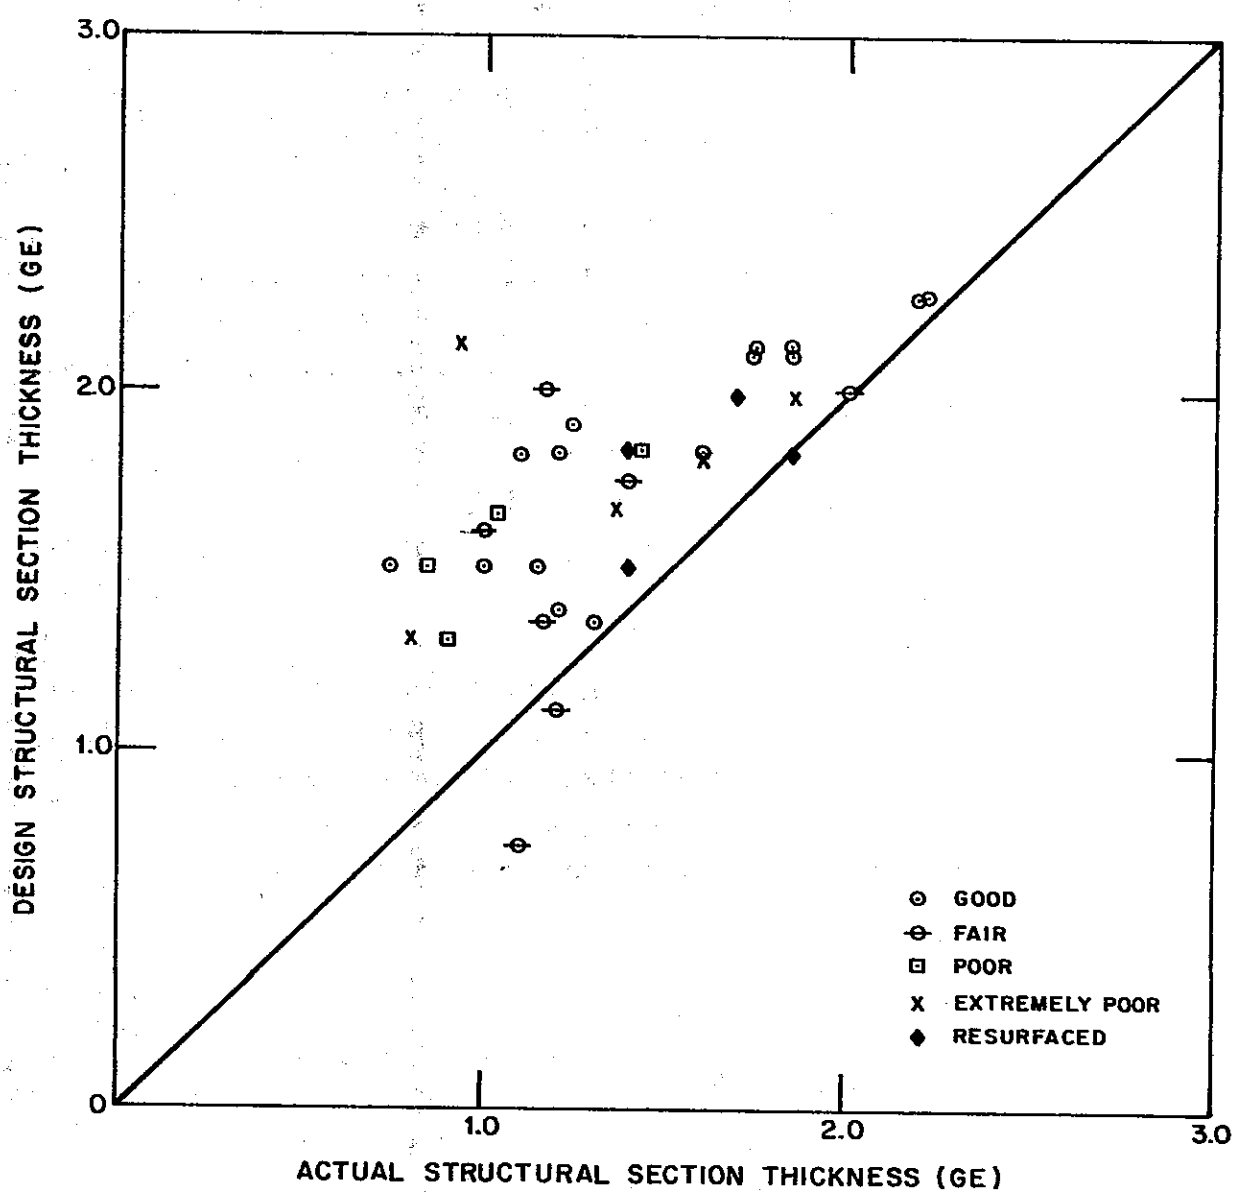
Comparisons of the required (by design criteria) and actual total gravel equivalent thickness and asphalt concrete surfacing thicknesses are presented in Figure 8 and 9 respectively. Based on Figure 8, there is little correlation between road performance and deficiency of the gravel equivalence of the total structural section. Many roads were found to be in good condition even though deficient by up to 0.75 foot in gravel equivalence. Others had been resurfaced or were in various stages of distress even though the constructed section was adequate or only slightly deficient according to the design formula.

## DEVIATION FROM STRUCTURAL SECTION DESIGN THICKNESS AND THE EFFECT ON PAVEMENT PERFORMANCE (LIME TREATED SOIL BASE)

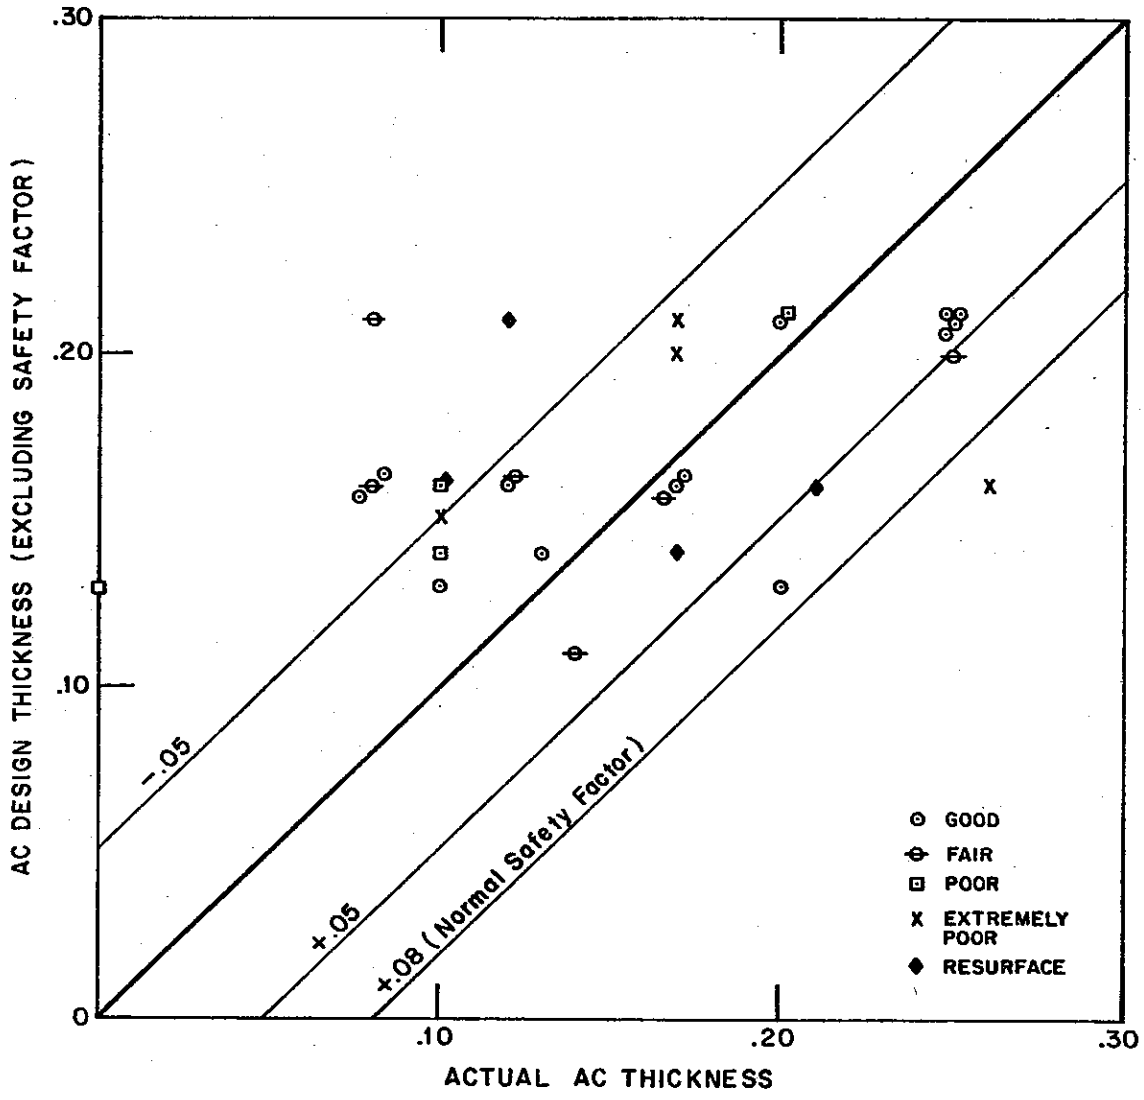
Figure 9

## DEVIATION FROM ASPHALT SURFACING DESIGN THICKNESS AND THE EFFECT ON PAVEMENT PERFORMANCE (LIME TREATED SOIL BASE)

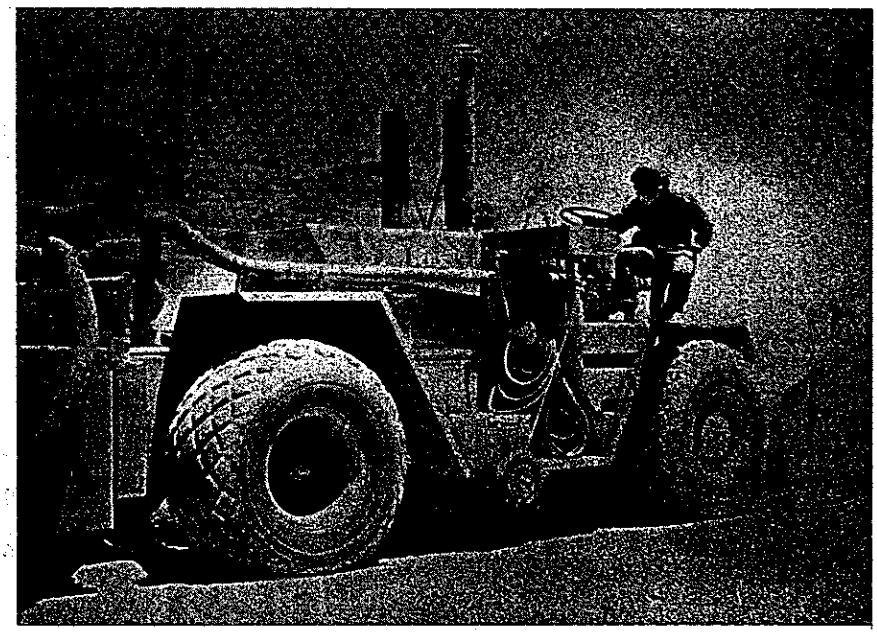
during both the distribution and mixing of these products. There have, in fact, been occasions when construction has been shut down because of the amount of lime dust in the air.

Figure 10
Dust Problem with Finely Ground Lime

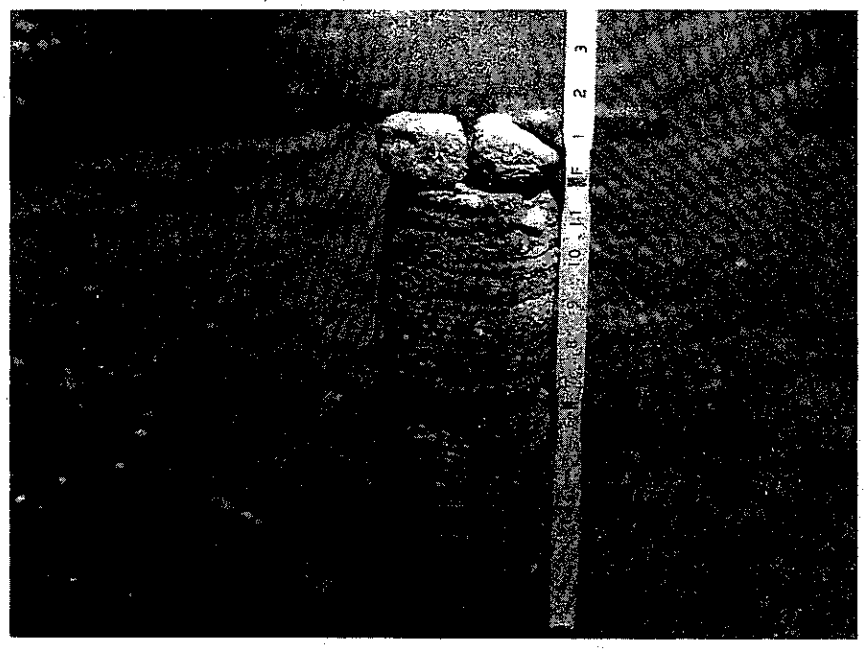
Figure 16
Construction Planes in Lime Treated Soil

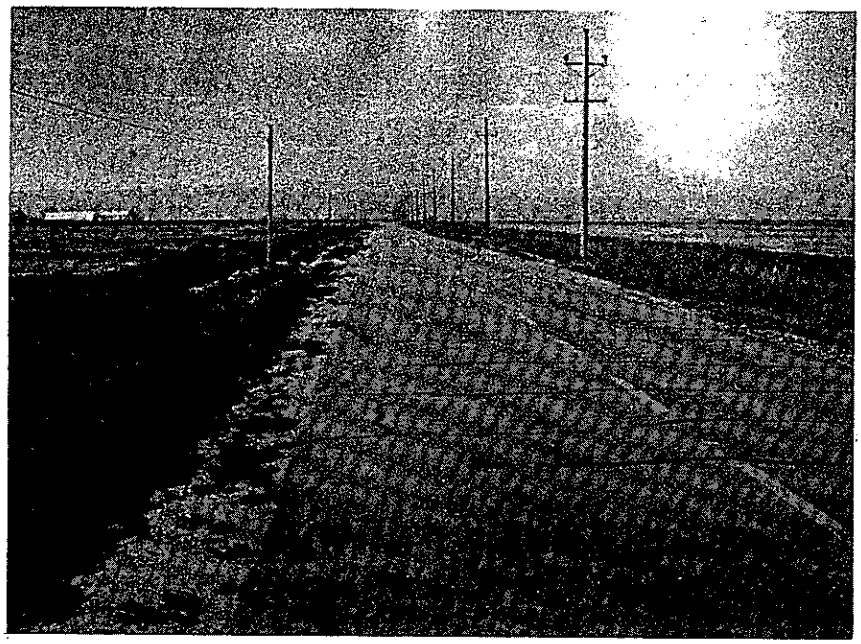
the more granular materials. Sixty percent of the roads constructed with lime treated aggregates showed evidence of shrinkage cracking compared to only twenty percent of the roads constructed with lime treated soils. Also, all of the roads which had visible shrinkage cracking were in fair to good condition after ten years of service. Only one of these had required resurfacing other than planned stage construction prior to the end of ten years. Evidently, the lime treated materials which had visible shrinkage cracking generally provided a stronger structural section (slab effect) than other lime treated materials which were not as susceptible to shrinkage cracking.

Figure 18
Shrinkage Cracking

6. Lime Treated materials must be protected from excessive drying. The surface of the compacted layer should be covered as soon as possible after compaction with the next layer of the structural section or a curing seal. When it becomes necessary to keep the surface of the lime treated material moist by the application of water, traffic should not be permitted on this moist material.

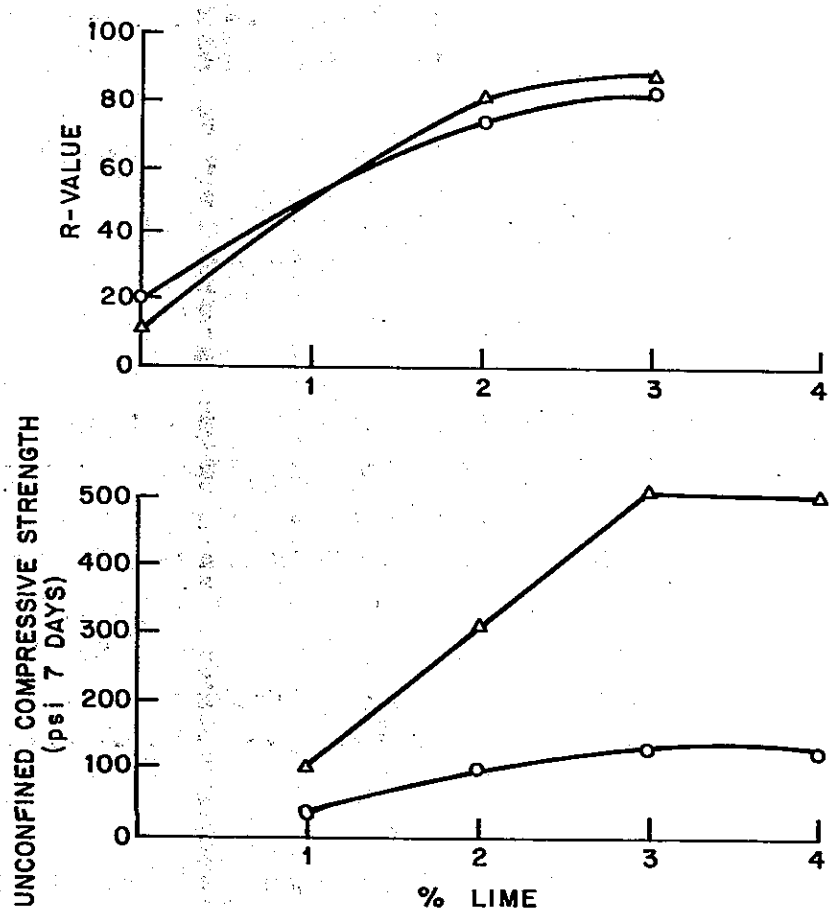
Figure 19

typified by the two sets of data plotted in Figure 19. Both soils achieved approximately the same R-value when equal amounts of lime were added. Unconfined compressive strengths for these same two soils are also plotted in Figure 19. Quite obviously, the cementing action was much greater with the one soil than with the other.

## A COMPARISON OF THE EFFECT OF LIME TREATMENT ON THE R-VALUE AND COMPRESSIVE STRENGTHS OF TWO TYPICAL SOILS
