4. TITLE AND SUBTITLE
Vehicular Crash Tests Of Unanchored Safety-Shaped Precast Concrete Median Barriers With Pinned End Connections

7. AUTHOR(S)
D.M. Parks, R.L. Stoughton, J.R. Stoker and E.F. Nordlin

9. PERFORMING ORGANIZATION NAME AND ADDRESS
Office of Transportation Laboratory
California Department of Transportation
Sacramento, California 95819

13. TYPE OF REPORT & PERIOD COVERED
Final Report

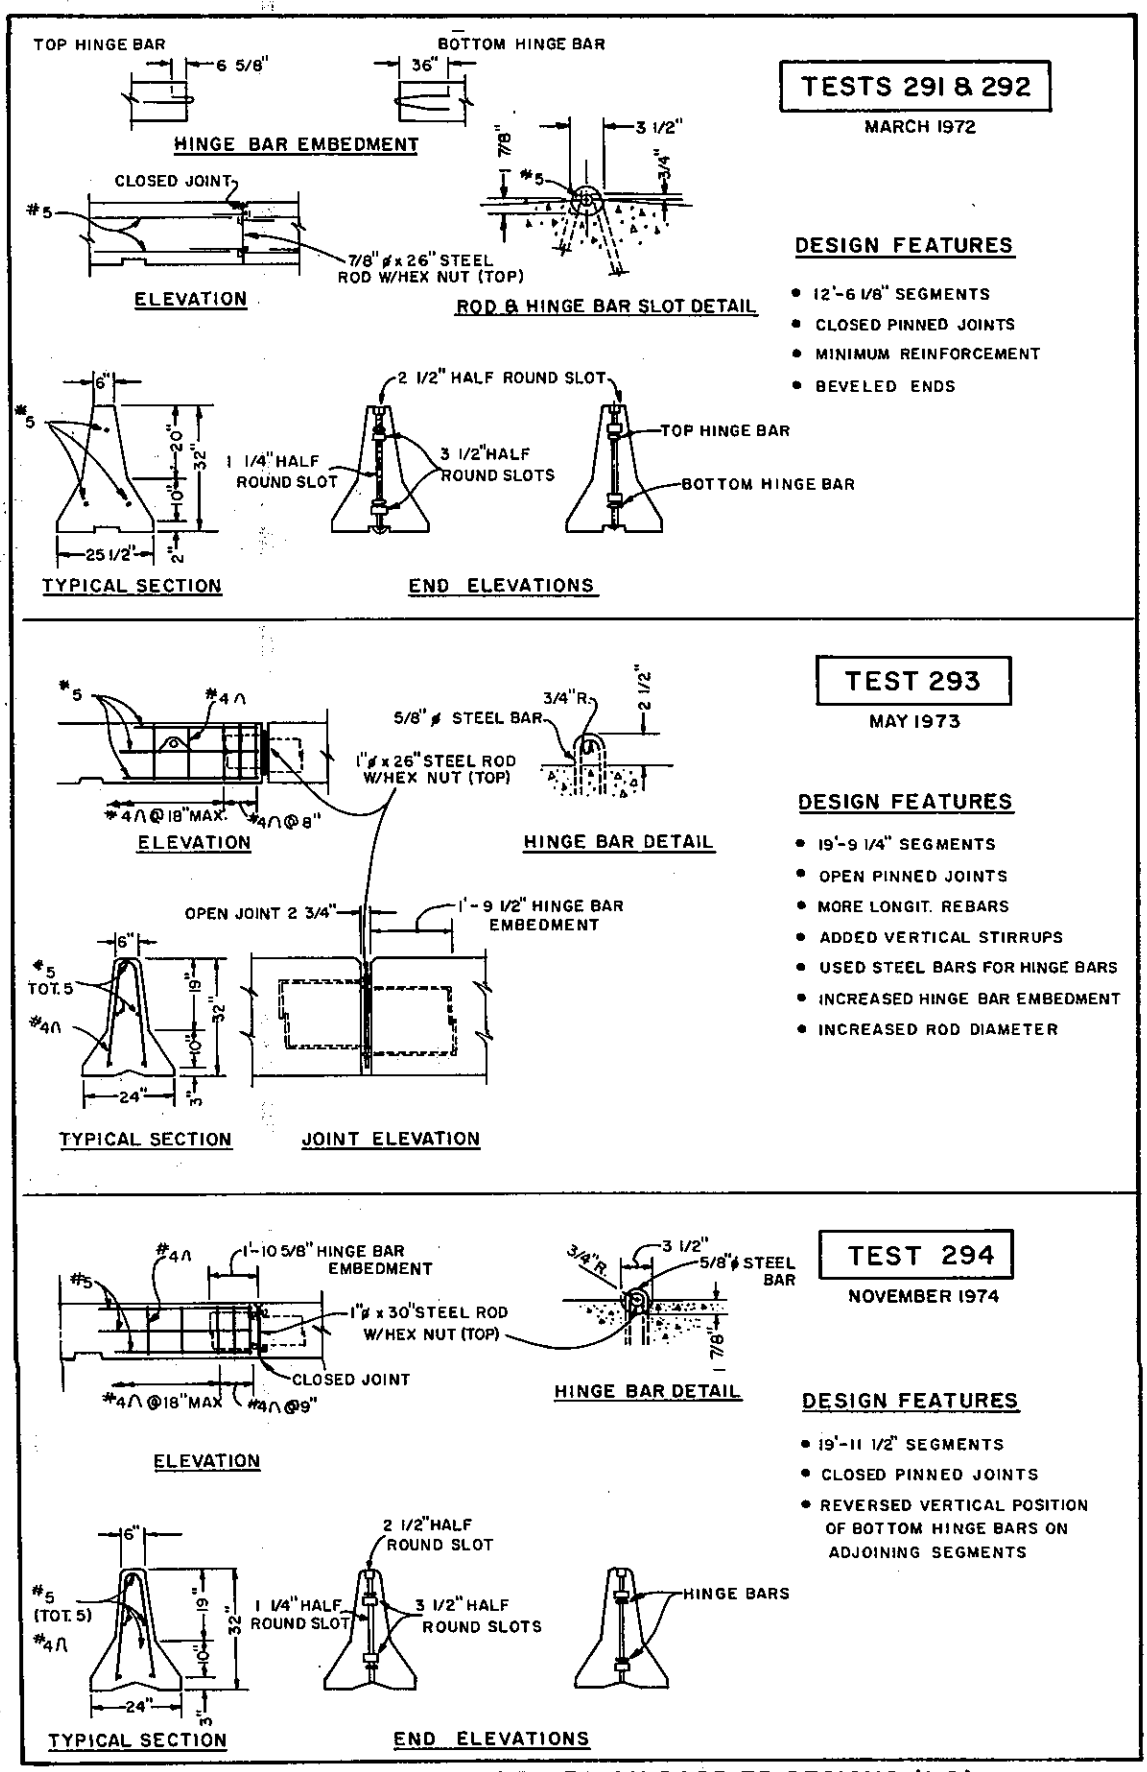
FIGURE 2, PRECAST MEDIAN BARRIER DESIGNS (1,2)

Key design features for each test barrier are shown in Figure 2. Detailed plans for the test barriers are included in the Appendix.

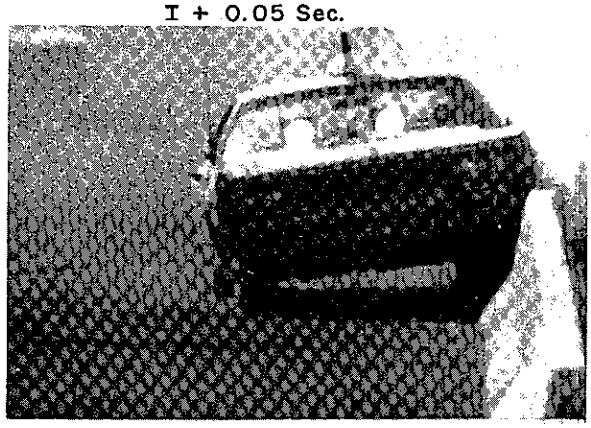
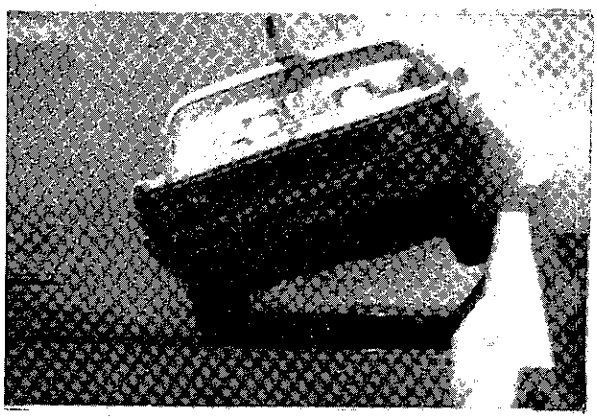
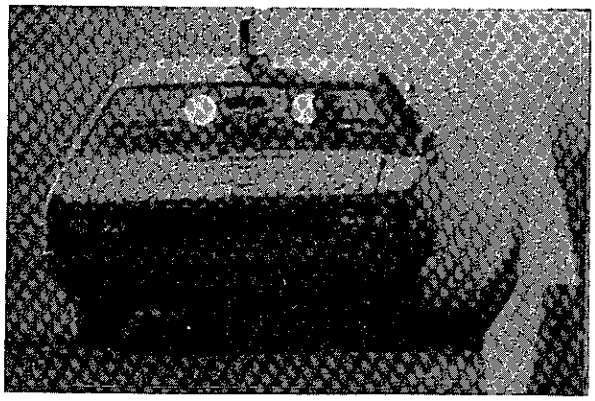
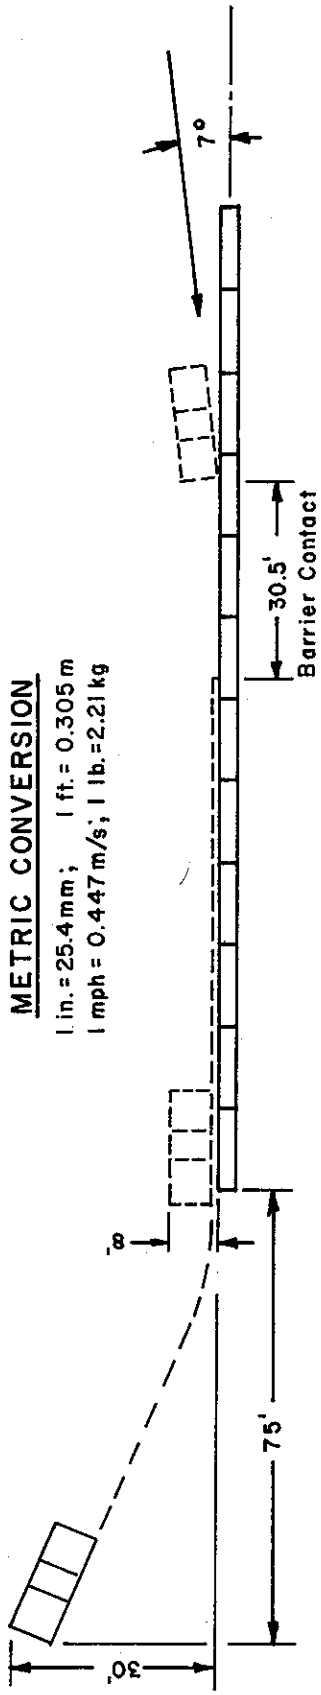
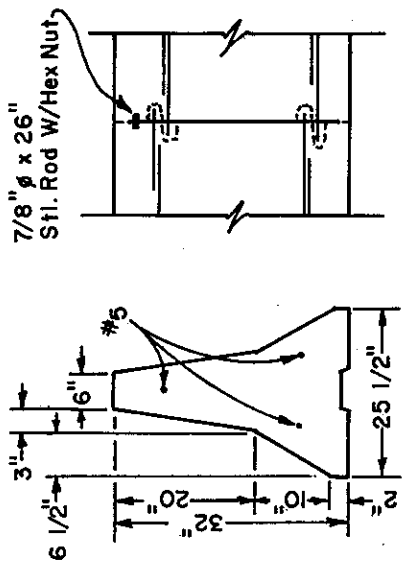
Figure 3, DATA SUMMARY SHEET

Test Conditions - A 1969 Dodge Polara sedan weighing 4860 lbs impacted the precast concrete test barrier at 7° with a velocity of 65 mph. The fourth 12.5 foot long segment of the 150 foot test barrier was impacted 3.5 feet beyond its upstream end, Figure 7.

Barrier Movement and Damage - Maximum lateral barrier displacement of 6 1/4 inches occurred at the first pinned barrier joint downstream from the point of impact, Figures 7 and 8. Five of the twelve barrier segments translated laterally during impact.

The barrier suffered minimal damage from impact. However, there was some minor concrete spalling at the bottom front face of the first joint downstream from impact due to local closing of the joint in compression.

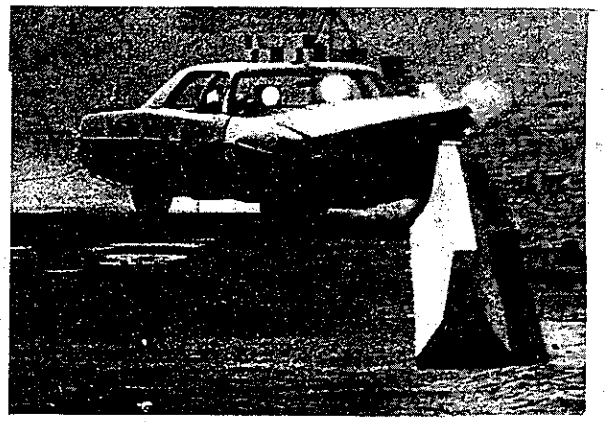
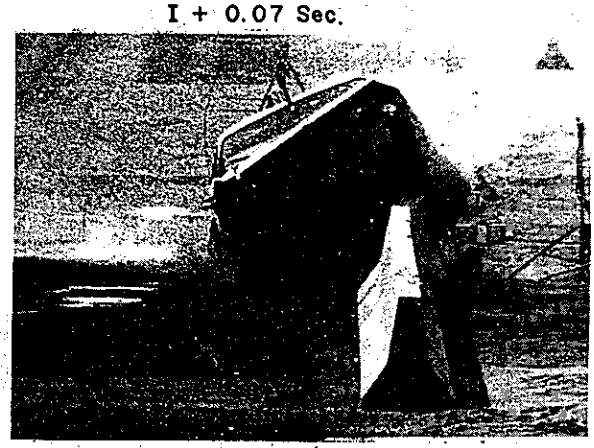
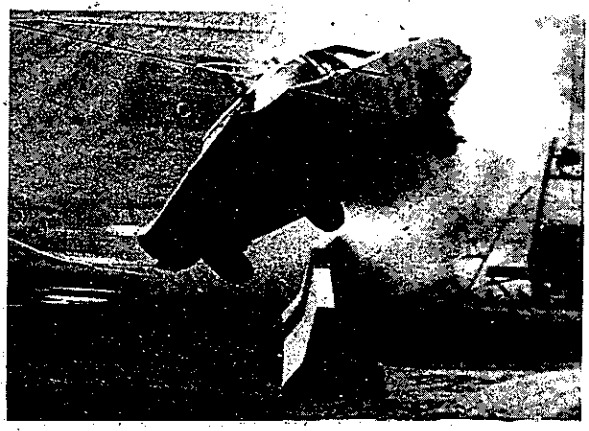
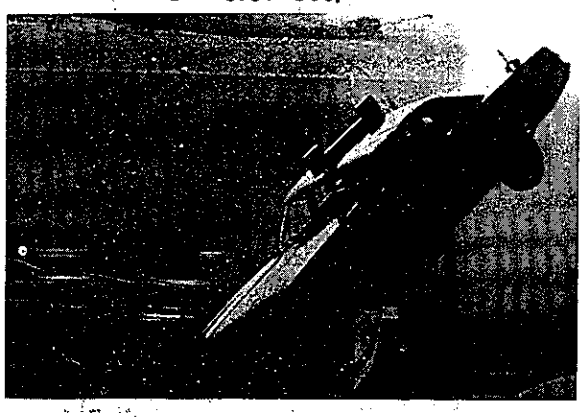
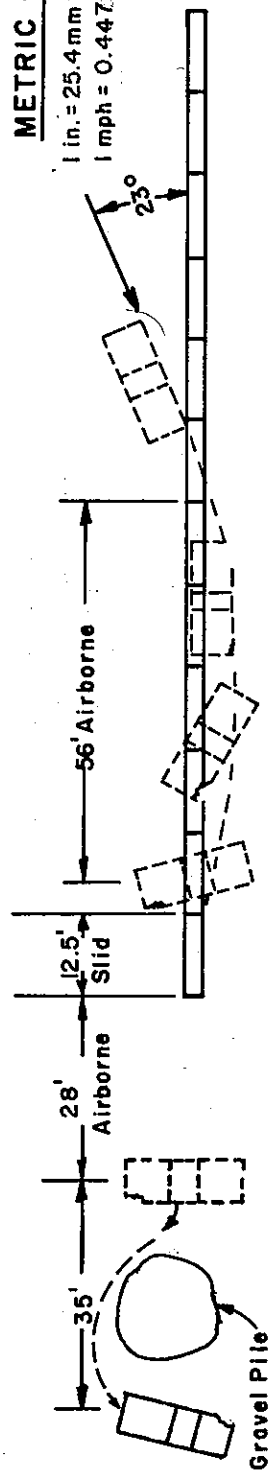
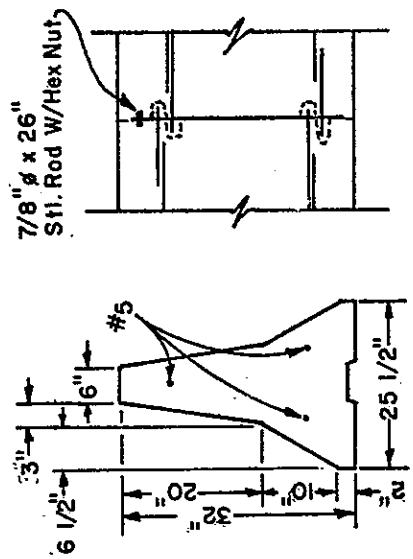
Figure 4, DATA SUMMARY SHEET

The 1969 Dodge Polara sedan impacted the precast concrete test barrier at 23° with a velocity of 68 mph. The sixth segment of the test barrier was impacted 1 foot beyond its upstream end, Figure 7.

Barrier Movement and Damage - Six barrier segments were laterally displaced during impact, Figures 7 and 8. Maximum lateral displacement of 22 1/4 inches occurred at the upstream end of the first impacted barrier segment, joint 5. The downstream end of this segment moved laterally 16 1/4 inches. All of the pinned joints of the barrier remained connected during impact. During impact, the initially impacted barrier segment leaned back about 16° away from its vertical axis.

The test barrier suffered considerable damage. At the point of impact the barrier failed in bending. The tension side of the barrier was completely fractured, while the front face of the barrier showed signs of a severe compression failure, Figure 10.

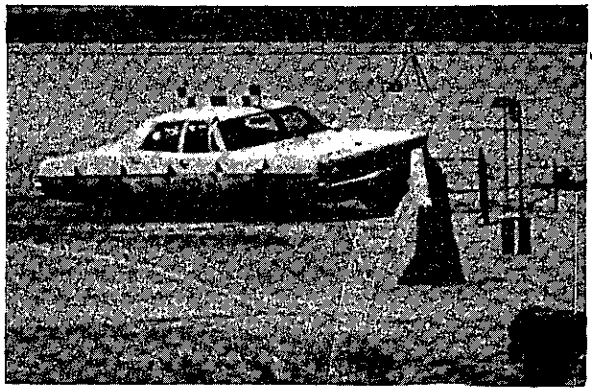
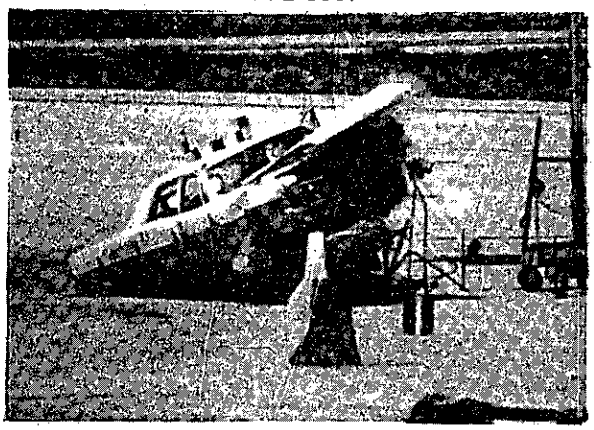
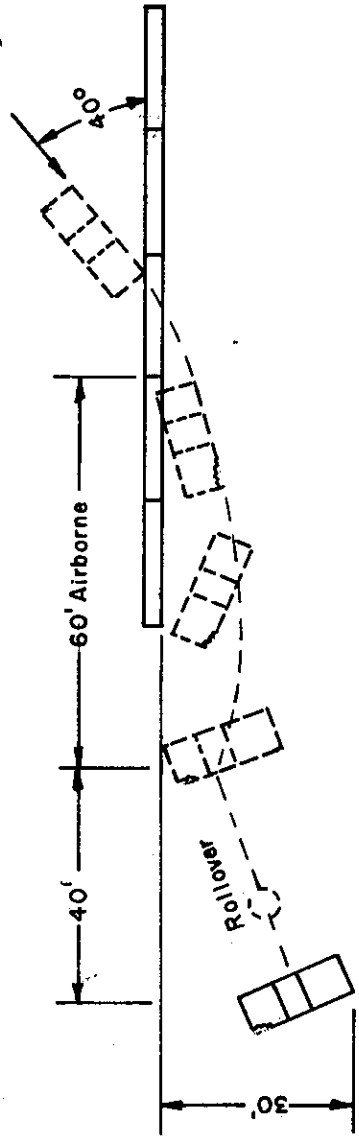
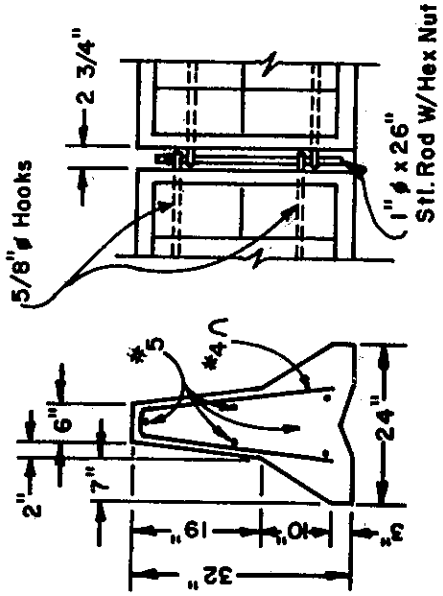
Figure 5, DATA SUMMARY SHEET

Test Conditions - A 1969 Dodge Polara sedan weighing 4860 lbs impacted the precast concrete test barrier at 40° with a velocity of 66 mph. A malfunction of the cable guidance bracket causing vehicle yawing prior to impact, prevented the vehicle from attaining an anticipated impact angle of 25°. The third 20 foot long segment of the 100 foot test barrier was impacted 1 foot beyond its upstream end, Figure 7.

Concrete spalling also occurred at joints 2 and 3, Figure 18.

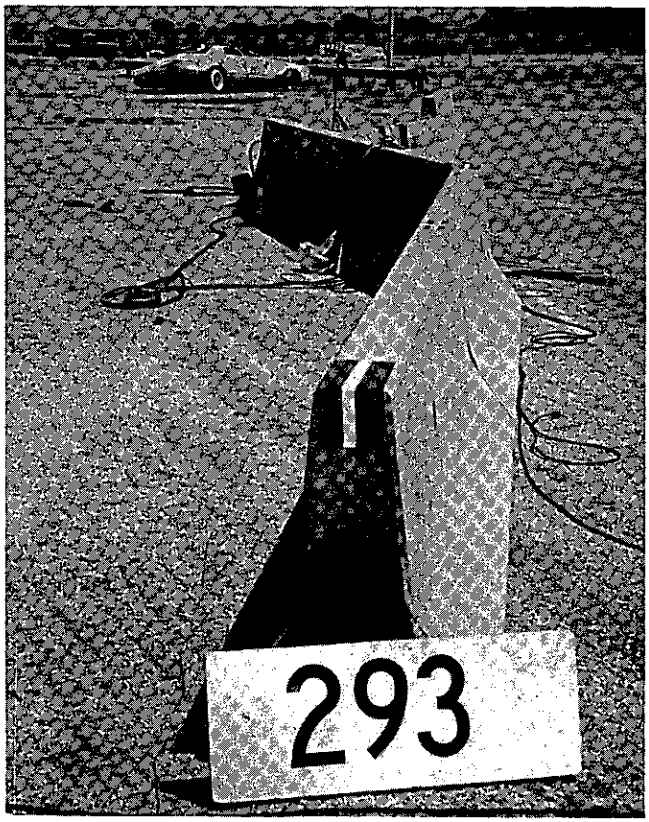
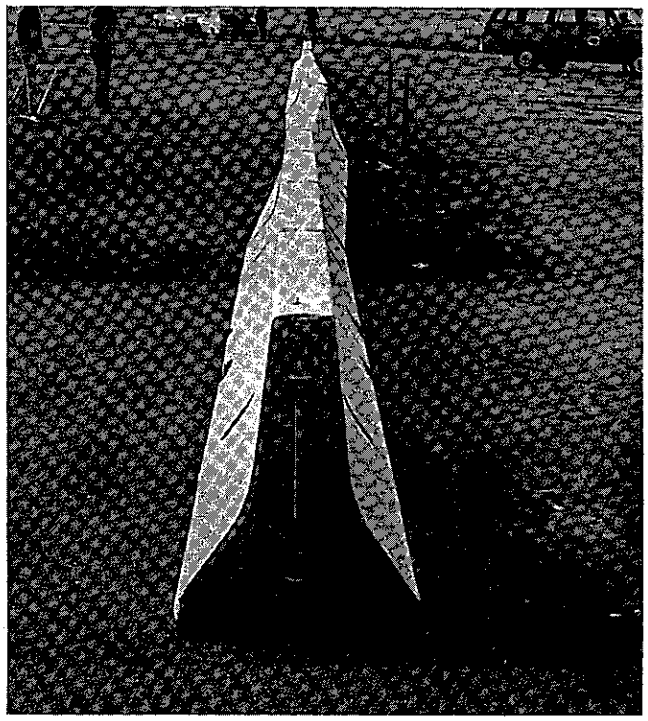
Figure 9, Barrier Movement

Barrier Movement and Damage - Four of five barrier segments were laterally displaced during impact, Figures 7 and 9. Only the last barrier segment remained on line. Maximum lateral displacement of 11 1/8 inches occurred at the upstream joint of the first impacted barrier segment, joint 2, Figure 7. The second and third joints failed to restrain the lateral and rotational movement of the impacted barrier segment, which tipped over on its side. The steel hinge bars and steel connecting rods were severely bent, Figure 16. The steel rod at joint 1 was also bent during impact, Figure 17.

Barrier Movement and Damage - Four of six barrier segments were laterally displaced during impact, Figures 7 and 9. Maximum lateral displacement of 5 1/2 inches occurred at the first barrier joint downstream from impact.

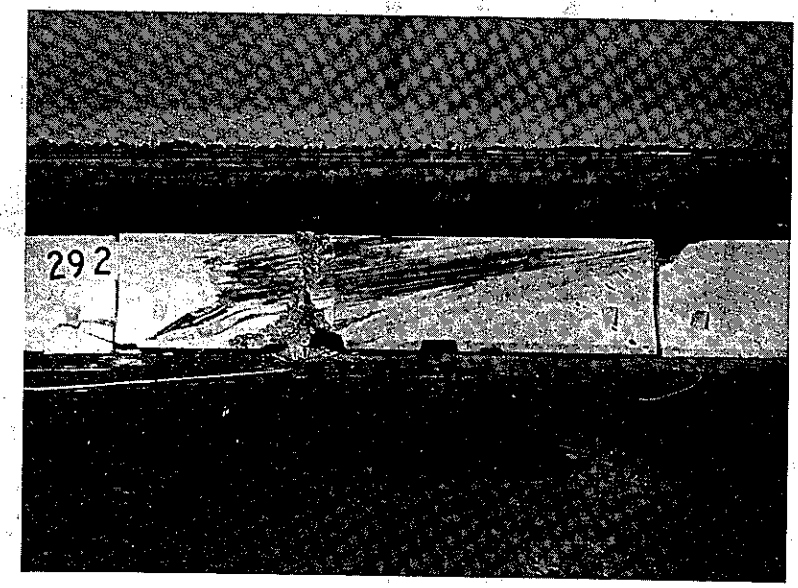
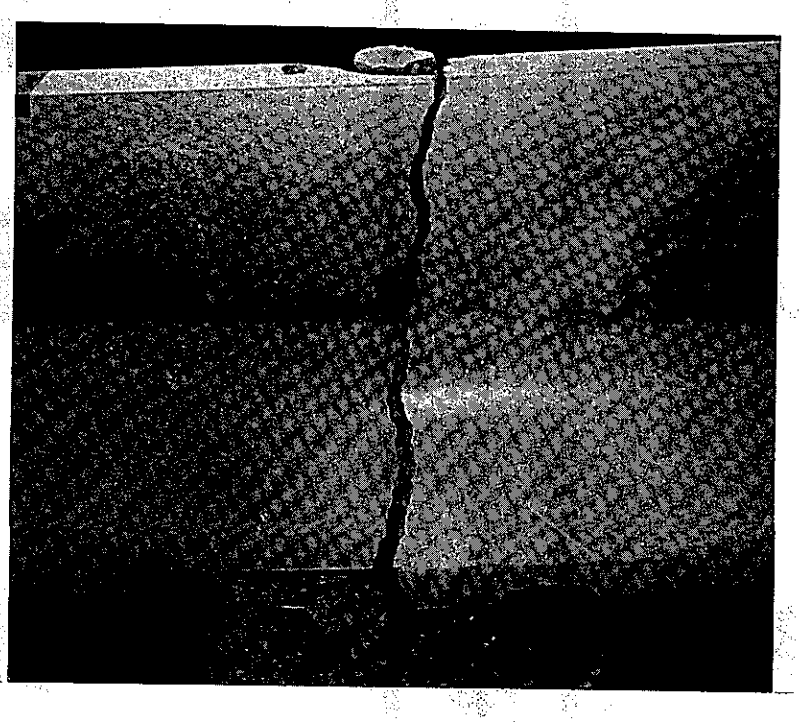
Figure 10, Barrier Damage, Test 292

Compression Failure at Point of Impact

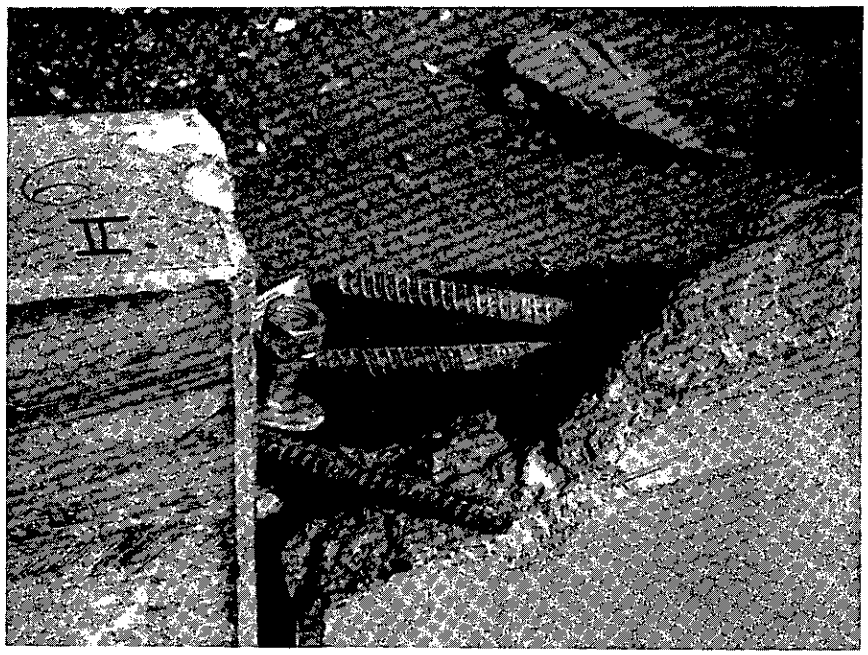
The top reinforcing steel hinge bar at the first downstream barrier joint from impact, joint 6, was pulled out of the concrete, Figure 11. A crack in a barrier segment at joint 7 also indicated a probable bond failure of a top reinforicng hinge bar, Figure 12.

Figure 11, Top Hinge Rebar Pull-Out Failure (view of impact side of barrier), First Joint Downstream from Impact, Test 292

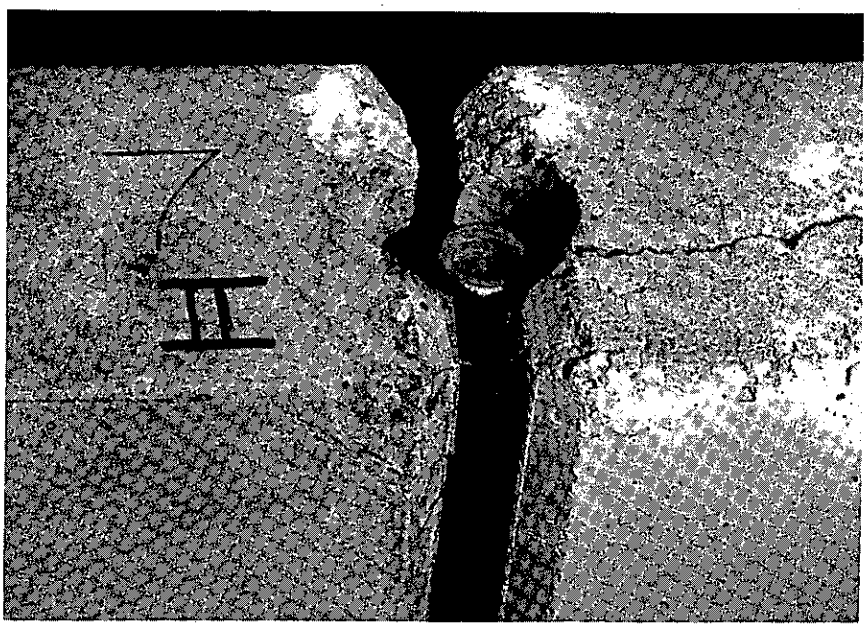
Figure 12, Probable Bond Failure of Top Hinge Rebar (view of impact side of barrier), Second Joint Downstream from Impact, Test 292

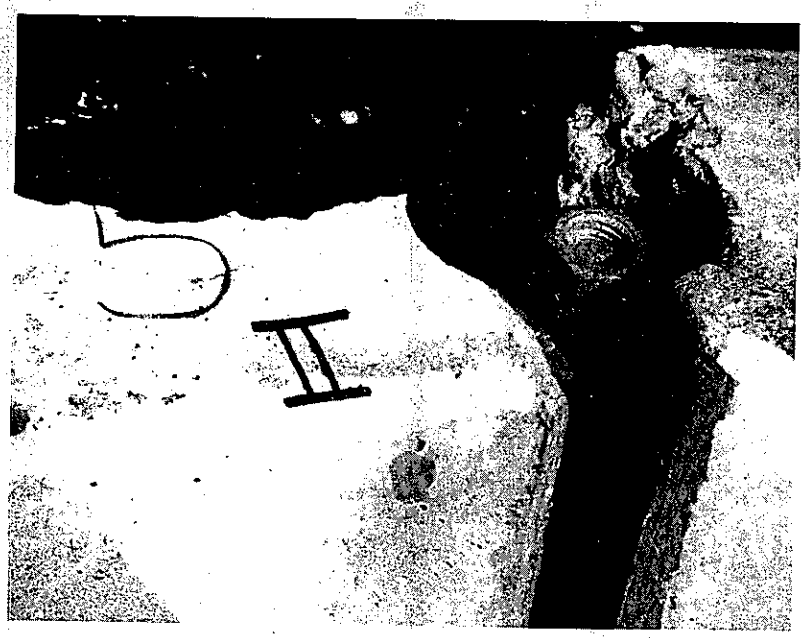
In addition to the fractured concrete at the locations of impact and pull-out of two top hinge bars, concrete spalled at joints 4, 5, and 6, Figures 13 through 15. Several large spalled pieces of concrete, 10 inches maximum dimension, were thrown about 25 feet in back of the barrier during impact. The steel rods connecting joints 4 through 7 were bent during impact.

Figure 13, Concrete Spalling at Joint 5
(first joint upstream from impact),
Test 292

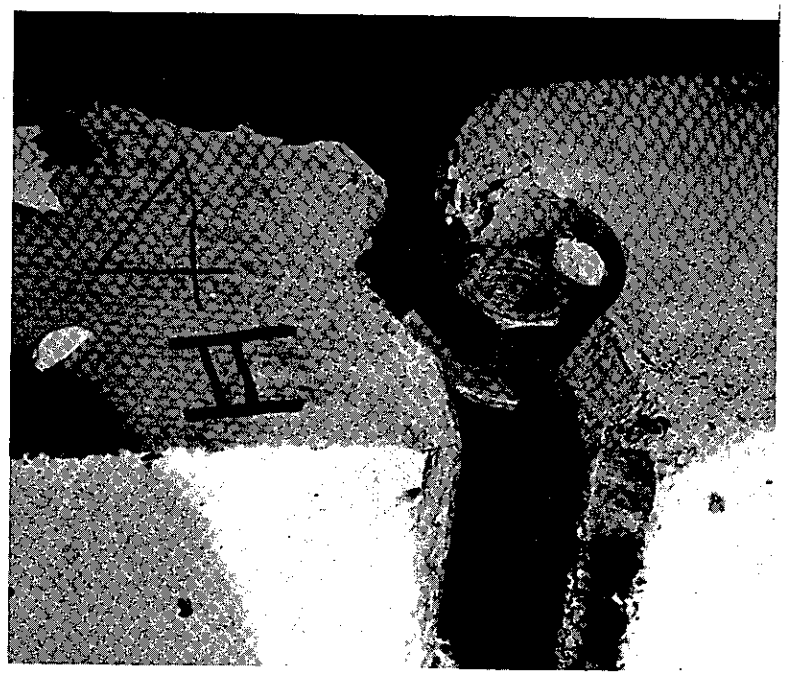
Figure 14, Concrete Spalling at Joint 4 (second joint upstream from impact), Test 292

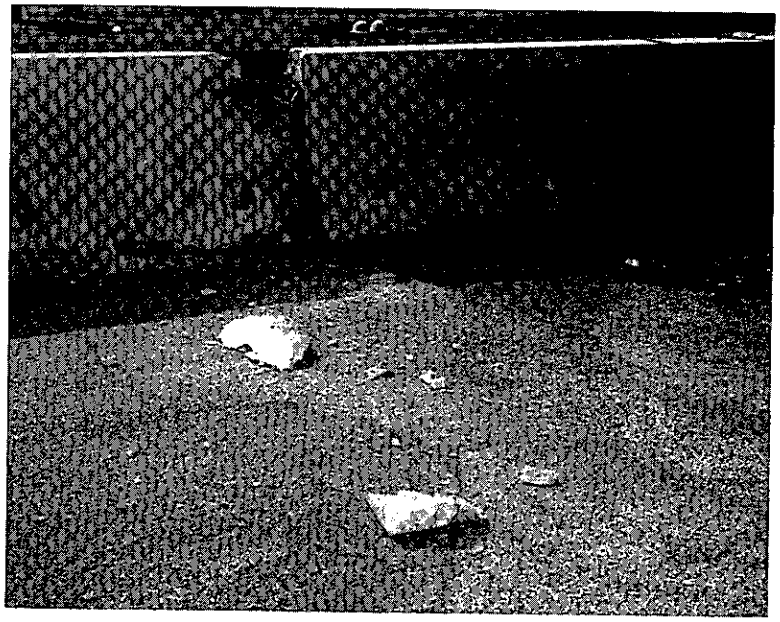
Figure 15, Concrete Spalling at Joint 6 (first joint downstream from impact) Test 292

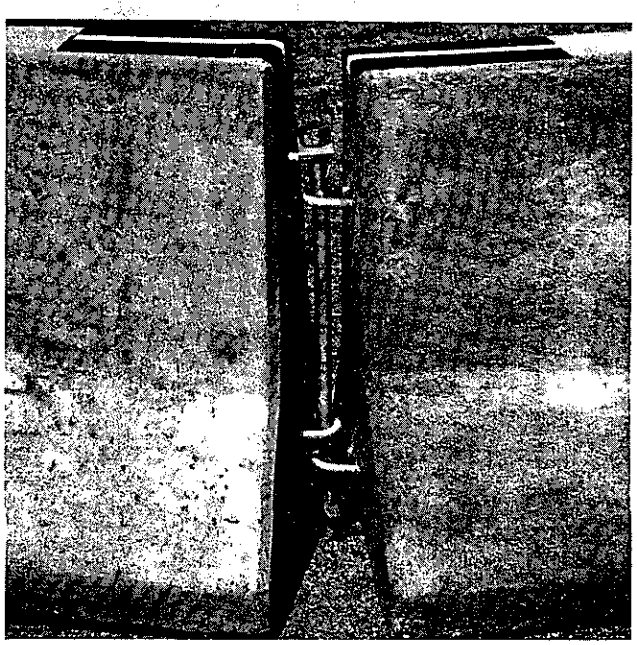
Figure 17, Bent Steel Rod at Joint 1 (second joint upstream from impact), Test 293

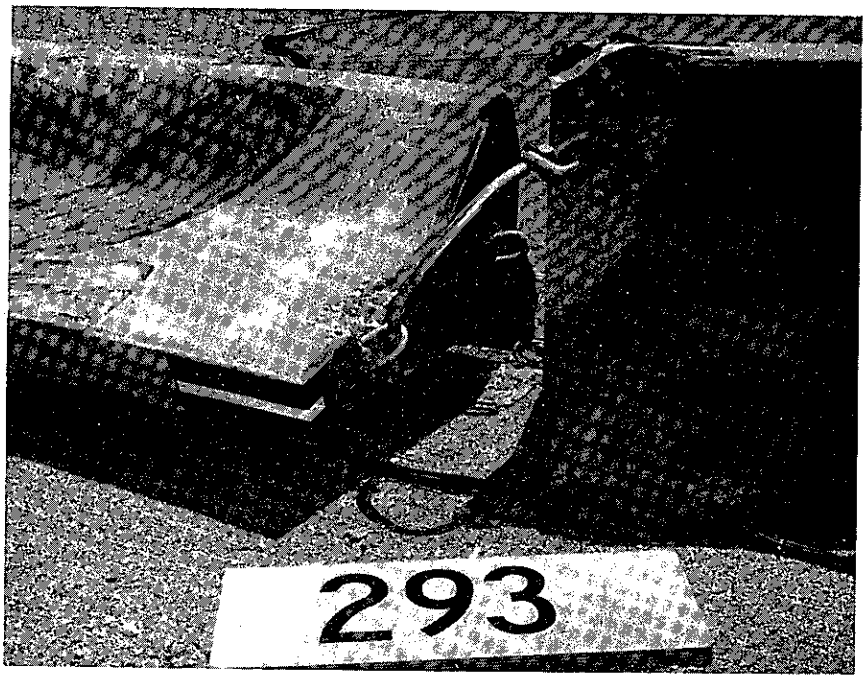
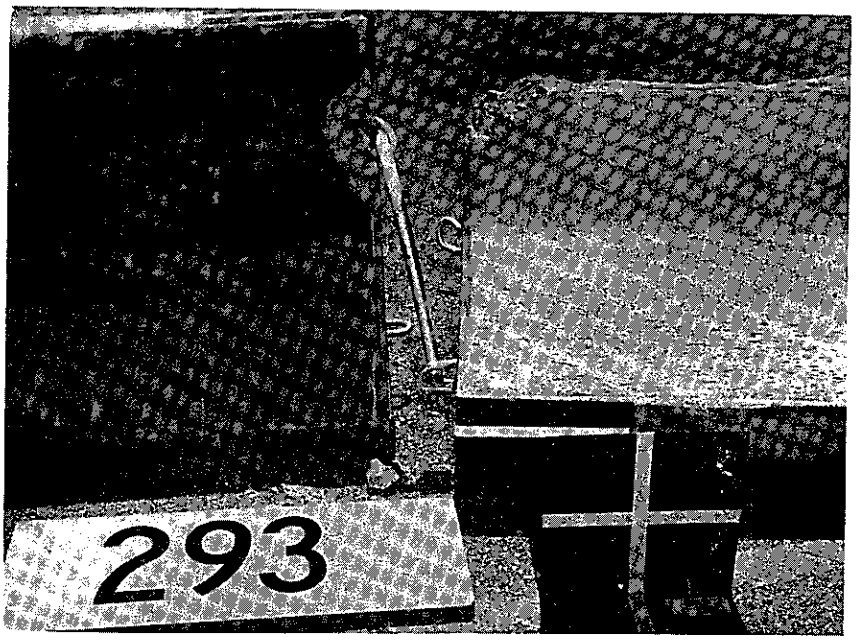
Figure 18, Concrete Spalling at Joints 2 and 3 (first joint upstream and downstream of impact, respectively), Test 293

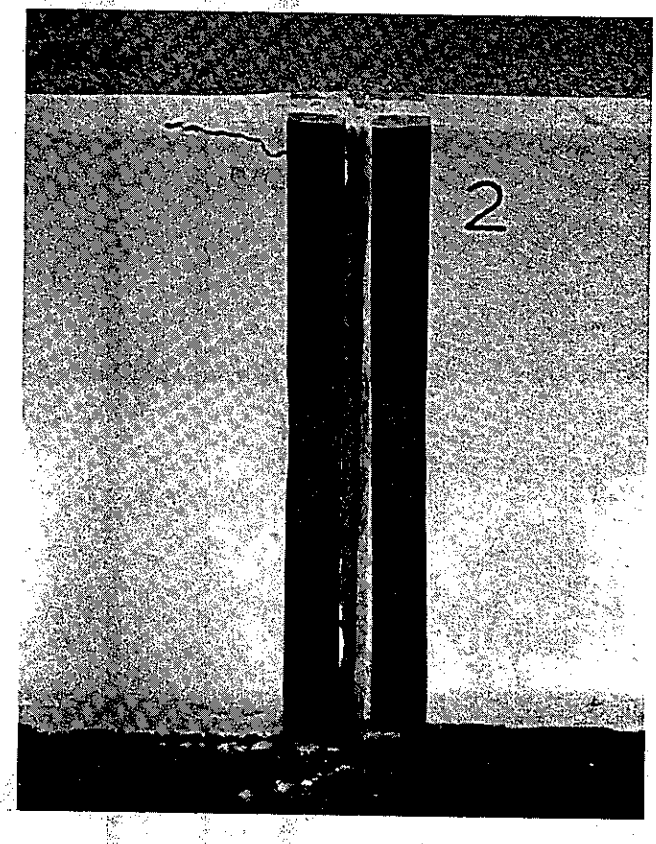
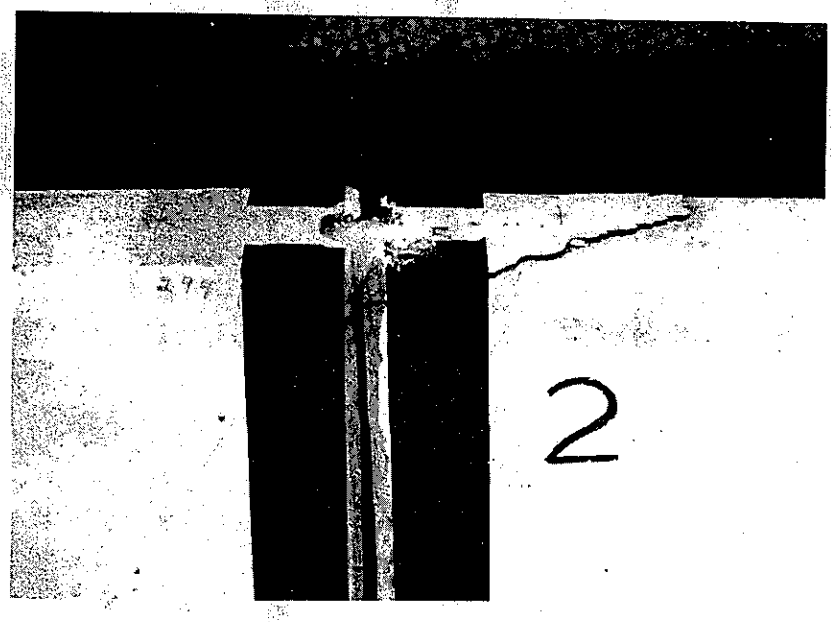
The test barrier suffered no structural damage other than some concrete spalling at the second, third and fourth barrier joints, Figures 19 through 21. Also, there were scrapes and tire scuff marks on the front face of the barrier, Figure 22.

Figure 19, Concrete Spalling at Joint 2 (second joint upstream from impact), Test 294

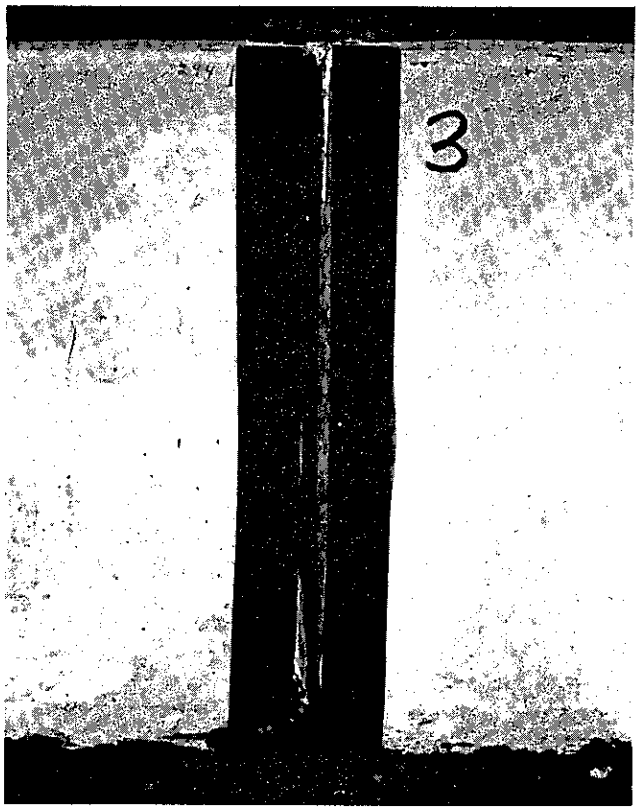
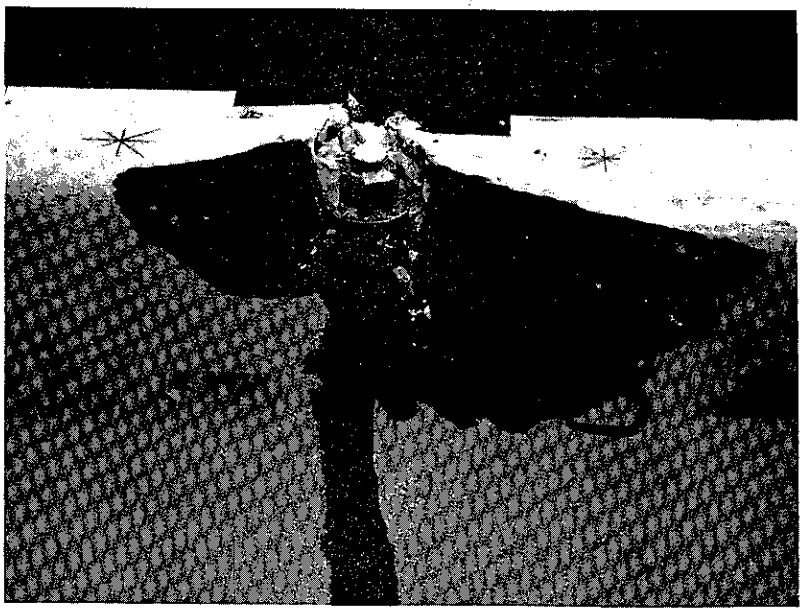
Figure 20, Concrete Spalling at Joint 3 (first joint upstream from impact), Test 294

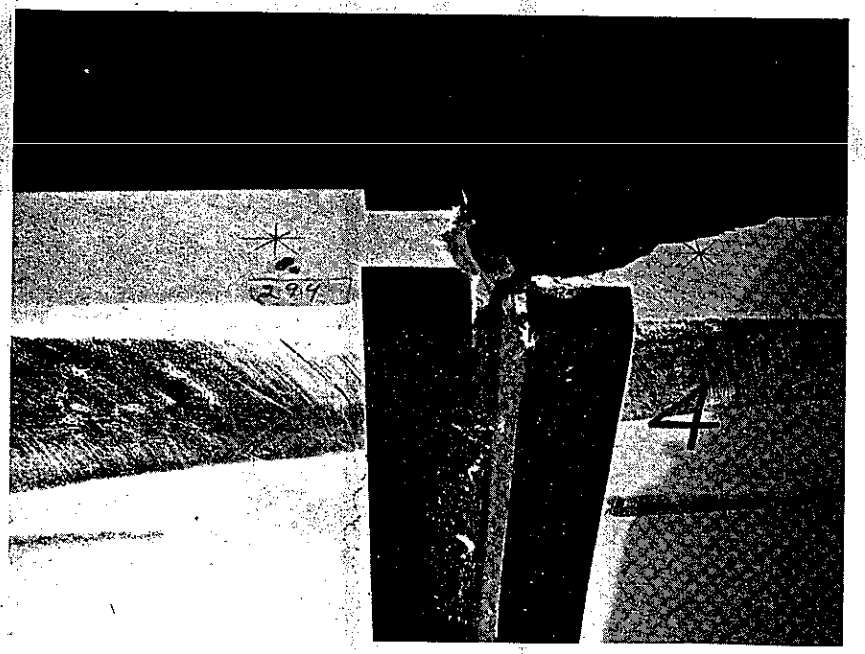
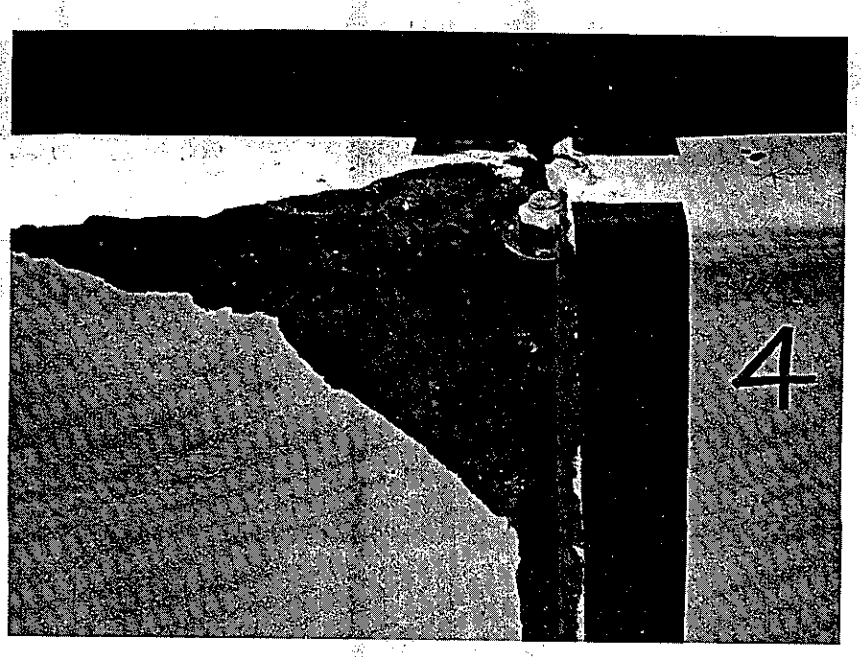
Figure 21, Concrete Spalling at Joint 4 (first joint downstream from impact), Test 294

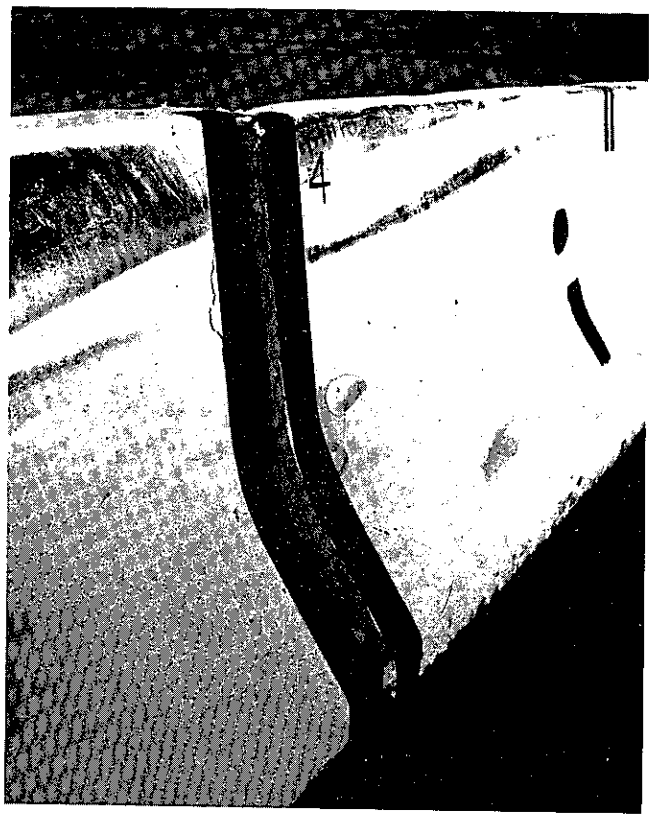
Figure 22, Barrier Scuff Marks and Scrapes, Test 294

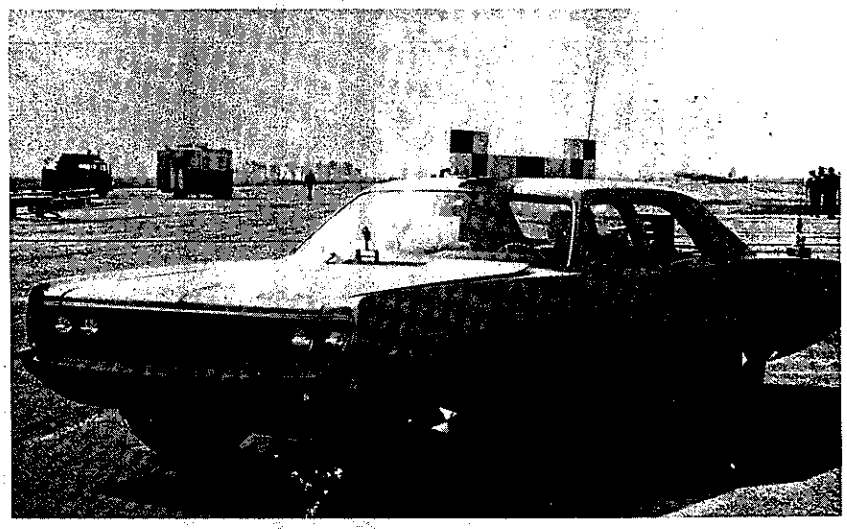
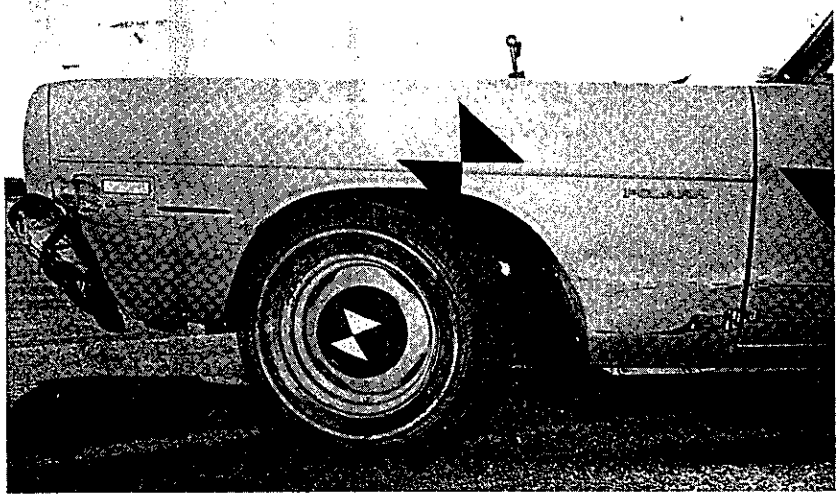
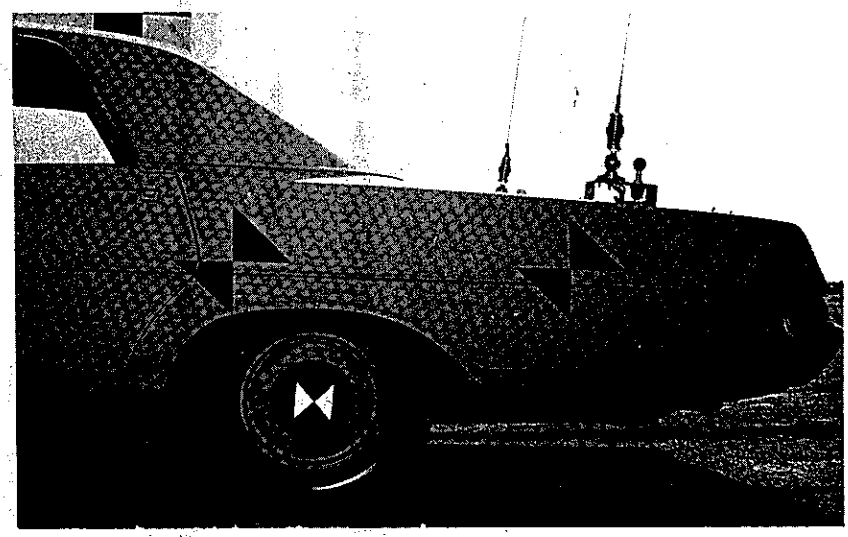
Figure 23, Vehicle Damage, Test 291

Vehicle Damage - Vehicle damage was also minimal, Figure 23. There were some minor dents and scratches on the left front and rear quarter panels of the vehicle. This same vehicle was used for a second impact test, Test 292, later the same day without being repaired. There was no intrusion of vehicle or barrier parts into the passenger compartment during impact.

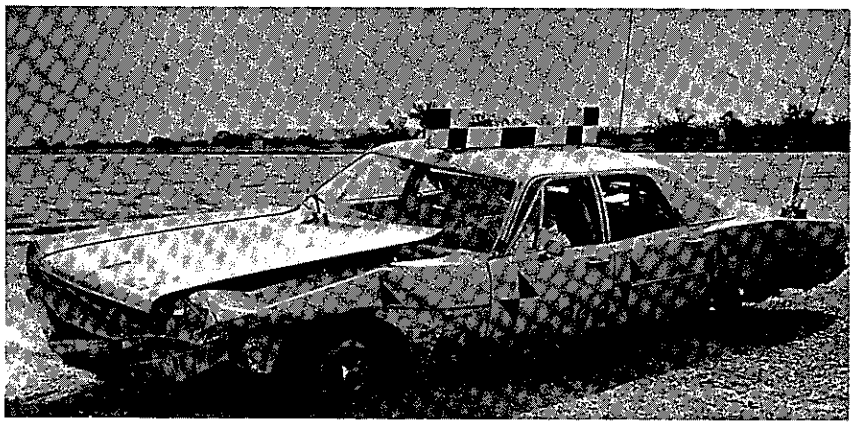
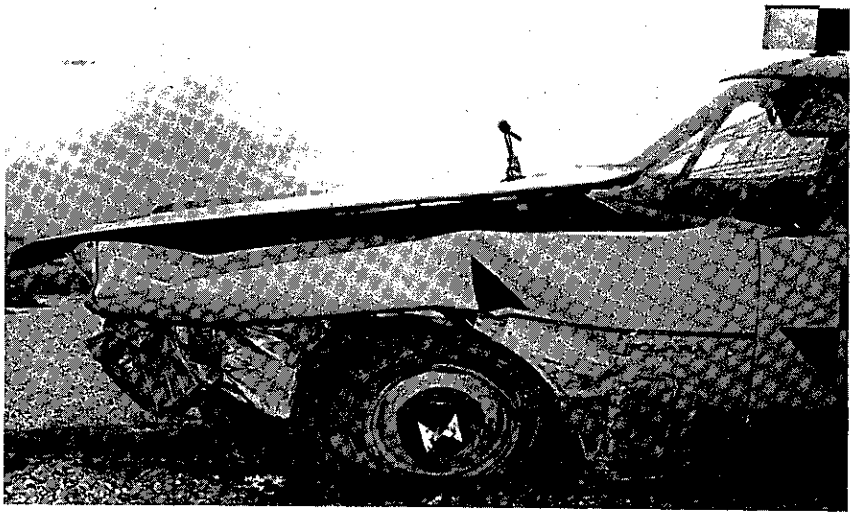
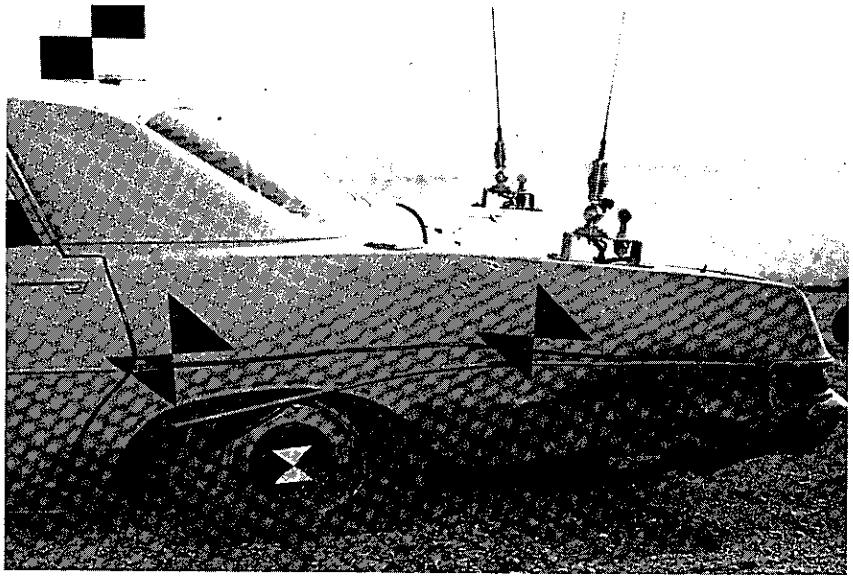
Figure 24, Vehicle Damage, Test 292

Vehicle Damage - The left side of the test vehicle suffered extensive damage during impact with the precast barrier segments, Figure 24. There was no intrusion of vehicle or barrier parts into the passenger compartment during impact.

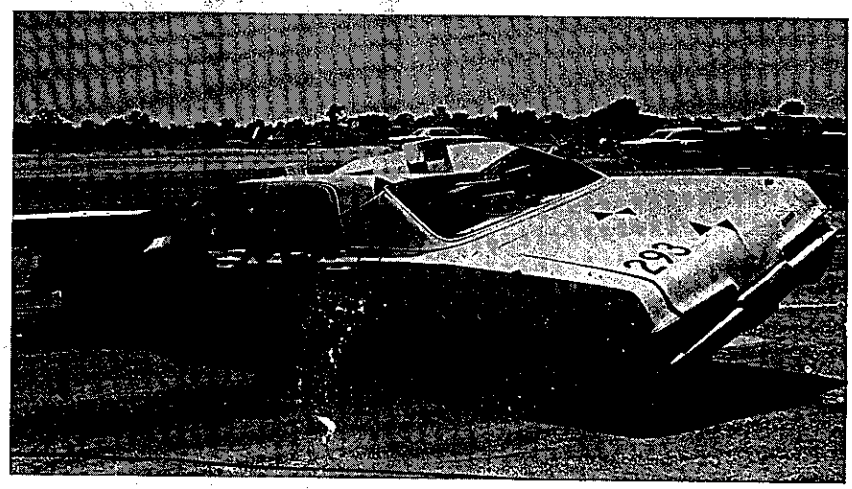
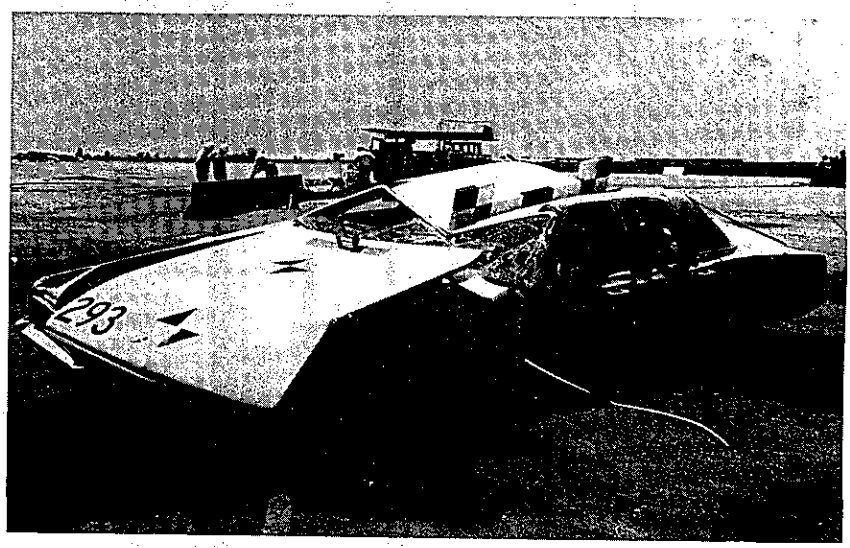
Figure 25, Vehicle Damage, Test 293

Vehicle Damage - The test vehicle was severely damaged from the barrier impact and post impact rollover, Figure 25. The engine intruded about 3 inches into the passenger compartment of the vehicle during impact.
