4. TITLE AND SUBTITLE
Vehicular Crash Tests Of Unanchored Safety-Shaped Precast Concrete Median Barriers With Pinned End Connections

7. AUTHOR(S)
D.M. Parks, R.L. Stoughton, J.R. Stoker and E.F. Nordlin

9. PERFORMING ORGANIZATION NAME AND ADDRESS
Office of Transportation Laboratory
California Department of Transportation
Sacramento, California 95819

13. TYPE OF REPORT & PERIOD COVERED
Final Report

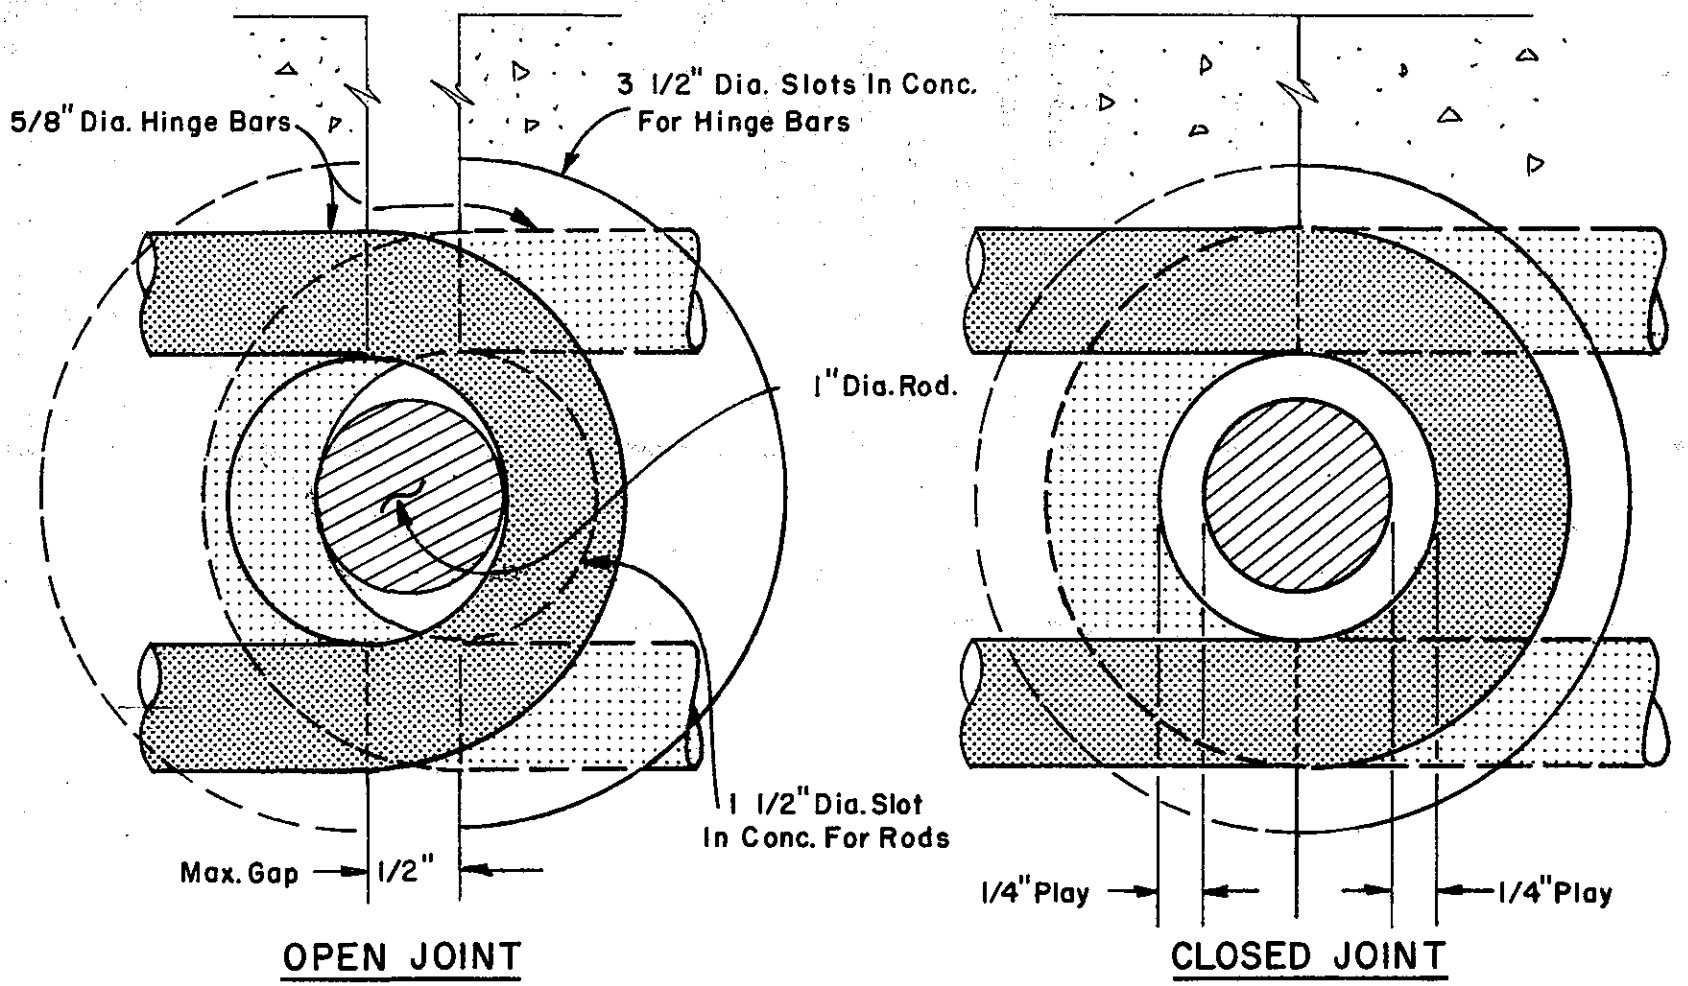
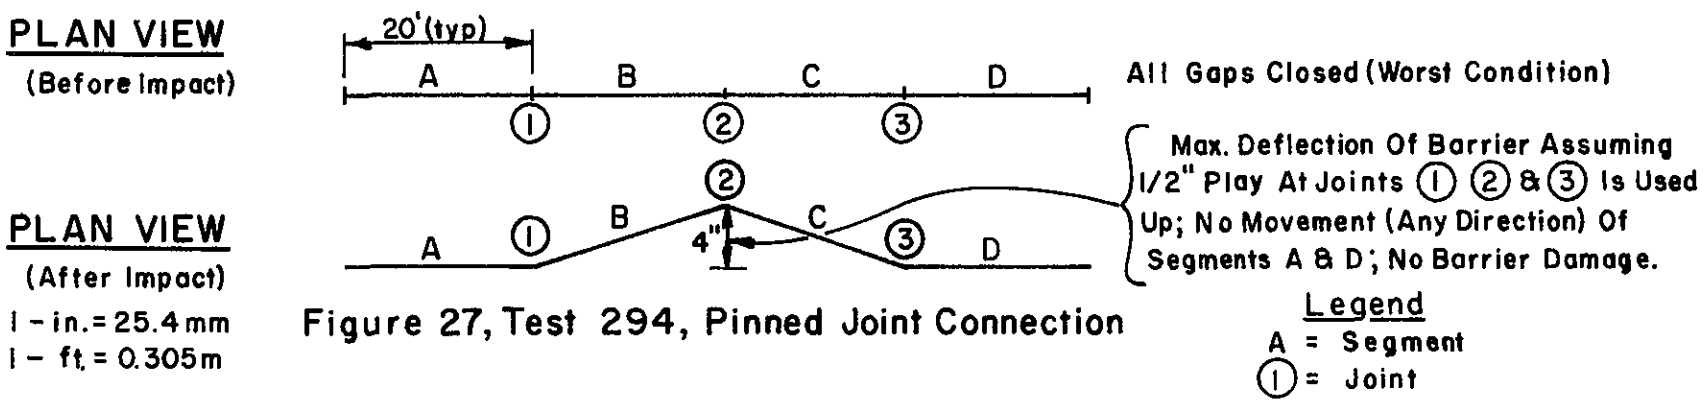
Figure 27, Test 294, Pinned Joint Connection

Summary. The amount of joint flexibility and the ability of the joints to transmit impact loads to adjoining segments is illustrated by the following example and Figure 27. In the barrier design for Test 294, there is a maximum amount of horizontal "play" or looseness between rods and hinge bars of 1/2 inch, i.e., if two adjoining segments are stretched out in opposite directions to the

maximum extent, the gap between segments will be 1/2 inch wide, Figure 27 open joint. If the segment ends are initially butted together, then there is a potential amount of "play" of 1/2 inch at each joint, Figure 27 closed joint. If two adjoining segments are deflected laterally until the 1/2 inch "play" is used up at the three end joints, then the maximum lateral deflection of the joint between the two segments will be about 4 inches, assuming 20 foot segment lengths with no movement of the segments adjoining the two which were deflected and no barrier damage.
