4. TITLE AND SUBTITLE
Vehicular Impact Test On Steel Channel-Beams Spanning A Gap In A Continuous Concrete Median Barrier

5. REPORT DATE
February 1979

13. TYPE OF REPORT & PERIOD COVERED
Final Report

The test parameters were as follows: Test 361---- 4,410 lb vehicle/ 61 mph/ 23 degrees

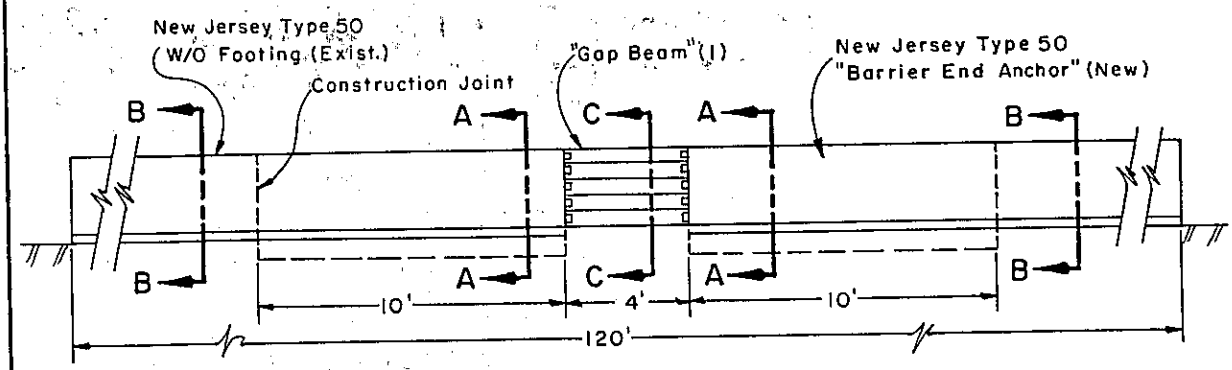
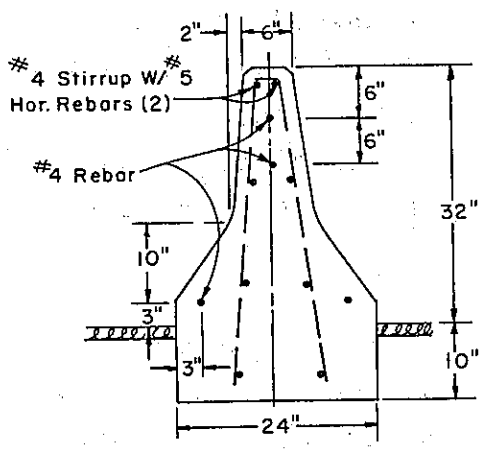
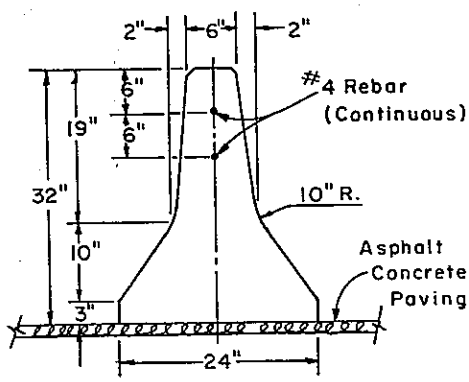
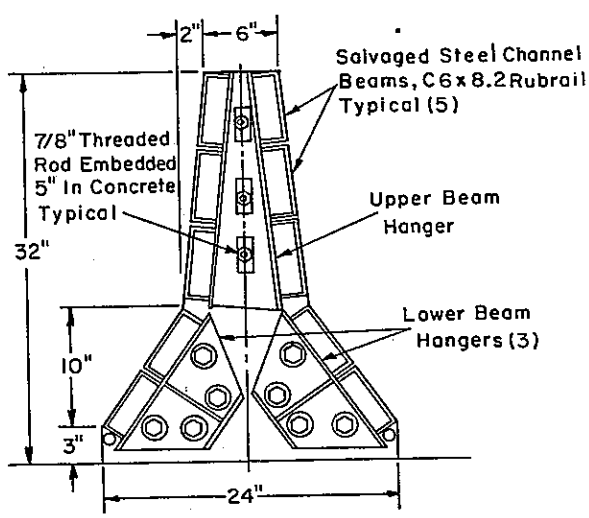
Figure 2, GAP BEAM SUMMARY SHEET*

The remaining 4 foot gap was spanned with an assemblage of steel hangers and beams, the "gap beam design". Figures 2 and 3 show the main elements of that design. Complete details of the gap beam design are shown in the Appendix, Figure 10A.

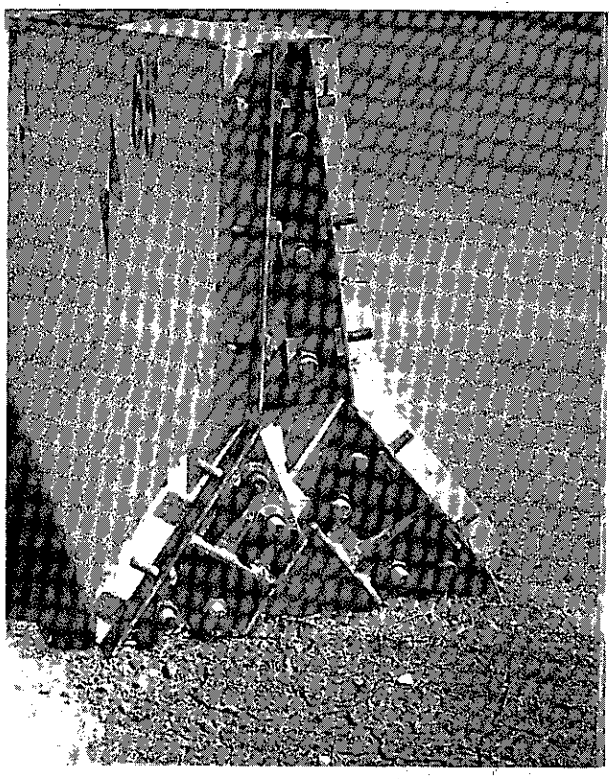
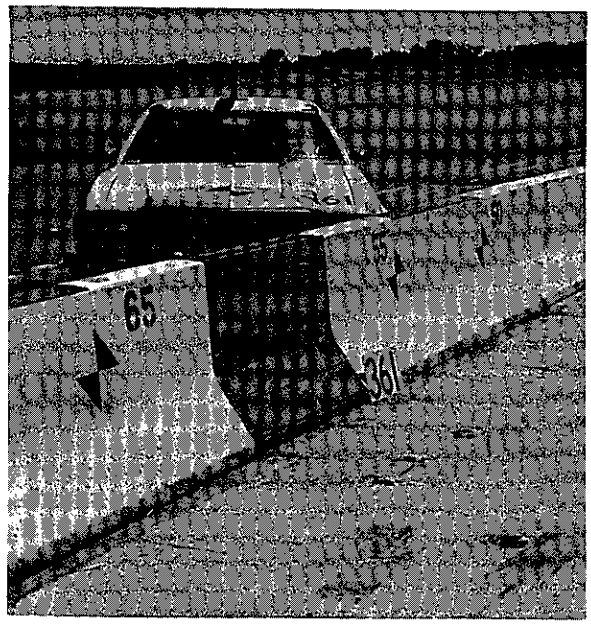
Figure 3 - Main Elements of Gap Beam Design

Threaded rods 7/8 inch in diameter, were cast in place in the ends of the new sections of CMB. They were embedded 5 inches in the concrete. The upper and lower beam hanger brackets, which were cut from pieces of C6x8.2 steel channel rubrail, were then bolted on and adjusted, making sure the beams would be flush with the outside face of the barrier. The nuts were torqued to 150 ft-lbs. Finally the channel beams, C6x8.2, were bolted on to the hanger brackets. The nuts were torqued

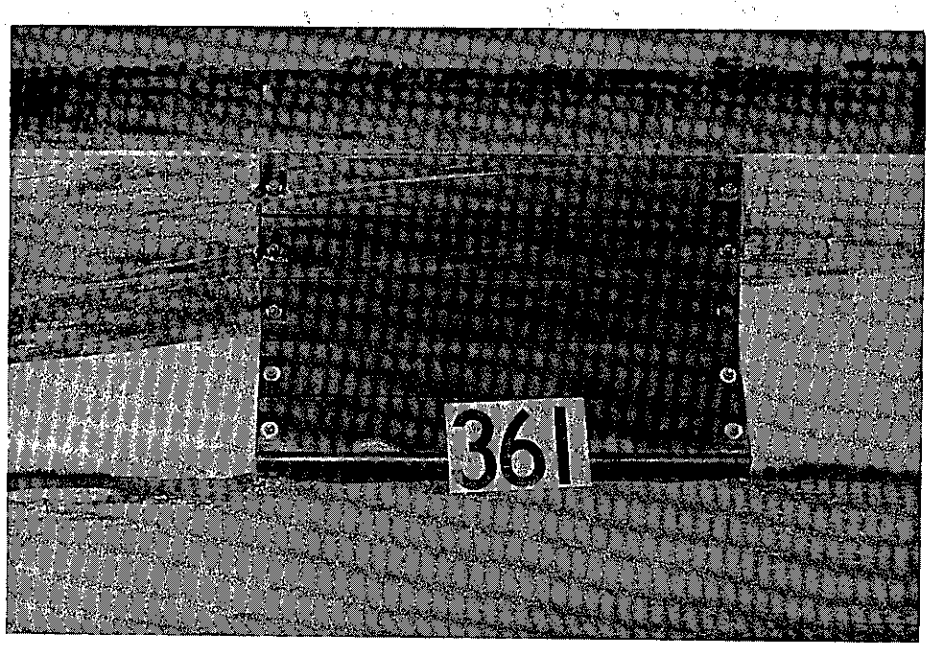
Figure 4 - Scuffs and Scrapes on Gap Beam

Gap Beam Performance and Damage - The gap beam sustained only minimal damage. The first three beams starting from the top of the barrier on the impact face were the only ones damaged. The top beam was bowed in permanently about 1/8 inch. The second beam was bowed in permanently about 1/4 inch. The third beam was not bowed. All three beams were scuffed and scraped as shown in Figure 4, but there was no apparent structural damage. The beams did not move in any other way. The two bottom beams were unmarked and showed no apparent damage of any kind. All beam and beam hanger connections showed no movement or failure of any kind.

The two top channel beams in the barrier bowed in slightly but it would not be necessary to replace them because the damage was so slight. Other than removing or painting over the scuff marks on the face of the gap beam, little maintenance would be required.

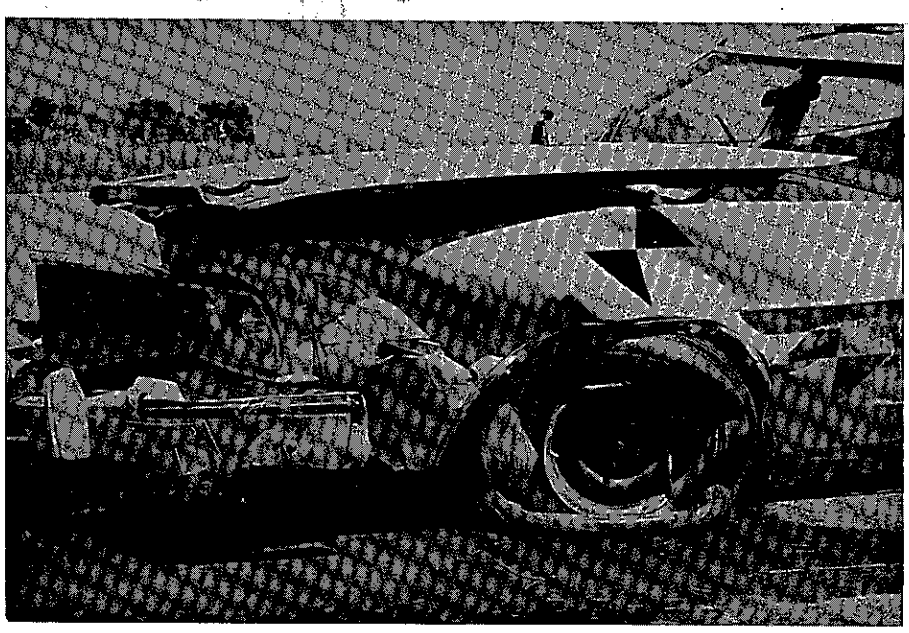
Figure 7 - Vehicle Damage

Vehicle Damage - The left front quarter panel and front bumper were crushed and pushed toward the right side of the vehicle as shown in Figures 7 and 8. The left side of the radiator was pushed back toward the fan and the windshield was cracked on the left side of the vehicle. The left front tire was flat and the rim was scraped and bent. The right front quarter panel was buckled above the tire.

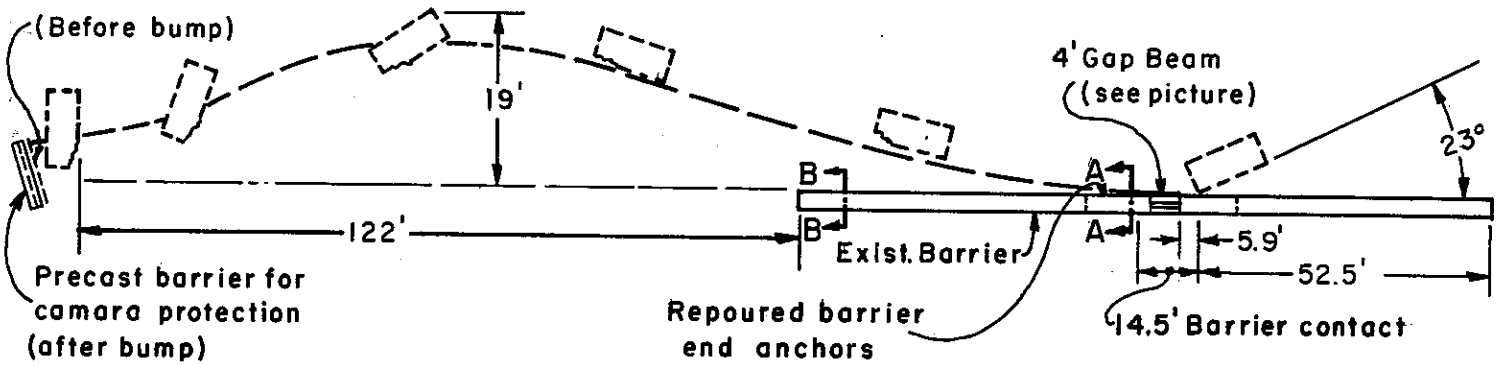
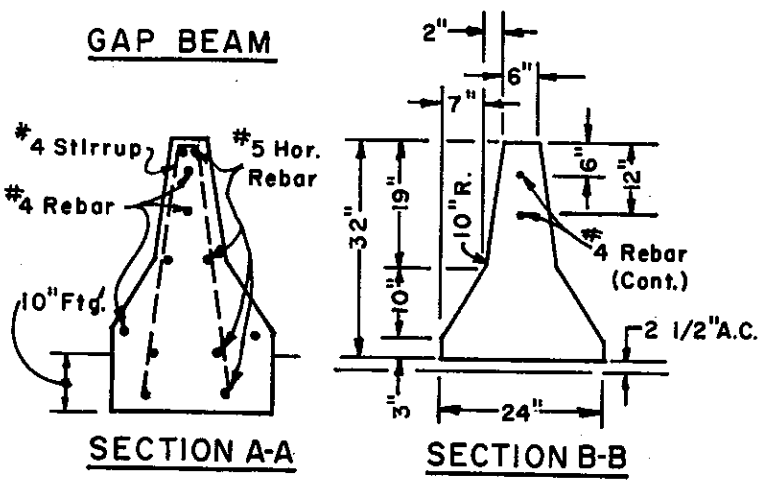
BARRIER	CMB WITH GAP BEAM
LENGTH OF BARRIER	120 FT.
MAX. PERMANENT LAT. DEFL. (SECOND BEAM FROM TOP)	0.25 IN.
MAX. DYNAMIC LAT. DEFL.	0.50 IN.
MAX. VEHICLE RISE/ROLL	3.5ft./22°
LAT. K.E. = (1/2)M(V SIN θ)²	84FT.-KIPS
VEHICLE DECELERATION (MAX. 50MS AVG.)	
LATERAL	9.9 g's
LONGITUDINAL	4.4 g's
VERTICAL	4.6 g's

TEST NO.	361
DATE	8/16/78
VEHICLE	1974 FORD GRAN TORINO
VEHICLE WEIGHT (WITH DUMMY & INSTRUMENTATION)	4410 LBS.
IMPACT SPEED	61 MPH
IMPACT ANGLE	23°
VEHICLE DAMAGE: TAD	LFQ-5, LD-3
VDI	10LFEW4
DUMMY RESTRAINT	LAP & SHLDR. BELT

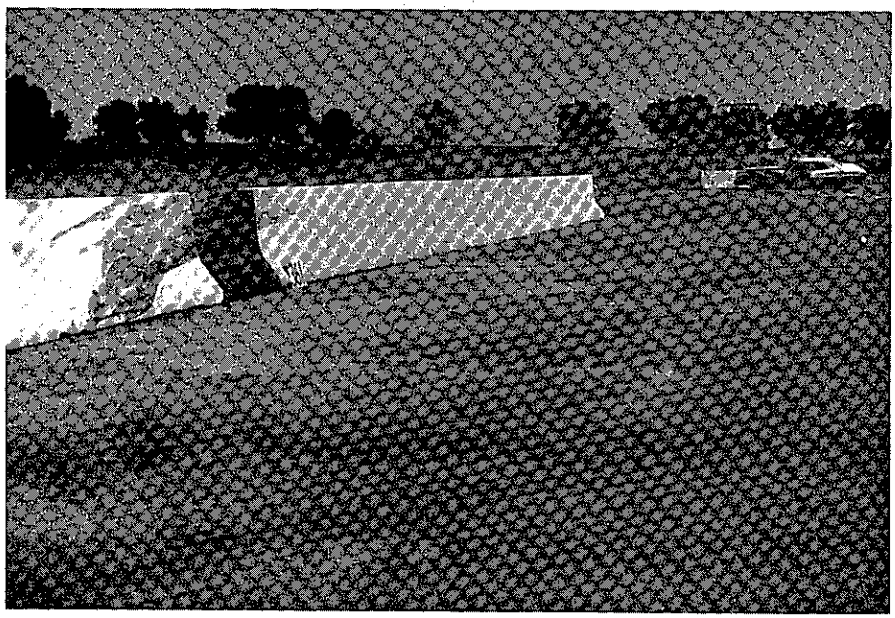
Figure 10 - Final Resting Position of Vehicle

The maximum rebound distance for the vehicle along its post-impact trajectory was about 19 feet from the impact side of the barrier. Assuming an 8 foot shoulder width next to the CMB and 12 foot traffic lanes, the test vehicle could have interfered with traffic in the lane closest to the barrier. The vehicle exited the barrier at about 7 degrees at a speed of about 50 mph. There was some flying debris from the vehicle but it probably would not have been hazardous to other vehicles due to its trajectory.

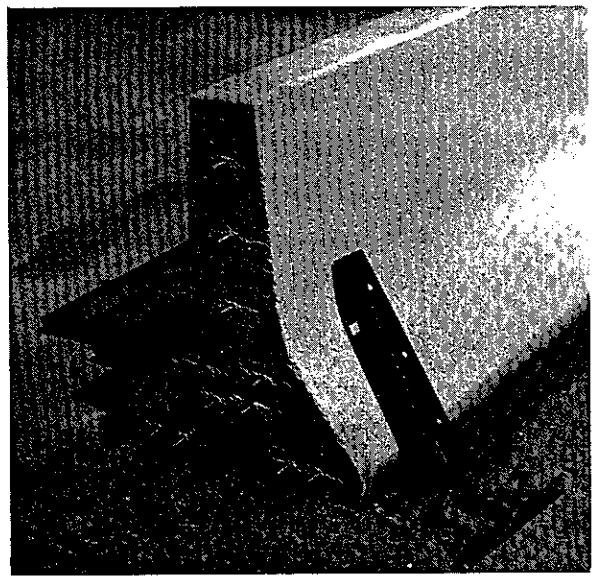
Barrier end anchor

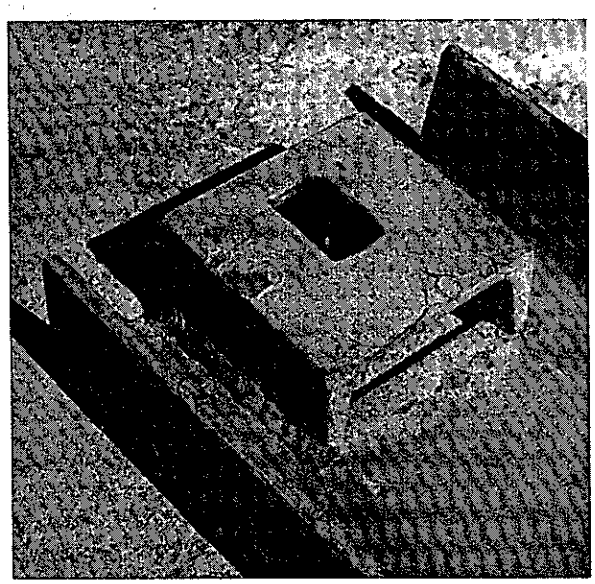
C3x4.1 brackets welded to channels

3. Cut 2 inch x 2-1/2 inch slots in channel beams and 3/4 inch x 1-1/4 inch slots in brackets, C3x4.1, and weld brackets to channels.

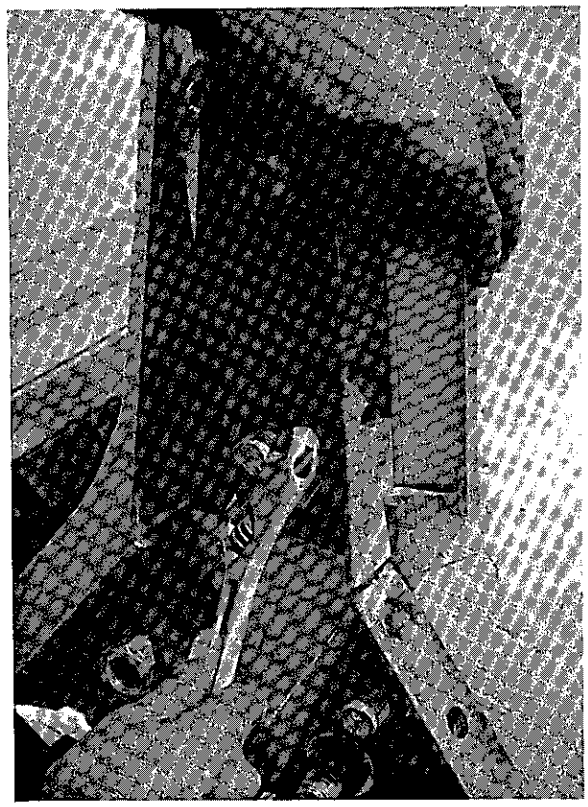
Upper beam hanger adjustment

4. Place upper beam hangers over threaded rods embedded in barrier. After placing nuts on to hold hangers in place, adjust right and left hanger so there is 1-7/8 inch from face of hanger to outside edge of barrier. Mark hangers for tack welding. Determine placement of 5/8 inch bolts for channel beam location. Mark and drill 11/16 inch holes.

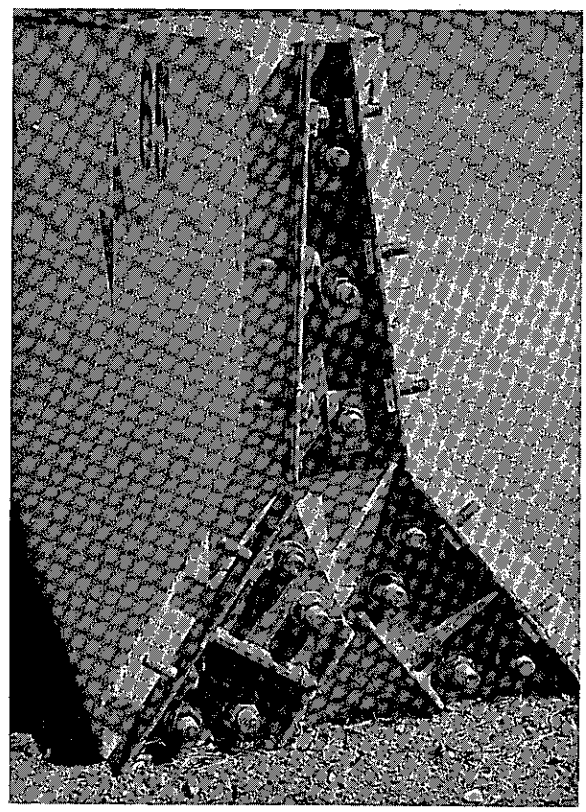
Upper and lower beam hangers bolted to barrier

6. Bolt the upper and lower beam hangers snugly ("wrench tight") onto barrier. Before bolting on the channel beams check to make sure they fit flush with outside face of barrier. If they do not, adjust beam hangers.

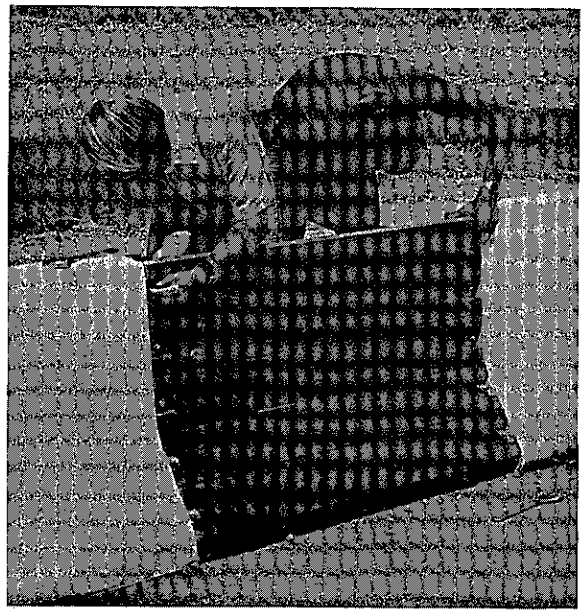
Bolting channel beams to hangers

7. Bolt channel beams snugly onto hangers, using specified spacing of beams.
