1. REPORT No.
FHWA/CA/TL-80/23

4. TITLE AND SUBTITLE
Model Slab Faulting Study

5. REPORT DATE
June 1980

9. PERFORMING ORGANIZATION NAME AND ADDRESS
Office of Transportation Laboratory
California Department of Transportation
Sacramento, California 95819

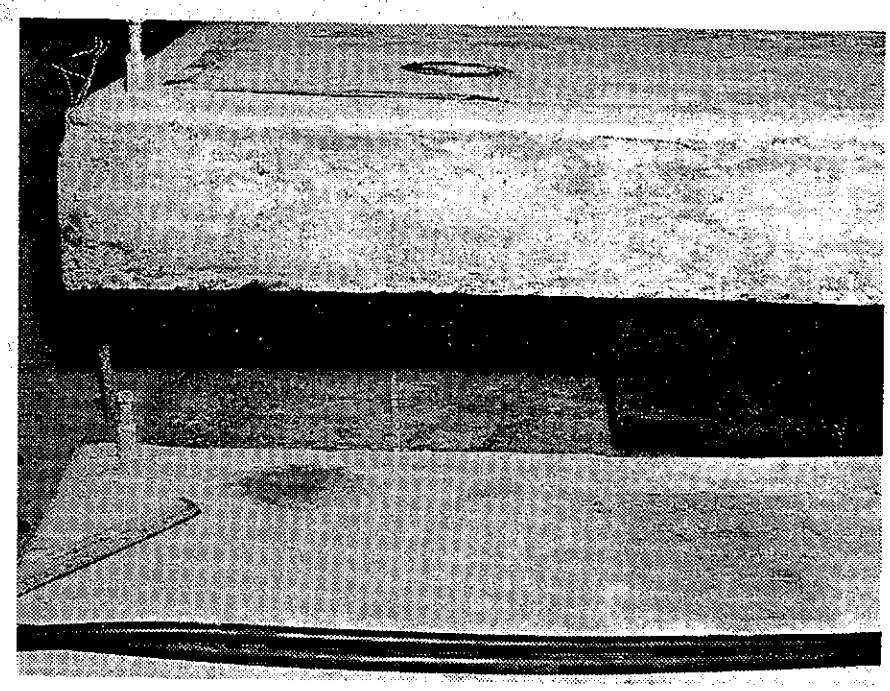
Fig. 14

Figures 14-17 show the base surfaces. Some of the coarser aggregate particles (3/8-1/2 in.) shown in Figure 15, probably came from either the bottom of the slab or the top of the CTB, as well as from the shoulder. Since all aggregates used, including the shoulder, were supplied by the same company, the source of coarser particles could not be identified. The small mound seen in the right center of Figure 15 is a buildup under the plug in the core hole. This was a result of failure to screw the plug

Deposit of aggregate particles beneath raised approach slab.

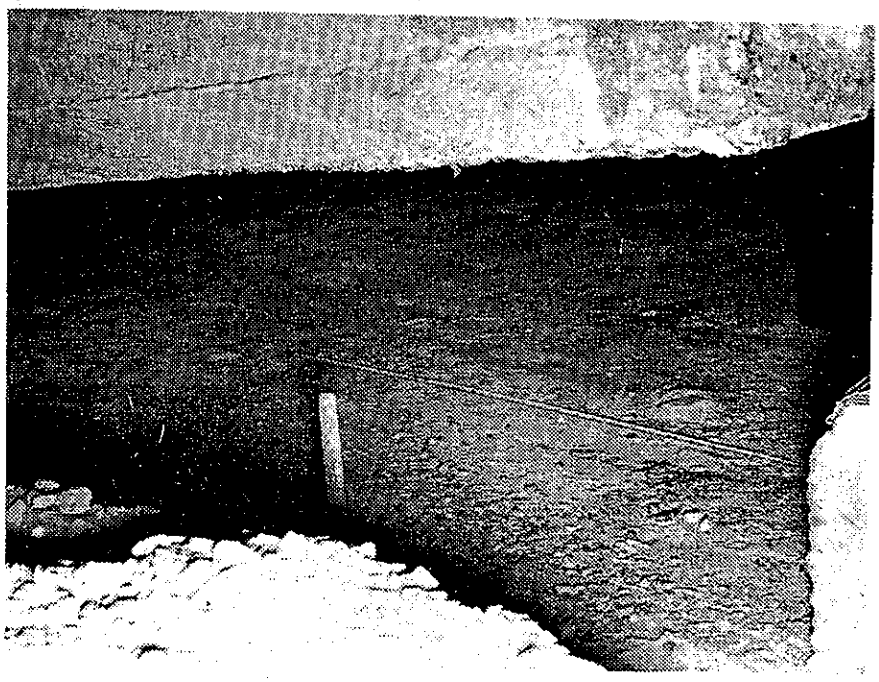
Fig. 15

Looking under approach slab from "shoulder" area. Showing close-up of migrated material.

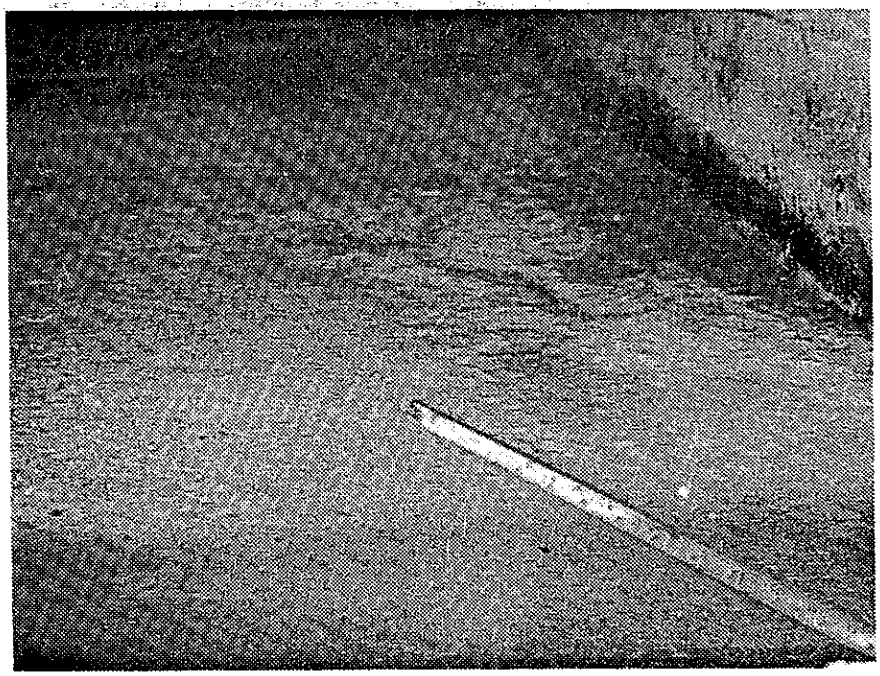
Fig. 16

Deposit of material along
inside wall of test bed.

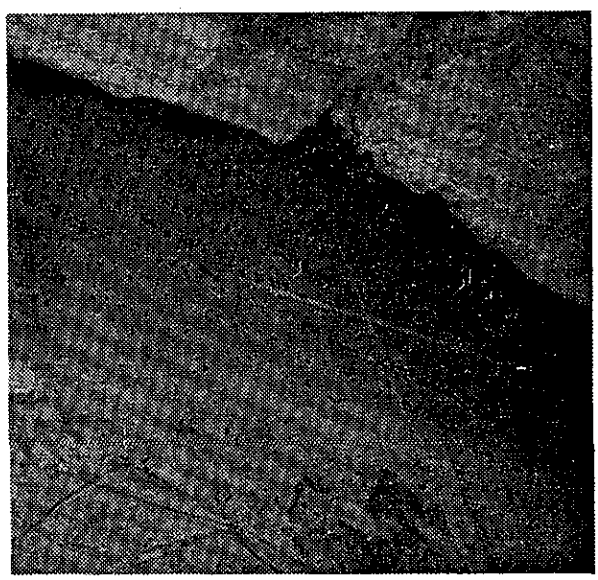
Fig. 17

On completion of the above observations, the migrated materials were removed by water and squeegee. The base under the leave slab, for about 16 sq ft near the joint and shoulder, was found to be badly scoured. As much as a half inch of base was removed in numerous spots. This condition was not found under the approach slab. The bottoms of both slabs indicated considerable abrasion, however.

View under leave slab
with both slabs raised.

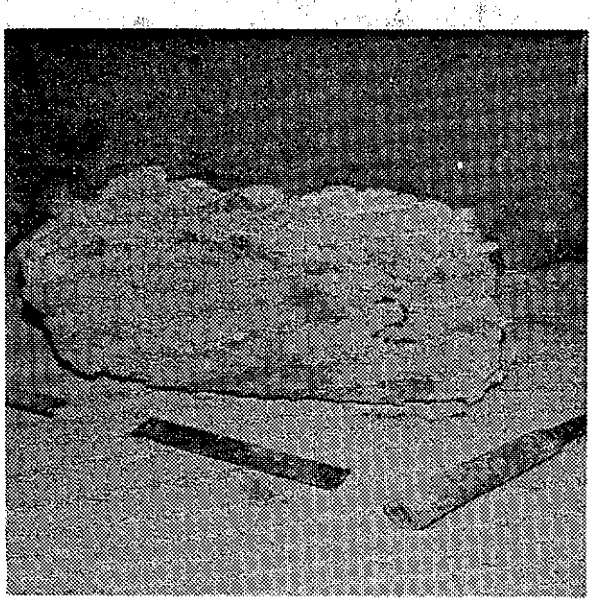
Fig. 18

Porous concrete plugged - edge adjacent to slab.

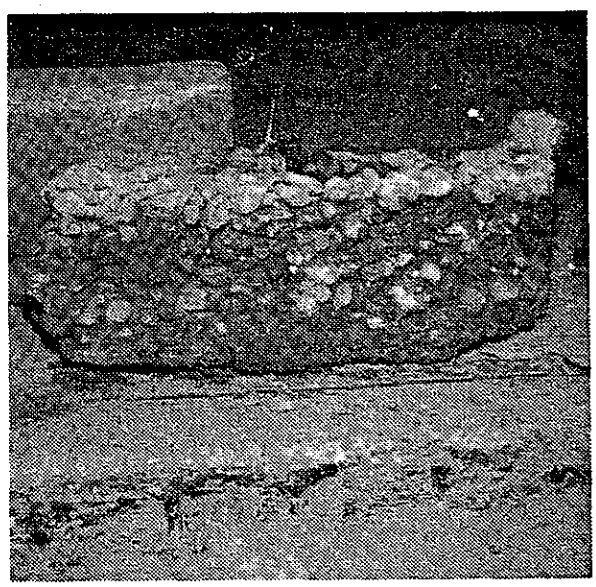
Fig. 19

Porous concrete - edge away from slab.

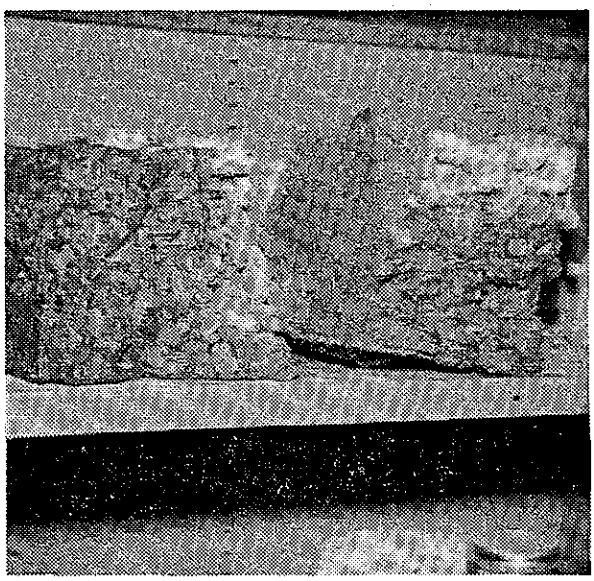
Fig. 20

Broken section of porous concrete - all voids filled.

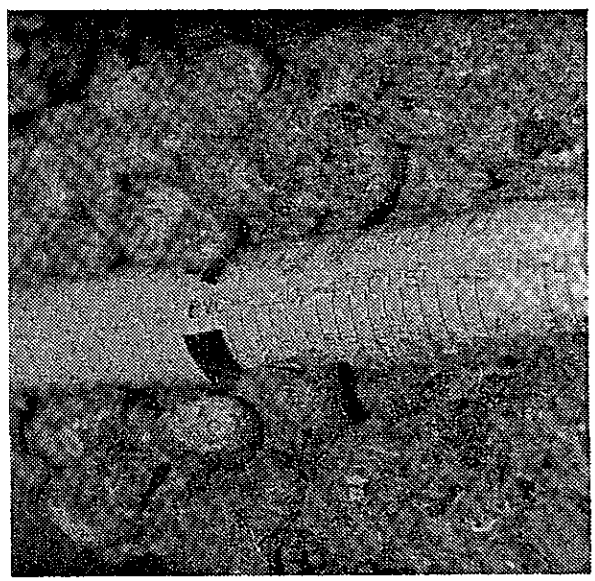
Fig. 21

Slotted pipe in porous concrete.

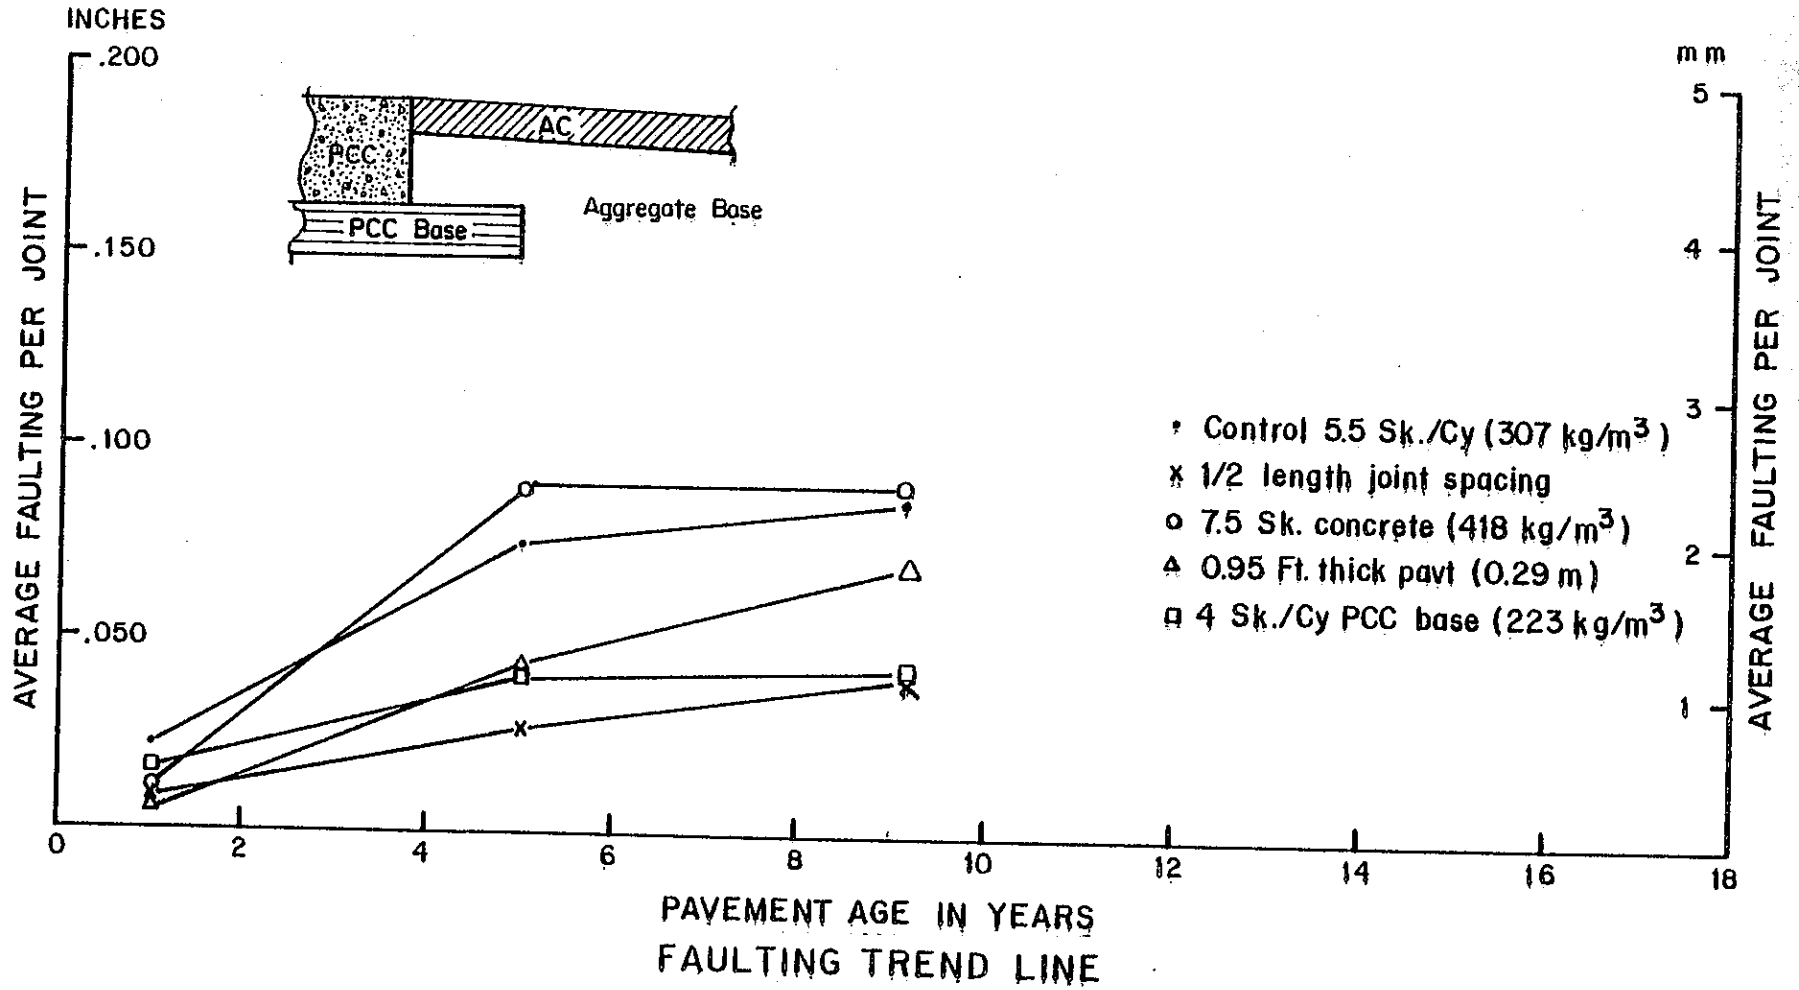
Figure B-24

PAVED 1971

CT BASE

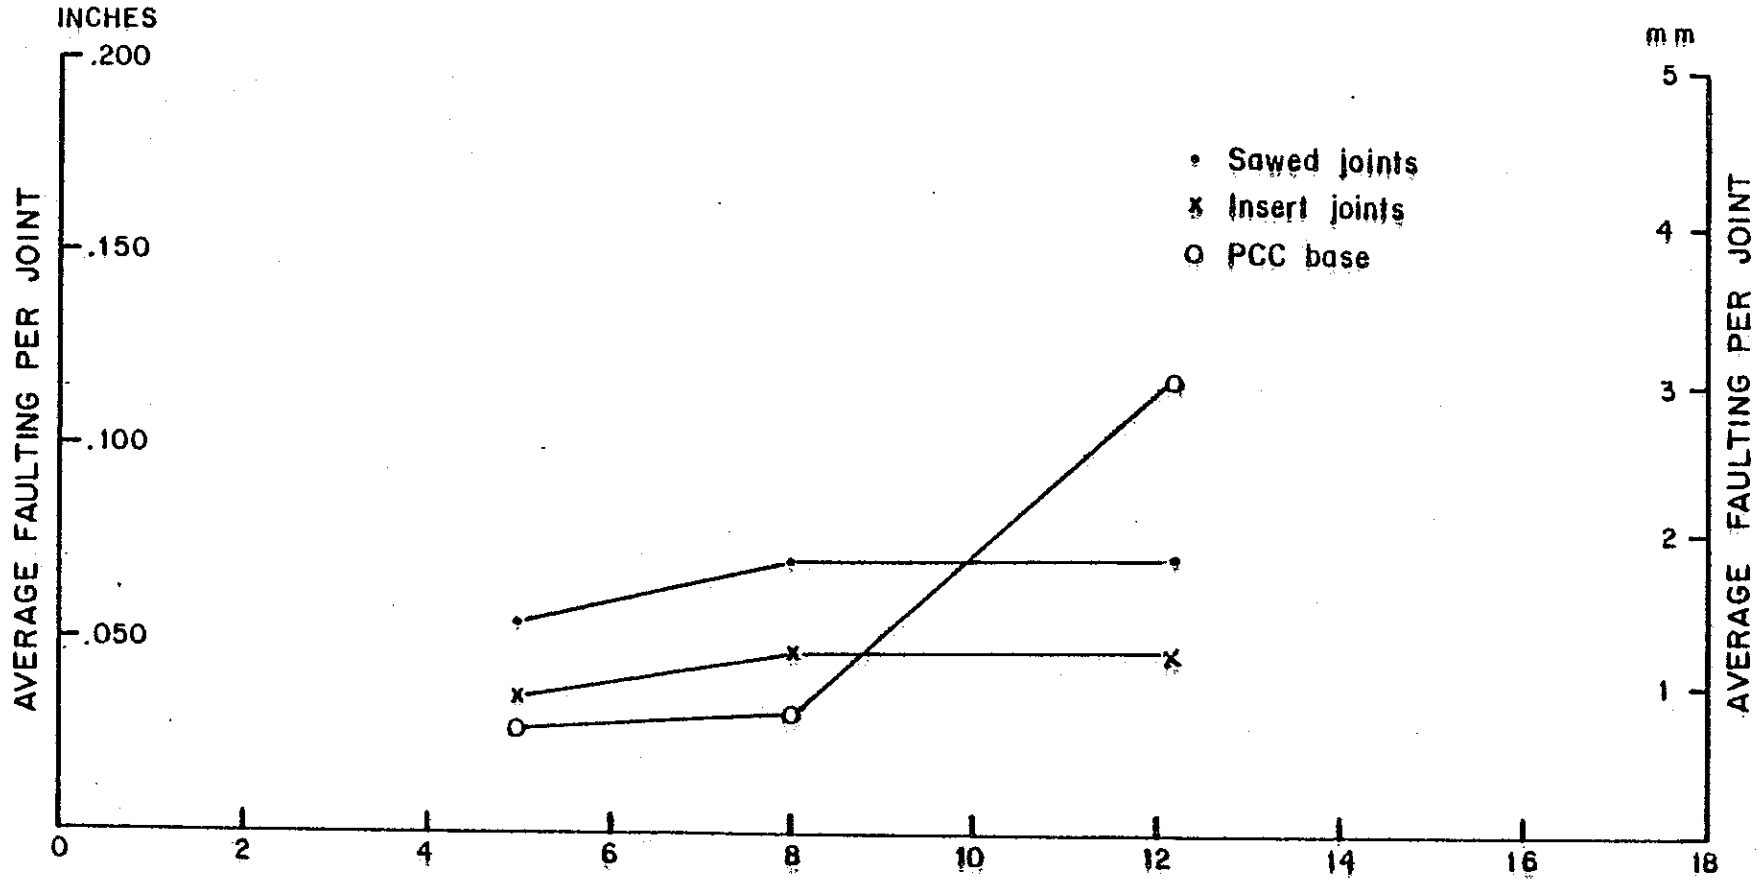
Figure B-25

11 SD 8
ALPINE

PAVED 1968
CT BASE & PCC

FAULTING TREND LINE

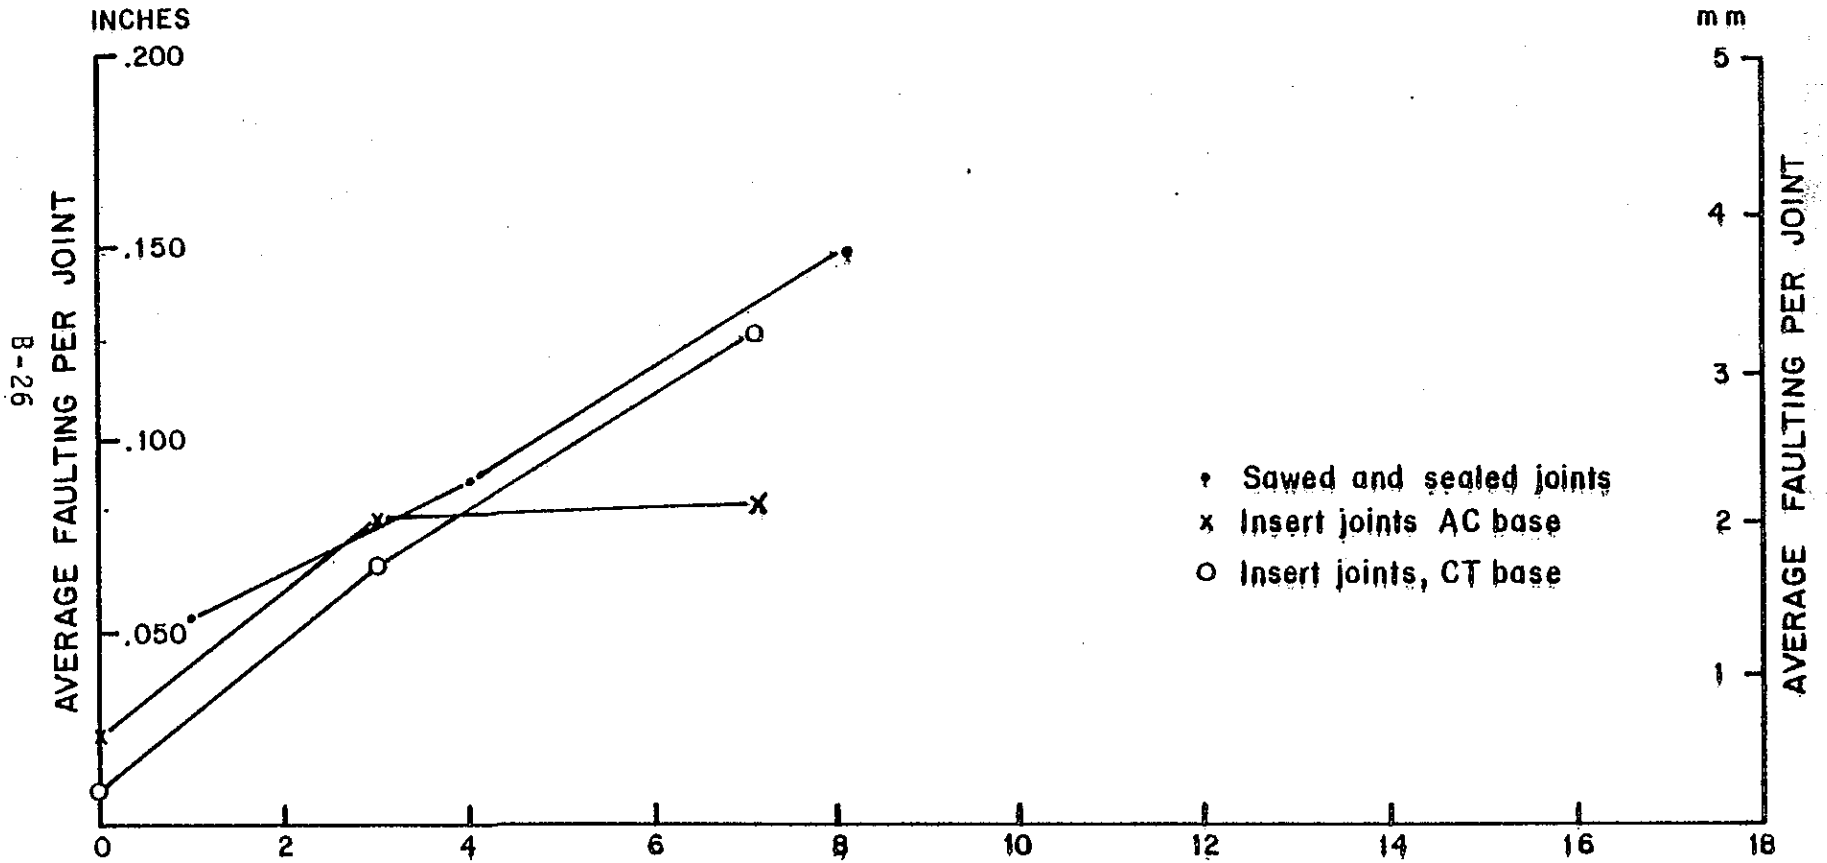
Figure B-26

02 Sis S
WEED

PAVED 1972 & 1973
CT & AC BASE

FAULTING TREND LINE

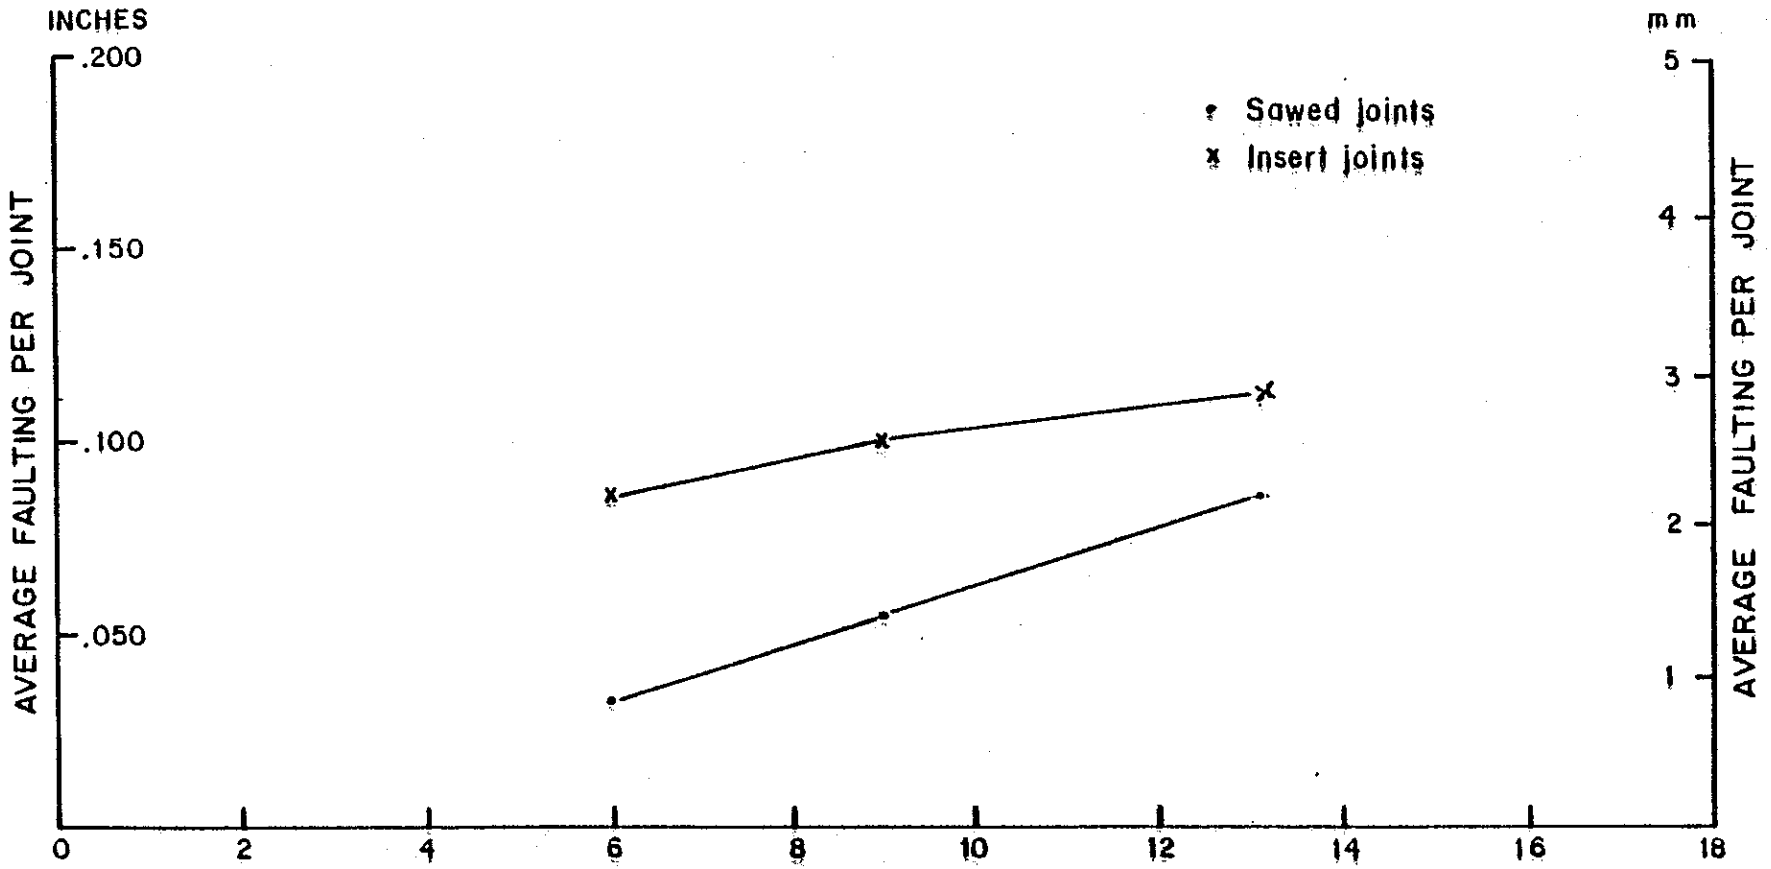
Figure B-27

06 Mad 152
RED TOP

PAVED 1967
CT BASE

FAULTING TREND LINE

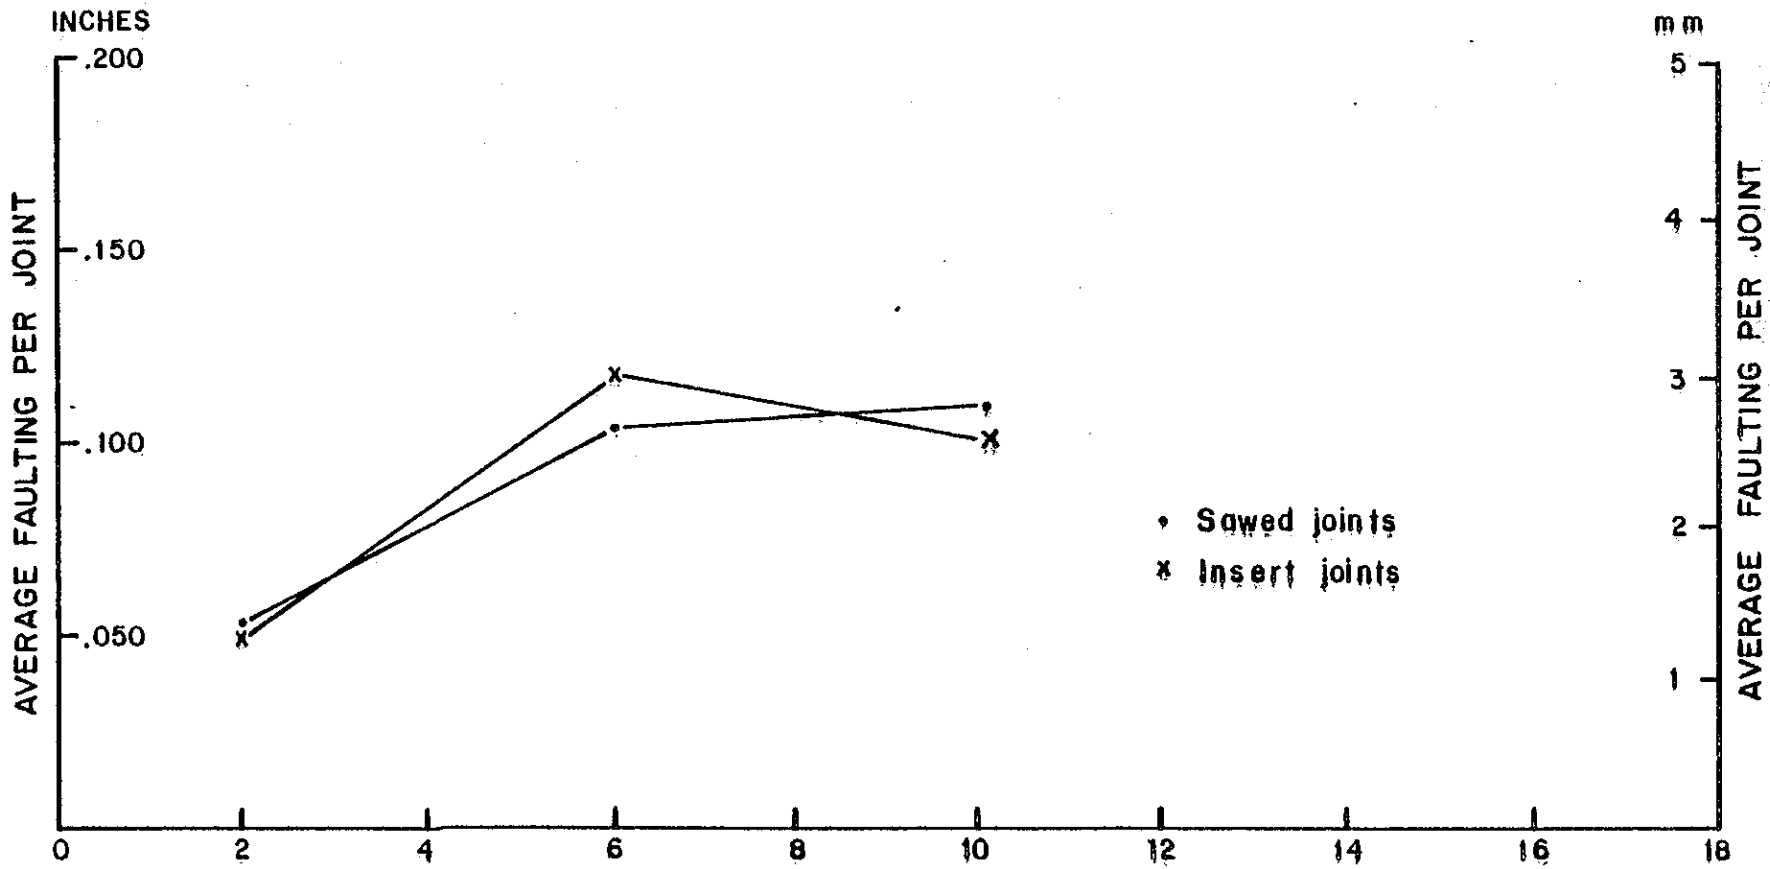
Figure B-28

02 Sis 5
YREKA

PAVED 1970
CT BASE

FAULTING TREND LINE

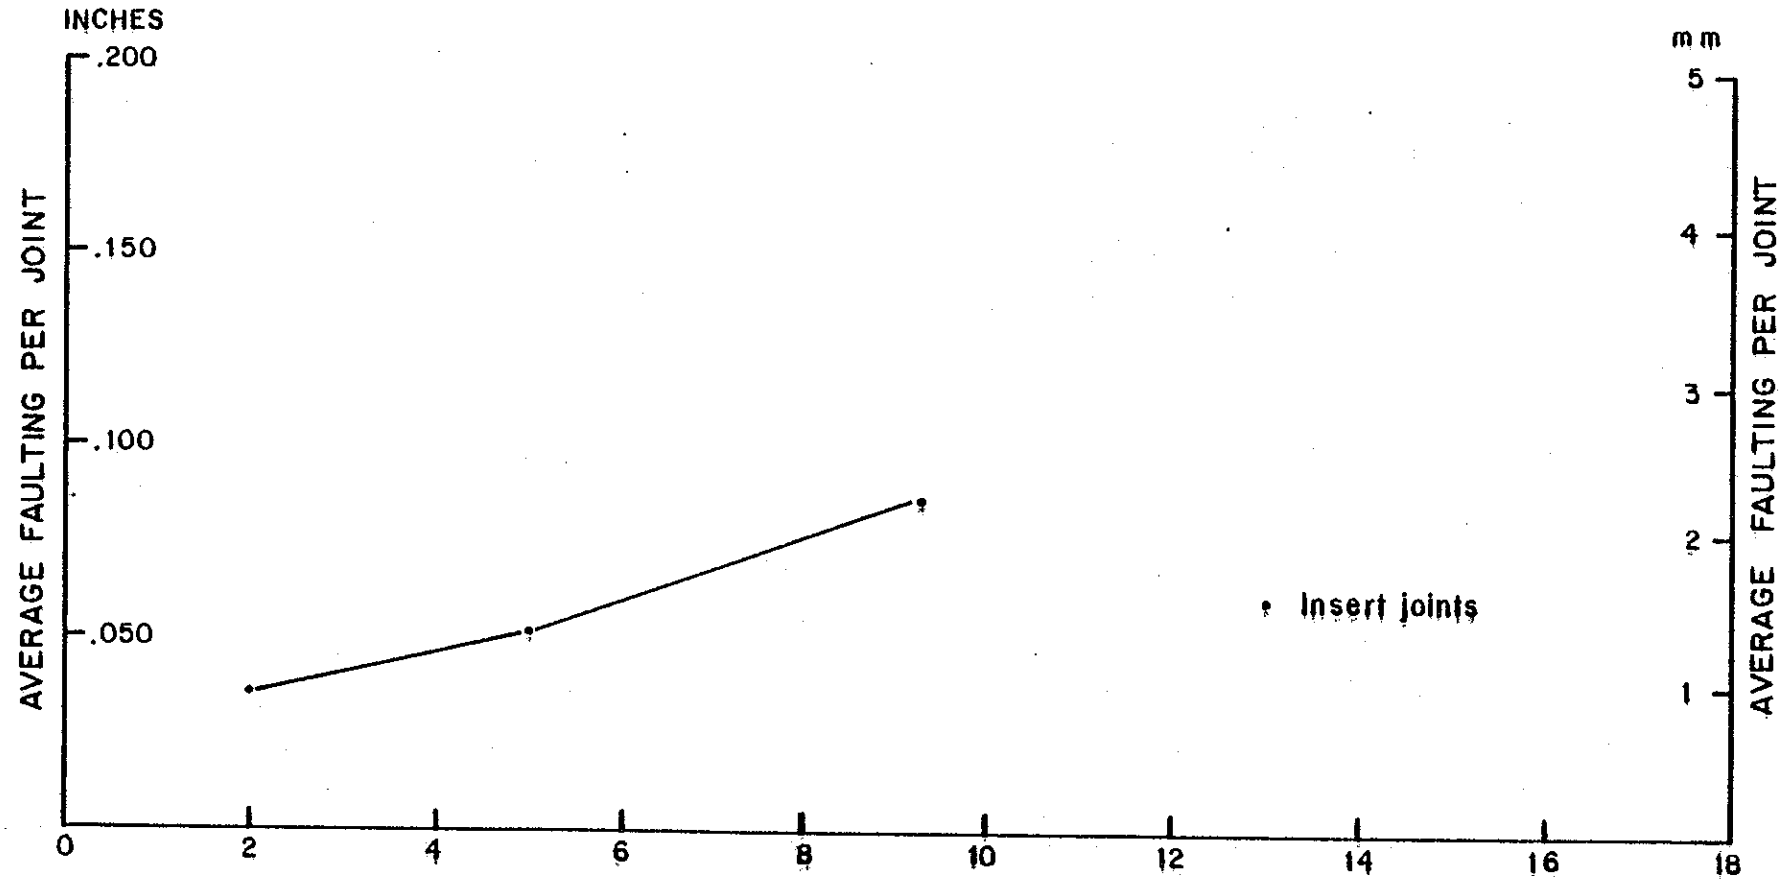
Figure B-29

06 Tul 99
GOSHEN

PAVED 1971
CT BASE

FAULTING TREND LINE

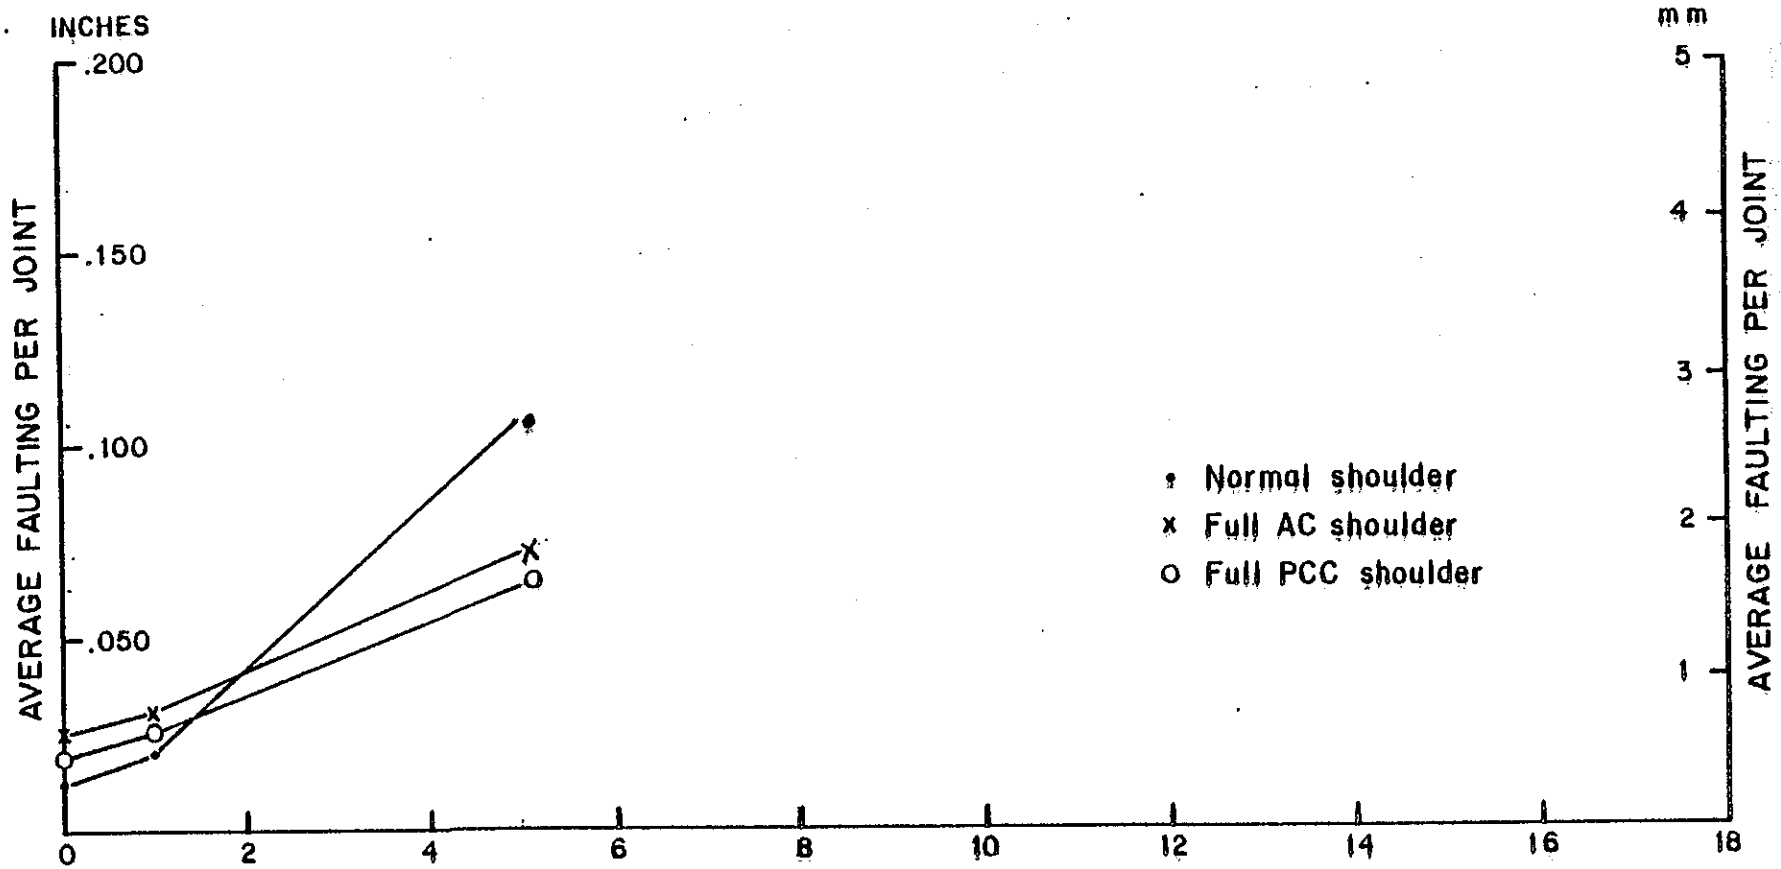
Figure B-30

04 Son 101
GEYSERVILLE

PAVED 1975
CT BASE

FAULTING TREND LINE
