4. TITLE AND SUBTITLE
Evaluation of Weathering Effects on Structural Steel

STATE OF CALIFORNIA
DEPARTMENT OF TRANSPORTATION
DIVISION OF CONSTRUCTION
OFFICE OF TRANSPORTATION LABORATORY

EVALUATION OF WEATHERING EFFECTS ON STRUCTURAL STEEL

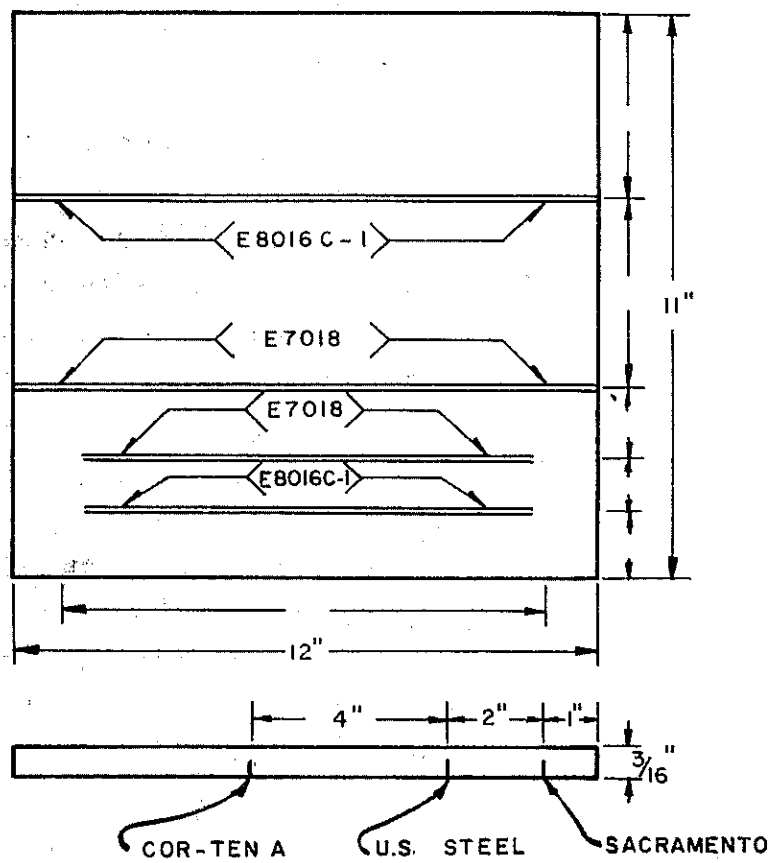
FIGURE 2a

color and corrosion patterns for this condition and also for the condition of undisturbed reinforcement could be evaluated. The electrode designations used on each steel grade for the butt-welded plates, along with a photograph of the Sacramento specimens with corrosion products intact, are presented in Figures 2a through 10a. Similarly, photographs of butt-welded plates from the Los Angeles and Point Reyes sites can be seen in Figures 2b through 10b.

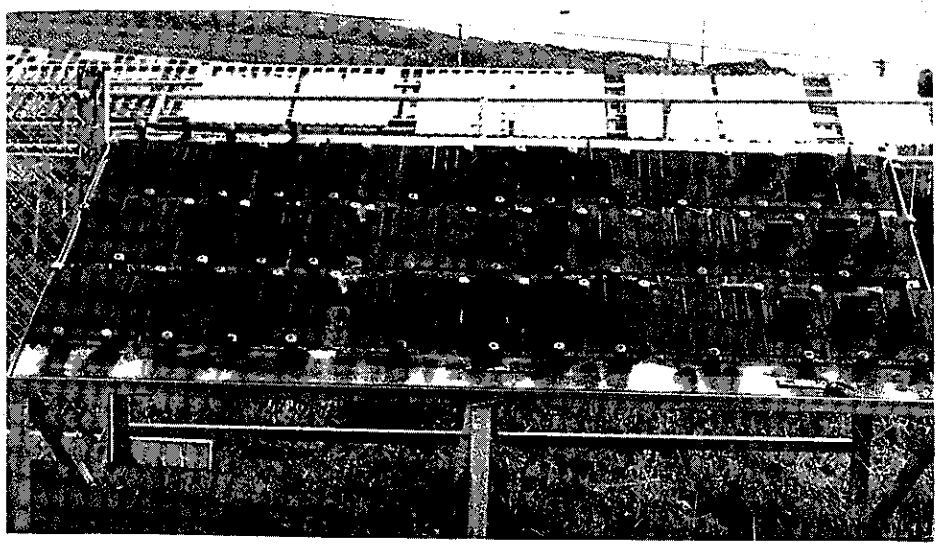
SACRAMENTO

The specimens were held in place with ceramic insulators and spaced so that material washed from one would not contaminate another as can be viewed in Figure 11 which shows the specimens in place on the weathering racks at approximately 13 years.

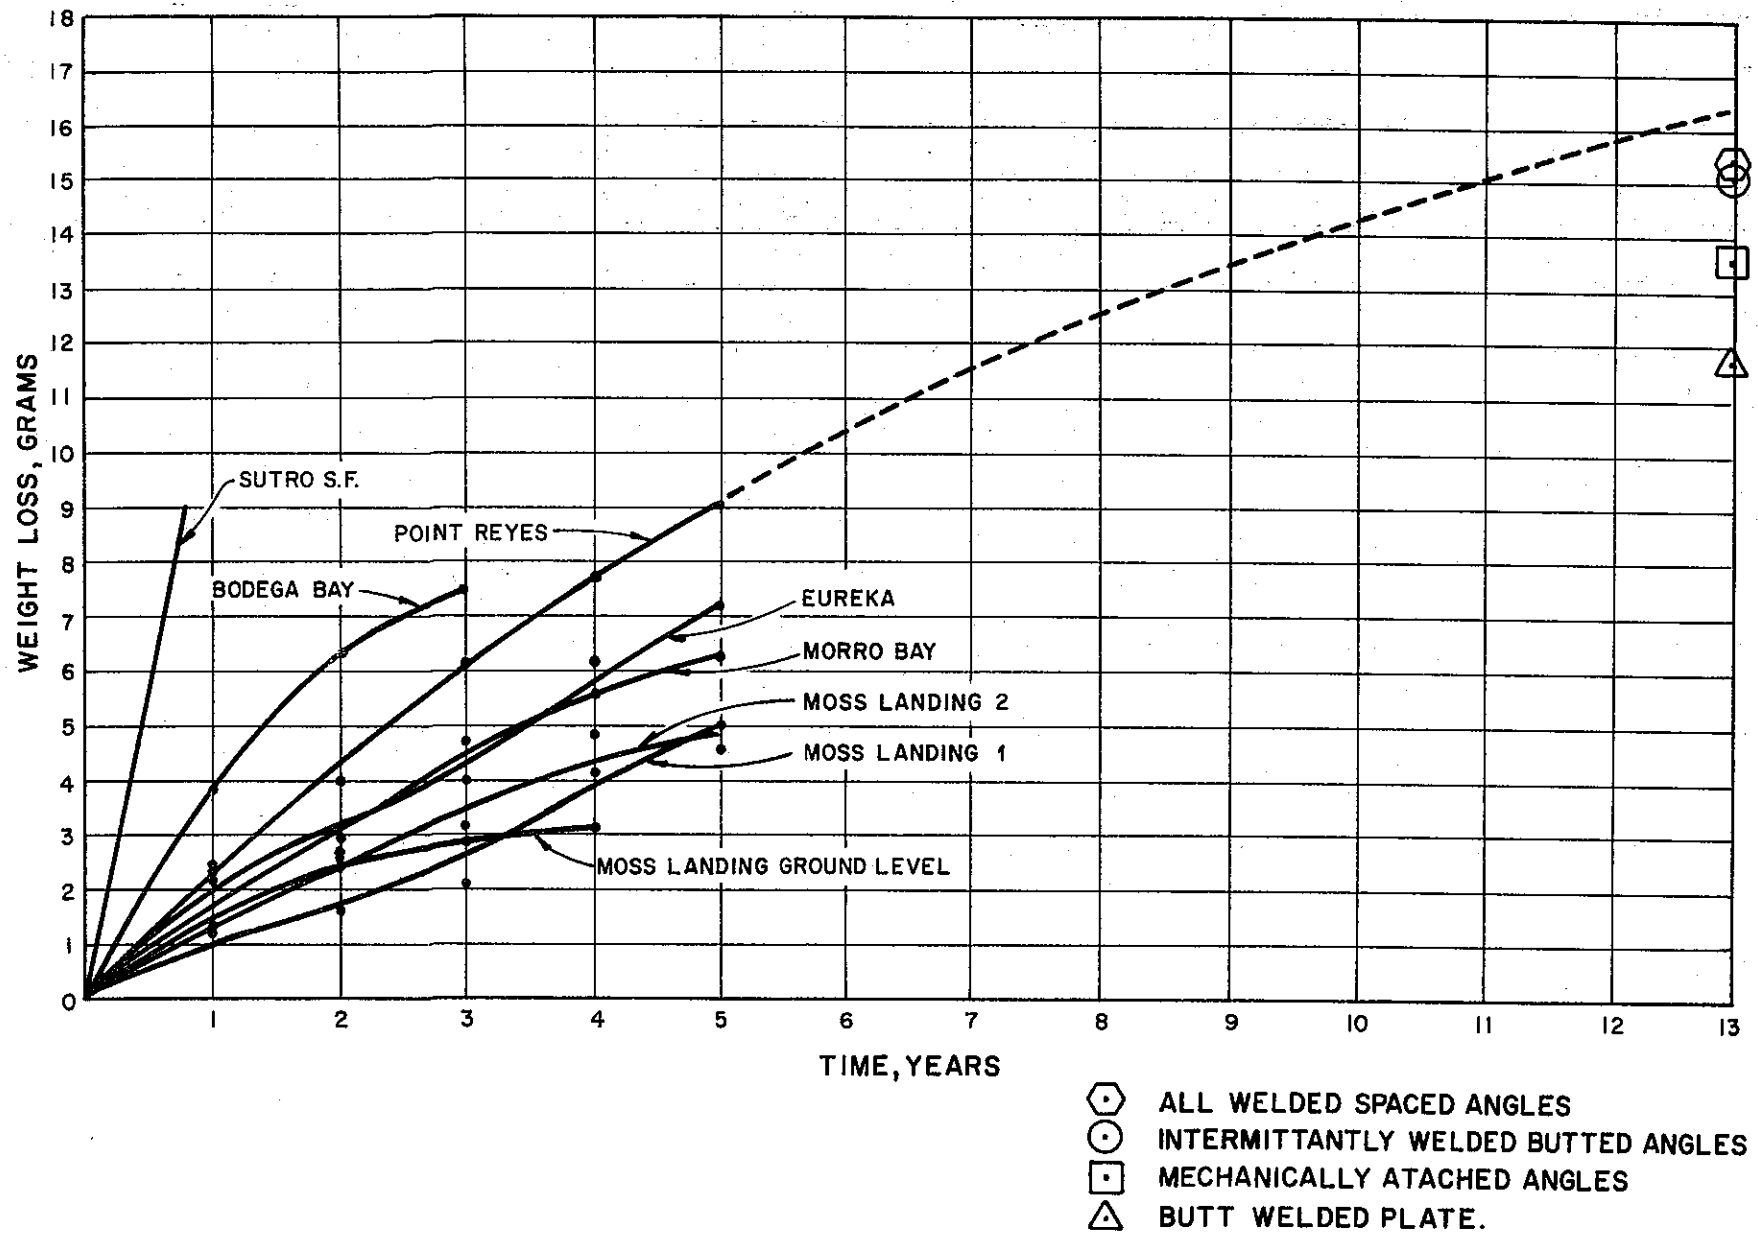
FIGURE 12

The weight loss per unit area after 13 years of the Point Reyes and Los Angeles specimens is compared to results of Thomas and Alderson(2) in Figures 12 and 13. Their graphs for marine and industrial environments are projected to 13 years so that a comparison of weight loss per unit area may be made. Table C gives weight loss in grams per square decimeter and the graphs by Thomas and Alderson give only total weight loss in grams but they list the dimensions of their specimens so that the area may be calculated. Also, their specimens are "MT 1010" steel which has a different chemistry from the A7 mild steel used in this project. However, it can be seen that the results at Point Reyes

TRANSLAB DATA POINTS SUPERIMPOSED ON A GRAPH OF ATMOSPHERIC CORROSION OF STEELS AS A FUNCTION OF TIME (COSTAL AREA) FROM THOMAS AND ALDERSON

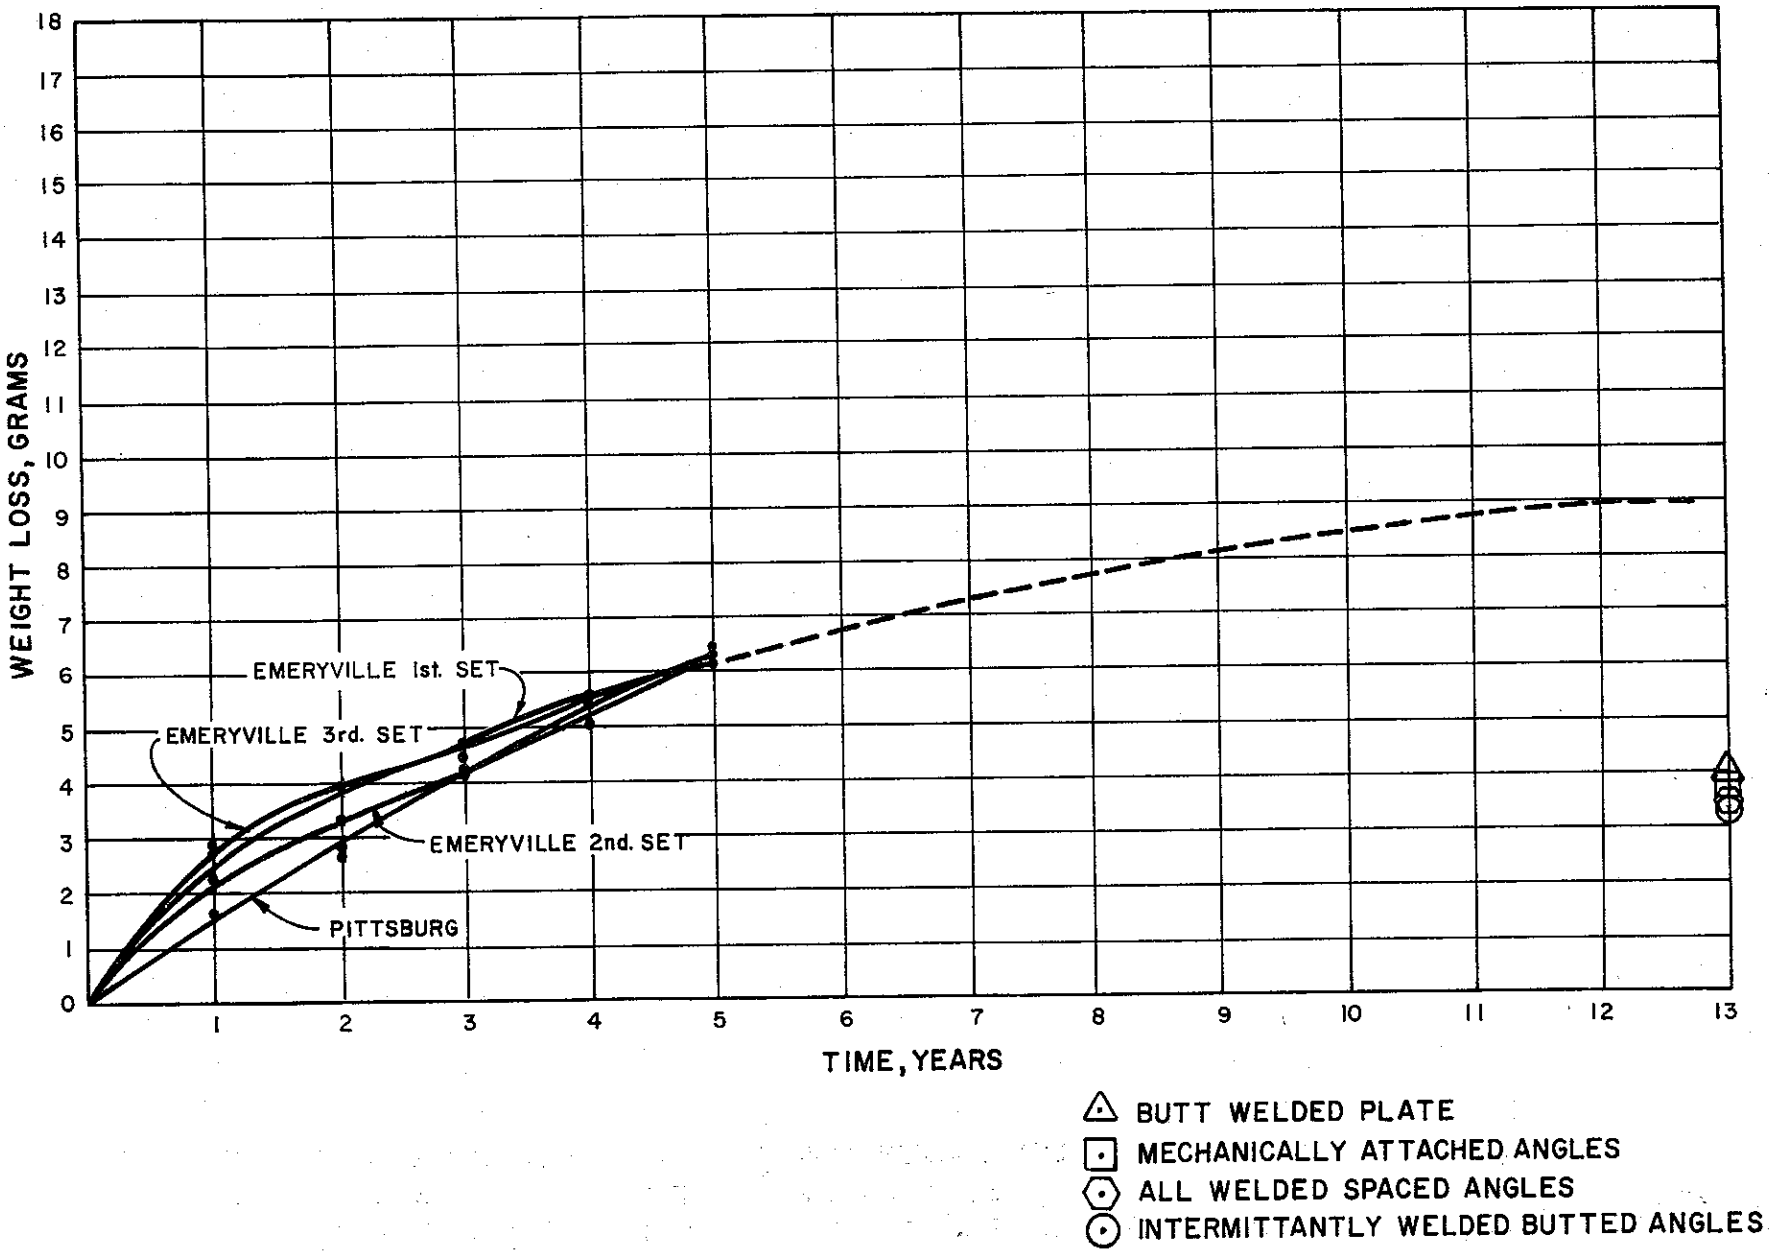
FIGURE 13

ATMOSPHERIC CORROSION OF STEELS TRANSLAB DATA POINTS SUPERIMPOSED ON A GRAPH OF AS A FUNCTION OF TIME (INDUSTRIAL AREA) FROM THOMAS AND ALDERSON

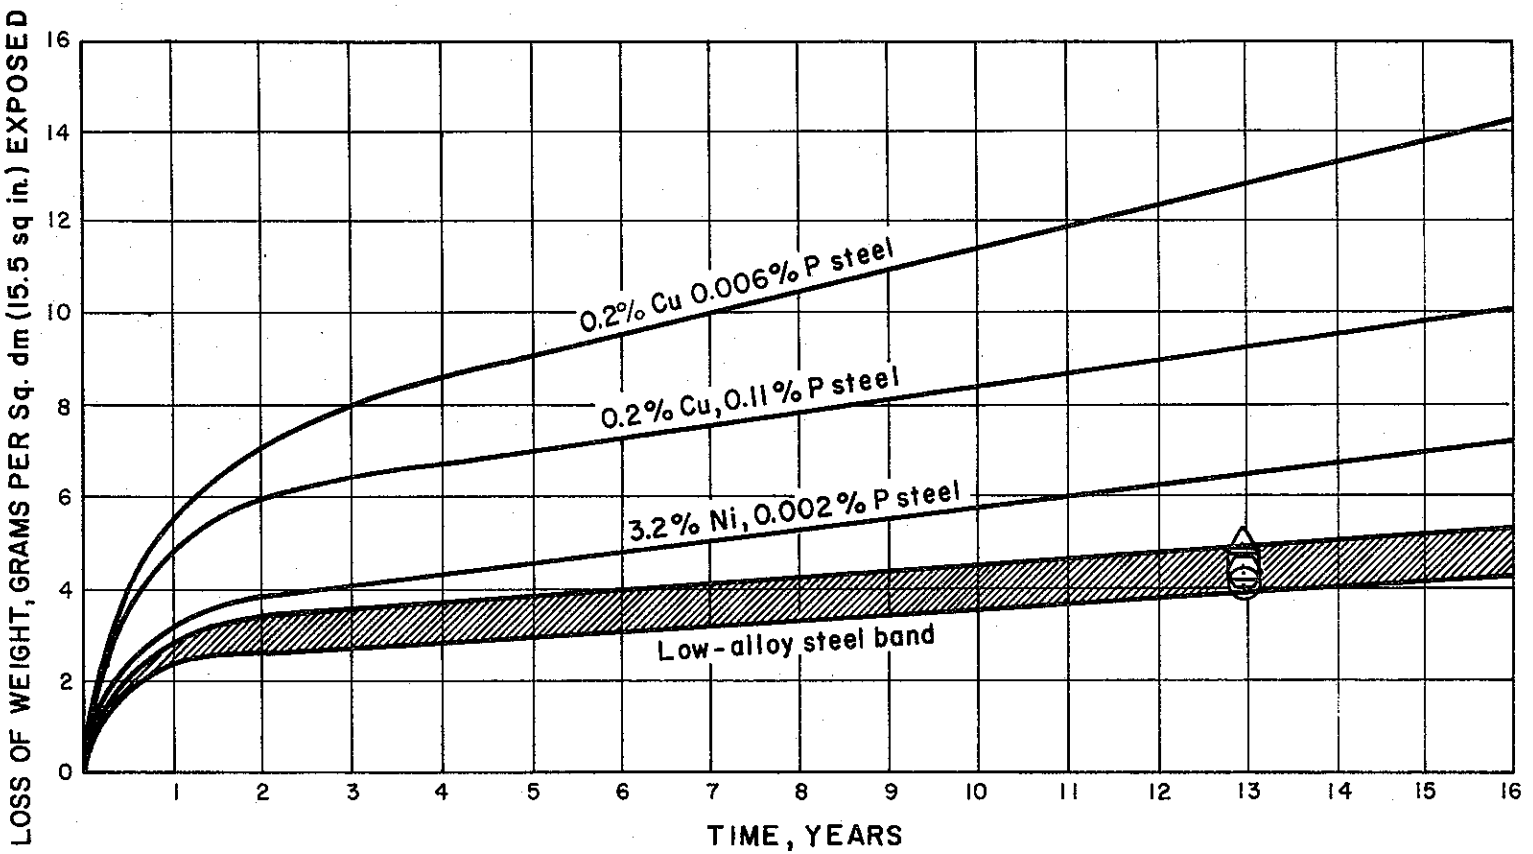
△ BUTT WELDED PLATE
⊡ MECHANICALLY ATTACHED ANGLES
⬡ ALL WELDED SPACED ANGLE
⊙ INTERMITTANTLY WELDED BUTTED ANGLES

TRANSLAB DATA POINTS SUPERIMPOSED ON A GRAPH OF ATMOSPHERIC CORROSION OF STEELS AS A FUNCTION OF TIME (INDUSTRIAL ATMOSPHERE) FROM C. LARRABEE, CORROSION HANDBOOK

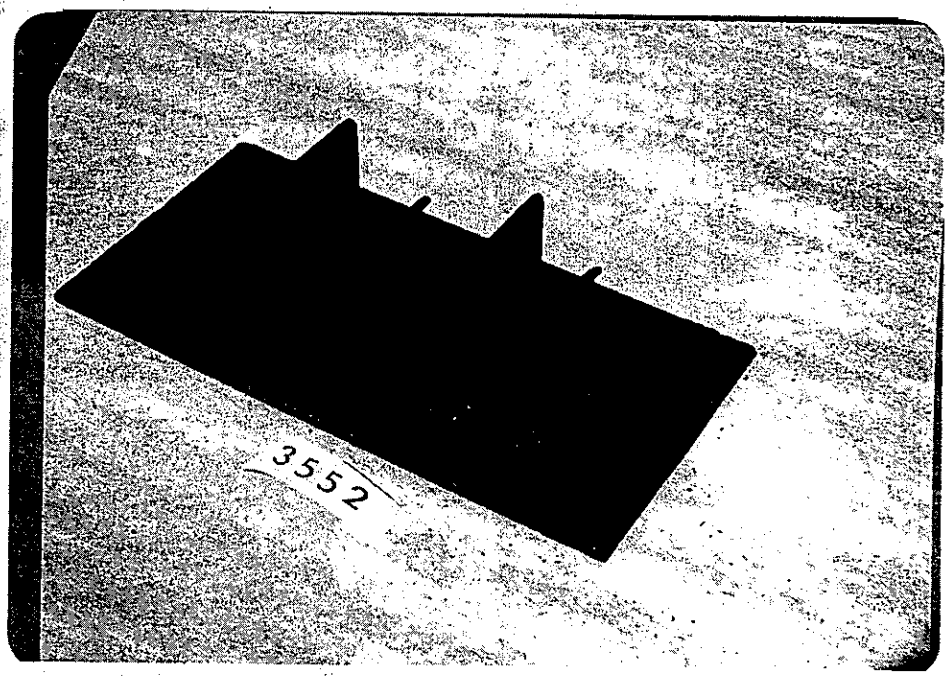
Figure 16a

The angles on specimen 3552 had two large deep pits as can be seen in the photographs of this specimen in Appendix B, Figures 16a and b. The depths of the two pits were 0.061 and 0.054 inch which is approximately 25% and 22% of the corroded angle thickness. (Original angle thicknesses were not measured. Percentages are of weathered thicknesses.) Specimen 2552 had a very high weight loss and it can be seen in the photograph in Appendix B, Figures 17a and b, that the two plates are spread about 3/16" and the tops of the angles are preferentially corroded on one side. Approximately 3/16" of the vertical height of the angles is corroded away on one side. The faces of the angles are deeply pitted to 30% of thickness. Specimen 2232 (not

A-7 STEEL BEFORE CLEANING. ANGLE HAS 0.5 COPPER.

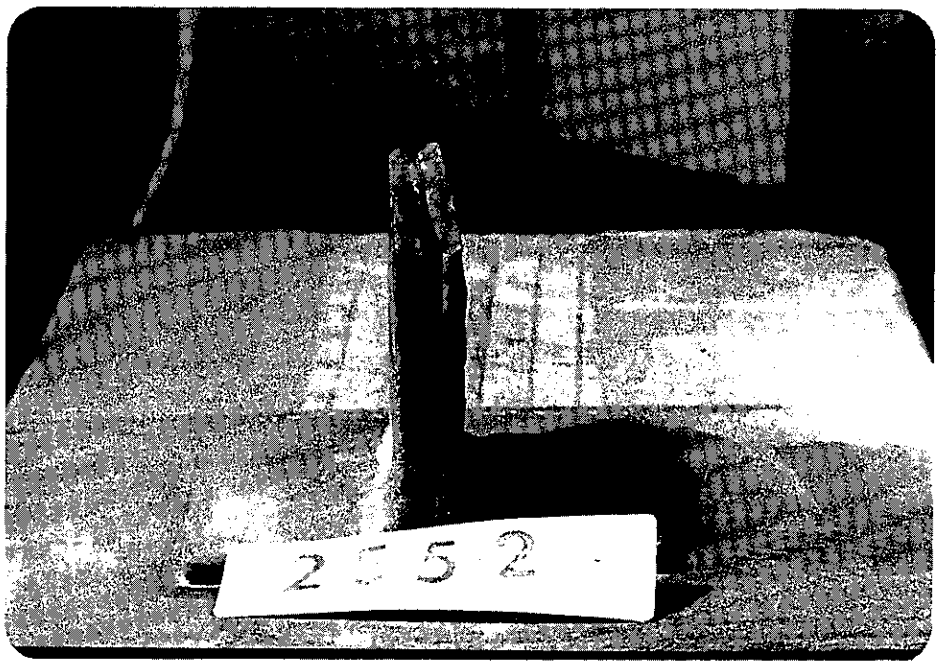
Figure 17b

A-7 STEEL WEATHERED AT PT REYES IS SEVERELY CORRODED.
TOP LEFT HALF IS PREFERENTLY CORRODED.

SIDE VIEW OF A-7 SPECIMEN SHOWN IN 17a.
NOTE SPREADING OF ANGLES.

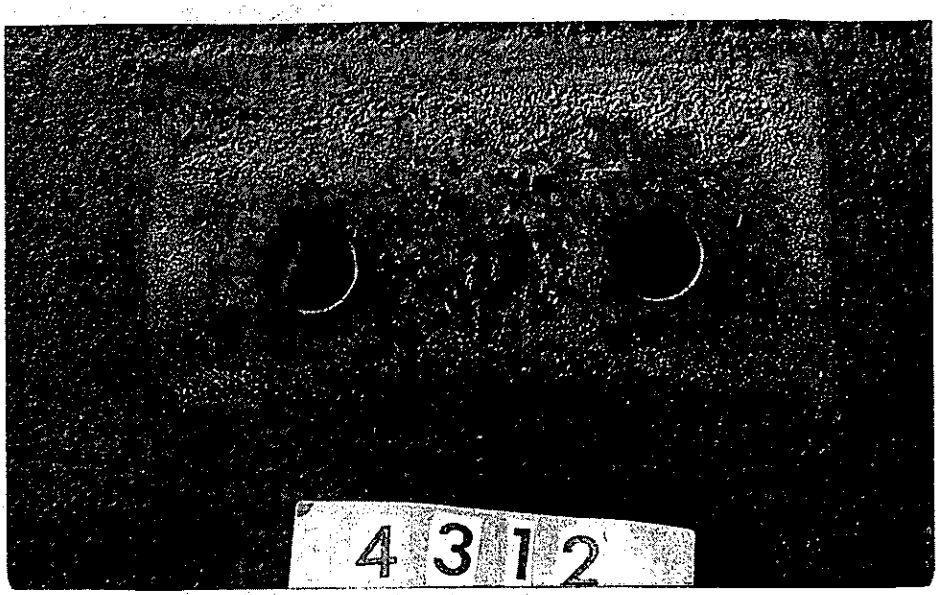
Figure 18a

T-1 STEEL SPECIMEN FROM PT REYES.

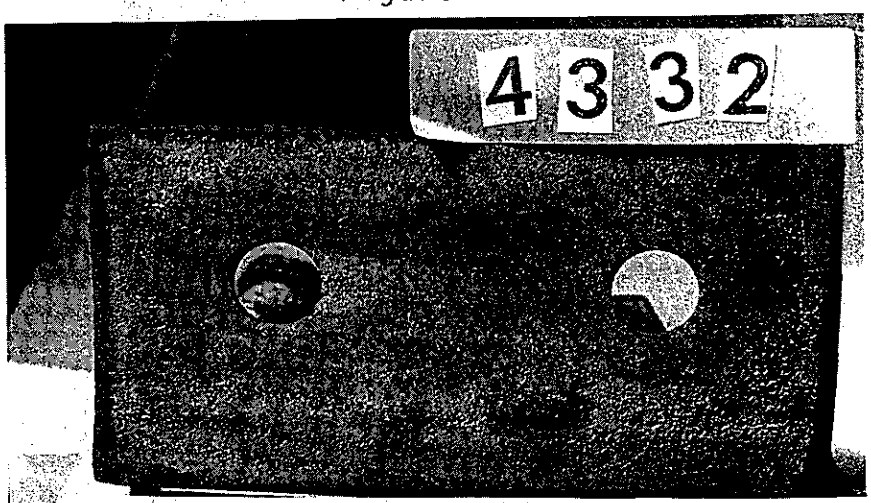
Figure 18b

SSS 100 A STEEL SPECIMEN FROM PT REYES
