5. REPORT DATE
January 1985

7. AUTHOR(S)
L. deLaubenfels

9. PERFORMING ORGANIZATION NAME AND ADDRESS
Office of Transportation Laboratory
California Department of Transportation
Sacramento, California 95819

EFFECTIVENESS OF RUBBERIZED ASPHALT IN STOPPING REFLECTION CRACKING OF ASPHALT CONCRETE
(Interim Report)

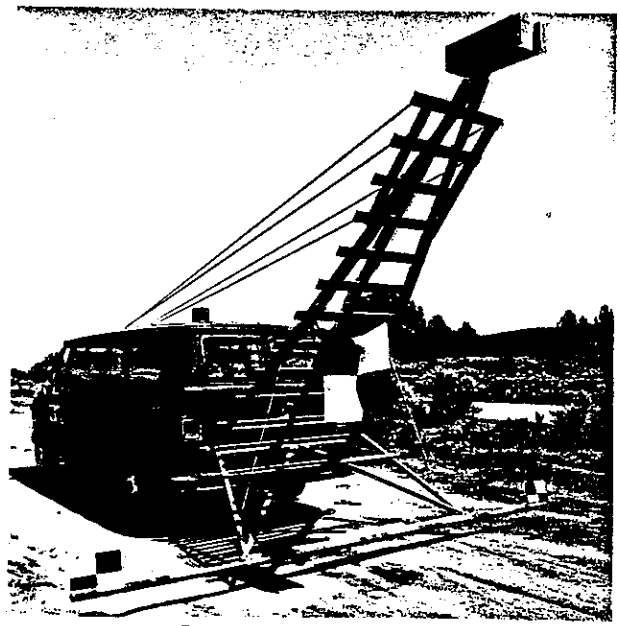
Photo "Hash" Marks on Pavement
Figure 3

Each test section was laid out on the pavement and divided into 20 equally-spaced picture points (PP), each delineated by a "hash mark" painted on the paved shoulder and numbered so as to label and identify each photograph (Figure 3). The ends of each test section were referenced with steel survey pins set outside the planned limits of work to allow the test sections to be retraced exactly on top of the overlay after completion of the project.

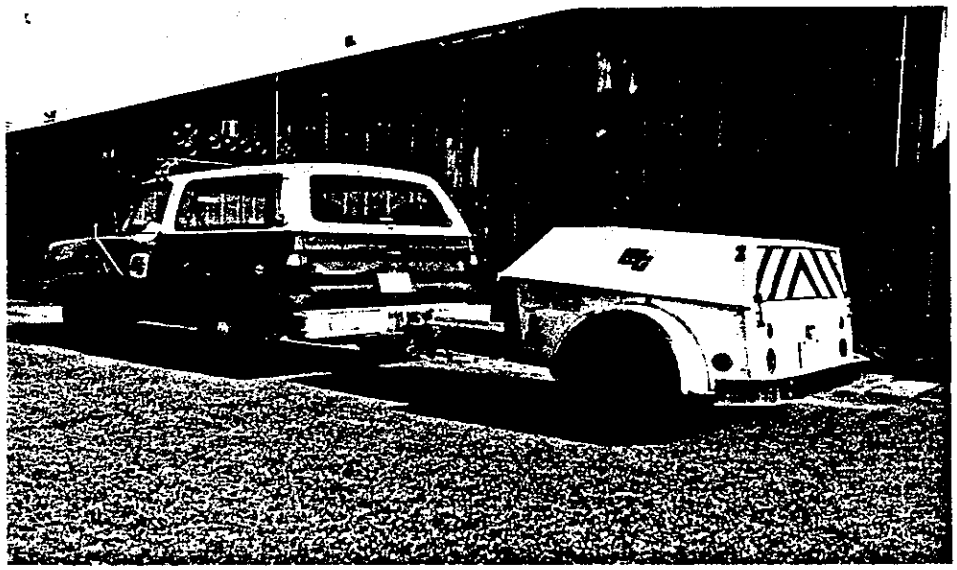
Figure 6

Dynaflect - Used to Measure Pavement Deflection

mile in both directions using a Dynaflect (Figure 6). Northbound andsouthbound lane values were carefully compared and found to be not significantly different. The southbound lane average values for entire project segments were then compared with the averages for the test sections alone. The test section values were found to be fairly representative. These ranged from a low of 0.023" (TS 7) to a high of 0.063" (TS 9) and averaged 0.043". These are Equivalent Deflectometer values and are considerably in excess of the "tolerable" deflection of 0.017" (Table 5 - Column 1).

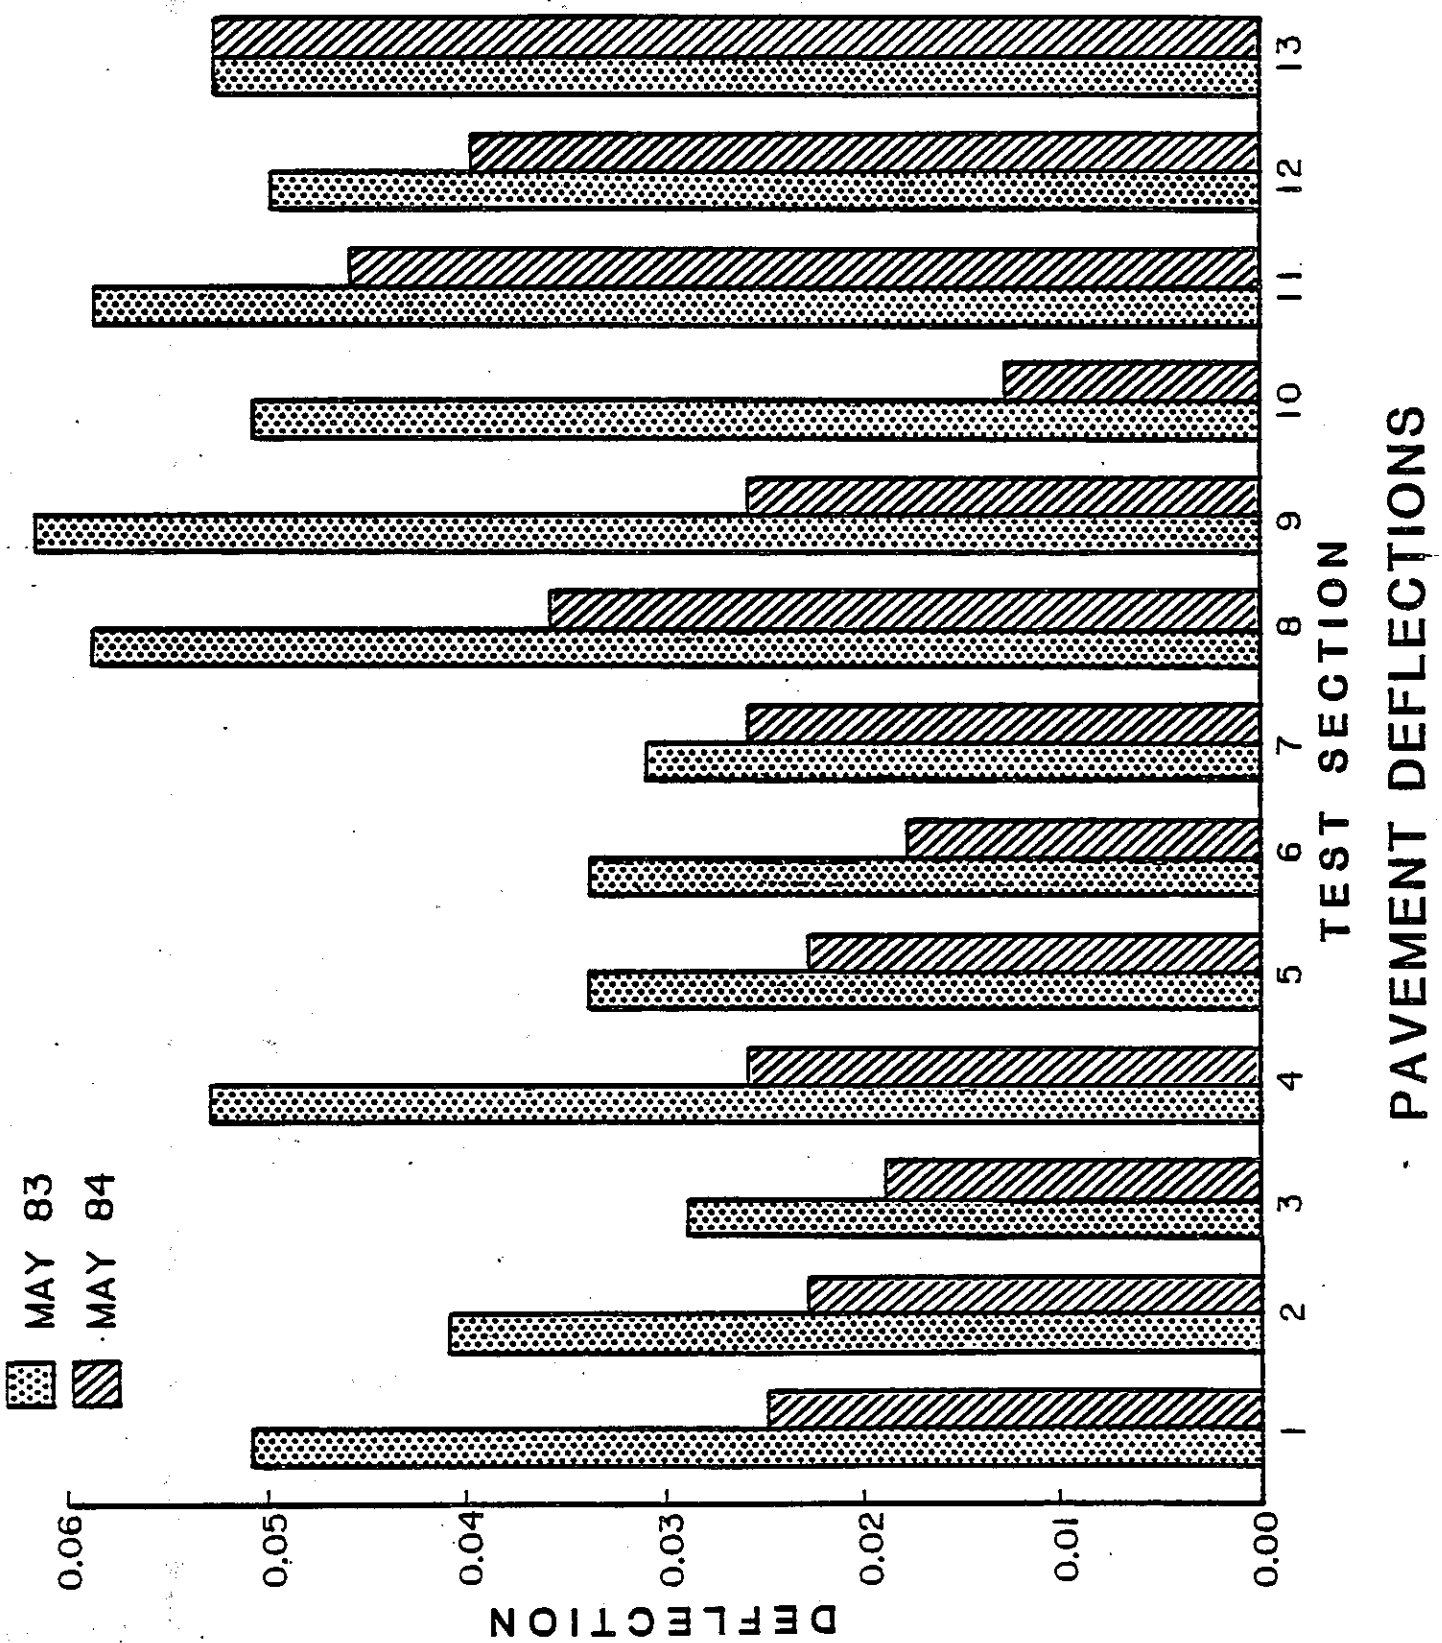
PAVEMENT DEFLECTIONS

A continuous deflection study of the entire project was made in May of 1983 (Figure 5). Deflections were measured each hundredth of a

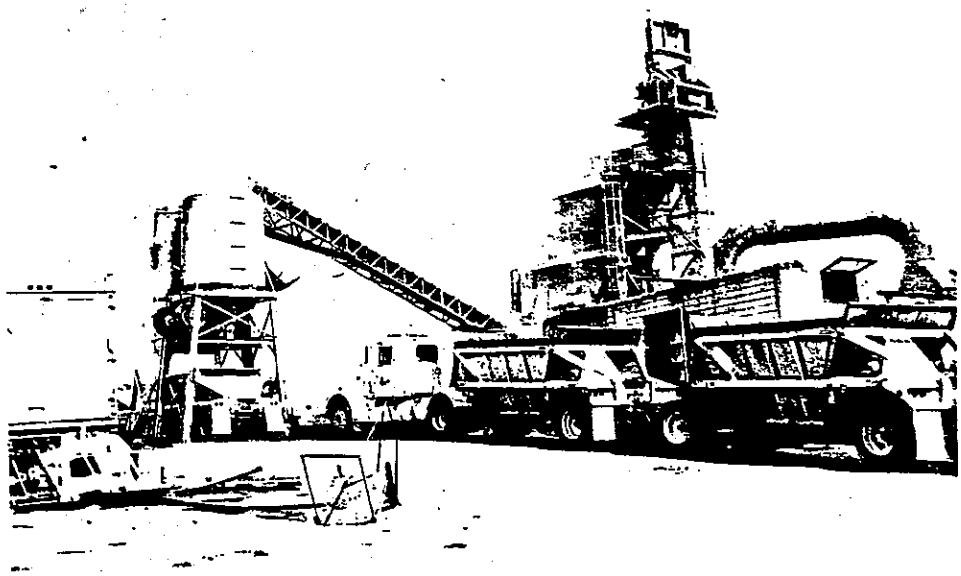
Batch Plant (10,000 lb capacity)
Figure 7

The plant (Figure 7) was a Standard 10,000 pound capacity batch plant located on Route 395 about 15 miles south of the project (P.M. 78.50). AC mix was hauled from the plant

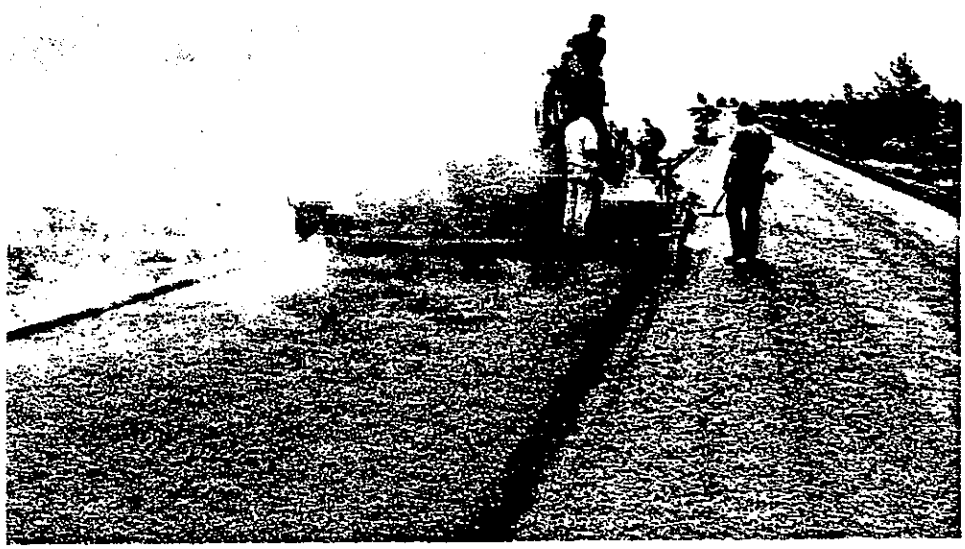
Figure 10

Loaded into the truck, and even in the windrow, the PlusRide mix was seen to quiver like gelatin. Tarps were not used on the 15-mile haul, as only 5 or 10 degree heat loss resulted. At the laydown temperature of up to 380° F, the paving operation was very smoky (Figure 10).

PlusRide Mix at 370°F

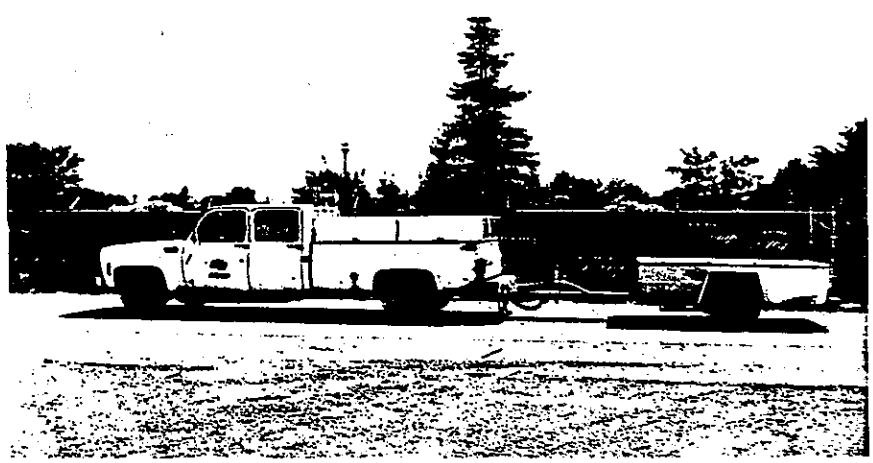
Towed Trailer Skid Tester
Figure 11

In October of 1983, skid tests were run on each of the 15 test sections using the Towed Trailer Skid Tester (Figure 11).

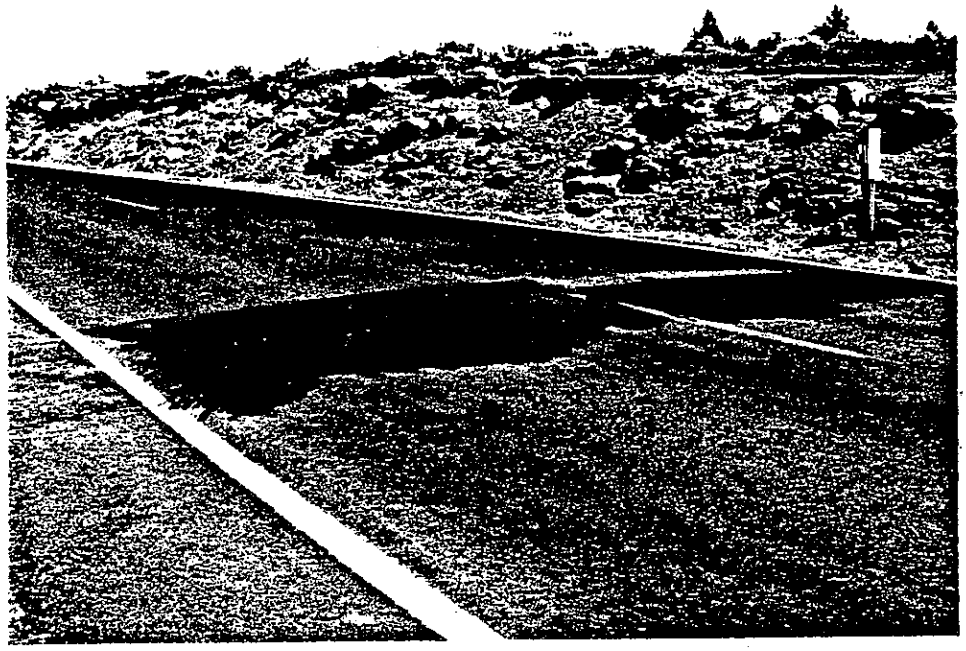
Figure 17

At some of the construction joints in the PlusRide (Segment 4), for about two feet from the joint, there is an area of heavy bleeding (Figure 17). According to the Resident Engineer, the contractor had a problem in this location spreading the AR-4000 paving asphalt used for the tack coat. The rate of application was sometimes too heavy in the first foot or two of the spread. This is, therefore, probably

the source of the excess asphalt now coming to the surface. Since the PlusRide DGAC has as low as one or two percent voids, little of the excess can be absorbed.

Bleeding at Transverse Joint (PlusRide)

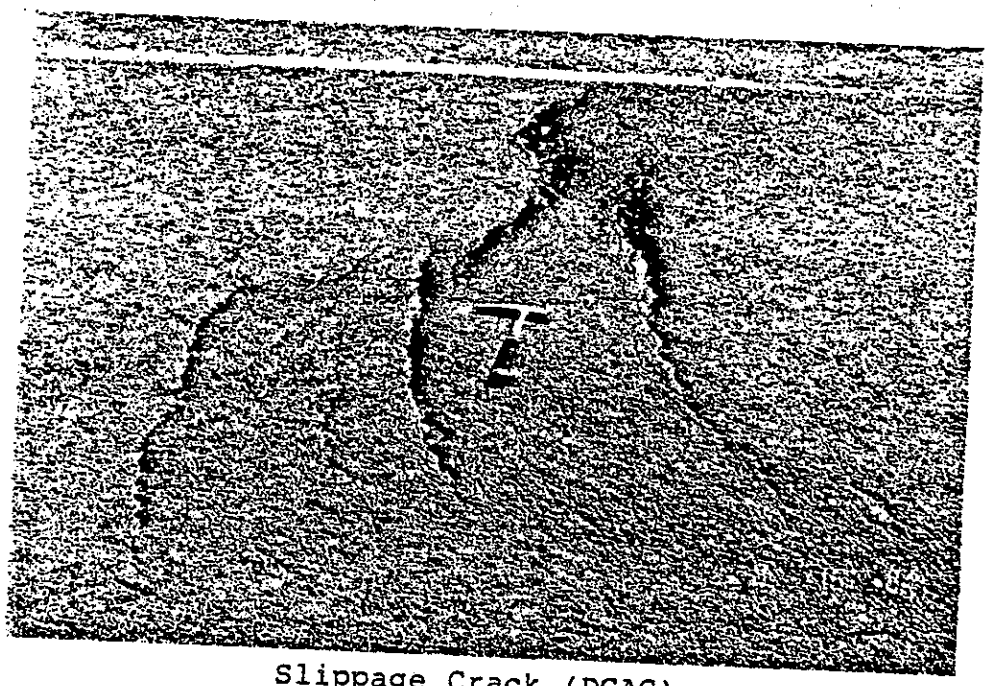
Figure 19

Slippage cracking has occurred in the southbound lane of Segment 8 (DGAC) at P.M. 98.55. A crescent-shaped crack was visible that measured 1-3/4 inches wide and extended transversely across both wheel tracks (Figure 19). It was convex to the south, downhill, and was apparently the result of vehicle braking on a poorly bonded surface course. Farther south (20' to 30') are several much smaller transverse surface "tears", each about 1/2 inch by 3 feet. They are about 20 feet apart and are in the outer wheel track. There was no sign of this problem elsewhere on the project.

Slippage Crack (DGAC)
