Crashworthiness Testing of A Portable Maintenance Work-Zone Barrier

Final Report

Report CA08-0277
December 2008

Roadside Safety Research Group
California Department of Transportation
5900 Folsom Blvd.
Sacramento, CA. 95819

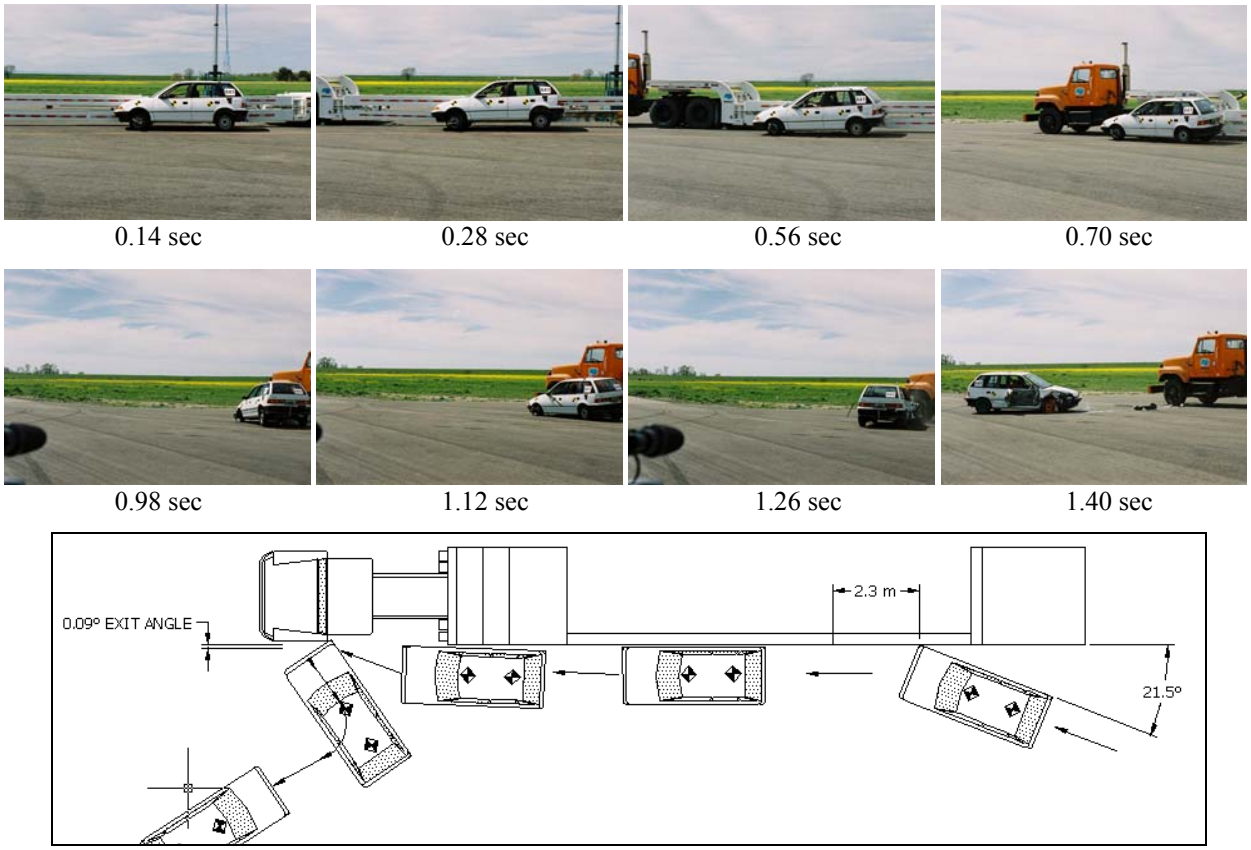
Figure 2-20. – Test 641 Impact Sequence and Diagram

After the initial impact the vehicle was smoothly redirected until the front end hit the overlap of the two box beams at 122 ms after impact. At this point the sheet metal began to snag in the overlap. The snagged sheet metal accumulated at the overlap and pushed the passenger door inward at 174 ms after impact. The vehicle lost contact with the barrier at 264 ms. The exit angle was 0.9º and the exit velocity was 57.7 km/h (35.9 mph). The right front tire was damaged during the initial impact, causing the vehicle to steer back toward the tractor truck. Roughly 380 ms after the initial impact the vehicle hit the backside of front bumper on the tractor truck. At this point the vehicle yawed to the right about its right front corner by approximately 110º before coming to a rest.

The right front corner of the vehicle sustained minor damage from the initial impact with the barrier. The amount of damage increased as the vehicle impacted the point where the box beams overlap each other. The sheet metal over the right front tire was crumpled inward and the tire deflated. The sheet metal over the passenger door was completely pulled away and the internal portion of the door was pushed inward. The final impact with the bumper on the tractor truck pushed the right front bumper of the test vehicle backward. The right front tire was also pushed back in the wheel well. Inspection of the occupant compartment revealed that there had been little to no deformation to the floorboard and firewall.

The barrier suffered minor scrapes and scratches from the impact with the vehicle. Sheet metal from the vehicle was lodged in-between the overlapping in the beams. During the impact with the vehicle, the barrier defected dynamically by 100 mm (3.94 in) and had a final static defection of 23-mm (0.91-in). The PMWB did not move from its initial location. The tractor truck had minor damage to the left side. The front bumper was push forward away from the truck slightly.

The barrier had minor scratches from the impact. A piece of the Metro's sheet metal was lodged in the area where the box beams overlap. The tractor truck had minor damage to the front end due to a secondary impact with the vehicle.

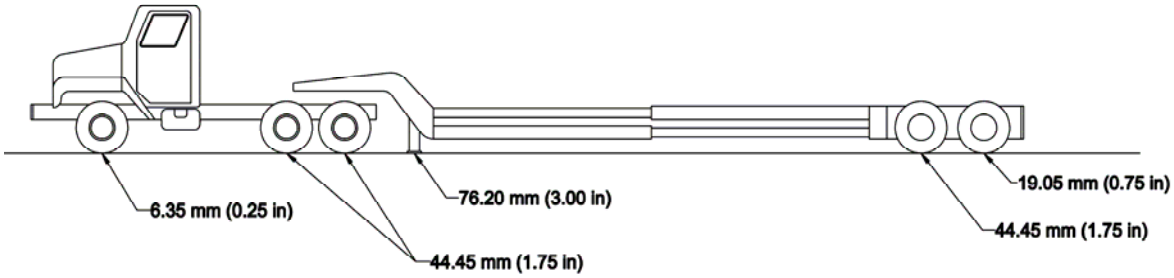
Figure 2-21. – Later Displacement of the Tractor Truck and Trailer to Test 642

During the impact with the vehicle, the barrier had a lateral dynamical deflection of 200 mm (7.87 in) and had a final static defection of 142 mm (5.59 in). Both the tractor truck and trailer were pushed away from the impact area (to the right/passenger side of the tractor truck and trailer). Figure 2-21 shows the amount of displacement of the tractor truck tires, trailer tires, and trailer brace.

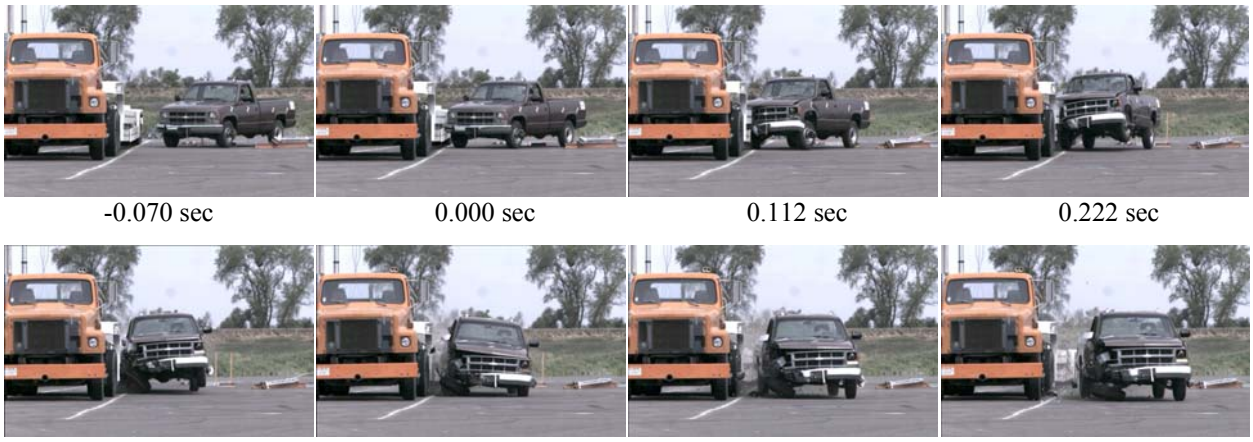
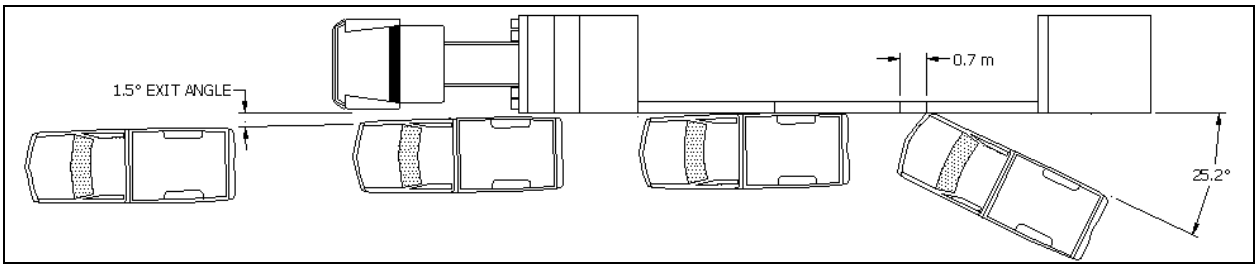
Figure 2-33. – Test 642 Impact Sequence and Diagram

The initial impact with the barrier caused the right front corner of the vehicle to deform inward and the hood to overlap the front face of the barrier. 30 ms later the vehicle impacted the overlap of the two beams. The hood of the vehicle continued to override the top of the barrier but the sheet metal covering the right front wheel well snagged on the overlap and was pulled away from the vehicle. At 132 ms much of right front corner panel was accumulated at the beam overlap and had completely torn away from the vehicle. Also, the sheet metal from the passenger door had pulled away from the vehicle. The hood of the vehicle overlapped the front face of the barrier 387 mm (15.4 in) and did not penetrate the back face of the barrier. The vehicle lost contact with the barrier at 448 ms after the initial impact. At this point the vehicle exited at an angle of 1.5° and a velocity of 45.9 km/h (28.5 mph).

The right front corner of the vehicle sustained significant damage due to the impact with the box beam overlap. Only the lower control arm was still attached to the front wheel hub assembly. All of the sheet metal that covered the right corner of the vehicle was torn away. The battery was exposed and only supported by its wiring. The right half of the front bumper was folded backward. The top of the passenger door was bent outward and the steel metal was crumpled inward.

The barrier appears to have suffered only minor damage and scraping. There was a large amount of the test vehicle's sheet metal lodged into the overlapping joint of the barrier's box beams.

The barrier suffered minor scratches caused by the vehicle. The tractor-trailer was pushed backwards slightly. A large section of sheet metal from the vehicle was wedged in-between the overlap in the box beams.

Each of the two tests conducted involved significant sheet metal damage. This was expected considering the reversed lap connection in the barrier elements for the top beam. The snagging of the sheet metal can probably be lessened if each of the beam elements were made to lap in the appropriate direction. However, this change would make a reverse hit even more damaging to the impacting vehicle.

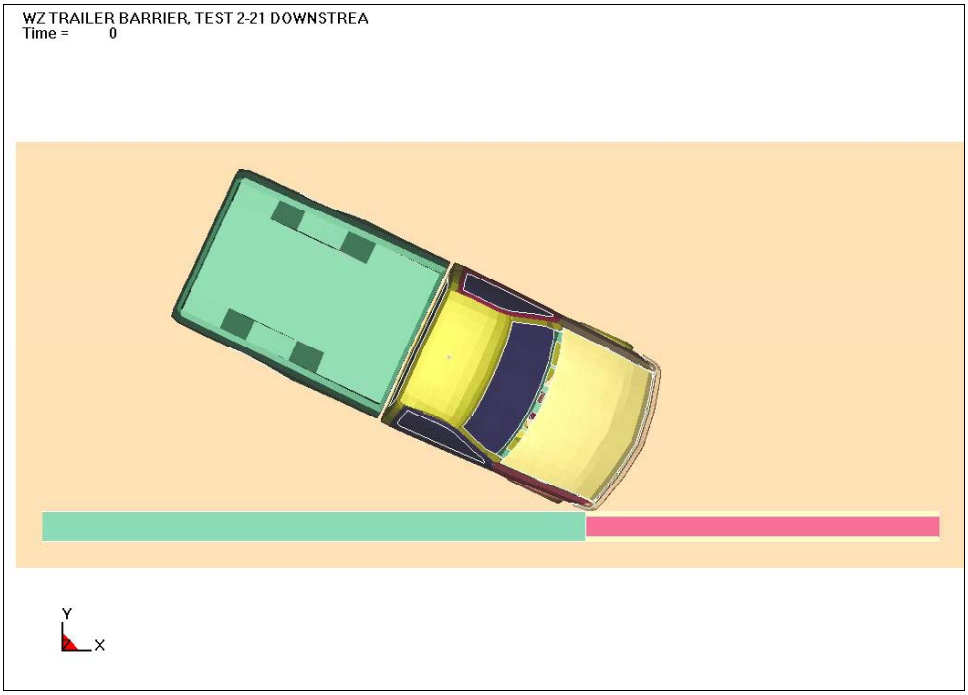
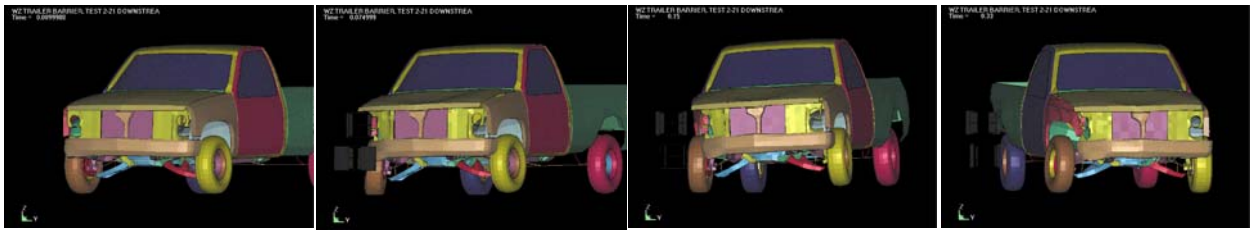
Figure 5-18. – Initial Orientation in Plan View for the Downstream Impact Simulation

m/s, both well below the limit of 12-m/s. The longitudinal ridedown acceleration was 5.1 g's and the lateral was 13.3 g's, both below the limit of 20-g's.

From the results of this computer analysis, it appears that a physical crash test conducted under the same parameters and conditions would pass. There is no guarantee, however, that these results would be replicated in a real test.
