STATE OF CALIFORNIA
DEPARTMENT OF TRANSPORTATION

Job Stamp
04-0120F4
SFOBB SAS

ASSISTANT RESIDENT ENGINEER'S **CONTRACTOR – ABFJV, Sub RPS**

Description of Operations @ W2 Cap Beam:

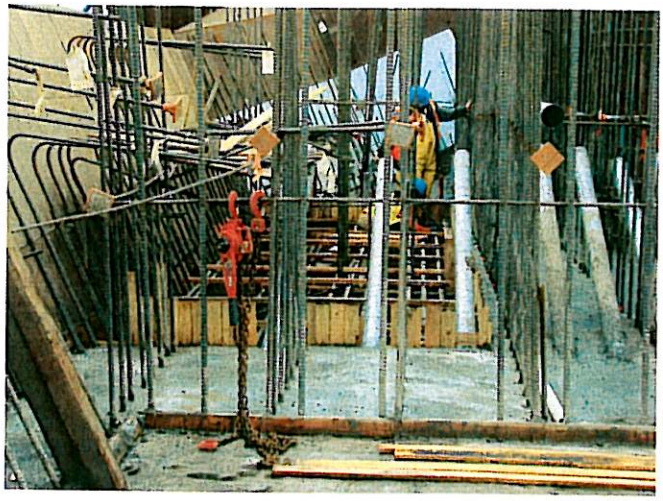
File Name:	DSC00616		
Date:	02-19-08	By Int:	M Bruce

Description: Curing mat placement of the center base slab.
