STATE OF CALIFORNIA	Job Stamp	7-day Const. Calendar	Day No. 697
DEPARTMENT OF TRANSPORTATION	SFOBB SAS	Project Work Day No.	Day No. 907
Form HC-10A (Rev. 6/80)	04-0120F4	Date	**11/9//2008**

ASSISTANT RESIDENT ENGINEER'S

CONTRACTOR – ABFJV

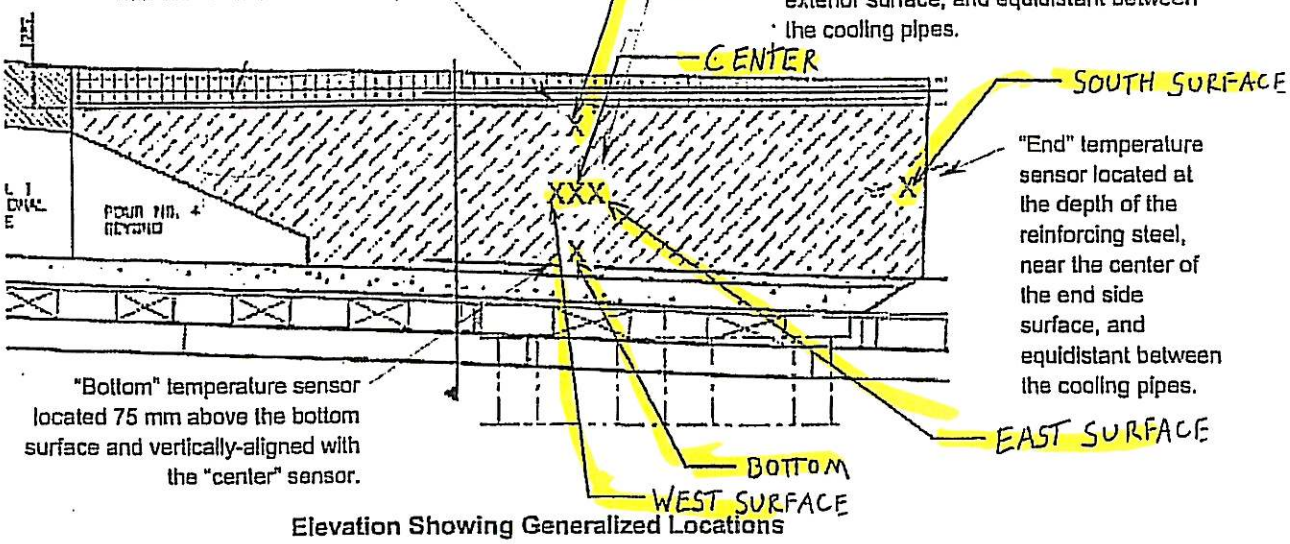
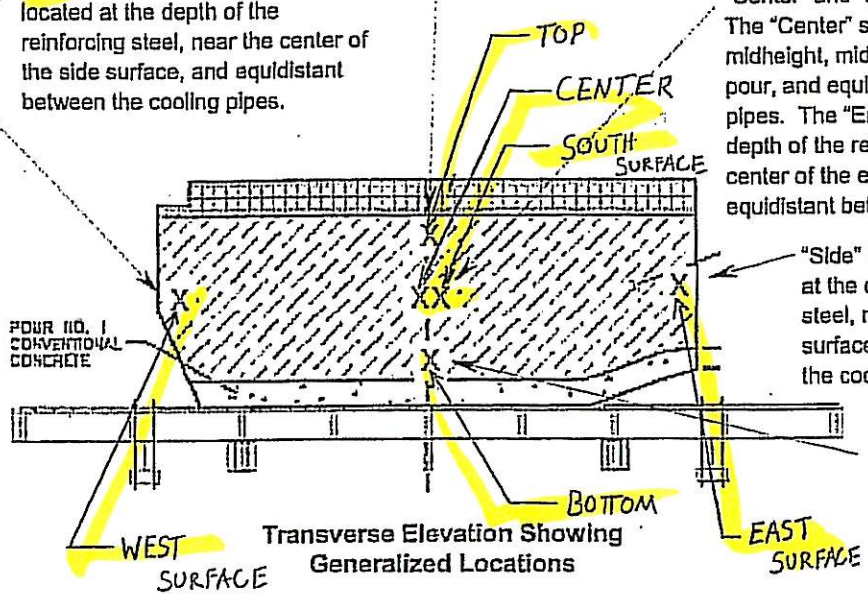
Drawing No. 8 - Temperature Monitoring Locations in Pours 4 and 5 (Not to Scale)

Note: The elevation on Drawing No. 7 illustrates "equidistant between cooling pipes".
