STATE OF CALIFORNIA
DEPARTMENT OF TRANSPORTATION

Job Stamp			
04-0120F4	Const. Calendar: 772		
SFOBB SAS	Project Work Day No.: 982		
	Date	01/23/2009	
	Inspectors Hours	Start 13:00	Stop 14:00
	Shift Hours	07:00	15:30

ASSISTANT RESIDENT ENGINEER'S **CONTRACTOR – ABFJV, Subs CMC-RS**

Description of Operations @ W2 Cap Beam:

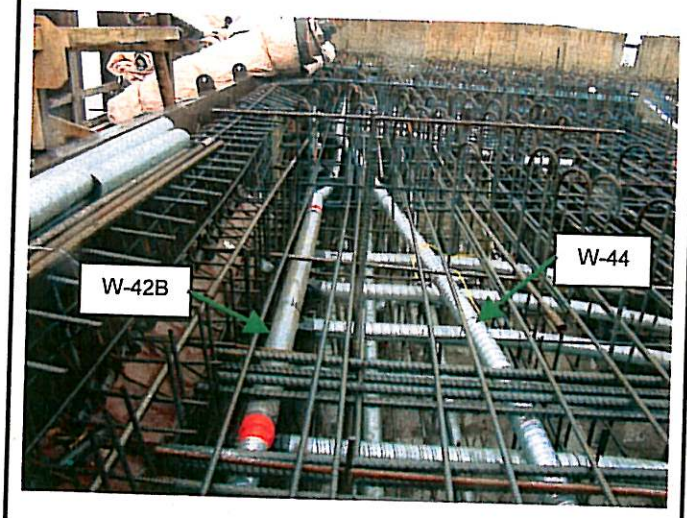
File Name:	Jan-23-2009 W2 Cap 007		
Date:	01-23-09	By Int:	M Bruce

Description: Ironworkers installing T-heads for the bikepath reinforcement on the east end of the cap beam.

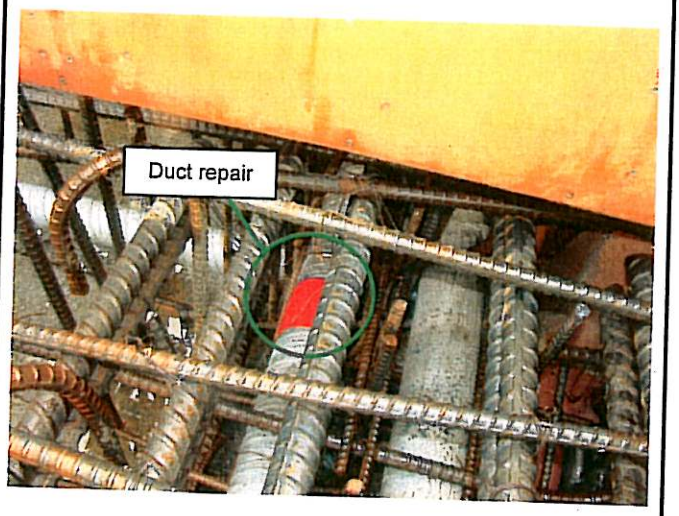
File Name:	Jan-23-2009 W2 Cap 010		
Date:	01-23-09	By Int:	M Bruce

Description: Photo taken from the west wall of the duct placement for continuity tendons W-42B and W-44.
