Daily Diary Report by Bid Item

Contract No.: 04-0120F4
Diary #: 322 **Const Calendar Day:** 637 **Date:** 07-Jun-2011 **Tuesday**
Inspector Name: Bruce, Matt **Title:** Transportation Engineer
Inspection Type: Continuous
Shift Hours: 07:00 am 05:30 pm **Break:** 00:30 **Over Time:** 02:00
Federal ID:
Location:
Reviewer: Mathur, Lalit **Approved Date:** **Status:** Submit

04-0120F4
04-SF-80-13.2/13.9
Self-Anchored
Suspension Bridge

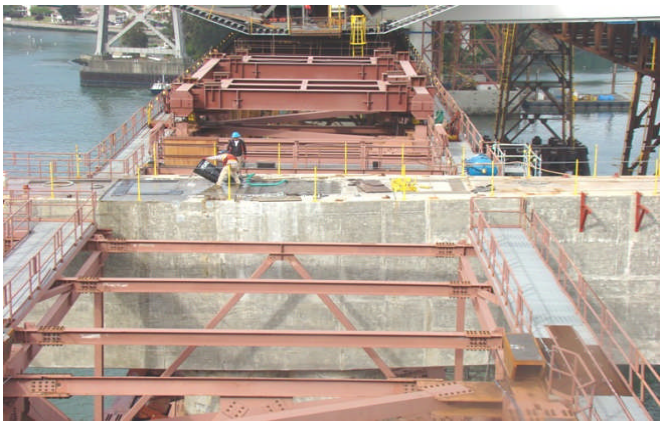
ABF ironworkers in the process of placing a bikepath panel.
