WELDING INSPECTION REPORT

Report No: WIR-002661
Date Inspected: 21-May-2008

Project Name: SAS Superstructure
Prime Contractor: American Bridge/Fluor Enterprises, a JV
Contractor: Zhenhua Port Machinery Company, Ltd (ZPMC), Changxing Island

Bridge No: 34-0006
Component: OBG

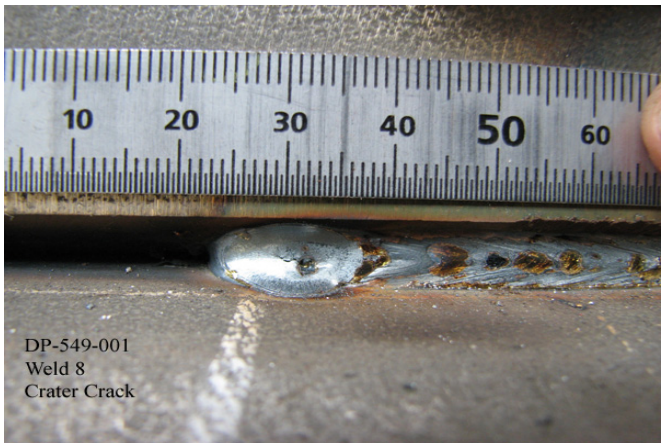
On 5-20-08, the Quality Assurance Inspector identified numerous cracked tack welds on closed rib partial joint penetration weld DP-594-001. The Quality Assurance Inspector asked ZPMC Quality Control Inspector Sun Wei if ZPMC has performed magnetic particle testing to the cracked GMAW tack welds. Sun Wei relayed that ZPMC has never performed magnetic particle testing to cracked tack welds on the closed rib connections. The Quality Assurance Inspector generated an Incident Report pertaining to failing to MT the cracked tacks on Deck Panel 594-001.

The Quality Assurance Inspector performed a random visual inspection of the GMAW tack welds of the closed rib partial joint penetration connections. The Quality Assurance Inspector marked 15 tack welds that contained crater cracks and informed Quality Control Inspector Sun Wei. Below is a digital photograph of one of the crater cracks.
