# WELDING INSPECTION REPORT

**Report No:** WIR-010173
**Date Inspected:** 26-Oct-2009

**Project Name:** SAS Superstructure
**Prime Contractor:** American Bridge/Fluor Enterprises, a JV
**Contractor:** Zhenhua Port Machinery Company, Ltd (ZPMC), Changxing Island

**Bridge No:** 34-0006
**Component:** OBG Components

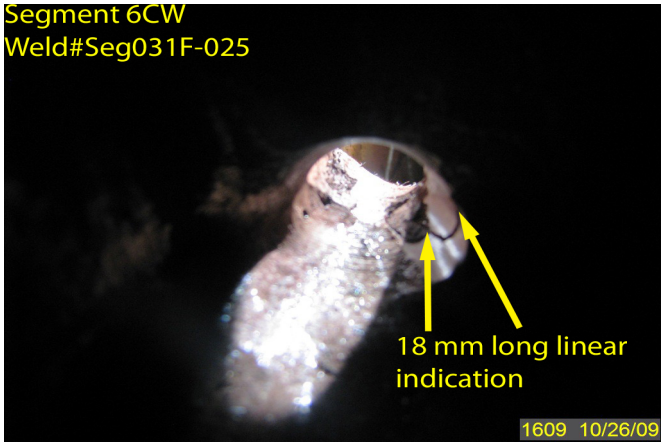
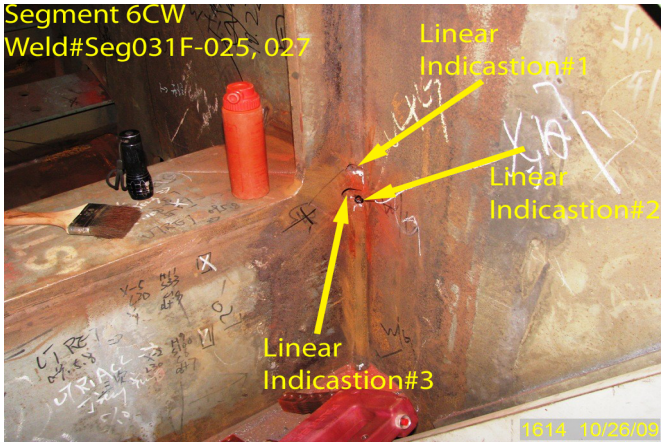
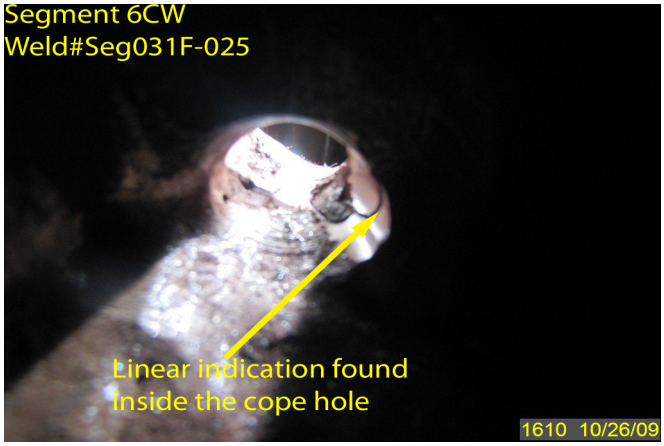
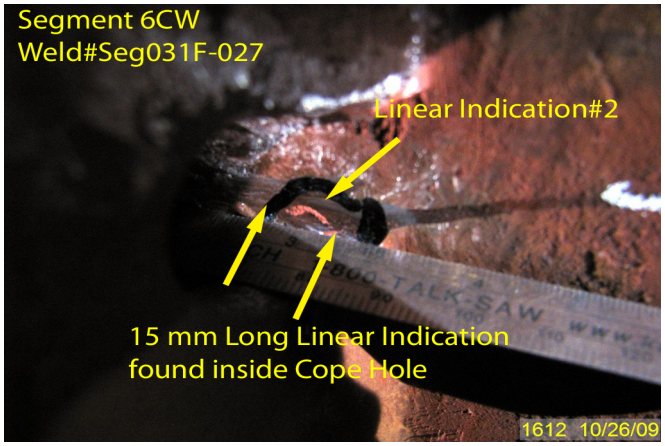
Caltrans Quality Assurance Inspector found three (03) Rejectable Indication inside the cope hole in segment6CW, weld#Seg031F-025 (18mm in length) and Seg031F-027 (two indications having 15 and 12 mm in length) during 10% Magnetic Particle Testing on the weld previously inspected and accepted by ZPMC. For further information, please see the attached pictures below.
