WELDING INSPECTION REPORT

Report No: WIR-010331
Date Inspected: 23-Nov-2009

Project Name: SAS Superstructure
Prime Contractor: American Bridge/Fluor Enterprises, a JV
Contractor: Zhenhua Port Machinery Company, Ltd (ZPMC), Changxing Island

Bridge No: 34-0006
Component: OBG Components

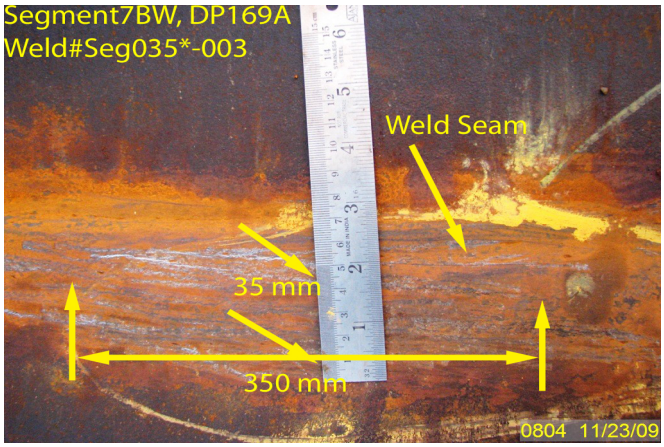
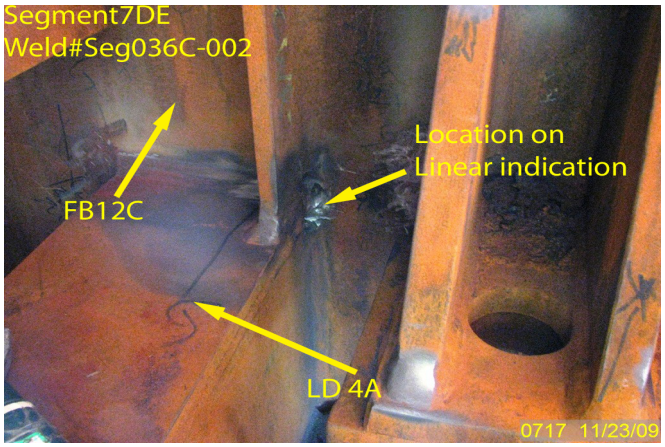
This Quality Assurance (QA) Inspector observed that a base material distortion repair was performed on Deck plate DP115A and DP169A, in way of deck panel splice weld Numbers Seg035*-002 and Seg035*-003 respectively. An aggregate length of 350mm x 35mm of filler material was deposited around the splice weld to rectify the distortion of the deck at the splice weld. This base material distortion repair was performed without the approval of the Engineer. For further information, please see the attached pictures below. Please see incident report on this date.

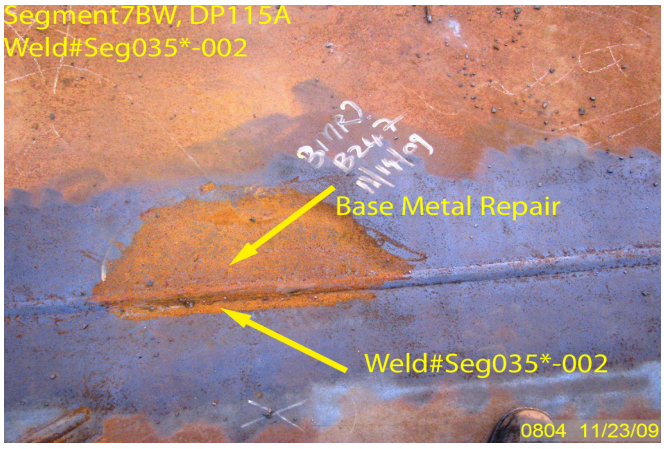
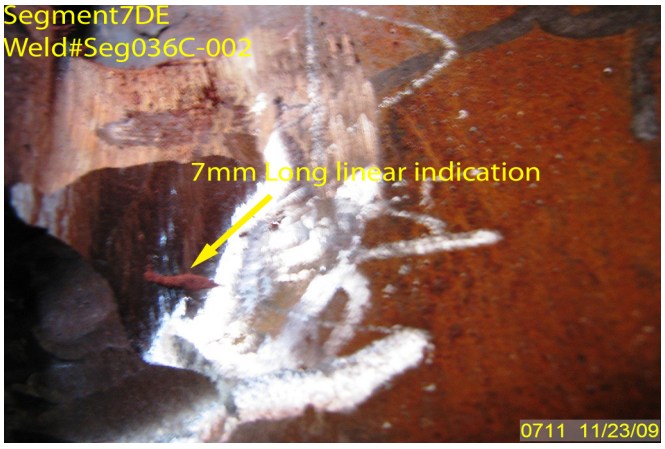
During a random 10% Magnetic Particle (MT) verification at segment 7DE, Caltrans Quality Assurance (QA) Inspectors discovered a Longitudinal linear indication on the segment 7DE Longitudinal Diaphragm (LD) to Floor Beam (FB) welds. The weld designation is as below. The indication was measured at 7mm in length. The approved weld drawings, detailed these welds as fracture critical welds (FCW).
Weld#Seg036C-002, Panel Point (PP)-056, LD to FB, CJP joint, approximately 7mm in length.
This weld was previously not tested by ZPMC MT Technician.
For further information, please see the attached pictures below. Please see incident report on this date.
Segment 7BW
