WELDING INSPECTION REPORT

Report No: WIR-010332
Date Inspected: 24-Nov-2009

Project Name: SAS Superstructure
Prime Contractor: American Bridge/Fluor Enterprises, a JV
Contractor: Zhenhua Port Machinery Company, Ltd (ZPMC), Changxing Island

Bridge No: 34-0006
Component: OBG Components

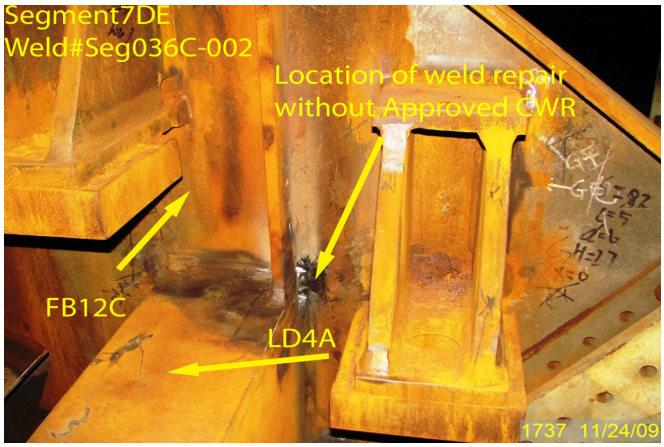
During a random 10% Magnetic Particle (MT) verification at segment 7DE, Caltrans Quality Assurance (QA) Inspectors discovered a Longitudinal linear indication on the segment 7DE Longitudinal Diaphragm (LD) to Floor Beam (FB) welds. The weld designation is as below. The indication was measured at 7mm in length.
Weld#Seg036C-002, Panel Point (PP)-056, LD to FB, CJP joint, approximately 7mm in length.
The approved weld drawings, detailed these welds as fracture critical welds (FCW) and ZPMC personal completed these weld repairs without prior Engineer approval or utilizing an approved critical weld repair procedure (CWR).
