WELDING INSPECTION REPORT

Report No: WIR-010444
Date Inspected: 01-Dec-2009

Project Name: SAS Superstructure
Prime Contractor: American Bridge/Fluor Enterprises, a JV
Contractor: Zhenhua Port Machinery Company, Ltd (ZPMC), Changxing Island

Bridge No: 34-0006
Component: OBG Components

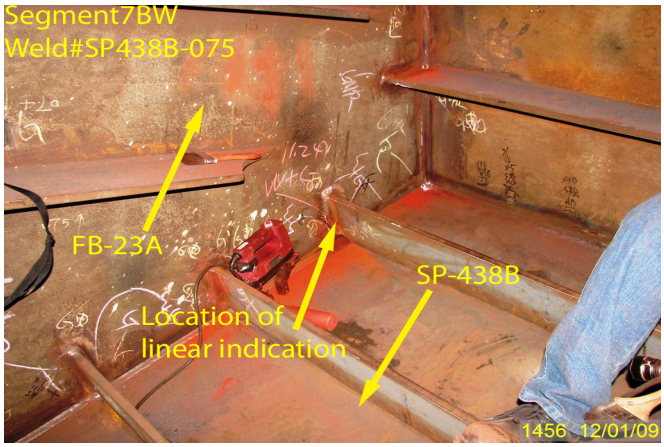
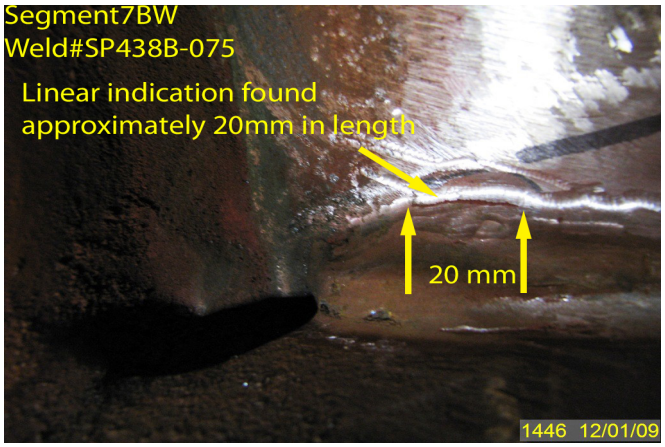
On this date Caltrans OSM Quality Assurance (QA) Inspector, Hiranch Patel, was present during the times noted above for observations relative to the work being performed.
During the Quality Assurance Magnetic Particle Testing (MT) review of welds located on Segment7BW, this Quality Assurance Inspector (QA) discovered the following issues:
-One (1) longitudinal linear indication measuring approximately 20mm in length.
-The weld is identified as: SP438B-075 @ Panel Point (PP)-051.
-The Weld is a Fillet Weld joining the Side Plate, SP438B I rib to Floor Beam, FB23A (FL3) joint.
-The OBG Segment is located at outside yard.
The Notice of Witness Inspection Number (NWIT) is 004768. The indication is located inside the area that has been previously tested and accepted by ZPMC Quality Control (QC) personnel
For further information, please see the attached pictures below. Please see incident report on this date.

Segment7BW
This QA inspector performed MT of approximately 15% of the area previously tested and accepted by ZPMC Quality Control personnel. This QA Inspector generated an MT report for this date. The member is identified as OBG Components. The weld designations reviewed are as follows:
-(SP438A-065, 064)
-(SP438B-070, 069, 074)
-(SP438B-075) Rejectable indication found
-(Seg035A-026, 015, 016, 010, 009)
-(SSD21-PP49.5-079~084, 085~090)
