WELDING INSPECTION REPORT

Report No: WIR-010726
Date Inspected: 15-Dec-2009

Project Name: SAS Superstructure
Prime Contractor: American Bridge/Fluor Enterprises, a JV
Contractor: Zhenhua Port Machinery Company, Ltd (ZPMC), Changxing Island

Bridge No: 34-0006
Component: OBG Components

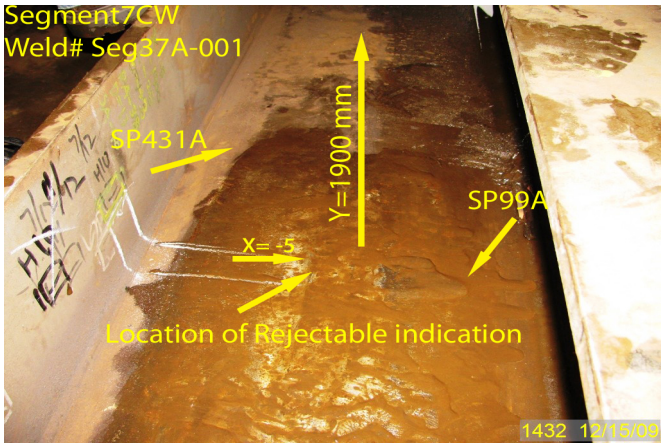
During the Quality Assurance Ultrasonic Testing (UT) review of weld located on Segment7CW, this Quality Assurance Inspector (QA) discovered the following issue:
-One (1) Rejectable Class “A” indication measuring approximately 25mm in length.
-The weld is identified as:
1. - Seg37A-001@ Panel Point (PP)-054~055, 25 mm in length.
-The Weld is a complete joint penetration (CJP) Butt Weld joining the:
1. - Side Plate. (SP)99A to SP431A joint.
-The OBG Segment is located at in front of blast shop.
The Notice of Witness Inspection Number (NWIT) is 004866. The indication is located inside the area that has been previously tested and accepted by ZPMC Quality Control (QC) personnel
For further information, please see the attached pictures below. Please see incident report on this date.
