WELDING INSPECTION REPORT

Report No: WIR-011132
Date Inspected: 28-Dec-2009

Project Name: SAS Superstructure
Prime Contractor: American Bridge/Fluor Enterprises, a JV
Contractor: Zhenhua Port Machinery Company, Ltd (ZPMC), Changxing Island

Bridge No: 34-0006
Component: Tower Components

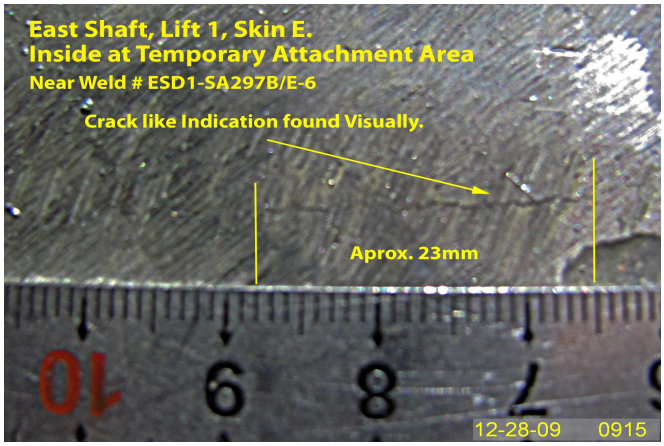
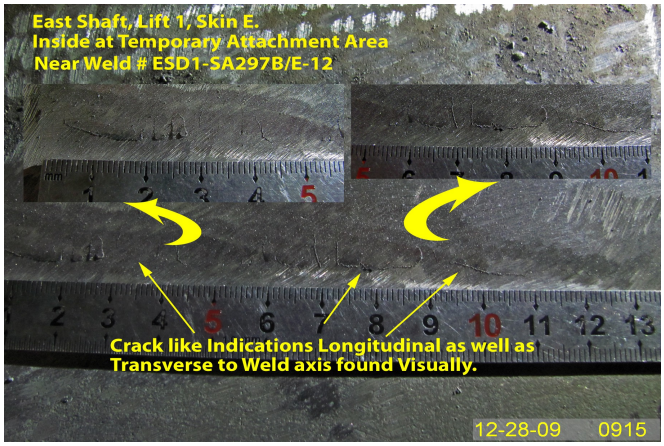
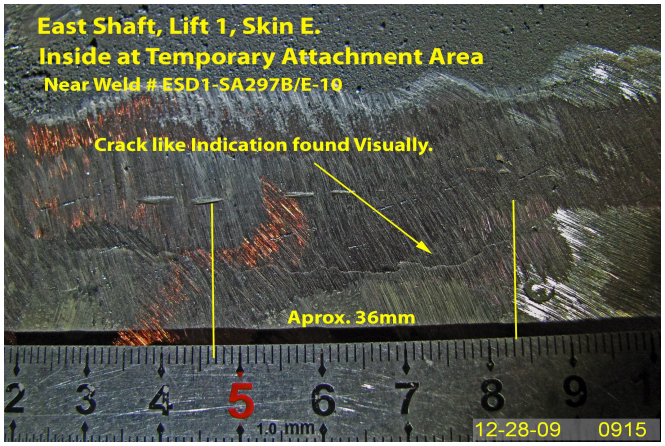
During random visual inspection at East Shaft, Lift 1, Skin E (Temporary Attachment Area near welds of bearing Stiffeners) this Caltrans Quality Assurance (QA) Inspector observed “Crack Like” indications at the removed Temporary attachment Weld area. The indications were shown to ZPMC and ABF QC Inspectors. No Incident report has been submitted on this issue. The attached photographs provide additional detail,
