DEPARTMENT OF TRANSPORTATION
DIVISION OF ENGINEERING SERVICES
Office of Structural Materials
Quality Assurance and Source Inspection

WELDING INSPECTION REPORT

Report No: WIR-011546
Date Inspected: 11-Jan-2010

Project Name: SAS Superstructure
Prime Contractor: American Bridge/Fluor Enterprises, a JV
Contractor: Zhenhua Port Machinery Company, Ltd (ZPMC), Changxing Island

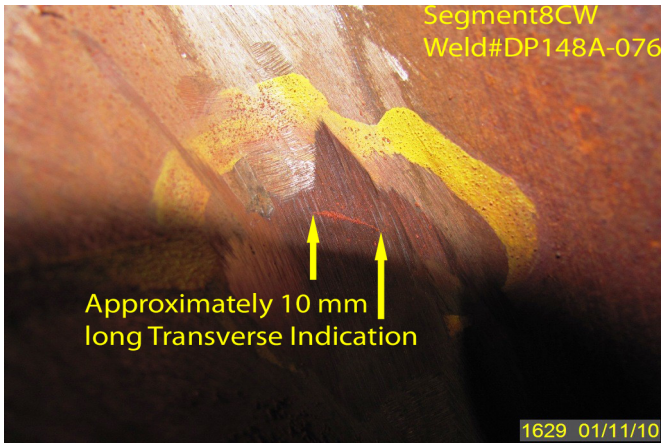
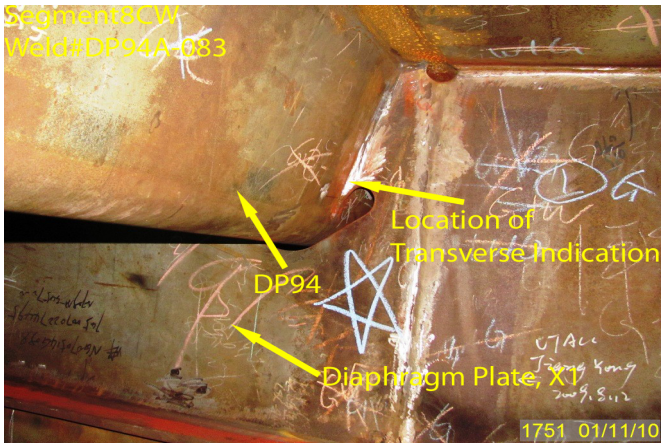
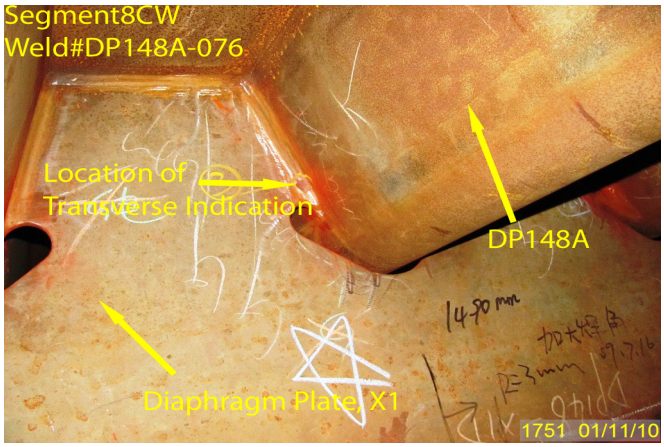
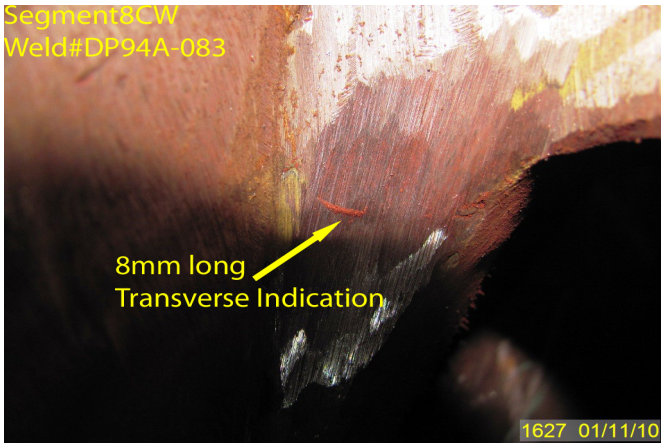
During the Quality Assurance Magnetic Particle Testing (MT) review of welds located on Segment8CW, this Quality Assurance Inspector (QA) discovered the following issues:
-Two (2) Transverse linear indication measuring approximately 8 mm and 10 mm in length.
-The welds are identified as: DP94A-083 (8 mm) and DP148A-076 (10 mm).
-The welds are a CJP Weld type joining the DP148A and DP94A Closed Ribs to Deck panel diaphragm plate X1.
-The OBG 8BE segment is located at In front of blast shop.
The Notice of Witness Inspection Number (NWIT) is 005037. The indication is located inside the area that has been previously tested and accepted by ZPMC Quality Control (QC) personnel. ZPMC's QC personnel are required to perform twenty five (25%) percent MT inspection of this weld.
For further information, please see the attached pictures below. Please see incident report on this date.

-(DP148A-058, 063, 068, 071, 079, 084, 087, 092, 095)
-(DP175A-058, 063, 068, 071, 076, 079, 084, 087, 092, 095)
-(DP229A-100, 105, 110, 113, 118, 121, 126, 129, 134, 137)
-(DP256A-100, 105, 110, 113, 118, 121, 126, 129, 134, 137)
-(DP536A-100, 105, 110, 113, 118, 121, 126, 129, 134, 137)
-(DP148A-076)-Rejectable indication found
-(DP94A-083)-Rejectable indication found
