WELDING INSPECTION REPORT

Report No: WIR-011904
Date Inspected: 01-Feb-2010

Project Name: SAS Superstructure
Prime Contractor: American Bridge/Fluor Enterprises, a JV
Contractor: Zhenhua Port Machinery Company, Ltd (ZPMC), Changxing Island

Bridge No: 34-0006
Component: Tower Components

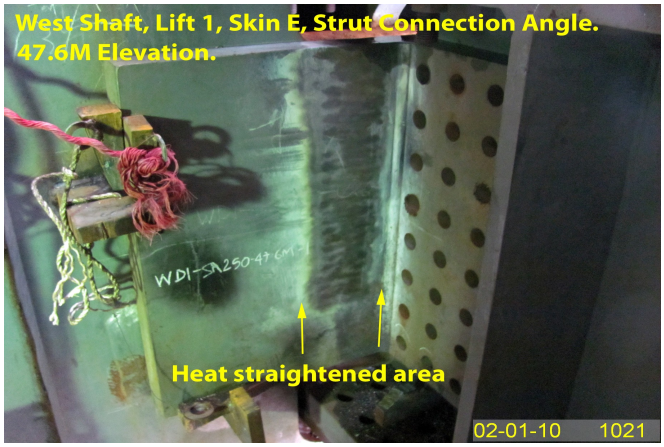
During the Quality Assurance (QA) random in-process visual inspection this QA inspector observed ZPMC Heat straightened some of the Strut connection angles on 47.6M Elevation. the Strut connection angles are identified as-

1) WD1-SA183-47.6M-3.
2) WD1-SA250-47.6M-1.
3) WD1-SA250-18M-2.
